IMPORTANT PRODUCT INFORMATION

Product: PACSystems™ RX7i CPUs

IC698CPE010-EJ (300 MHz), CPU Firmware Version 3.11

IC698CPE020-EJ (700 MHz), CPU Firmware Version 3.11

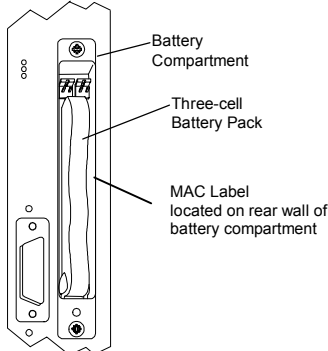
Subject	Description
MAC address	<p>A label on the rear wall inside the CPU's battery compartment identifies the MAC address assigned to the CPU's embedded Ethernet Interface. The label is visible when the battery is removed from its compartment. (The battery does not need to be disconnected to temporarily remove it from the compartment.)</p>

<p>The diagram shows a vertical battery compartment. At the top is a circular opening labeled 'Battery Compartment'. Below it is a 'Three-cell Battery Pack'. On the right side of the compartment, there is a small rectangular label labeled 'MAC Label located on rear wall of battery compartment'.</p>
Configuration of IP Address is Required Before Using Ethernet Communications	<p>The Ethernet Interface within the CPU module cannot operate on a network until a valid IP address is configured. The necessary Ethernet addressing information must be configured prior to actual network operation, or to recover from inadvertent changes to the Ethernet addressing data at the Ethernet Interface. Use one of the following methods to initially assign an IP address:</p> <ul style="list-style-type: none"> ■ Connect a serial terminal to the Station Manager port of the PACSystems RX7i . Then use the CHSOSW command to enter the desired IP address. For details, see the <i>PACSystems TCP/IP Communications Station Manager</i> manual, GFK-2225. ■ Temporarily assign an IP address to the module using the SetIP tool over the Ethernet network. For details, see <i>TCP/IP Ethernet Communications for PACSystems</i>, GFK-2224. ■ The Ethernet Interface automatically obtains a temporary IP Address from a BOOTP server on the network. For details, see <i>TCP/IP Ethernet Communications for PACSystems</i>, GFK-2224.
