Document No.: 200-RN-001

S911 Bracelet Firmware and Utility Release Note

Version 2.04

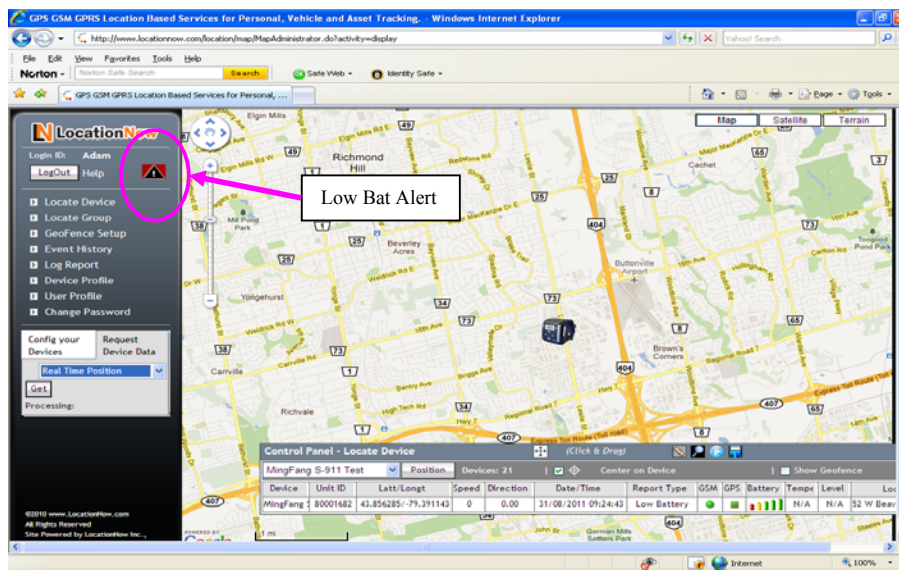
**Fig. 1**

- Generate a flashing trigger indication on operation menu, see Fig. 1 below
- Send a alert email to destination preset by user

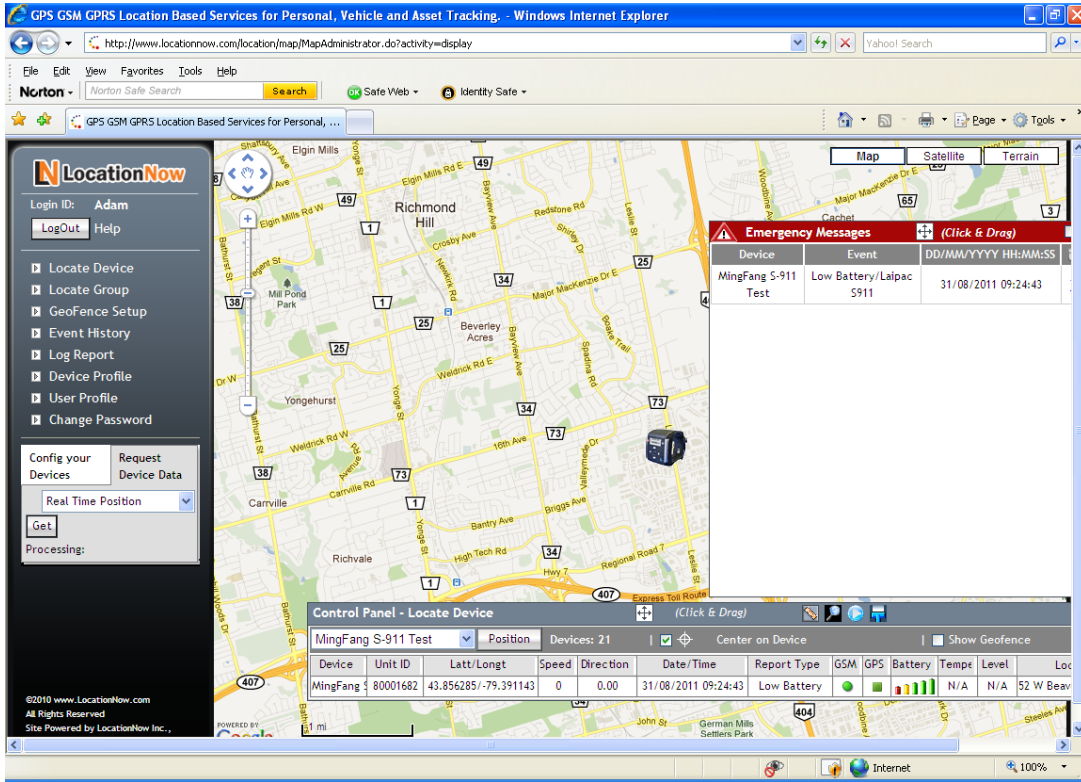
Click this alert icon, an Emergency Message window will popped out to tell user what kind of event alert it stands for. See Fig. 2 above.

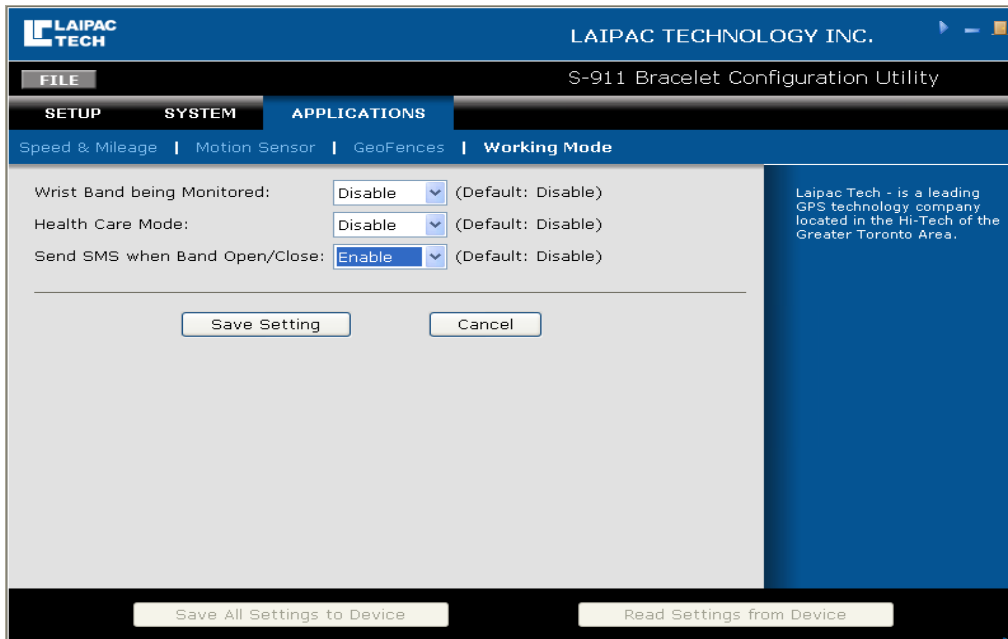
1. **Bracelet Utility Rev 0.8.929.6 (new)** should be used by user to upgrade his Bracelet unit to BL V1.46 firmware and configure hi/hers unit. See detail download and configuration operation procedure in other relative document.
2. After download new firmware to unit, user must go through re-configuration procedure below
 - a. Read the current configuration from the unit
 - b. Revise those setting if it is necessary
 - c. Save this new setting back to unit
 - d. Remove the USB connection cable
 - e. Power down and power on the unit
3. BL V1.46 is coming with the following new features
 - a. When Bracelet-ST unit detects its security band is being opened or closed, it can send SMS message to the destination requested by Emergency No.1. Bracelet-ST user can select this function by enabling the item “Send SMS when Band open/close”, see below

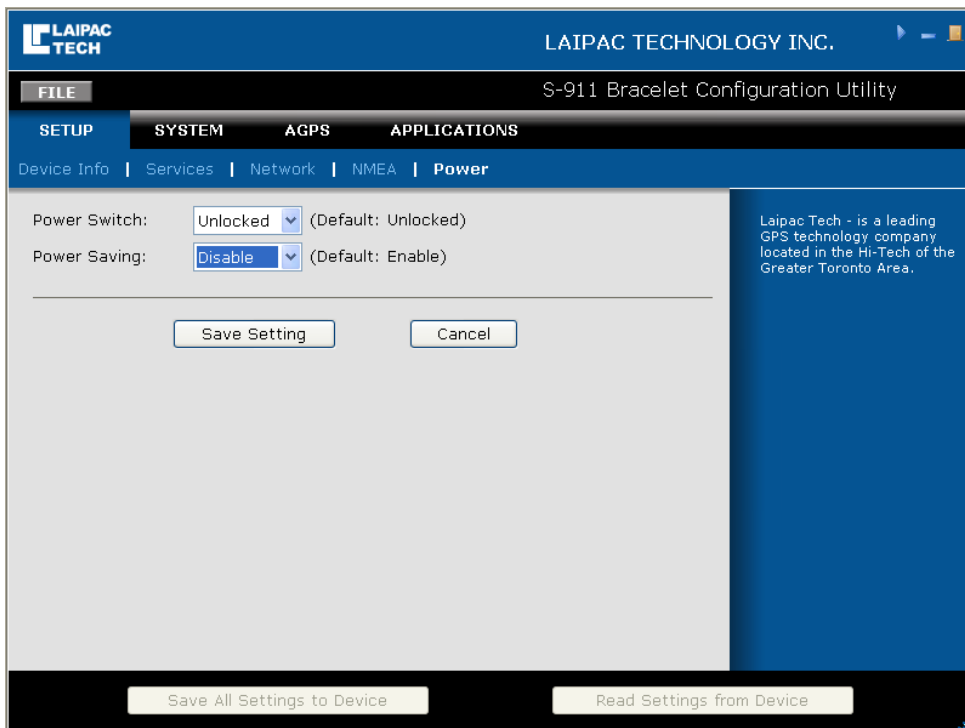
1. **Bracelet Utility Rev 0.8.929.4** can be used by user to upgrade his Bracelet unit to BL V1.42 firmware and configure his unit. See detail downloading and configuration operation procedure in other relative document.
2. After download new firmware to unit, user must go through re-configuration procedure below
 - a. Read the current configuration from the unit
 - b. Revise those setting if it is necessary
 - c. Save this new setting back to unit
3. BL V1.42 has featured by better geo-fence performance. To fully use this new feature, user should set the “Power” option as “Disable”, see picture below.

5. If select “Power” as “Enable”, unit will work under its power saving mode. On average, if unit is in normal GPS and GSM signal receiving condition, it is able to keep working close to 36 hours when unit’s report time interval is 15 minute.
5. BL v1.42 also further improve the performance to develop GSM connection
