**Release Notes**  
**Schroff firmware part number 63998-08165**  
**Based on Pigeon Point Systems (PPS) firmware release 2.7.4 for ShMM-500**

**Release Date: July 01, 2011**

The firmware package “63998-08165.zip” contains Firmware release 2.7.4 for the **ShMM-500**. The PPS supplied RFS image has been modified by Schroff to adapt the firmware to Schroff ATCA shelves. The kernel image has not been modified and is identical to the PPS kernel image. The U-boot environment has been modified to reflect the necessary non-volatile system settings for this firmware running on Schroff shelf managers. The Schroff part number for this firmware release is 63998-08165.

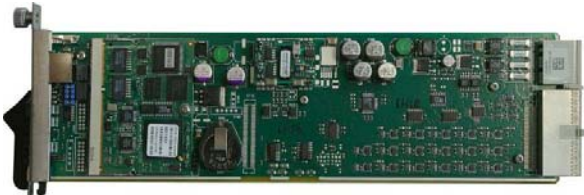
| Photo | Type | RC2-variable |
|---|---|---|
| <p><b>Note: If you have this shelf manager in your Zephyr or Ventus shelf please follow the special upgrade instructions.</b></p> <p>The part number of the ACB-IV shelf manager is on the label at the rear side of the shelf manager, see photo below:</p> <ul style="list-style-type: none"> <li>- Radial IPMB version: p/n = 21594-347</li> <li>- Bused IPMB version: p/n = 21594-346</li> </ul> | ACB-IV | rc.acb-HPDL |

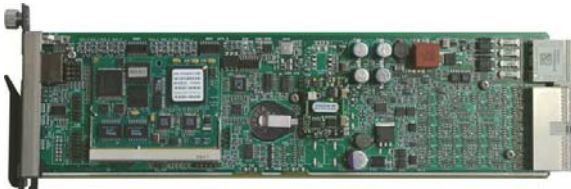
| Photo | Type | RC2-variable |
|---|---|---|
| <p>The part number of the ACB-III shelf manager is on the label at the rear side of the shelf manager, see photo below:</p> <ul style="list-style-type: none"> <li>- Radial IPMB version: p/n = 21593-251</li> <li>- Bused IPMB version: p/n = 21593-250</li> </ul> | ACB-III | rc.acb3 |

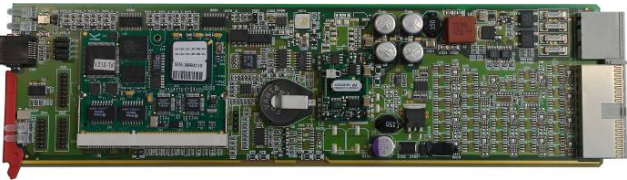
The following Shelf Manager types originally shipped with ShMM-300 modules but might have been upgraded to ShMM-500 modules by the customer

| | ACB-III | rc.acb3e |

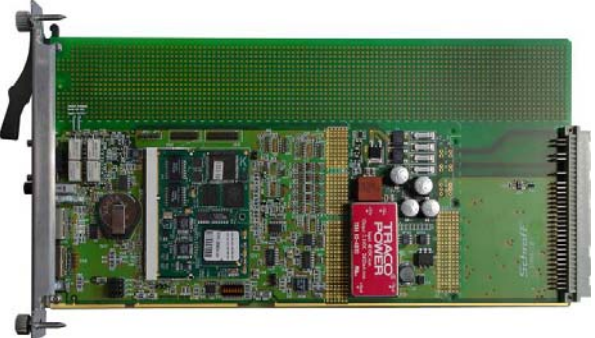
| | ACB-II<br>ACB-II with ShMM-500 | rc.acb2<br>rc.acb2-HPDL |

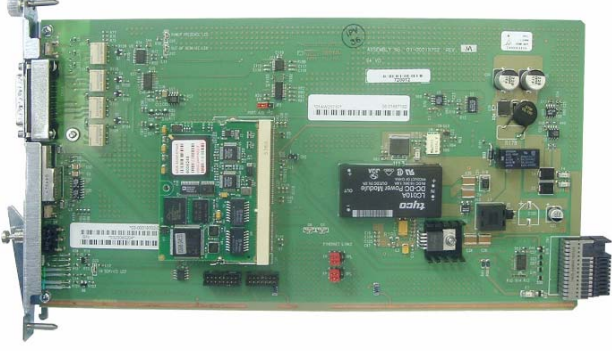
| | SMC-1 | rc.acb-es |
