IMPORTANT PRODUCT INFORMATION

Product: IC693CPU364 CPU Module with Ethernet Interface

IC693CPU364-BE with Limited Production Firmware Release 10.10

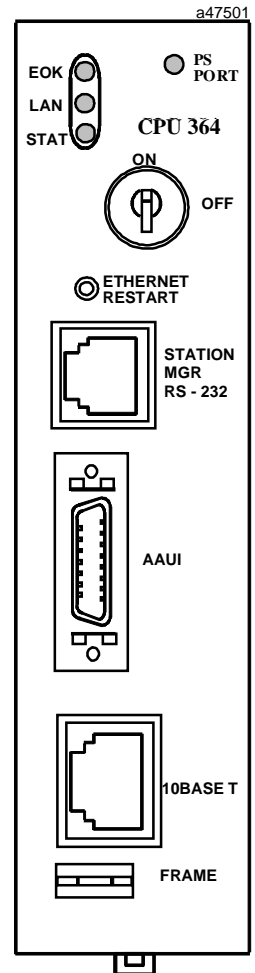
Note: On some modules the LED labeled "PS PORT" may say "SNP," and/or the port labeled "STATION MGR RS-232" may say "PORT 1 RS-232"; these are labeling changes only - the functionality was not changed.
