# GENERAL INFORMATION

## TROUBLESHOOTING

# Troubleshooting

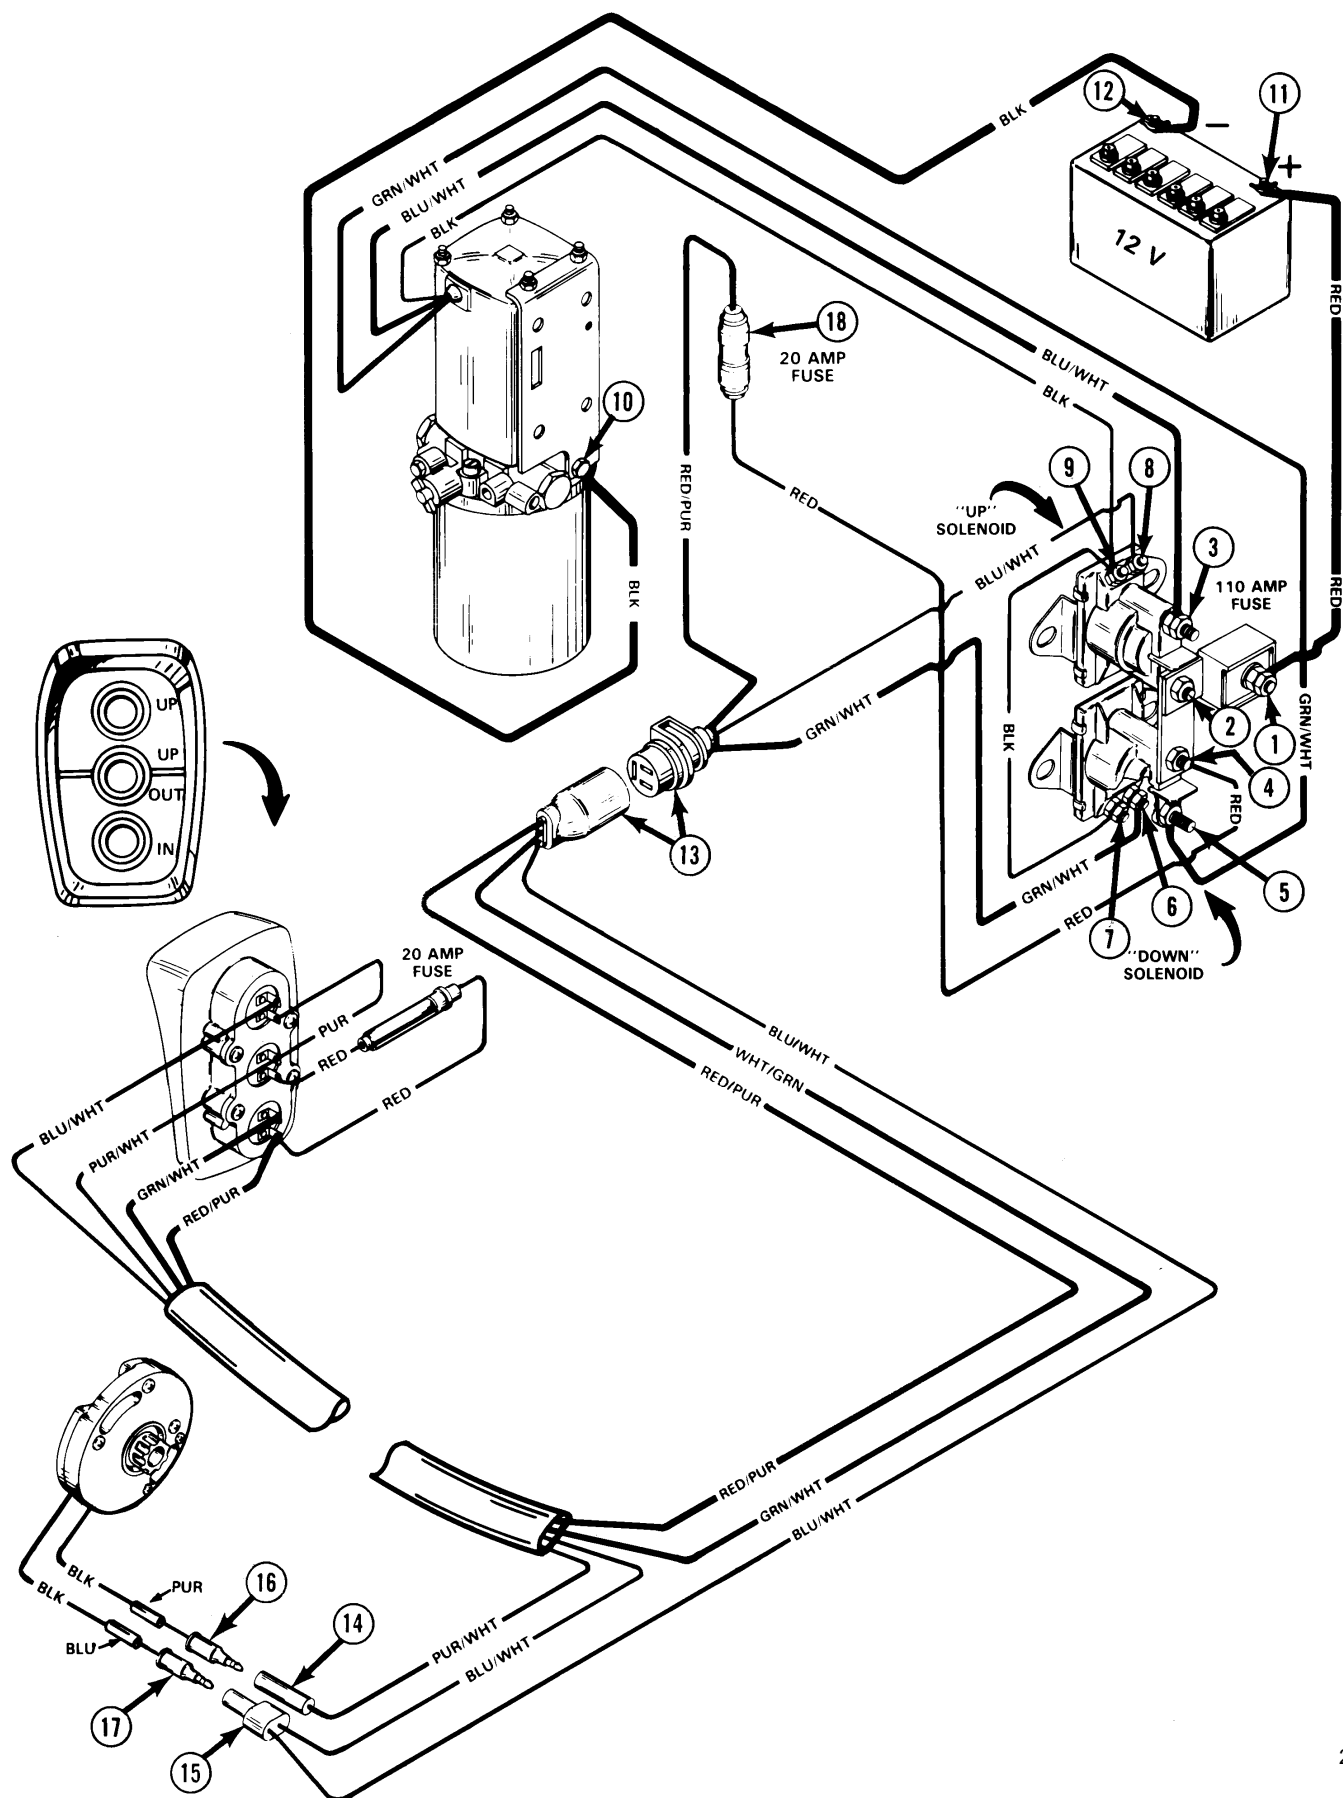
26351

Wiring Diagram (With 3-Button Trim Control)

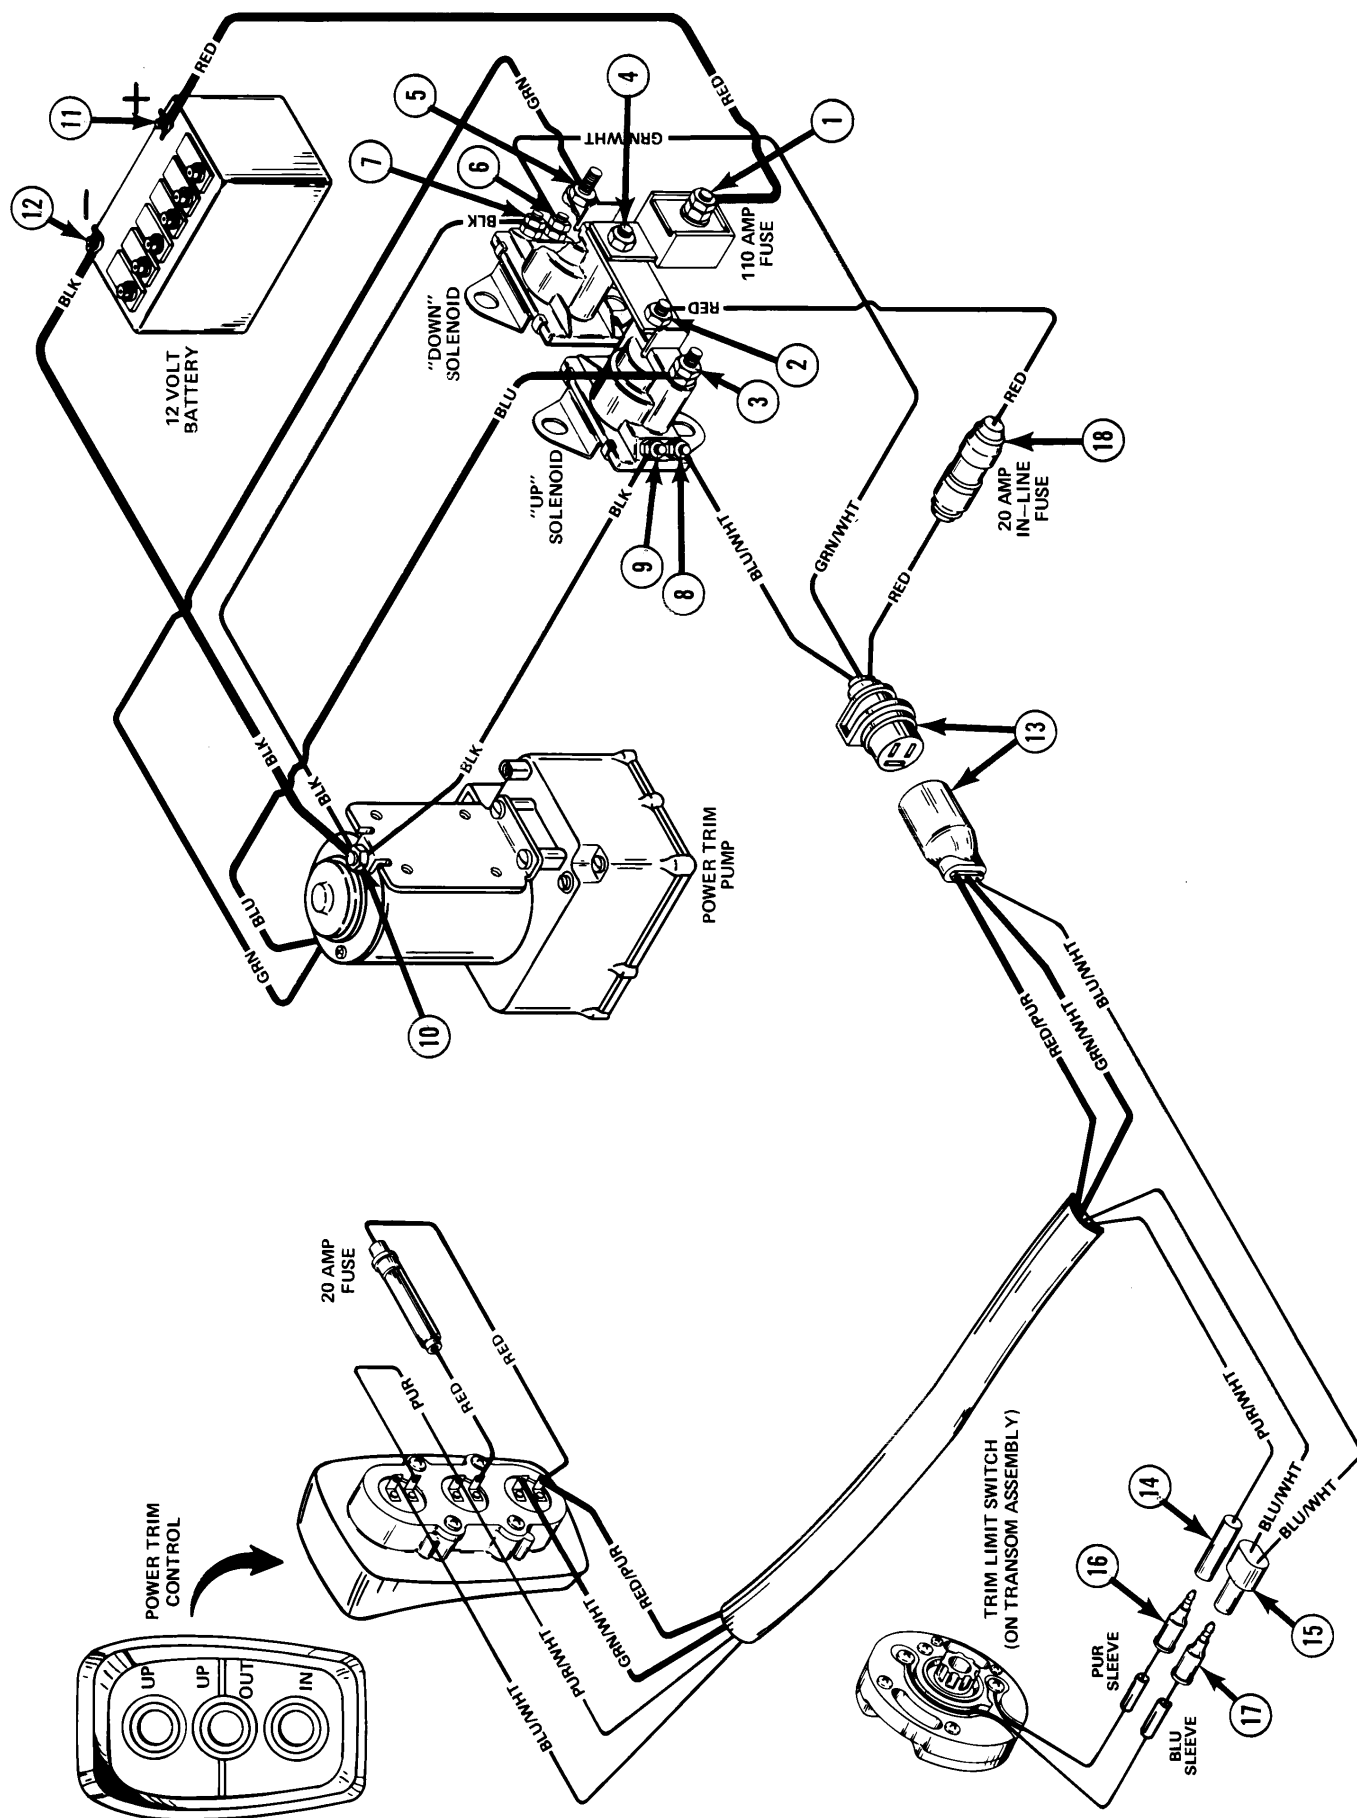
**Power Trim Electrical System Wiring Diagram (with 3-Button Trim Control)**

**NOTE:** Refer to wiring diagram, following, for assistance in electrical system troubleshooting.

Cause	Remedy
1. Pump positive battery cable connection loose or corroded.	1. Check cable "14."
2. 110 amp fuse blown or loose, or corroded solenoid connection.	2. Check for voltage at terminal "5."
3. Pump motor brushes stuck, corroded or worn out.	3. Clean or replace.
4. Armature commutator dirty.	4. Clean or replace.
5. Armature faulty.	5. Test and replace if bad.
6. Field and frame faulty.	6. Test and replace if bad.
7. Pump gears frozen.	7. Replace pump adaptor.
8. Trim harness shorted between UP and DOWN circuit.	8. Disconnect blue-white lead "2" from solenoid terminal. If pump motor will now run in the DOWN direction, a short in the harness is indicated.

Cause	Remedy
1. Pump negative battery cable loose, corroded or damaged	1. Check cable "13" for a loose or corroded connection, or damage.
2. Mode switch wiring harness connector is loose at pump.	2. Secure connection "47."

3. Faulty thermal circuit breaker in pump motor.	3. Connect a jumper wire between terminals "1" and "7." If pump now operates, circuit breaker is faulty and field and frame assembly must be replaced.

6. Faulty mode switch.	6. Check for voltage at terminal "24" (with mode switch in "Auto" mode) and terminal "26" (with switch in the "Manual" mode). Replace switch if no voltage is indicated.

Cause	Remedy
1. Loose or Dirty solenoid connections.	1. Check connections "4," "7," and "12."
2. Faulty mode switch or open in DOWN circuit.	2. Check for voltage at terminal "12" while trimming DOWN (in "Manual" mode). If no voltage is indicated, repeat test at terminal "22" and "23." If voltage exists at terminal "23," but not at "22" switch is faulty. If voltage is present at terminal "22," check leads "3" and "48" and connector "47" for an open condition.
3. Faulty DOWN solenoid.	3. Replace.

<b>Cause</b>	<b>Remedy</b>
1. Loose or dirty solenoid connections.	1. Check connections "10" and "11."
2. Faulty solenoid.	2. Check for voltage at terminal "11" while trimming DOWN (in "Manual" mode). If no voltage is indicated, replace solenoid.
3. Faulty DOWN field winding.	3. Replace field and frame.

<b>Cause</b>	<b>Remedy</b>
1. Loose or dirty solenoid connections.	1. Check connections "5" and "6."
2. Faulty solenoid.	2. Check for voltage at terminal "6" while trimming UP. If no voltage is indicated, replace solenoid.
3. Faulty UP field winding.	3. Replace field and frame.

Cause	Remedy
1. Loose or dirty solenoid connection.	1. Check connections "7" and "8."
2. Faulty solenoid.	2. Check for voltage at terminal "8" while trimming UP (in Manual mode). If voltage exists, an open condition in solenoid is indicated and solenoid must be replaced. If no voltage is indicated, refer to steps 3 through 6 following.
3. Loose or corroded trim limit switch lead connections.	3. Check connections "32" and "36."
4. Faulty trim limit switch.	4. Disconnect trim limit switch leads "32" and "36" and connect a continuity meter between leads. Continuity should exist with drive unit in DOWN position. If not, readjust or replace switch as necessary.
5. Open circuit in wiring harness.	5. Check leads "30," "35," "46," and "2" for loose or corroded connections or physical damage.
6. Faulty control module.	6. Replace.

Cause	Remedy
1. Open in control module battery cables or wiring harness.	1. Check cables "16" and "18," and lead "20."
2. Faulty mode switch.	2. Check for voltage at terminal "24" and "25" with switch in Auto mode. If voltage exists at terminal "25," but not "24," switch is faulty.
3. Faulty control module.	3. Replace.

1. Open circuit in control module sense lead.	1. Check lead "17" (in Figure 12) for loose or corroded connections or damage.
2. Faulty control module.	2. Replace.

Cause	Remedy
1. Faulty mode switch.	1. Check for voltage at terminal "21" and "22" while turning ignition switch to "Run" position (in "auto" mode). If voltage exists at "21", but not at "22", switch is faulty.
2. Open circuit in wiring.	2. Check lead "19" for a loose or corroded connection or damage.
3. Faulty control module.	3. Replace.

Cause	Remedy
1. Faulty mode switch.	1. Check for voltage at terminal "26" with mode switch in "Manual" mode. If no voltage is indicated, replace switch.
2. Open circuit wiring harness.	2. Check leads "27" and "33" for loose or corroded connections or damage.

Cause	Remedy
1. Faulty IN/DOWN switch in manual trim control.	1. Check for voltage at terminal "38" while trimming IN/DOWN (in "Manual" mode). If no voltage is indicated, switch is faulty.
2. Open circuit in wiring harness.	2. Check for voltage at terminal "23" while trimming IN/DOWN. If no voltage is present, check leads "28" and "34" for a loose or corroded connection or damage.
3. Faulty mode switch.	3. Check for voltage at terminal "22" while trimming IN/DOWN. If no voltage exists, switch is faulty.

Cause	Remedy
1. Trim control 20 amp fuse (if so equipped) - "43" blown.	1. Determine cause for blown fuse and correct before replacing fuse.
2. Open in power supply lead to trim and trailer switch.	2. Check voltage at terminal "44." If no voltage is indicated, check lead "45" for a poor connection or damage.
3. Faulty trim OUT/UP switch (applies only to trim controls where it is necessary to actuate trim UP switch in order for trailer switch to function).	3. Check for voltage at terminal "40" while actuating trim OUT/UP switch. Replace switch if no voltage is indicated.

Cause	Remedy
1. Faulty trim OUT/UP switch (applies only to trim controls where it is not necessary to actuate trim UP switch in order for trailer switch to function - not shown).	1. While actuating switch, check for voltage at output terminal. Replace switch if voltage is not indicated.
2. Open circuit in wiring harness	2. Check leads "31" and "37" for loose or corroded connections or damage.
3. Faulty control module.	3. Replace.

Cause	Remedy
1. Faulty trailer switch.	1. Check for voltage at terminal "41" and "42" while actuating trailer switch. If voltage exists at terminal "42," but not at terminal "41," a faulty switch is indicated. If no voltage exists at terminal "42," check power supply lead for an open.
2. Open in wiring.	2. Check lead "39" for a loose or corroded connection or damage.

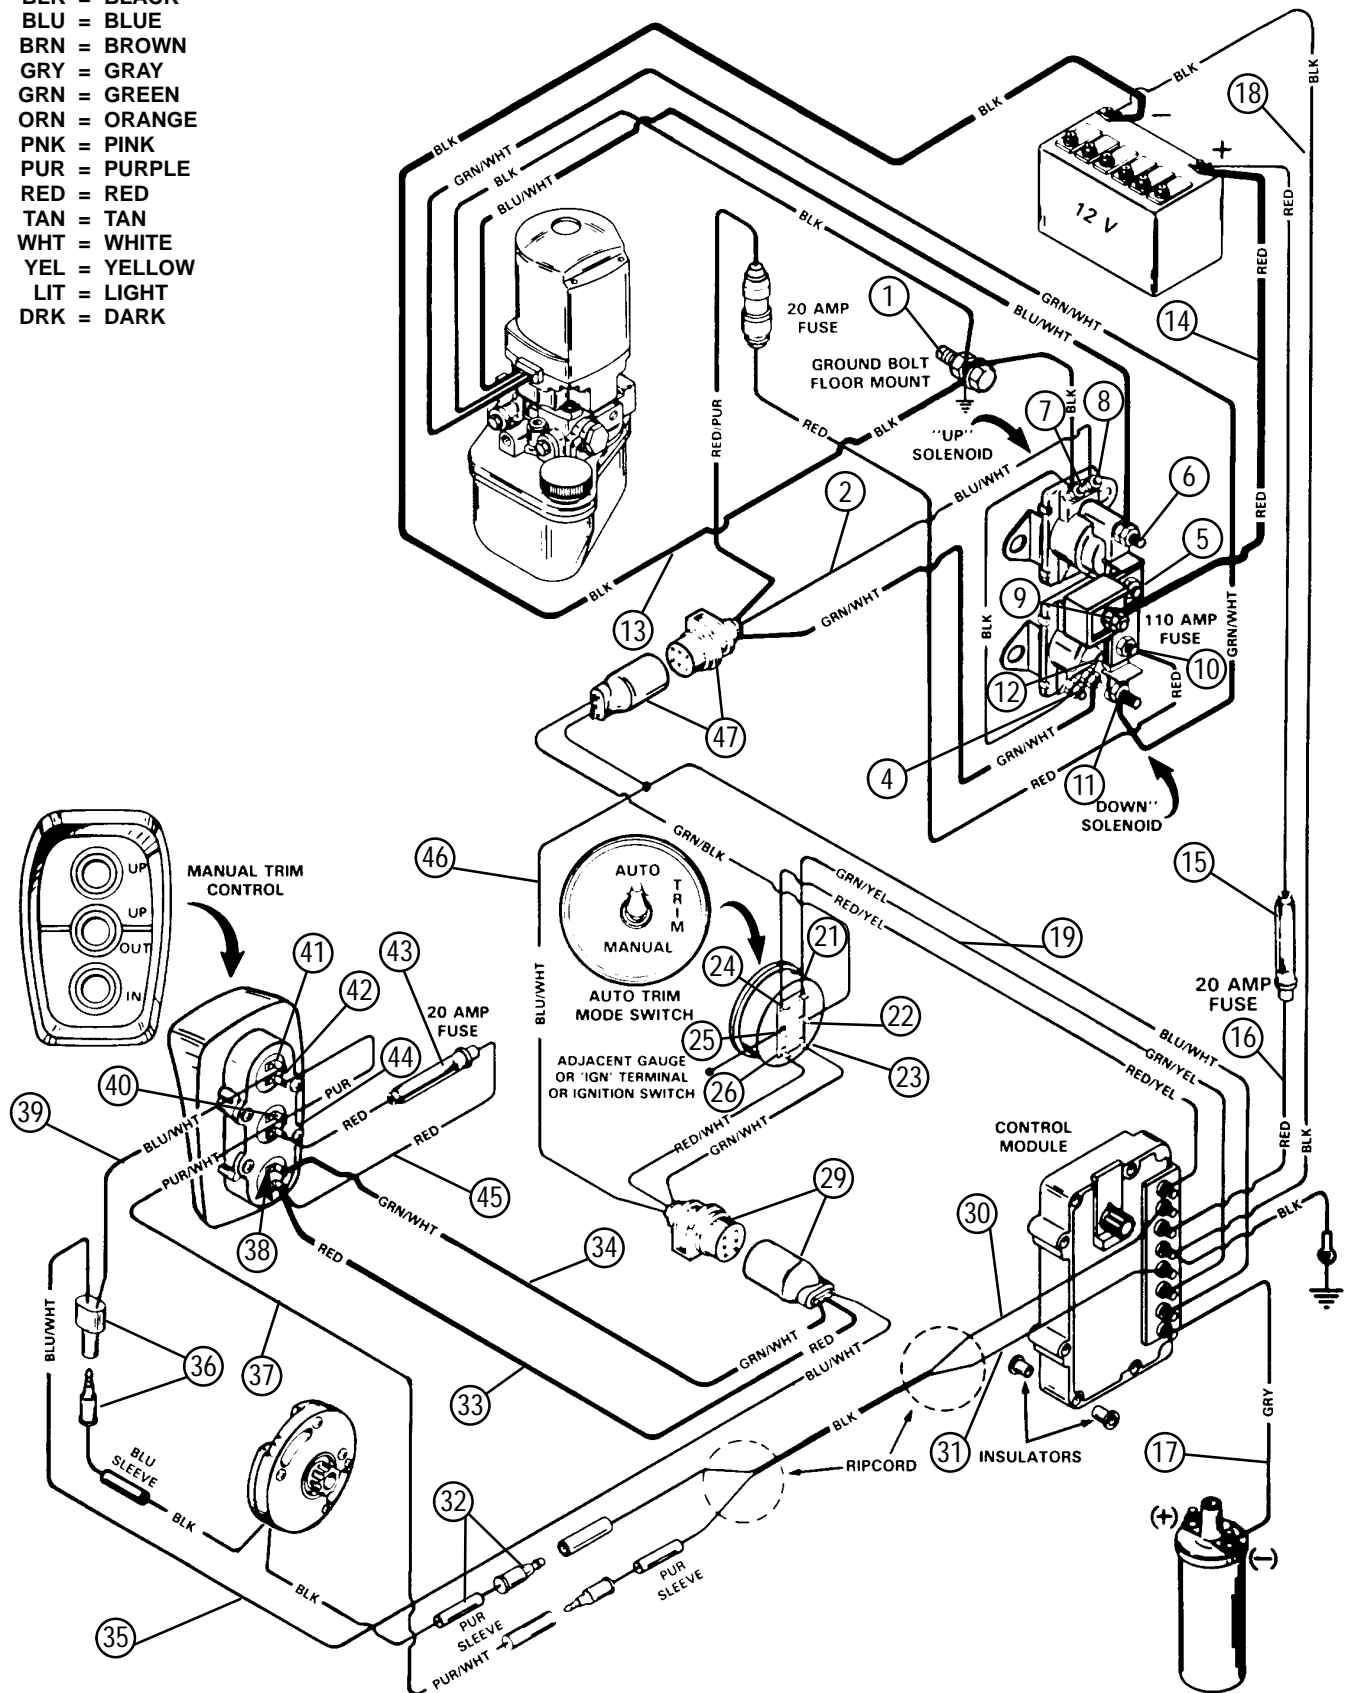
22178

# Auto Trim II System Wiring Diagram

BLK = BLACK  
 BLU = BLUE  
 BRN = BROWN  
 GRY = GRAY  
 GRN = GREEN  
 ORN = ORANGE  
 PNK = PINK  
 PUR = PURPLE  
 RED = RED  
 TAN = TAN  
 WHT = WHITE  
 YEL = YELLOW  
 LIT = LIGHT  
 DRK = DARK

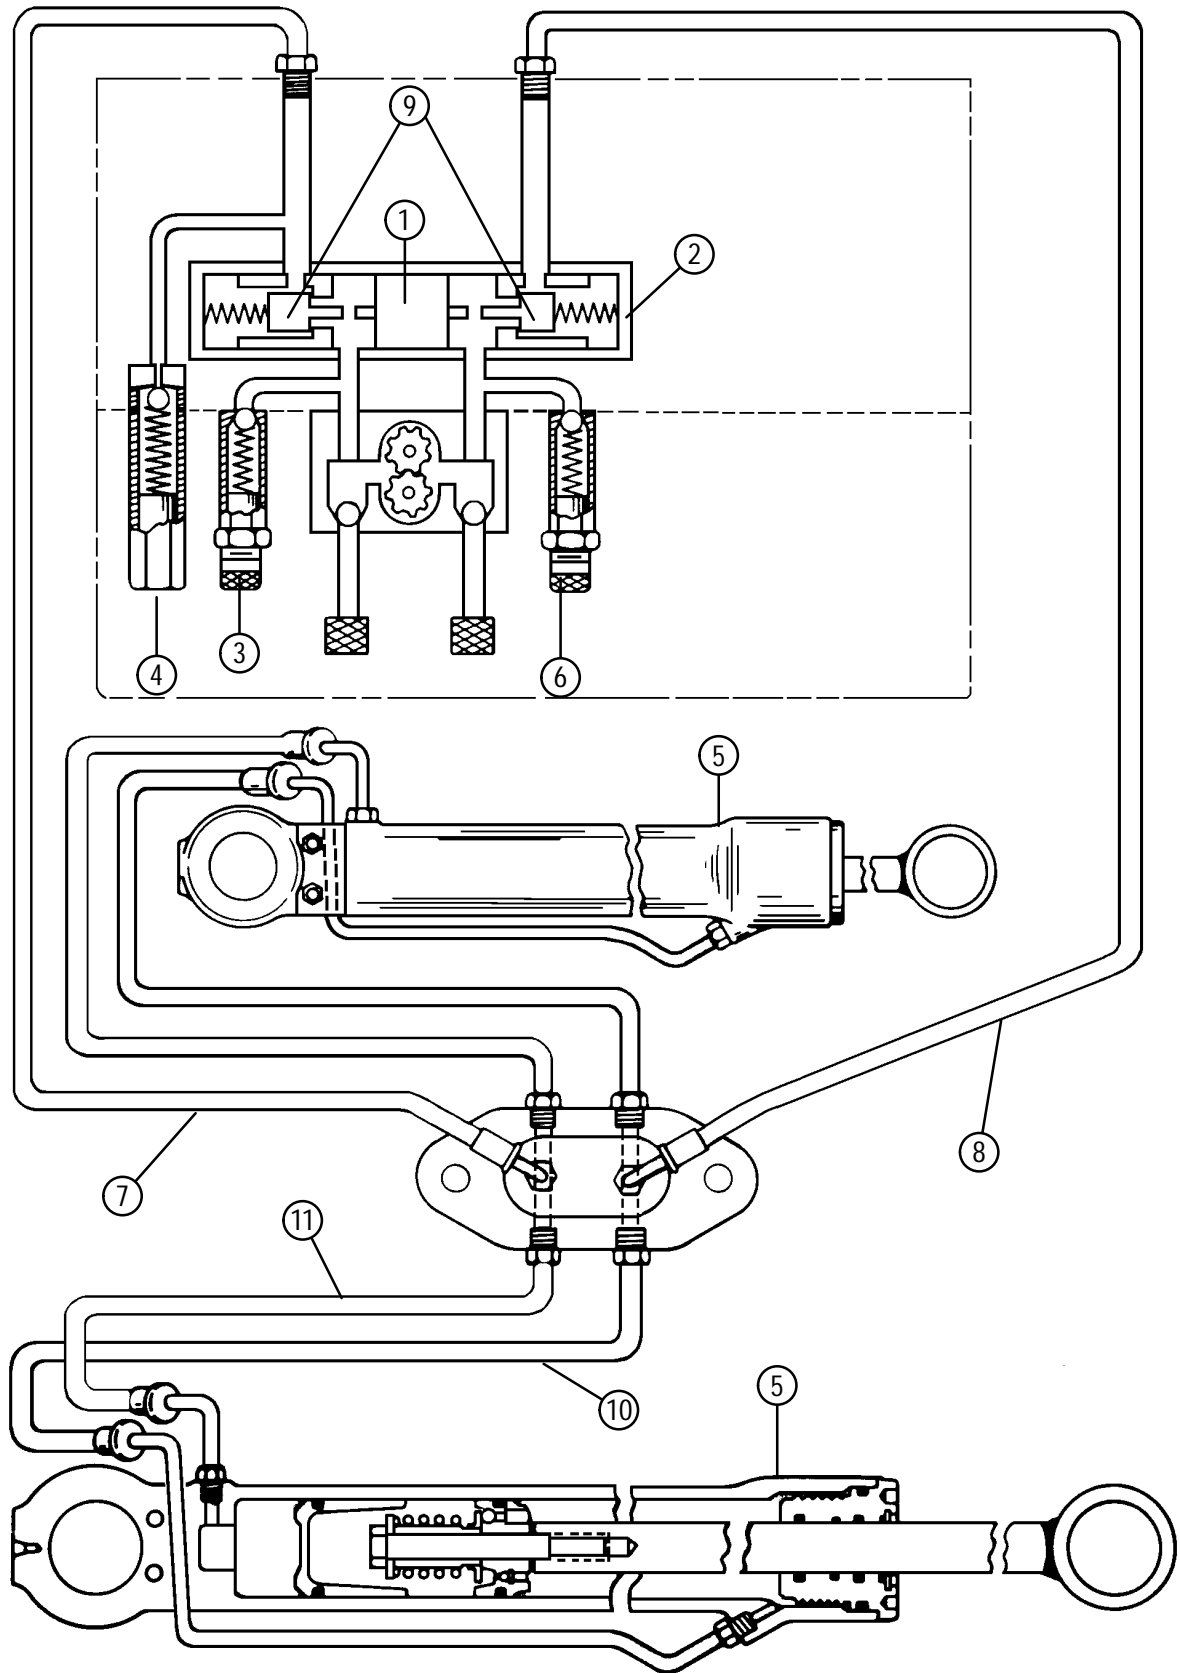
73552

## Power Trim Hydraulic Schematic

- 1 - Shuttle
- 2 - Pump Adaptor
- 3 - Out/Up  
Pressure  
Relief Valve
- 4 - Thermal Relief  
Valve
- 5 - Trim Cylinder
- 6 - IN/DOWN  
Pressure Relief  
Valve
- 7 - Out/Up  
Hose
- 8 - IN/DOWN  
Hose
- 9 - Pilot Check  
Valves
- 10 Gimbal Ring  
to Trim Cylinder  
IN/DOWN  
Hose
- 11 Gimbal Ring  
to Trim Cylinder  
OUT/UP  
Hose

5. Hoses reversed on one cylinder only.	5. Connect hoses "7" and "8" correctly.
6. Trim cylinder(s) binding.	6. Check for cause of binding (bent piston rod, scored cylinder, etc.). Repair or replace as necessary.

4. Insufficient IN/DOWN pressure or shuttle "1" valve stuck.	4. Test (as explained in "Testing Power Trim Pump", Sec 5A). If shuttle "1" is stuck, replace pump adaptor. (Sec 5A) If pressure is low, replace adaptor or attempt to repair by replacing the following item: • IN/DOWN pressure relief valve "6."

5. Trim cylinder(s) block leaking internally.	5. Test. Rebuild or replace cylinder as necessary.
6. Trim cylinder(s) "5" binding.	6. Check for cause of binding. Repair or replace as necessary.

7. Gimbal housing-to-trim pump hydraulic hose "8" or "7" pinched.	7. Replace hose "8" or "7."
8. Hoses "10" and "11" reversed on one trim cylinder only.	8. Reconnect hoses "10" and "11" correctly.

9. Drive unit binding in gimbal ring.	9. Check for cause of binding and replace.
10. Down Pressure relief valve "6" has dirt particles under check ball.	10. Replace with a new valve kit.

Cause	Remedy
1. Air in trim system.	1. Check for cause of entry. Fill and bleed system.
2. Leaky shuttle poppet valve "1."	2. Install repair kit for shuttle valve "1."

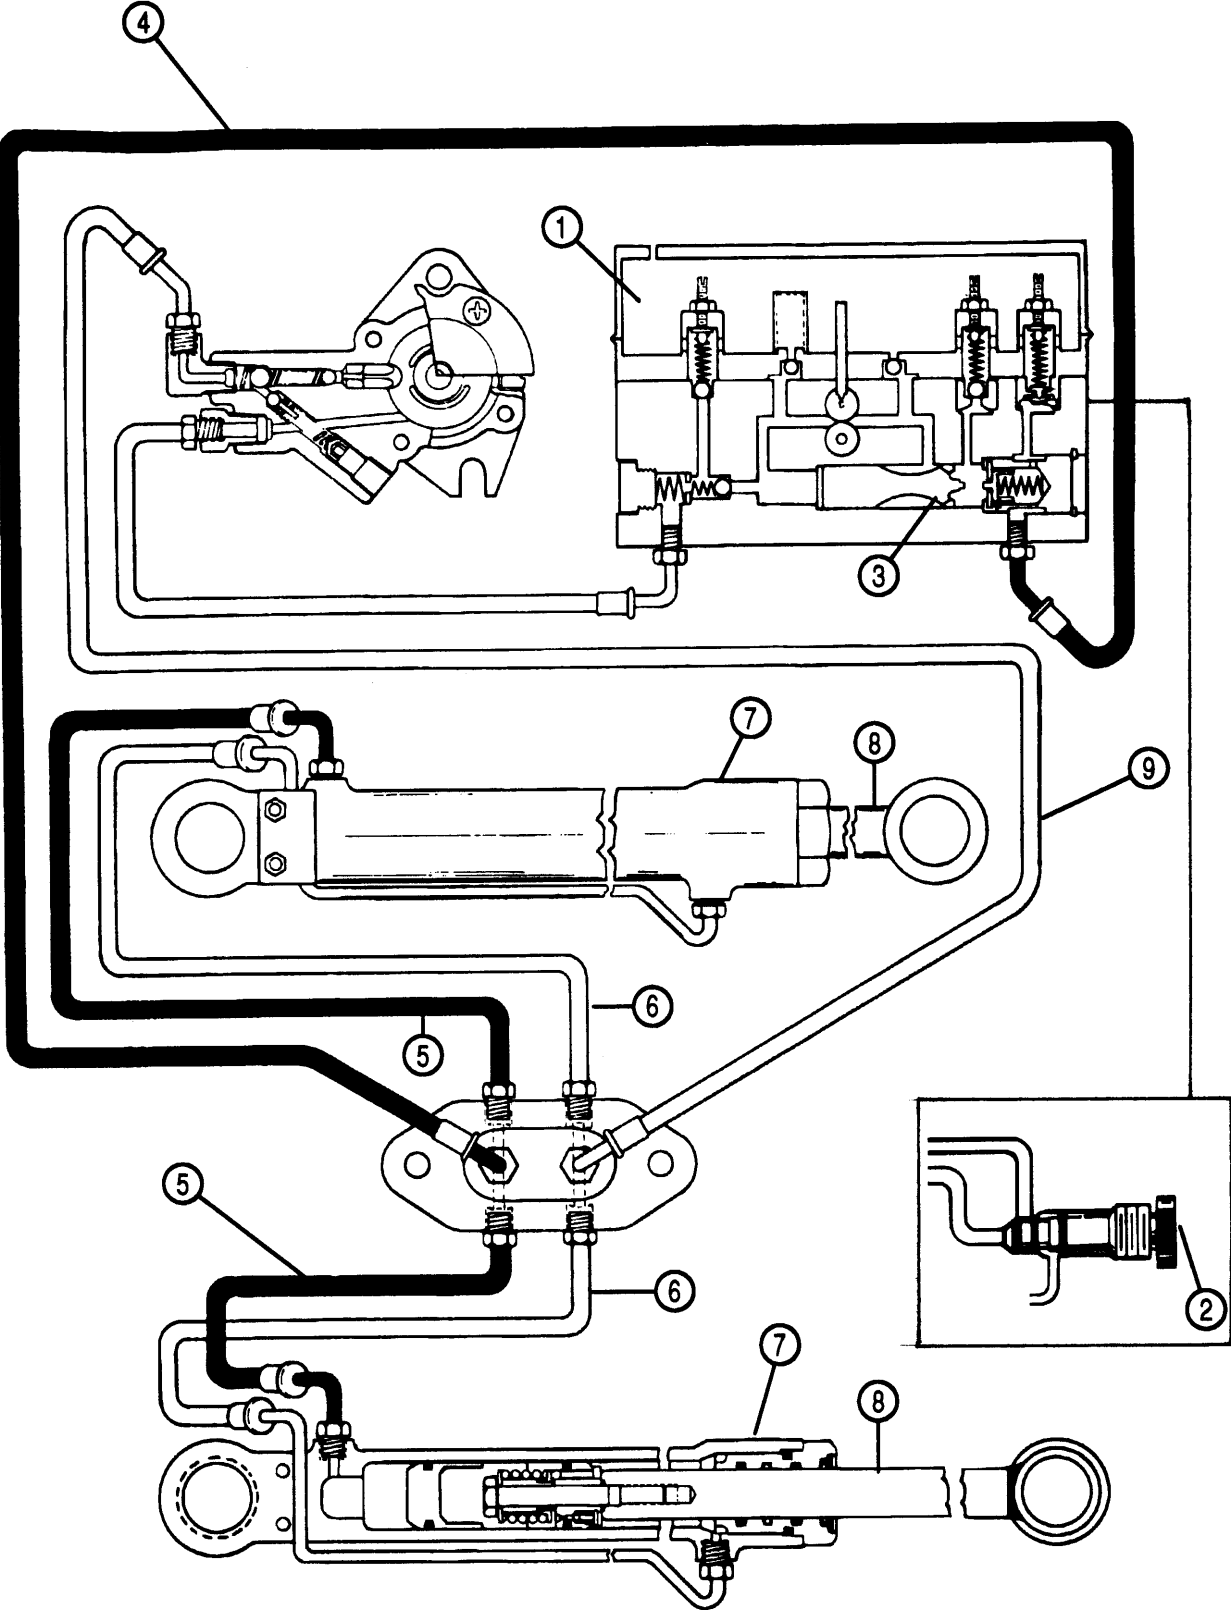
Prestolite Trim System Diagram

Cause	Remedy
1. Contaminated oil.	1. Flush system with clean oil, refill pump and bleed trim system.
2. Oil level low.	2. Check for cause of low oil level and correct. Add oil to pump (1) and bleed system.

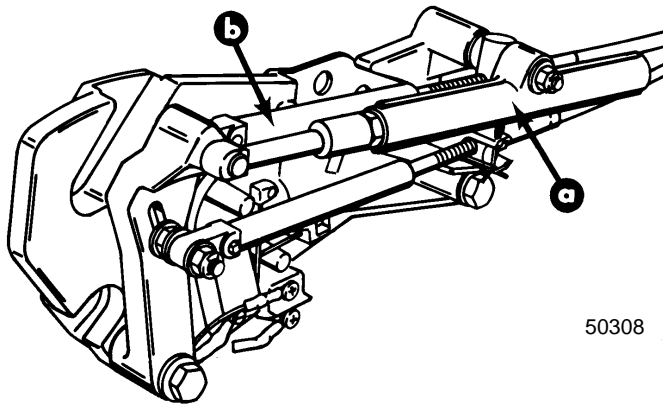
50308

**NOTE:** Some models may be equipped with a shift assist assembly. The only difference with these models is that the remote control shift cable attaching hardware is slightly longer. Shift cable adjustment is the same as all other versions.

- a - Shift Assist Assembly
- b - Remote Control Shift Cable

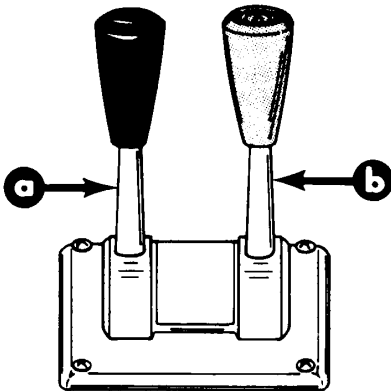
71339

**IMPORTANT:** If boat is equipped with A REMOTE CONTROL THAT HAS SEPARATE SHIFT AND THROTTLE LEVERS, this shift assist assembly should NOT be used. The use of the shift assist assembly with this type of remote control can cause the shift lever to move out of gear unexpectedly.

- a - Shift Lever
- b - Throttle Lever

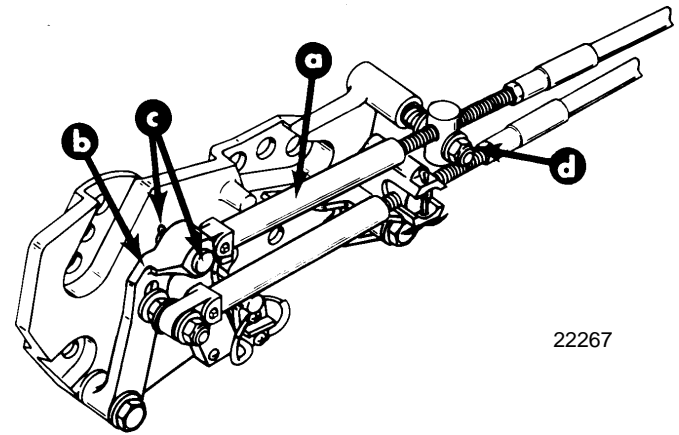
22267

1. Disconnect remote control shift cable.

### Later Models (With Plastic Shift Lever)

- a - Remote Control Shift Cable
- b - Plastic Shift Lever
- c - Clevis Pin and Cotter Pin
- d - Locknut and Washer

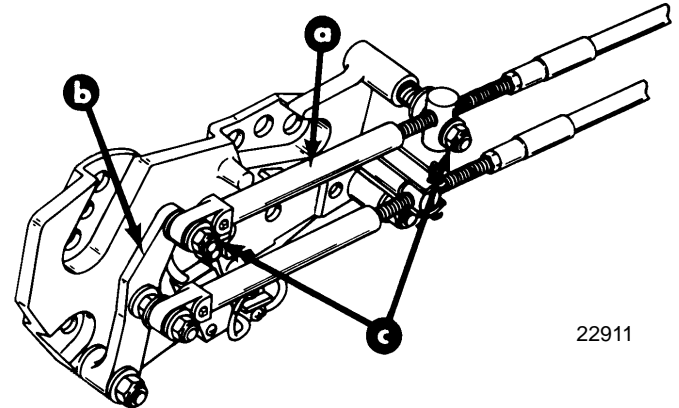
22911

### Earlier Models (With Metal Shift Lever)

- a - Remote Control Shift Cable
- b - Metal Shift Lever
- c - Locknuts and Washers

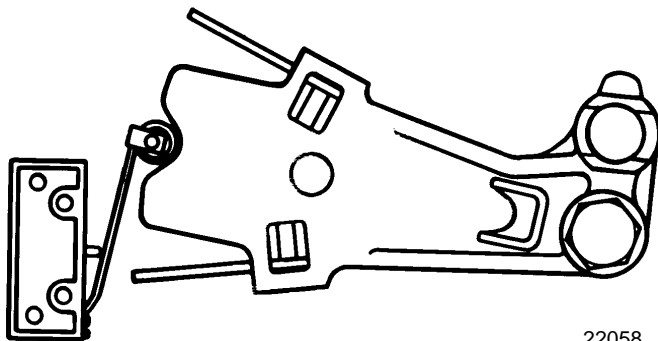
22058

**IMPORTANT:** When pushing or pulling on drive unit shift cable in the following steps, apply enough pressure so that shift cutout switch roller starts to move off center of notch, then ease up slightly. Use a fine tip marking device to mark threaded tube to obtain an accurate measurement.

a - Shift Cutout Switch Roller

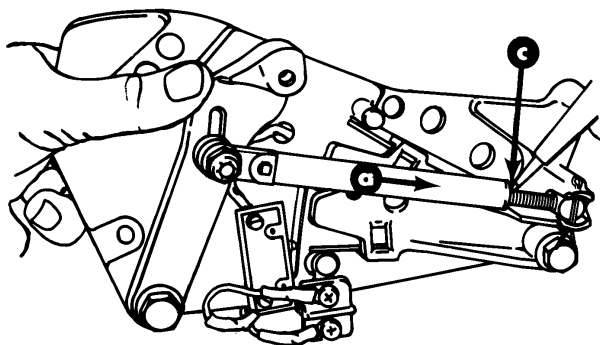
50499

- a. Place drive unit into gear by pushing in on drive unit shift cable, while simultaneously rotating propeller shaft counterclockwise until shaft stops, to ensure full clutch engagement.
- b. Place a mark on shift cable threaded tube against edge of end guide.

- a - Drive Unit Shift Cable
- b - Propeller Shaft
- c - Threaded Tube

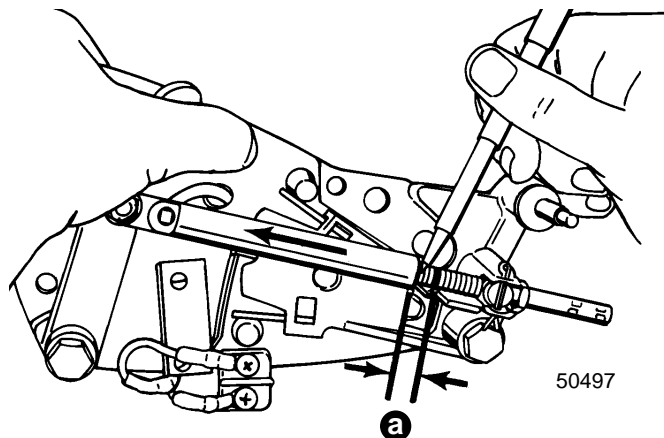
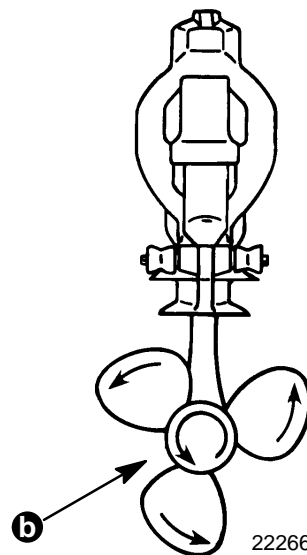
- c. While maintaining pressure on propeller shaft in a counterclockwise direction (to keep clutch locked with gear), lightly pull out on shift cable end guide and place another mark on threaded tube.
- d. Measure distance between both marks. Distance should be **9/16 in. (14 mm) or less**.

- a - 9/16 in. (14 mm) or Less
- b - Propeller Shaft

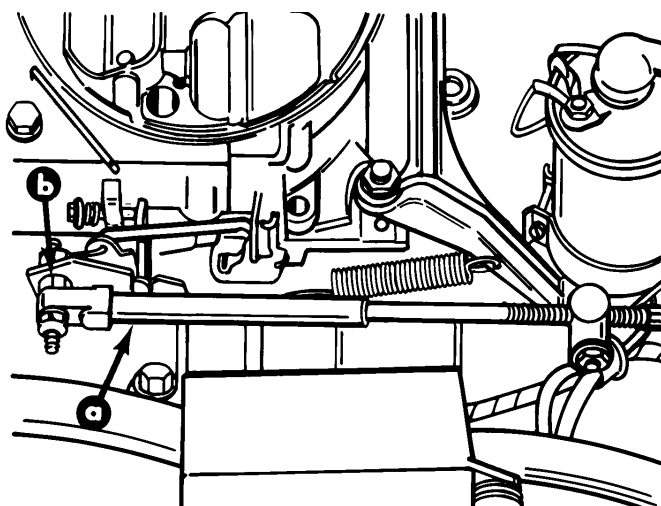
22062

- At least two people will be needed for the following procedure, one person to check the adjustment and one person to stay at the control station of the boat.
  - Ensure boat is secured to dock and precautions have been taken to avoid damage to boat prior to placing drive unit into gear.
1. Start engine and let it warm up (Refer to operating procedures in Operation and Maintenance Manual).
  2. Disconnect throttle cable(s) from carburetor(s).

- a - Throttle Cable End Guide
- b - Carburetor Throttle Lever

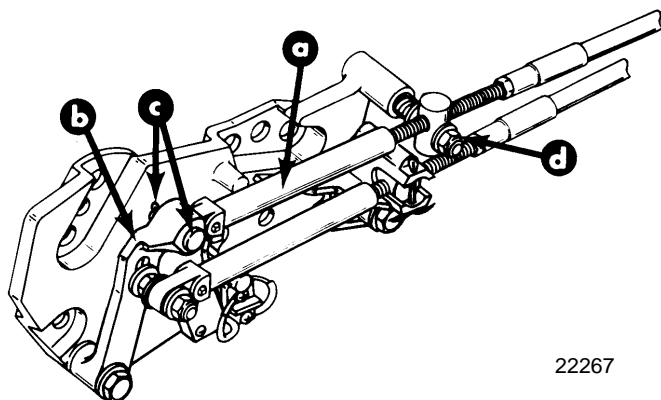
22267

3. Disconnect remote control shift cable.

### **Later Models (With Plastic Shift Lever)**

- a - Remote Control Shift Cable
- b - Plastic Shift Lever
- c - Clevis Pin and Cotter Pin
- d - Locknut and Washer

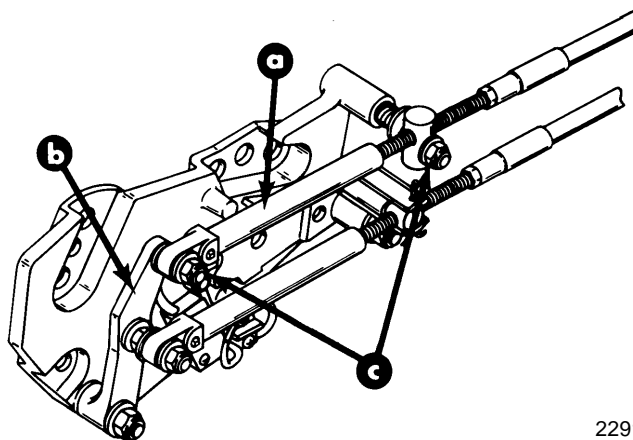
22911

### **Earlier Models (With Metal Shift Lever)**

- a - Remote Control Shift Cable
- b - Metal Shift Lever
- c - Locknuts and Washers

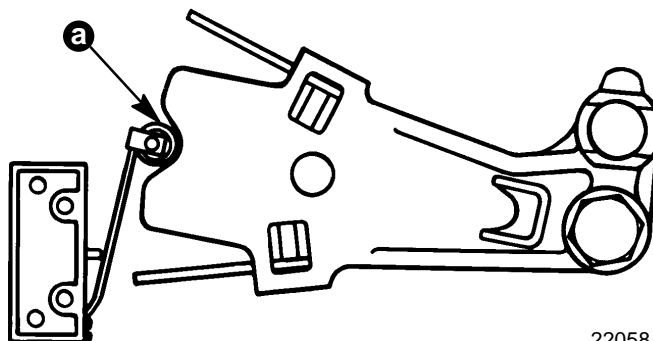
22058

**IMPORTANT:** When pushing or pulling on drive unit shift cable, in the following steps, apply just enough pressure so that shift cutout switch roller just starts to move off center of notch; then, ease up slightly. Use a fine tip marking device to mark threaded tube to obtain an accurate measurement.

- a - Shift Cutout Switch Roller

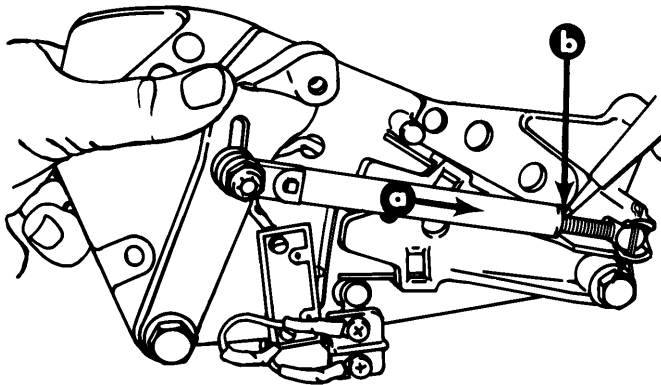
50499

- a. Push in on drive unit shift cable.
- b. Place a mark on shift cable threaded tube, against cable end guide.

a - Drive Unit Shift Cable  
b - Threaded Tube

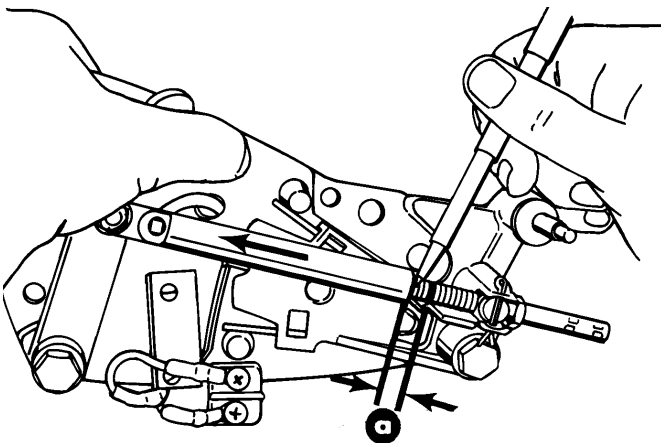
50497

- c. Lightly pull on drive unit shift cable end guide and place another mark on threaded tube.
- d. Measure distance between both marks. Distance should be **9/16 in. (14 mm) or less**.

a - 9/16 in. (14 mm) Or Less

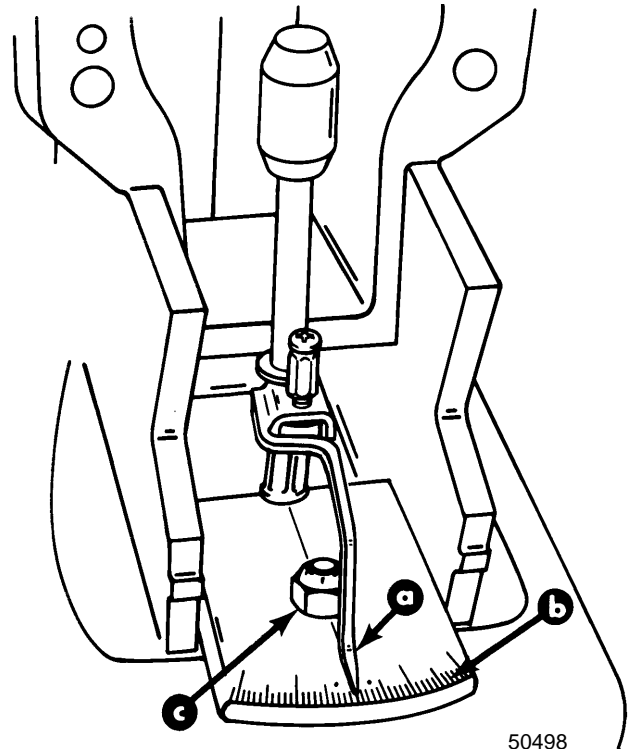
50498

1. To determine shift shaft rotational end play, use a tool such as the one shown to measure degrees of play in shift shaft with clutch locked and held in gear.

- a. Install tool as shown.

a - Pointer - Installed on Shift Shaft  
b - Scale (1° Increments)  
c - Nut

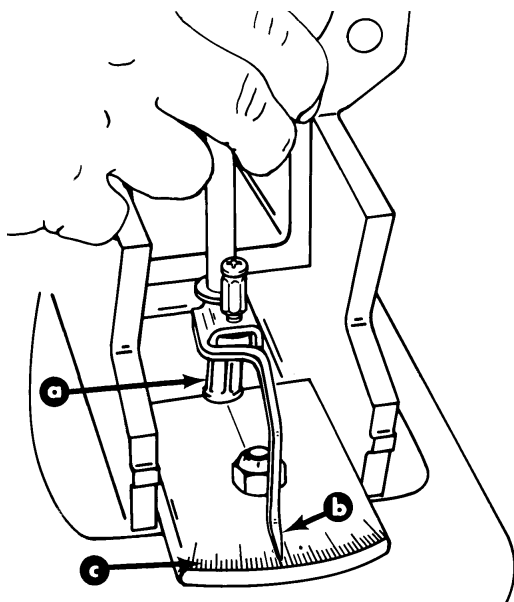
50498

- b. Rotate shift shaft coupler clockwise while simultaneously turning propeller shaft counterclockwise until clutch locks into gear. Make note of pointer location on scale.

- a - Shift Shaft Coupler  
b - Pointer  
c - Scale

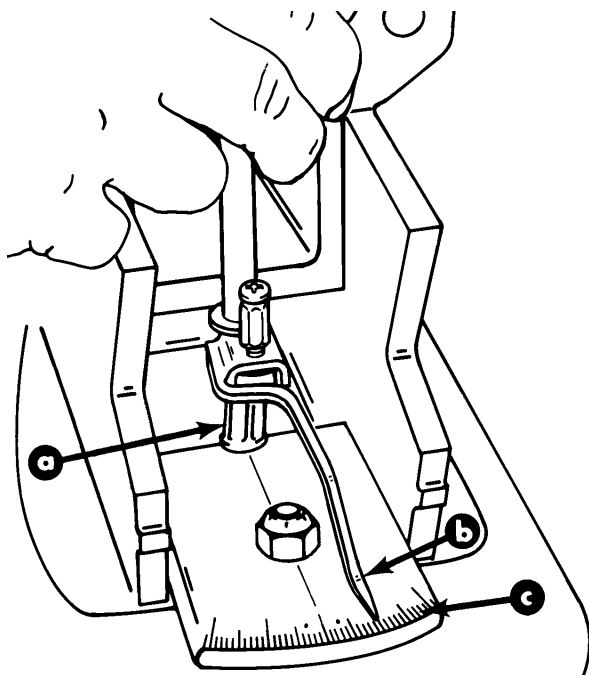
50498

- c. While maintaining pressure on propeller shaft to keep clutch locked with gear, lightly turn shift shaft coupler counterclockwise. Make note of pointer location.

- a - Shift Shaft Coupler  
b - Pointer  
c - Scale

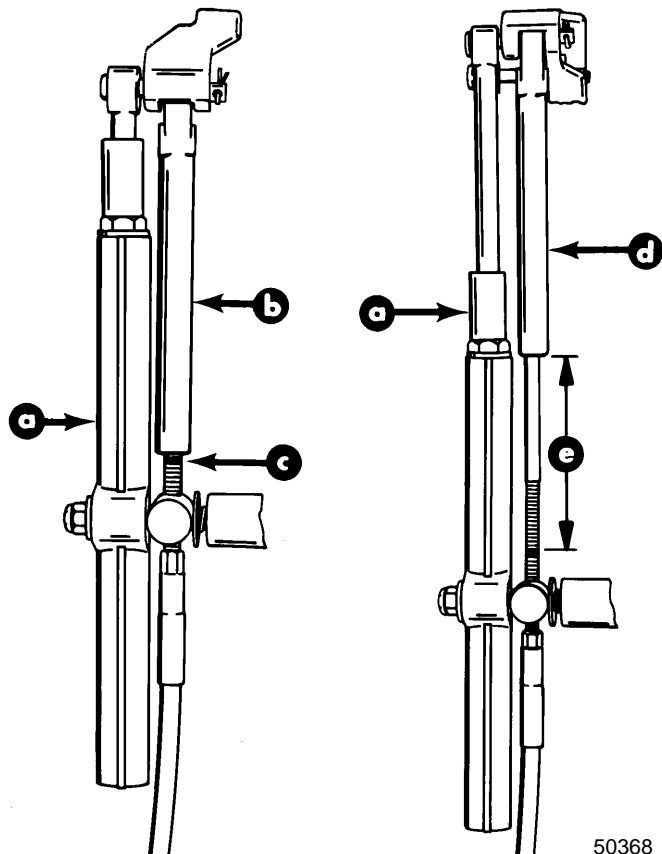
50368

2. Place remote control into the opposite gear from that established in step 1. Measure the distance between the edge of the shift cable end guide and the mark in step 1. Total shift cable output must not be less than 2-7/8 in. (73 mm) or more than 3-1/8 (80 mm). If out put is incorrect, remote control and/or shift cable must be replaced.

#### With Shift Assist Assembly

- a - Shift Assist Assembly
- b - Remote Control Shift Cable - Retracted
- c - Edge of Cable End Guide Mark
- d - Remote Control Shift Cable - Extended
- e - Measurement Taken from Mark to Edge of Cable End Guide: **2-7/8 in. (73 mm) to 3-1/8 in. (80 mm)**

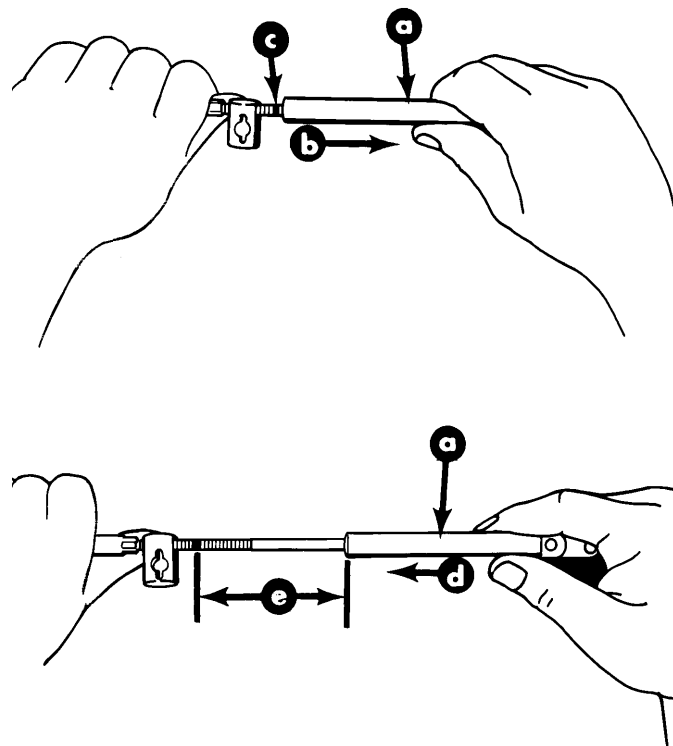
50499

#### Without Shift Assist Assembly

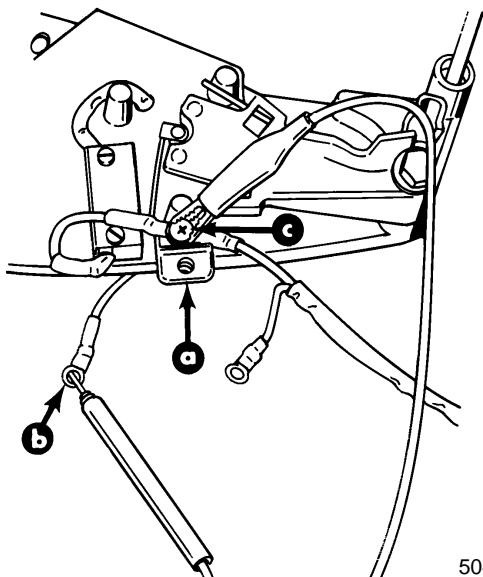
1. Disconnect cutout switch white/green wire from terminal block.
2. Connect ohmmeter positive (+) lead to cutout switch white/green wire and ohmmeter negative (-) lead to cutout switch black wire at terminal block.
3. Set ohmmeter on Rx1 scale.

- a - Terminal Block
- b - Cutout Switch WHITE/GREEN Wire
- c - Cutout Switch BLACK Wire

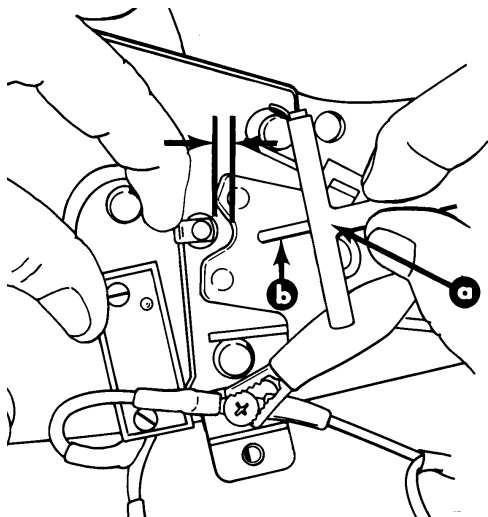
4. Slowly move cutout switch roller off of its seat. Circuit should close (full continuity reading), when roller is moved 1/8 in. (3 mm). Use the 1/8 in. rod on the end of special tool to gauge this movement.

- a - Special Tool
- b - 1/8 in. (3 mm)

If switch closes too early [less than 1/8 in. (3 mm)]: Roller must be bent away from its seat.

If switch closes too late [more than 1/8 in. (3 mm)]: Roller must be bent toward its seat.

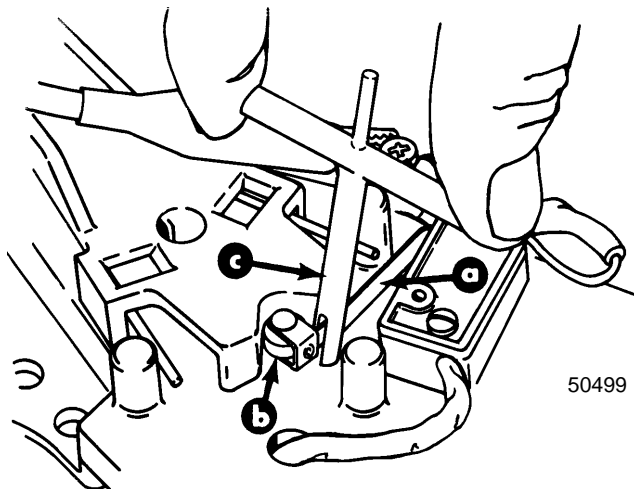
If necessary, use special tool to bend lever as shown.

- a - Lever
- b - Roller
- c - Special Tool

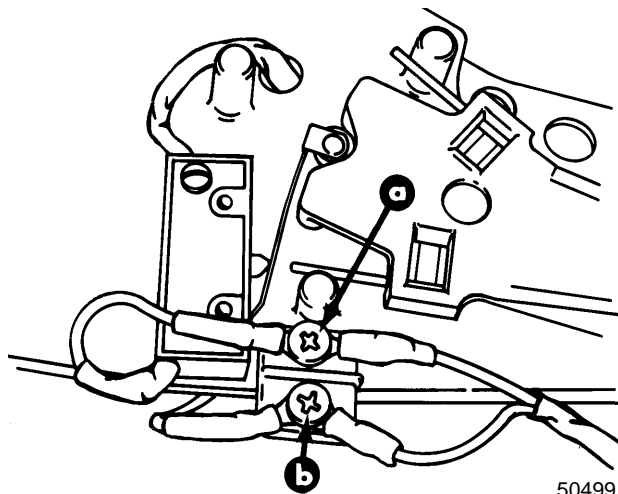
5. Once cutout switch is timed properly, reconnect wires at terminal block and coat terminals with liquid neoprene.

- a - BLACK Wires
- b - WHITE/GREEN Wires

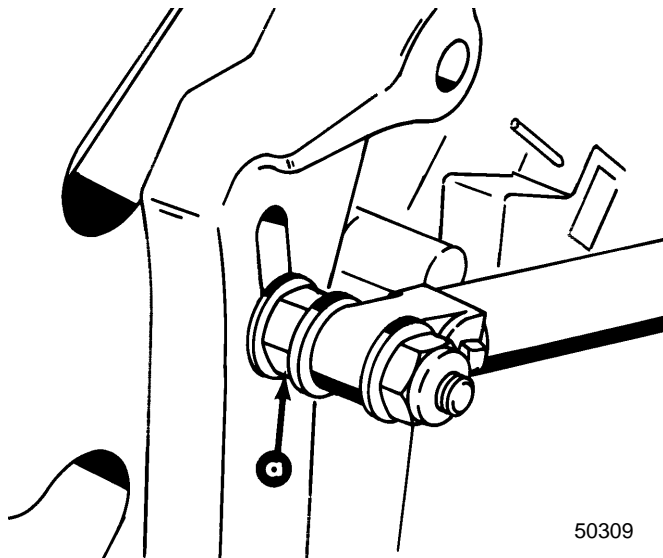
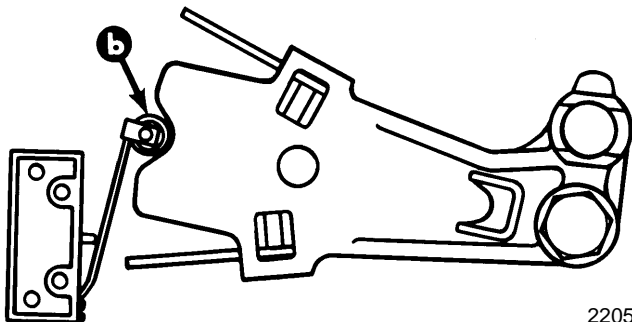
While shifting, rotate propeller shaft clockwise. Clutch should engage and cause propeller shaft to lock. If clutch does not engage, loosen adjustable stud on shift lever and move it upward in slot until clutch engages with gear. Retighten stud. Shift remote control several times and ensure that shift cutout switch roller is still centered.

- a - Adjustable Stud
- b - Shift Cutout Switch Roller
