# GENERAL INFORMATION

## TROUBLESHOOTING

# Troubleshooting

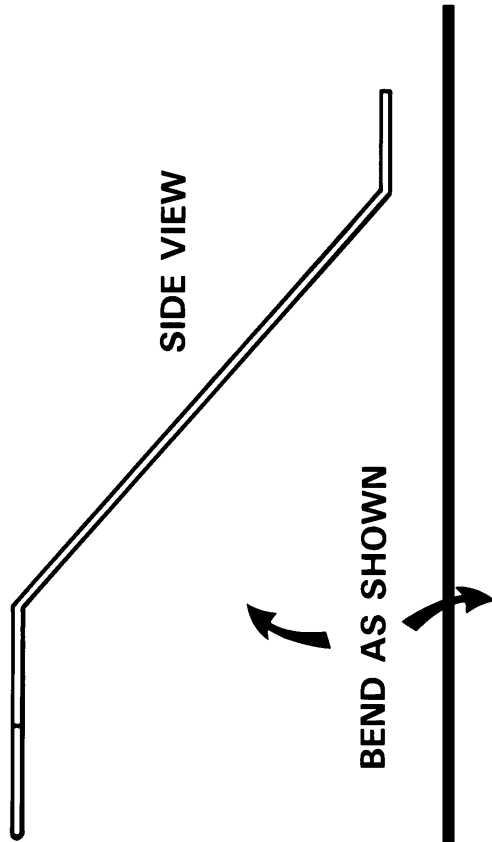
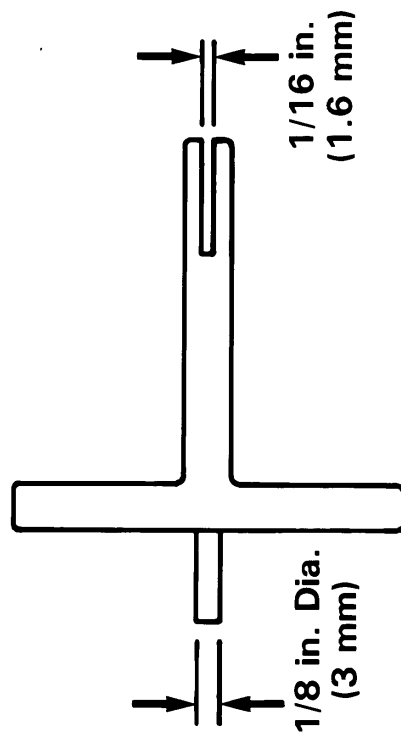
CUTOUT SWITCH  
ADJUSTMENT TOOL

TOP VIEW

**NOTE:** Refer to the end of this section for the pattern and dimensions needed to fabricate a similar tool.
