# SPARC Enterprise™ T5120 and T5220 Servers Product Notes

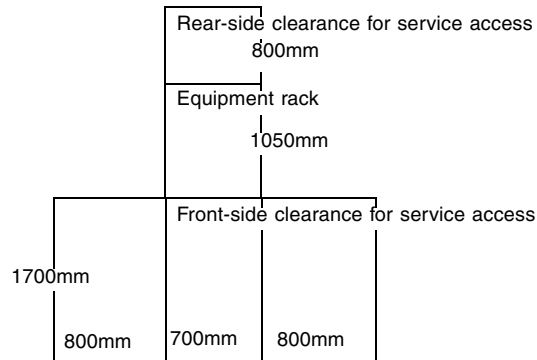
**FIGURE 1** Minimum Clearance for Service Access

No stepladder is required if this server is installed at the 20U level or lower. A stepladder is required if it is installed at the 21U level or higher. [FIGURE 1](#) shows the minimum clearance for service access required for either server.

1. If the server is installed at the 20U level or lower (\*1): (\*1 Judged based on the level of the equipment top)

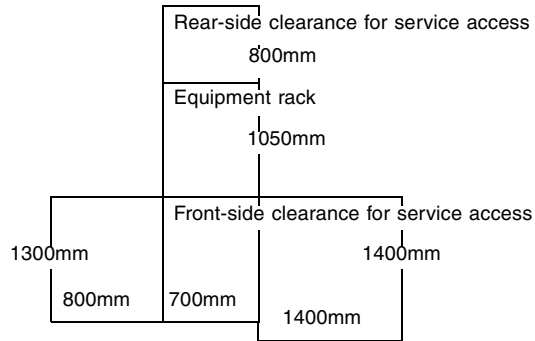
2. If the server is installed at a level between 21U and 40U (\*1): (\*1 Judged based on the level of the equipment top)
