AMERICAN BONANZA SOCIETY NEWSLETTER

BONANZA OF THE MONTH

Enjoying one's aircraft is the name of the game. Dr. Millard Harmon, ABS #2633, 34 Elsmere Ave., Delmar, NY 12054, tells us how he has personalized his Model 36, N7710R, with numerous convenience and safety features. His interesting description of his various "Harmonizers" follows on the next page.

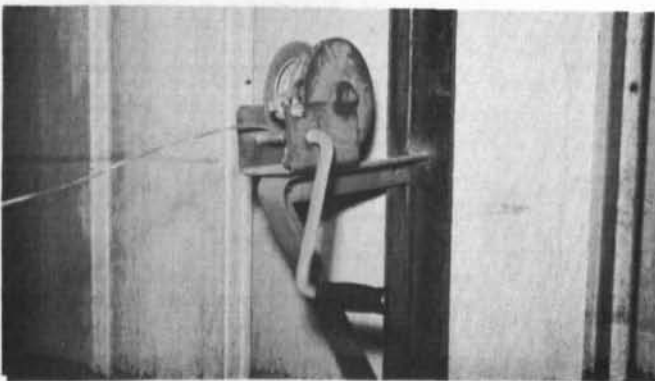
If one doesn't have a helper to steer the nosewheel, one must take care that the tail is tracking into the T straight. One may have to run back and adjust the nose-wheel until the plane is moving in a straight line into the hangar. Usually it will enter the hangar with only one or two adjustments if it is lined up to start.

If the plane is more than ten feet out from the hangar entry, with the cable attached to the tie-down ring, hang something conspicuous on the cable to prevent someone trying to drive behind the plane while you are getting set to operate the winch.

We maneuver the Bonanza by hand until it is more or less lined up, then run back to the winch and crank it into the hangar. We have an asphalt paved floor and paved ramp.

We experience considerable floor heaving from frost, making it almost impossible to hand push the Bonanza over the sill and back into the hangar in winter.

Be sure and disconnect the cable after winching in. If a slack cable is left hooked to the tail, next time you pull the plane out over the sill, the locked winch and hooked cable will stop the plane with a jerk that might do damage to the fuselage.
