SILVER SPORT
Transmissions

INSPECTION AND CORRECTION **OF BELLHOUSING TO** **CRANKSHAFT ALIGNMENT**

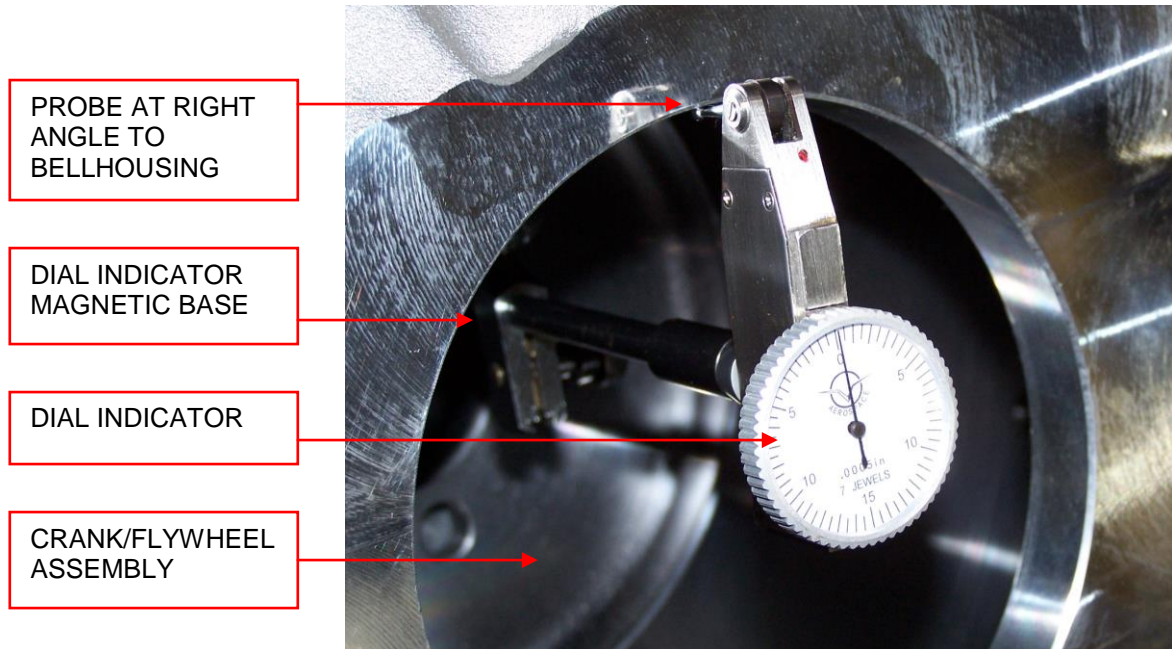
- Position the indicator probe in contact with the smooth bore of the bellhousing that the transmission will fit into later. The **dial indicator probe** needs to be **perpendicular** to the bellhousing face to ensure accuracy.

Make sure the indicator has adequate travel in both directions and will be in constant contact with the bore register during the entire 360 degrees of rotation so that you will obtain accurate readings. It is not necessary to begin at a certain position on the bore, any point will work. Mark the point where you begin on the bellhousing with a hash mark using chalk or a marker as a reference.

2. Attach the magnetic base to the face of the crank, flywheel or stationary portion of clutch. The dial indicator base does **not** need to be centered on the crankshaft, and the magnetic base will usually be much more stable if mounted on the flat surface of the flywheel. As the engine is rotated by hand, the dial indicator and base will move in a perfect circle around the exact centerline of the crankshaft.

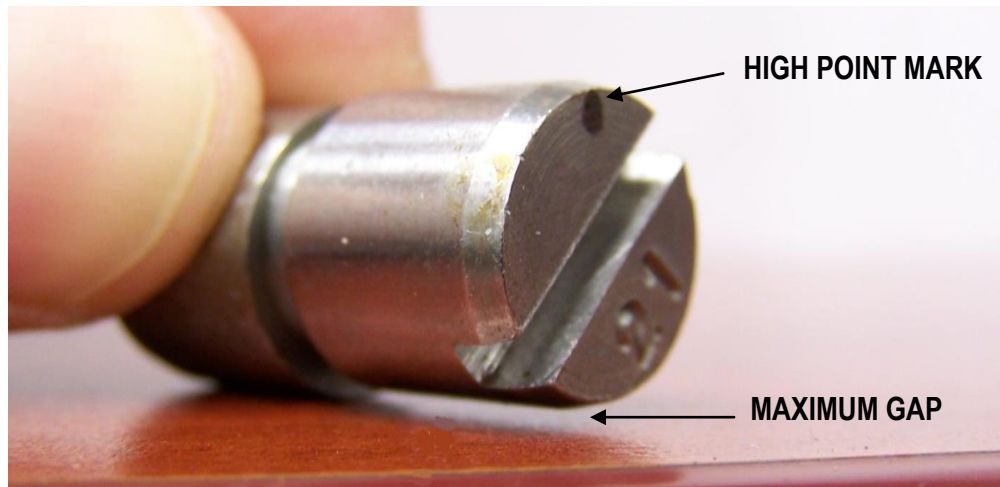
- f. Heat may help.
3. Determine where the maximum offset is on each new pin by rolling the engine side of the dowel on a hard flat surface and looking for the maximum height point as it is being rolled. Mark the high spot with a dot from a paint marker or permanent marker.

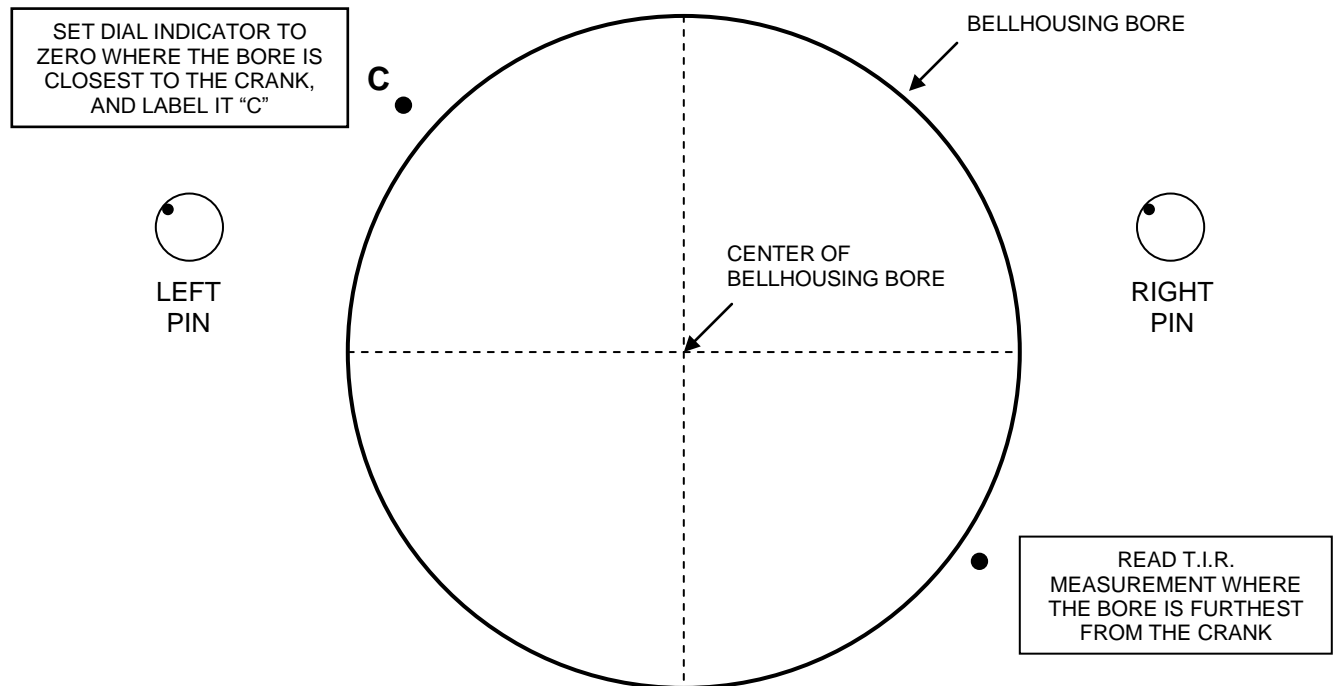
On the bellhousing below, the misalignment is such that the bore is closest to the crank at the upper left. The dial indicator would be set to zero at that point (labeled “C”). The T.I.R. would be measured where the bellhousing bore is furthest from the crank, which should be directly opposite that point. Let’s assume the T.I.R. reading is 0.034”. Actual misalignment would then be:

$$0.034" \div 2 = 0.017"$$

The chart on page three shows that 0.017" misalignment requires a pair of 0.014" offset pins. The pins should be oriented so that their maximum offset is in the same direction as an imaginary line drawn from bore center to point "C".

5. Install the pins into the rear of your engine block with the dot on the pins (maximum offset point) oriented in the same direction as the “C” mark on the bellhousing bore. **Always orient both pins in the same direction!**
