Technical Service Bulletin

SUBJECT:			No: TSB-12-13-002
ECM REPROGRAMMING FOR DTC P0016 or P0017: CRANKSHAFT/CAMSHAFT POSITION			DATE: February, 2012
			MODEL: See below
CIRCULATE TO:	<input type="checkbox"/> GENERAL MANAGER	<input type="checkbox"/> PARTS MANAGER	<input checked="" type="checkbox"/> TECHNICIAN
<input checked="" type="checkbox"/> SERVICE ADVISOR	<input checked="" type="checkbox"/> SERVICE MANAGER	<input checked="" type="checkbox"/> WARRANTY PROCESSOR	<input type="checkbox"/> SALES MANAGER

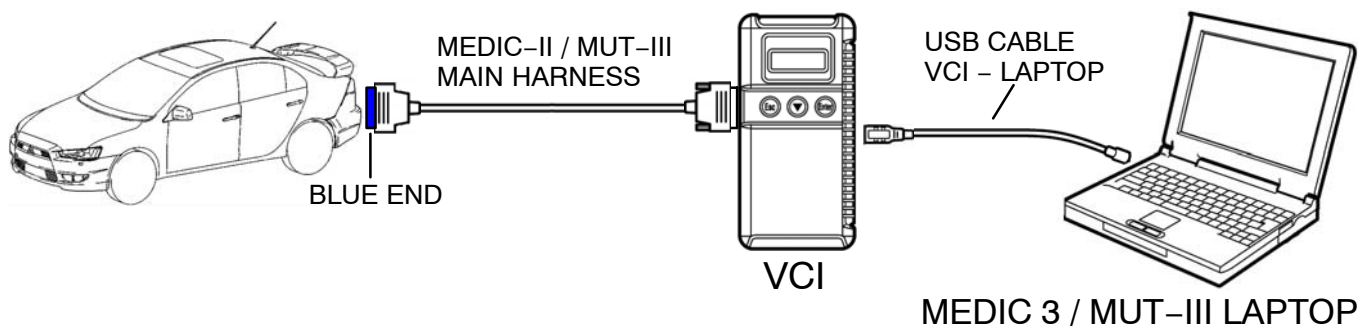
Connect the equipment as follows:

- Turn the laptop computer on. If you're running on battery power and the charge indicator in the lower right hand corner of the screen does not show a full charge, it is recommended that either the laptop battery be charged prior to beginning, or that reprogramming be completed with the A/C power adaptor connected to the laptop.
- Connect the USB cable to the VCI.
- When the laptop displays the MUT-III main screen, connect the USB cable to the laptop.
- Connect the MUT-III main harness with the blue DLC connection to the VCI.
- Connect the blue connector of the MUT-III main harness to the vehicle's data link connector.
- Turn the VCI power switch ON. Verify that the indicator lamp in the upper right corner of the screen is green.

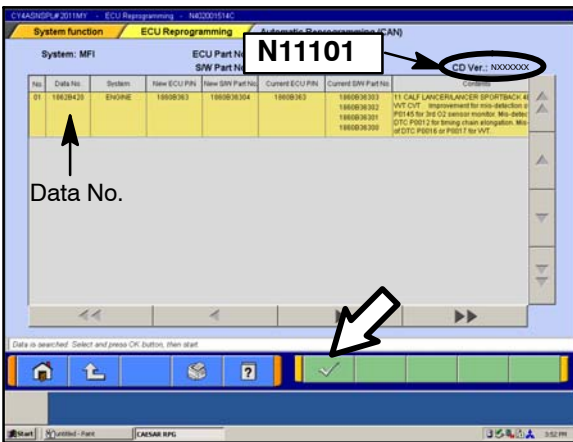
- l. The Automatic Reprogramming(CAN) database screen will display.

Confirm the database number at the top right of the table is **N11101** or higher.

If more than one row is displayed in the table, refer to the ECM Reprogramming Chart beginning on page 2 to select the proper Data No. for this procedure and select the appropriate row.

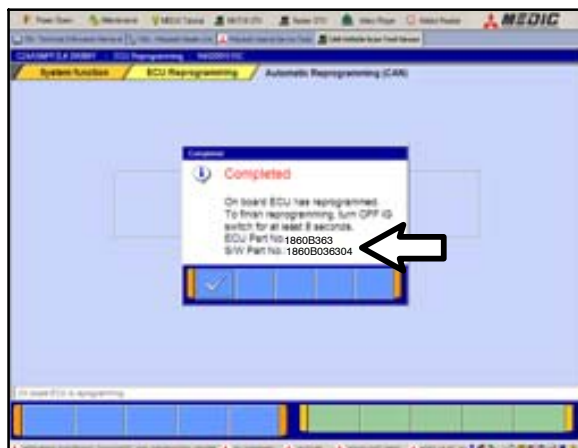
- o. This message will display when ECM reprogramming is successfully completed. Confirm the “New S/W P/N” displayed matches the table at the beginning of this TSB.
- p. You will be prompted to turn the ignition switch to the OFF position, wait at least 8 seconds, then turn it back on.
- q. Click the check mark and you will be returned to the “ECU Reprogramming” page.

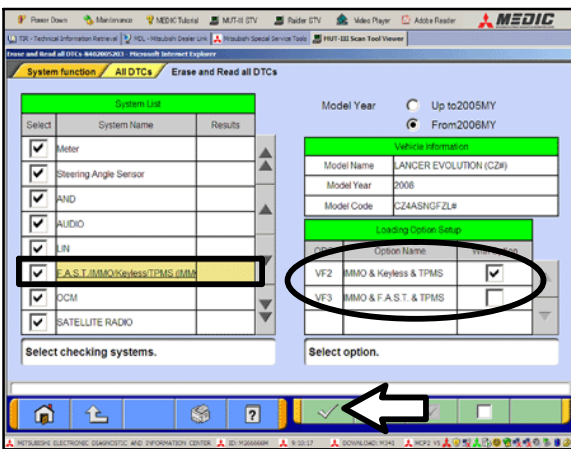
e. In the left column, scroll to and click FAST/IMMOB/KEYLESS/TPMS. In the right column, check the correct option code (VF#) from the Loading Options Setup list. This will activate the check mark at the bottom of the page.

- Vehicles with regular keyless entry (buttons on a multi-function key), select VF2.
- Vehicles with F.A.S.T. key, select VF3.
