## SECTION A DISASSEMBLY, INSPECTION, AND OVERHAUL OF THE CENTER SUPPORT

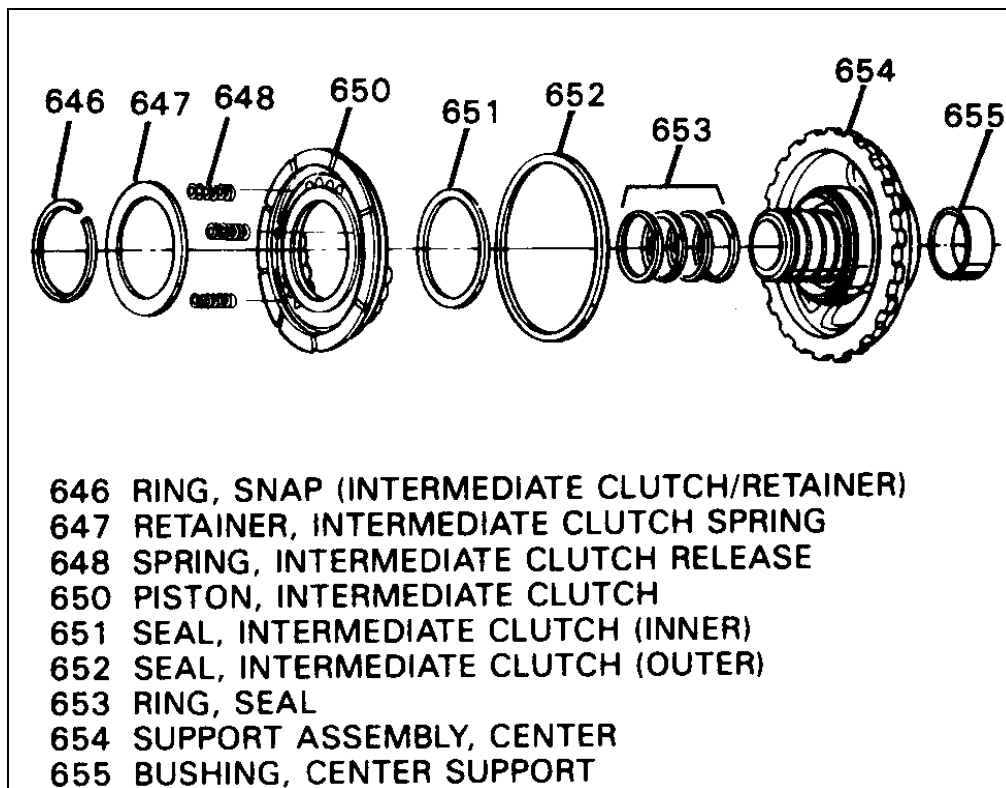
FIGURE 13A-1

Figure 13A-1 is the master schematic of the center support assembly with the cast aluminum intermediate clutch piston. Figure 13A-2 is the master schematic of the center support assembly with the stamped steel intermediate clutch piston.

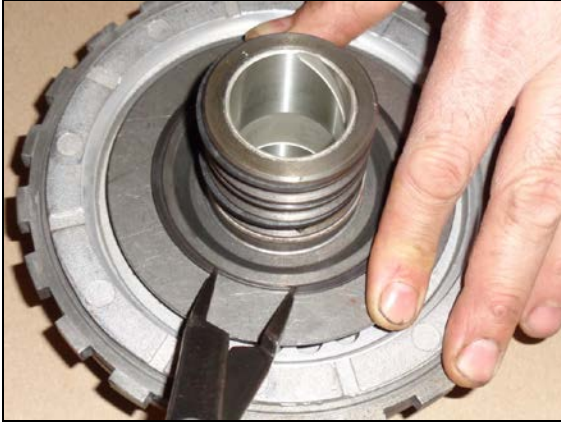
FIGURE 13A-3

Press down on the intermediate clutch spring retainer (647) and remove the snap ring (646) that fastens it to the center support. See Figure 13A-3. Lift off the retainer. See Figure 13A-4.

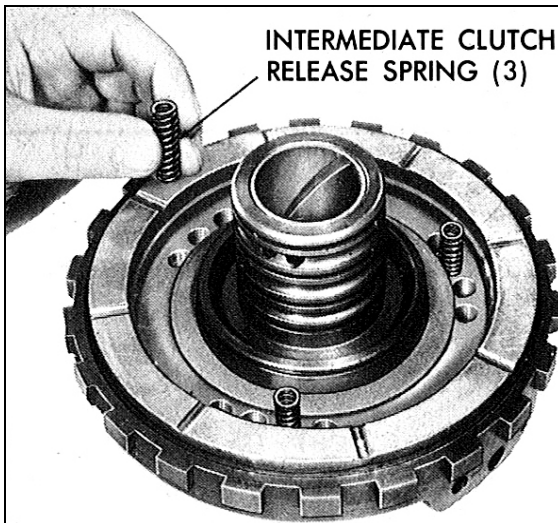
FIGURE 13A-5

Remove the three intermediate clutch release springs (648) from the cast aluminum intermediate clutch piston (650). See Figure 13A-5. Note that all 1964 and 1965 models, as well as all 1966 to 1972 Cadillacs were fitted with 12 intermediate clutch release springs. Inspect the release springs for cracks, fatigue, and distortion. Shiny wear visible on the spring outside diameter is considered normal. With models that use the stamped steel intermediate clutch piston, remove the three intermediate clutch release springs followed by the plastic intermediate clutch spring guide (649). See Figure 13A-6.

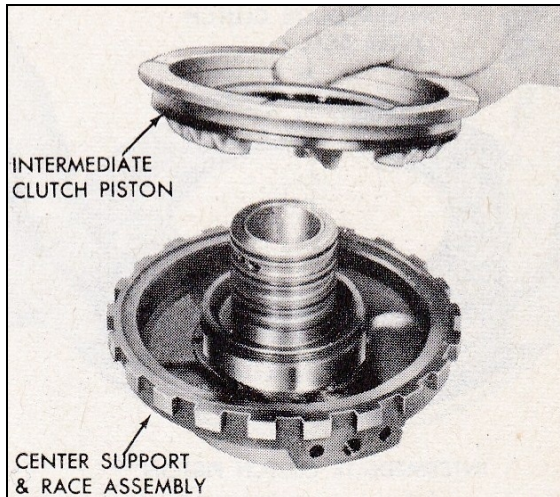
FIGURE 13A-7

Remove the intermediate clutch piston (650) from the center support (654). Removal of the cast aluminum piston is shown in Figure 13A-7. Removal of the stamped steel piston is shown in Figure 13A-8.

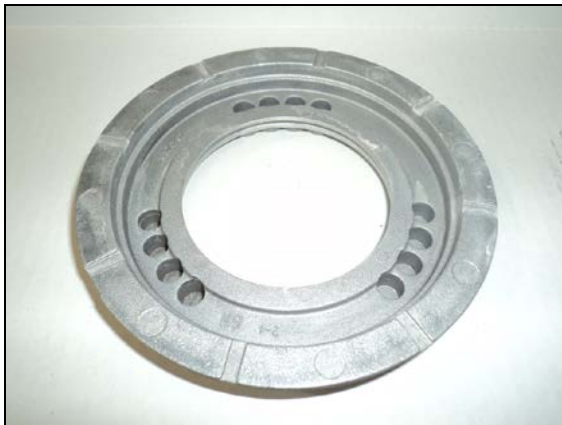
FIGURE 13A-9

As noted, the intermediate clutch piston may be either cast aluminum or stamped steel. The cast aluminum piston is shown in Figure 13A-9. The stamped steel piston is shown in Figure 13A-10.

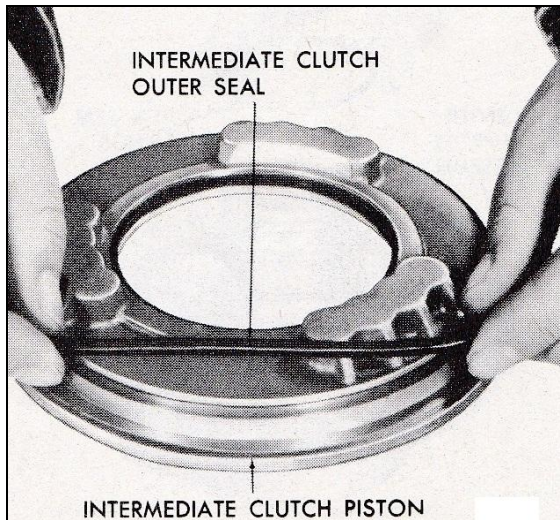
FIGURE 13A-11

Remove the outer (652) and inner (651) lip seals from the intermediate clutch piston. See Figures 13A-11 and 13A-12. Examine the seals and become familiar with how they fit the piston and seal in the support. Do not discard the seals. You will use them to identify the replacement seals later on during assembly. Inspect the piston for cracks. Inspect the piston seal grooves for nicks or damage.

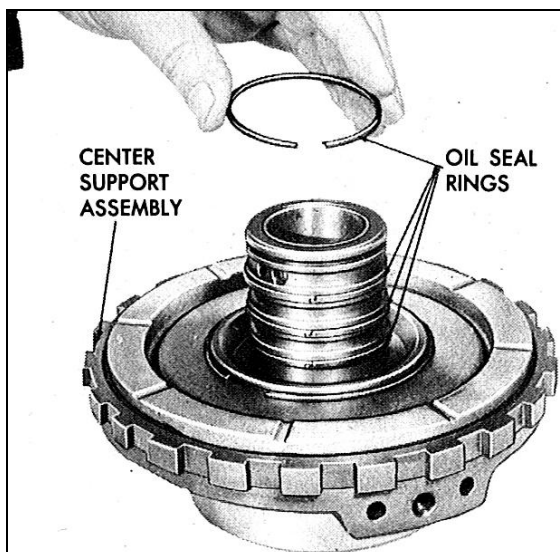
FIGURE 13A-13

Remove and discard the four oil seal rings (653) from their ring grooves in the center support. See Figure 13A-13. 1964 to 1974 models were assembled with cast iron hook type oil seal rings. 1975 and up models received scarf cut Teflon type oil seal rings. See Figure 13A-14.

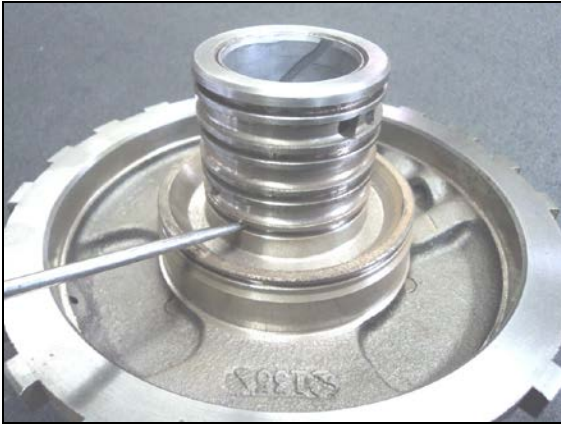
**FIGURE 13A-15**

Inspect the seal ring grooves for signs of wear or damage. See Figure 13A-15. If any of the seal rings are stuck or sticking in their grooves, check the seal ring grooves for signs of damage resulting from contact with the direct clutch housing. When the direct clutch housing operates with excessive radial runout, the seal ring bore on the inside diameter of the housing comes in contact with the outside diameter of the seal ring grooves. This results in the peening over or closing of the seal ring groove openings. Inspect and replace the center support if necessary. When using cast iron, solid Teflon, or Peak oil seal rings, test fit the rings in their respective grooves. Insert the outside diameter of the ring into the ring groove and rotate it around the full diameter of the groove. See Figure 13A-16. The ring should rotate smoothly around the groove. If the ring fails to rotate smoothly, inspect the groove for nicks or burrs. Remove any imperfections with a small file and recheck. Seal ring groove width should measure @ approximately .095". Ring groove depth should measure @ approximately .090".

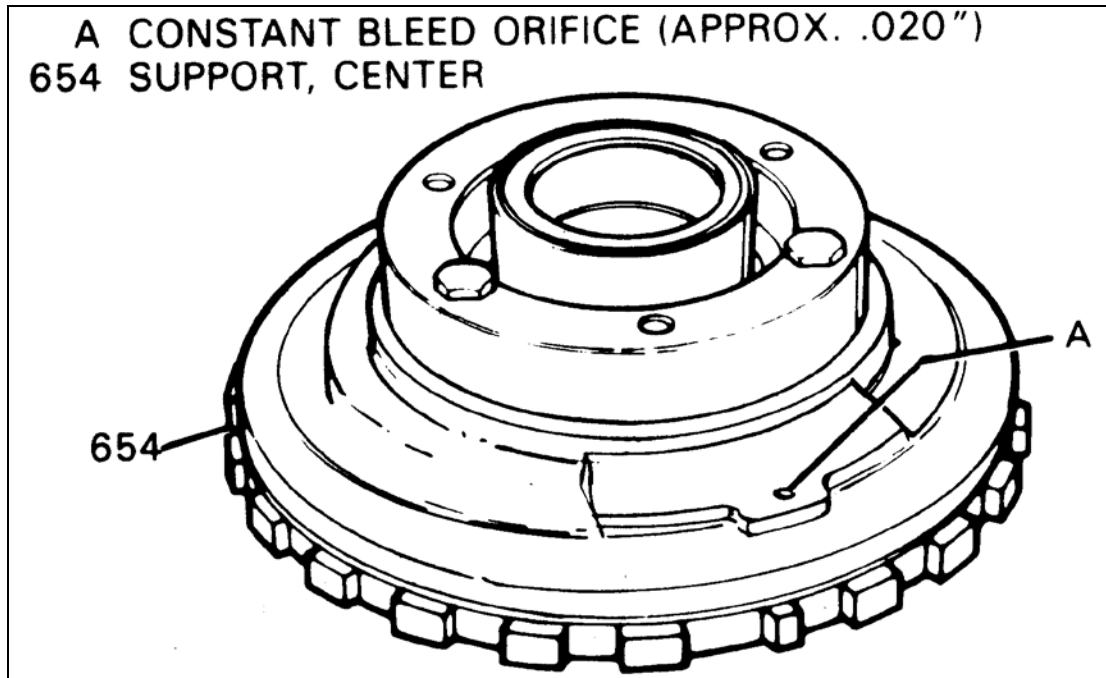
FIGURE 13A-17

Verify the presence of the bleed orifice cup plug installed in the intermediate clutch piston cavity. See Figure 13A-17. Verify the bleed orifice in the cup plug is free of obstruction and/or debris. Note that all 1964 and 1965 models, as well as all 1966 to 1972 Cadillacs were fitted with center supports void of the orifice cup plug.

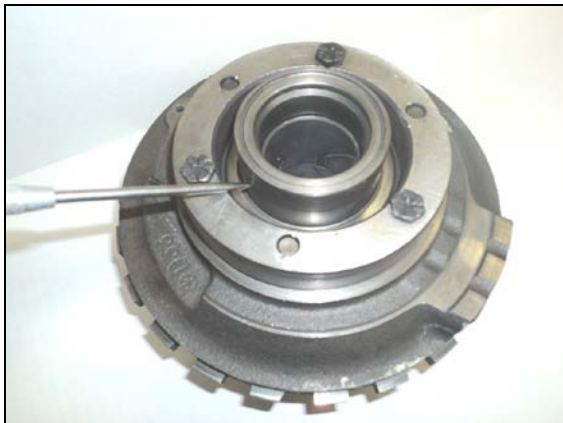
FIGURE 13A-18

The reaction carrier bushing journal is an integral part of the center support. See Figure 13A-18. Inspect the bushing journal for any signs of abnormal wear. Use your fingernail to check for scoring or grooving of the journal. Minor scoring can sometimes be removed with a fine grit emery cloth. Lubrication for the reaction carrier bushing is supplied thru a hole in the bushing journal. Verify the oil hole in the bushing journal is free of obstruction and/or debris. See Figure 13A-19. Prepare the journal by gently polishing it with a fine scotch pad.

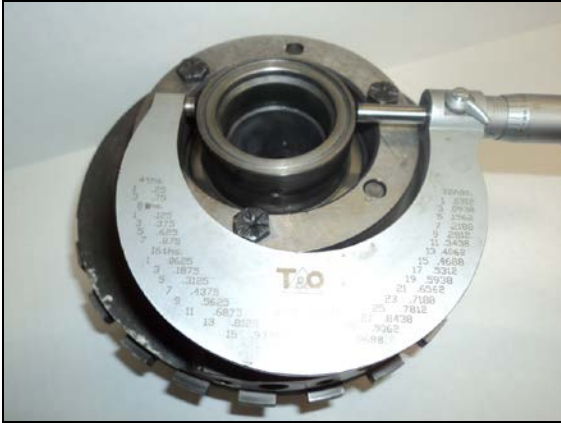
FIGURE 13A-20

Measure the bushing journal with a micrometer. See Figure 13A-20. The specification for the bushing journal diameter is 2.187" to 2.1875". The low roller clutch inner race is an integral part of the center support. See Figure 13A-21. Inspect the race for any signs of abnormal wear or damage. Use your fingernail to check for scoring or grooving of the race.

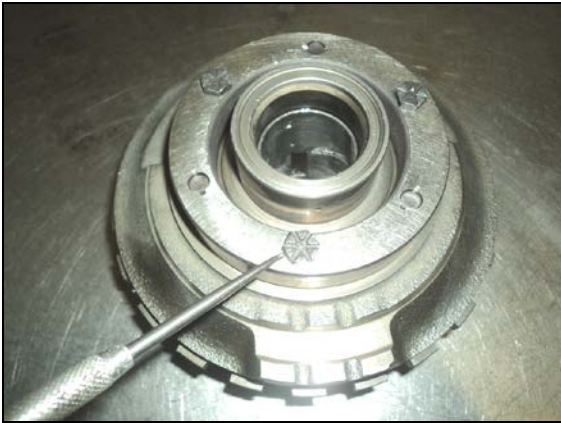
FIGURE 13A-22

The inner race is pinned and bolted to the center support. See Figure 13A-22. DO NOT remove the bolts. Inspect the threads that receive the center support to case bolt for signs of damage or stripping. See Figure 13A-23.

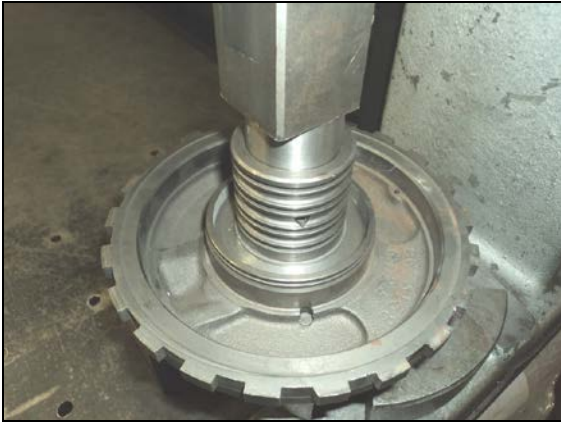
FIGURE 13A-28

Note that this bushing does not like to be installed with a hammer and bushing driver. Align the bushing oil slot with the center support oil hole, and using an arbor press install the bushing into the support. See Figure 13A-28. Install the bushing flush with the top of its bore. Once again verify that the bushing oil slot and the center support oil hole are in alignment. Flush the center support out with clean solvent and blow dry with compressed air to remove any material generated during bushing installation. To verify the bushing has been installed properly, lube the bushing and install the sun gear shaft into the support and verify smooth rotation. See Figure 13A-29.

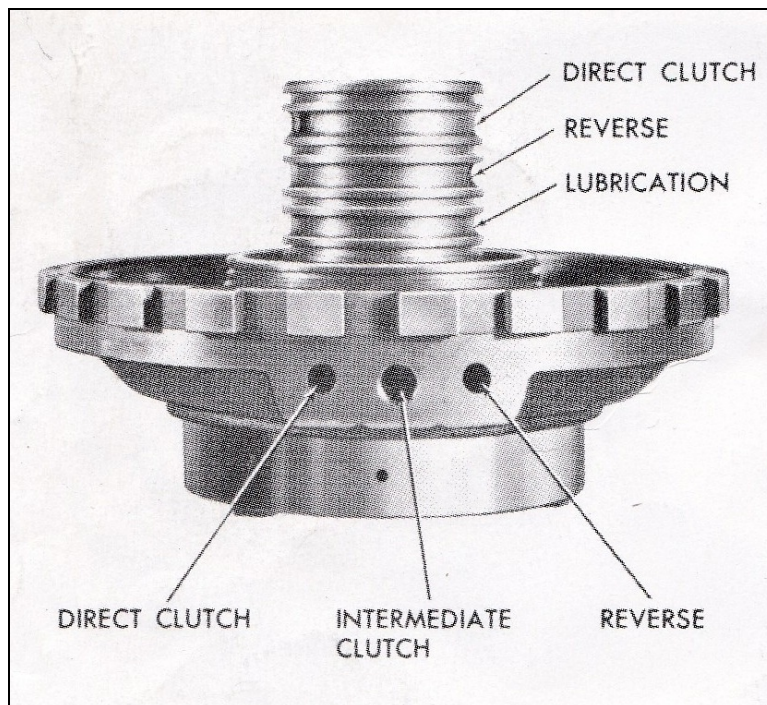
FIGURE 13A-30

Air check the center support oil passages to verify they are not interconnected. See Figure 13A-30.

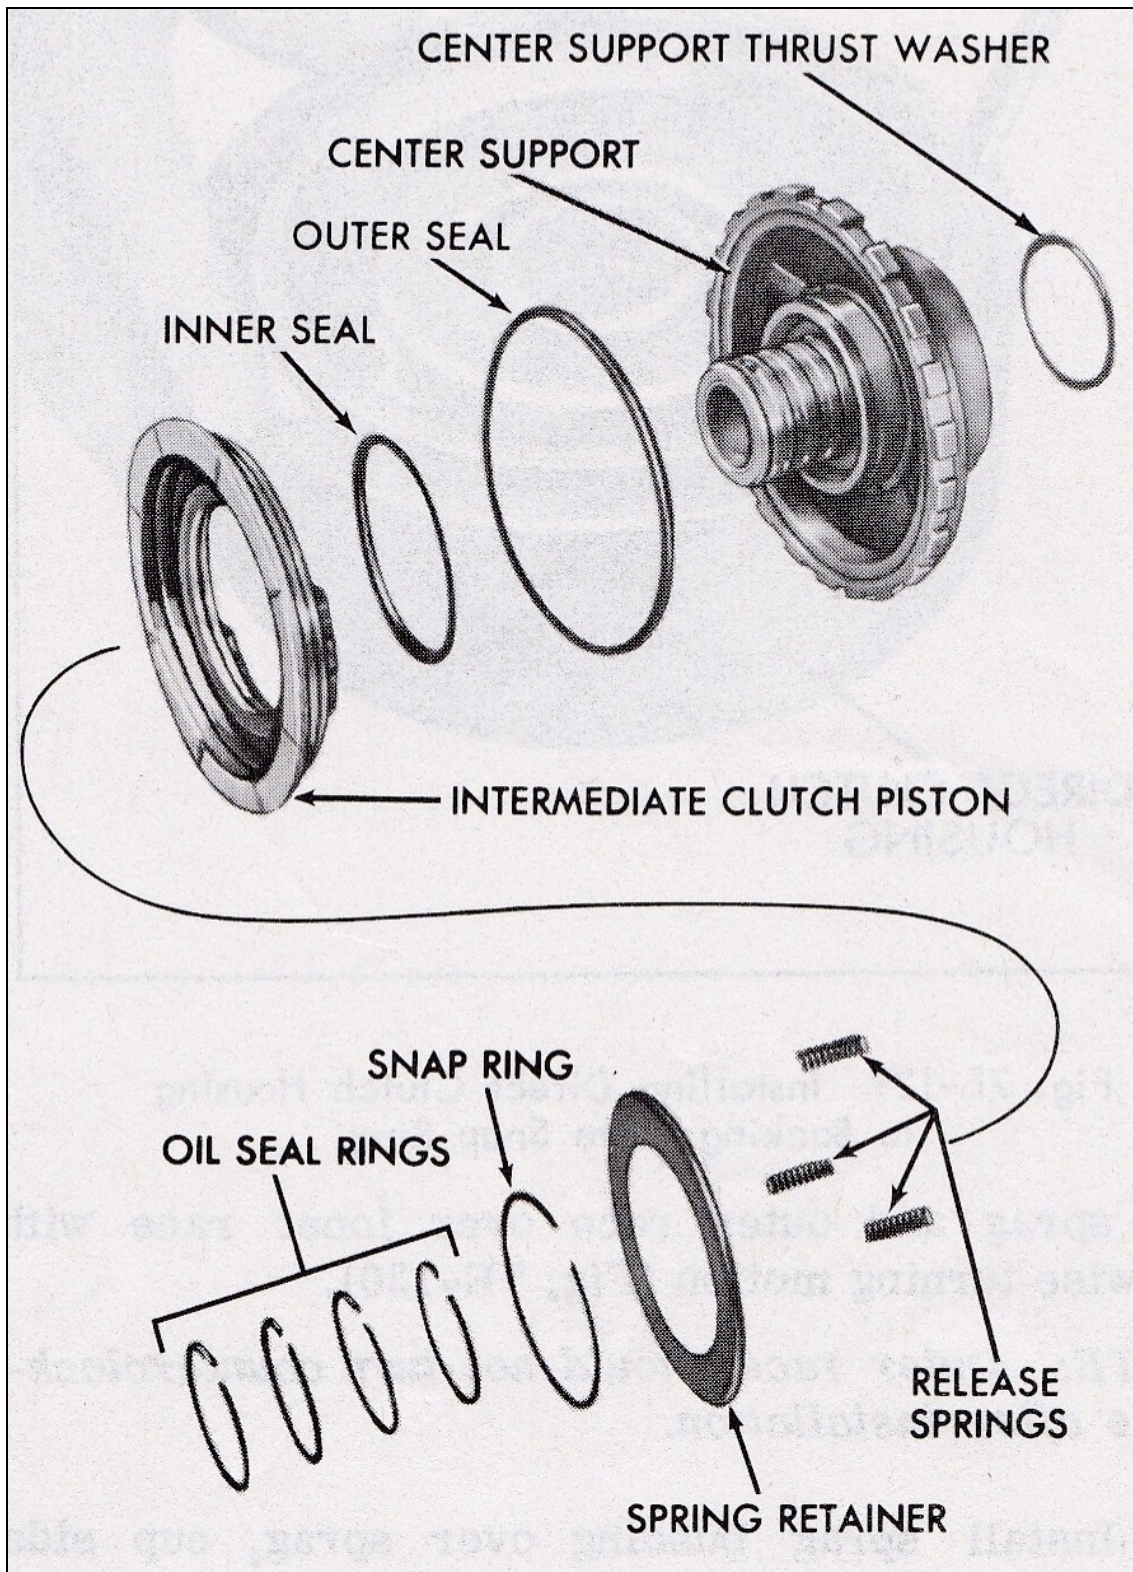
FIGURE 13A-31

Use Figure 13A-31 as a guide to reassemble the center support and related components.

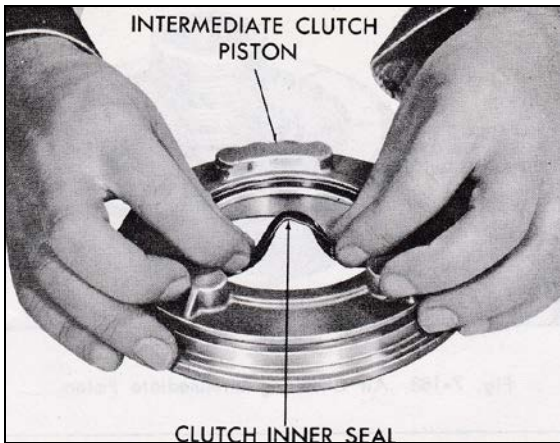
FIGURE 13A-32

Install the inner (651) and outer (652) intermediate clutch piston lip seals onto the intermediate clutch piston (650). See Figures 13A-32 and 13A-33. The lip of the seals will point towards the rear of the piston.

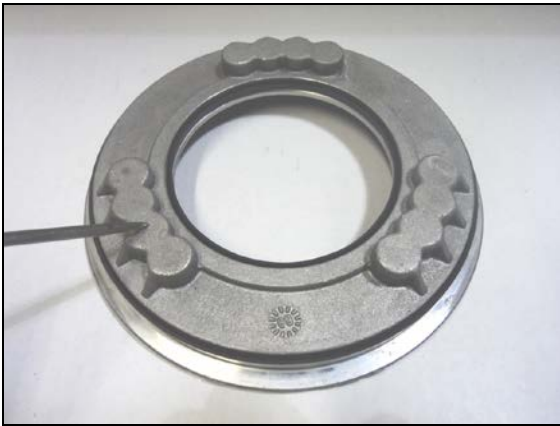
FIGURE 13A-34

Before attempting installation of the piston, take note of how the protruding spring pockets at the rear of the intermediate clutch piston fit into the spring pocket cavities in the front face of the center support. See Figures 13A-34 and 13A-35.

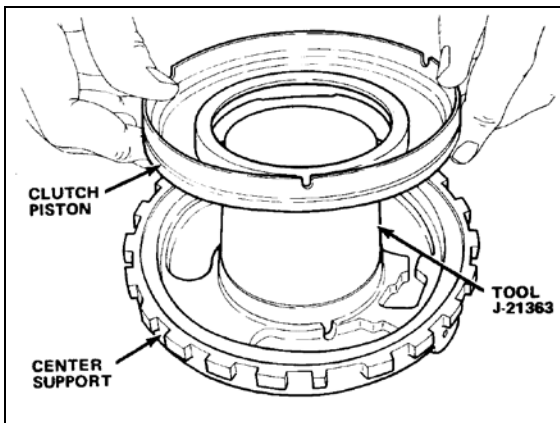
FIGURE 13A-38

Figures 13A-38 and 13A-39 show two versions of the service manual method and tooling for installing the piston. This tool is not necessary for the seasoned professional, but may be helpful to the production or novice builder.

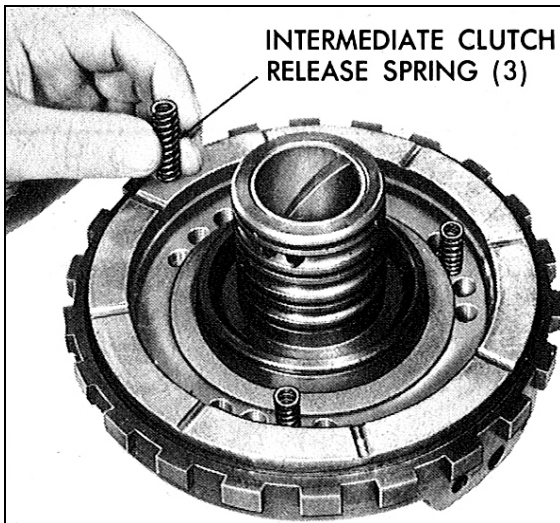
FIGURE 13A-40

Install the three intermediate clutch release springs (648) into the cast aluminum intermediate clutch piston (650). Be sure to install the springs evenly spaced. See Figure 13A-40. With all 1964 and 1965 models, and all 1966 to 1972 Cadillacs install 12 intermediate clutch release springs. With models that use the stamped steel intermediate clutch piston, install the plastic intermediate clutch spring guide (649) into its cavity in the piston, followed by the three intermediate clutch release springs. See Figures 13A-41 and 13A-42. Install the intermediate clutch spring retainer (647) on top of the springs. See Figure 13A-43.

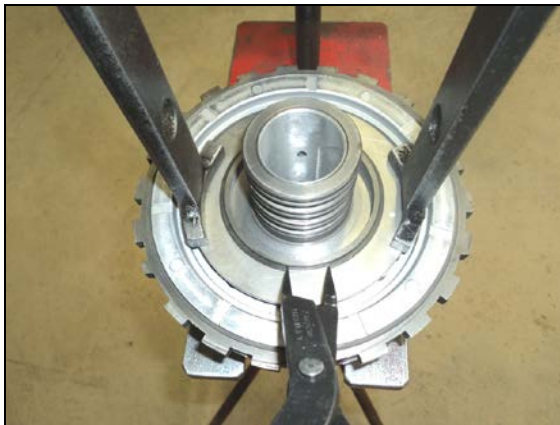
FIGURE 13A-44

Compress the retainer and install the snap ring (646). See Figure 13A-44. Figure 13A-45 shows the service manual method and tooling for the job. When working with pistons that use three release springs, the retainer may be compressed by hand. Verify the clutch release springs are not leaning. If necessary, straighten them with a small screwdriver. Air check the clutch piston for proper operation by applying 20 to 25 PSI of compressed air to the intermediate clutch passage in the center support. See Figure 13A-46. Note that using excessive pressure during the air check can blow the piston and seals out of the bore and can result in parts damage or personal injury. Applying air pressure should result in the piston pumping up against release spring pressure. Releasing air pressure should result in the piston retracting against release spring pressure. Most center supports will have the bleed orifice cup plug in the rear. See Figure 13A-47. A small amount of air is expected to escape out of the bleed orifice, but there should be no leakage from the lip seals. If the piston fails to pump up or release, disassemble the components and check for the problem before continuing. A final check with full pressure will be performed during the final assembly of the transmission. Install the thrust washer (656) into its recess in the rear of the center support. Retain the washer with assembly lube. See Figure 13A-47.

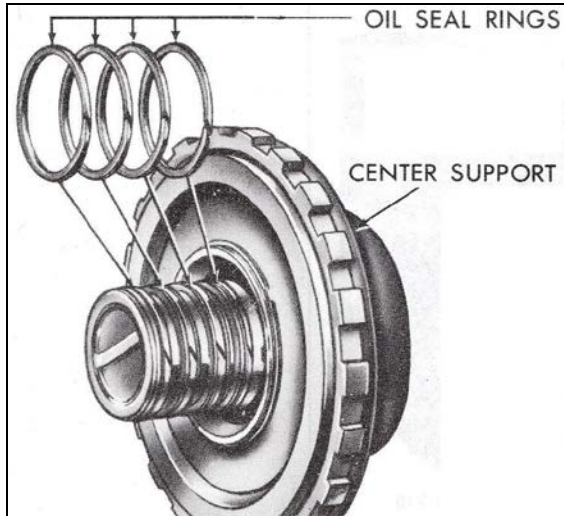
FIGURE

Install four oil seal rings (653) into the ring grooves in the center support. See Figure. Note that with applications which dual feed the direct clutch housing, the omission of the second oil seal ring from the top of the seal ring boss is required. If the dual feed methods in this publication are being implemented, the omission of the seal ring is required. Note that the use of cast iron seal rings is not recommended in any TH400 with fixed line pressure or line pressure values greater than stock. Rapid seal ring, ring groove and direct clutch housing bore wear will most certainly result. Teflon or Peak oil seal rings are preferred. Proper orientation of cast iron hook type seal rings is shown in Figure.

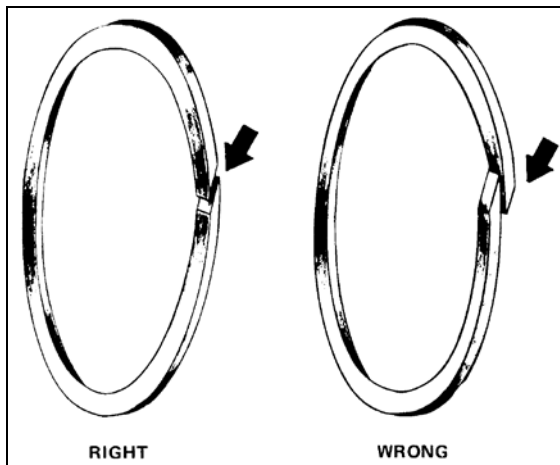
FIGURE

Proper orientation of Teflon scarf cut seal rings is shown in Figure. Properly installed Peak seal rings are shown in Figure.

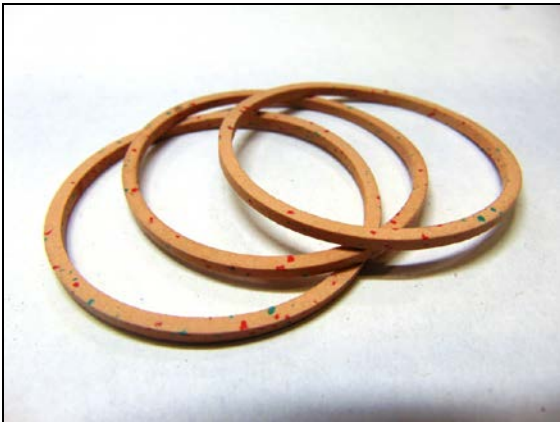
FIGURE

Solid Teflon sealing rings were fitted to the center support of early model 4L80E transmissions. See Figure. These rings will retro-fit the TH400 center support but require the use of specialized installation tools or some ingenuity on the part of the installer. A sleeve is fit over the sealing ring boss, and its height adjusted so that its leading edge is just above the seal ring groove the ring will be installed in. The sealing ring is then placed over the conical end of the sleeve, and a second tool is used to push the ring down over the sleeve, stretching the inside diameter just enough so that it can enter the ring groove. See Figure.

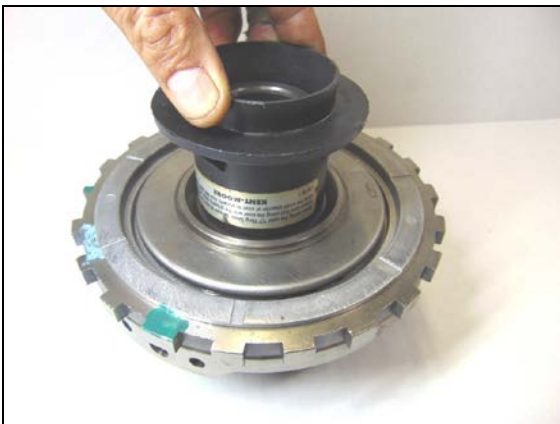
FIGURE

A sizing tool is then fit down over the rings and rotated, sizing the rings to the proper dimension. See Figure. A completed solid seal ring retro-fit is shown in Figure. Note the omission of the second oil seal ring, indicating the direct clutch housing is being dual fed.

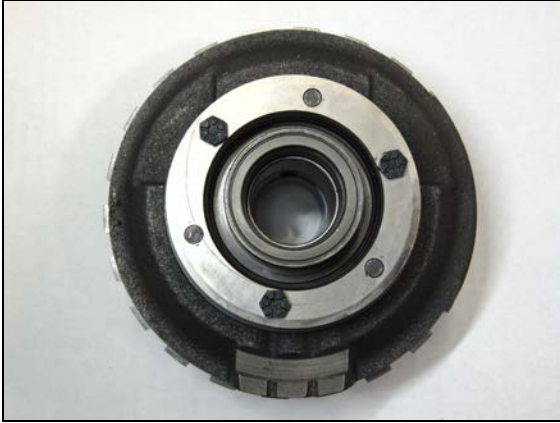
FIGURE

Note that all 1964 and 1965 models, as well as all 1966 to 1972 Cadillacs were fitted with a center support assembly void of a bleed orifice cup plug in the intermediate clutch piston cavity. See Figure. Note that these models also used twelve intermediate clutch release springs (648) instead of the usual three installed in all other models. Unlike later models, these supports are void of center support to case lugs in the casting at the area shown in Figure. Although the lugs are present on later model supports, the case has always been void of “receiver grooves” in that area. This alludes to the fact that it was easier to manufacture the support with all of the lugs rather than to “time” each support during the machining process.

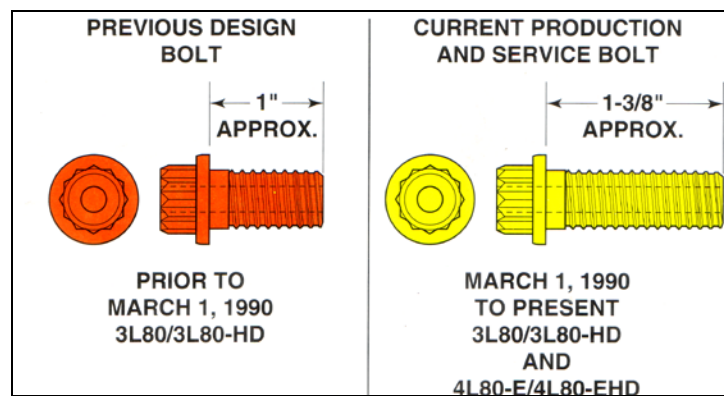
FIGURE 13B-3

All TH400 transmissions produced after March 1, 1990 received a revised center support casting. This is known as the second design center support. The casting number for the second design center support is 8678032. This is the same support used in all production 1991 to 1995 GM 4L80E transmissions. This support uses the anti fretting ring and the width of the lugs measures approximately .330". The 8678032 casting has slight differences in non critical dimensions when compared to the 8623138 casting, however; they do not affect fit or function. The second design support also received a different center support to case bolt. This bolt is longer than the previous design and must be used with second design supports only. See Figure 13B-3. When used with the anti fretting ring and proper center support to case bolt, the second design center support is fully interchangeable with both the early and late first design center supports.

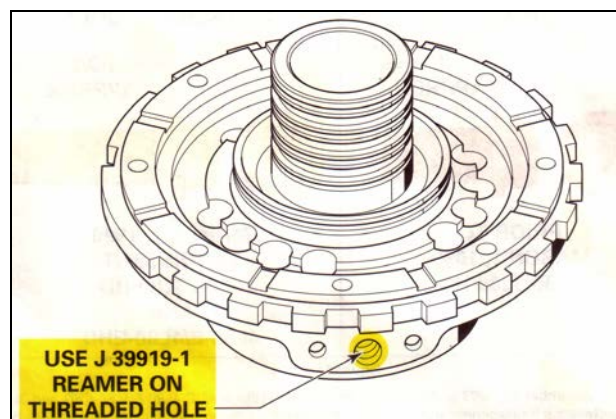
FIGURE 13B-4

Beginning on December 21, 1993 some TH400 GM Goodwrench Replacement Transmissions that used the second design support were built with a new case to center support service bolt. The bolt is coated with zinc chromate and is yellow in color. According to GM, the reaming of the threaded hole and the installation of the new bolt allowed the support to be reconditioned in the field one time before replacement. See Figure 13B-4. Apparently the engineers believed that the support was a wear item and was to be replaced during overhaul. The service bolt and instruction sheet is available under GM Part Number 24202218.

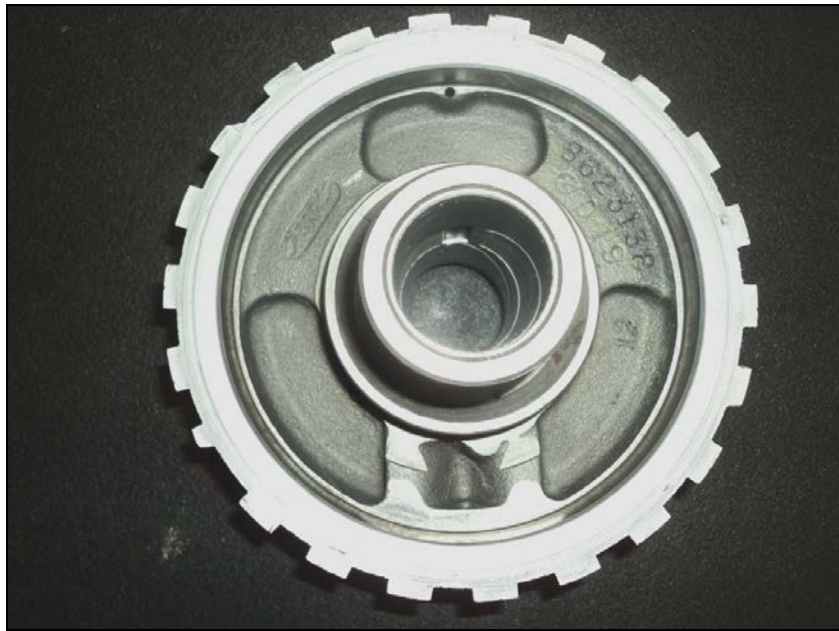
FIGURE 13B-5

There is a unique difference found when comparing the first and second design center supports. The first design center support uses 17 full width center support to case lugs. See Figure 13B-5. The second design center support only uses two full width center support to case lugs. See Figure 13B-6. No technical information regarding the reasoning for the change has ever been made available. It is evident that the reduced lug count can allow increased radial movement between the center support to case interface under extreme loading conditions in Lo range.

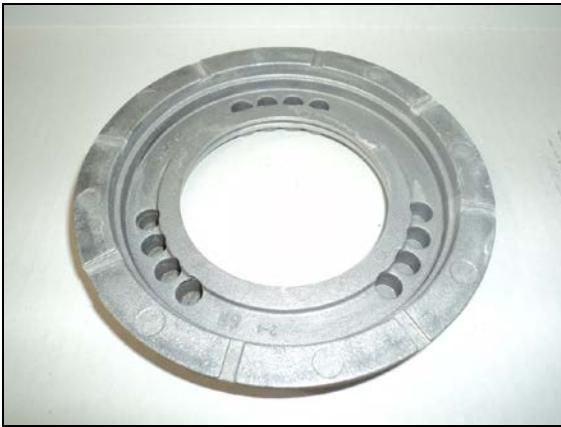
FIGURE 13B-7

From 1964 to 1973, all TH400 transmissions were built with the cast aluminum intermediate clutch piston. See Figure 13B-7. In 1974, the stamped steel intermediate clutch piston was introduced and used on some models, while the aluminum piston was used on others. See Figure 13B-8. Use of the stamped steel piston continued until the end of the 1984 model year, at which time its use was discontinued. Note that unlike the aluminum piston, the steel piston is void of release spring pockets. To provide a means for locating the springs, the plastic intermediate clutch spring guide is used with the steel piston. Both intermediate clutch piston combinations are fully interchangeable. Steel piston usage in performance builds is not encouraged. With increased line pressure, it suffers from deflection and a narrow work surface, reducing clutch pack performance. The piston work surface is the area of the front face of the piston that contacts and pushes on the first steel in the clutch pack. See Figure 13B-9. Note the narrow work surface of the steel piston compared to the wide work surface of the aluminum type.

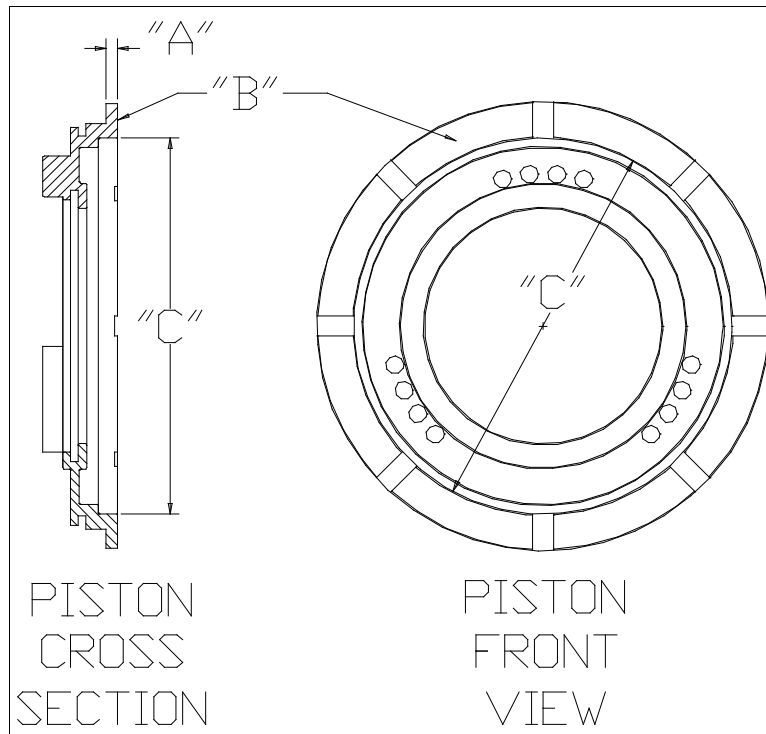
**FIGURE 13B-10**

The terms “overall work surface height” (“A”), “work surface” (“B”), and “counterbore diameter” (“C”) describe piston features pertinent to identification and interchange. See Figure 13B-10.

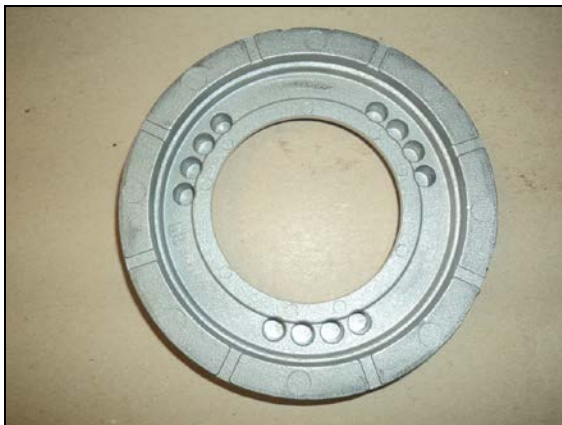
There are two types of production cast aluminum intermediate clutch pistons for the 4L80E. 1991-1995 models received part number 8661657 and are known as the early pistons. 1996 and up models received part number 24202553 and are known as the late pistons.

**EARLY PISTON # 8661657**

Functional dimensions between the early 4L80E intermediate clutch piston and the TH400 stamped steel or cast aluminum piston are similar with one exception. As cast, the overall work surface height of the 4L80E piston measures .140", compared to .155" with the TH400 piston. This will result in a .015" increase in intermediate clutch pack end clearance when retrofitting. This is no major cause of concern, and if necessary, clutch pack end clearance can be adjusted during final transmission assembly. All early 4L80E intermediate clutch pistons will retro-fit all TH400 transmissions.

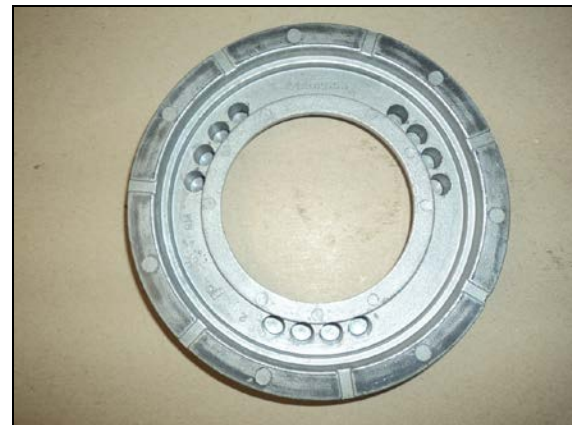
**LATE PISTON # 24202553**

The piston overall work surface height was reduced from .140" to .090", restoring clutch pack end clearance lost with the addition of the waved plate. This is where a potential problem can occur. Whenever installing a late 4L80E intermediate clutch piston into a TH400, the matching waved plate (684) must also be used. If not, the first steel plate in the clutch pack will not rest on the piston as intended. Instead, it will sit on top of the beveled center support to the case snap ring (645). See cut away view in Figure 13B-14. This will result in excessive intermediate clutch piston travel and possible functional problems may result. When used as a set, the late 4L80E intermediate clutch piston and matching waved plate will retro-fit all TH400 transmissions.

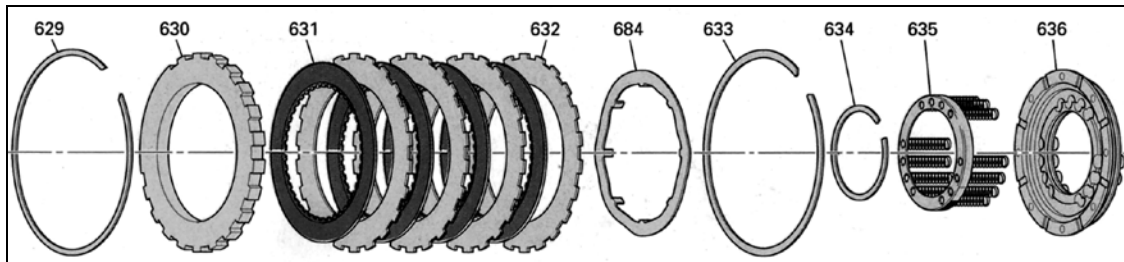
FIGURE 13B-11

Late model 4L80E transmissions incorporate the use of a waved plate installed between the intermediate clutch piston and the first steel plate in the clutch pack as a cushioning device. See Figure 13B-11.

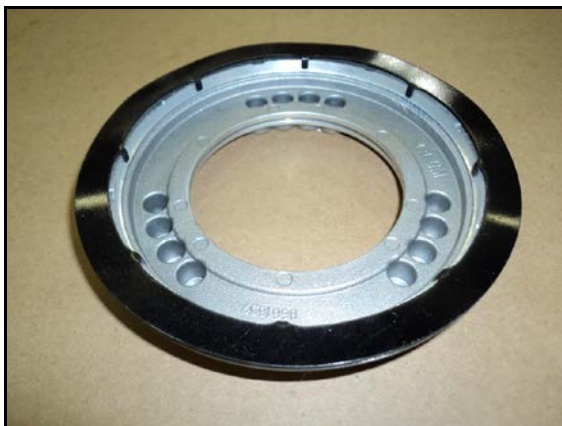
FIGURE

Clutch piston dimension revisions accommodate the waved plate. Locating tabs on the inside diameter of the wave plate permit the locating of the waved plate to the counterbore of the piston. See Figure 13B-12. The counterbore diameter was enlarged from 5.125" (common between all TH400 and early 4L80E intermediate clutch pistons), to 5.225", providing the necessary clearance for the waved plates locating tabs. See Figure 13B-13.

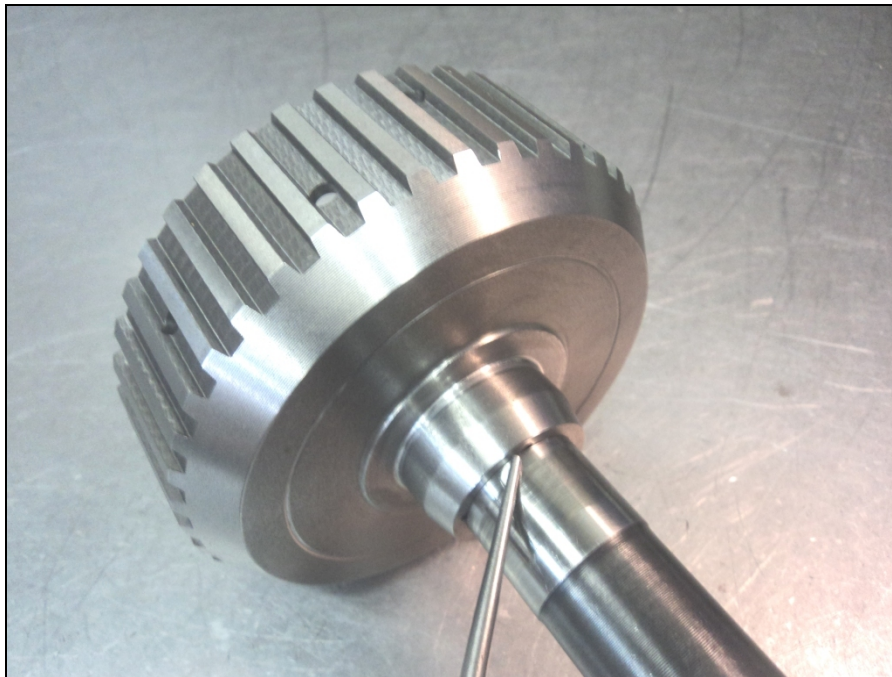
**FIGURE 13C-4**

Normal operating conditions result in the forward clutch housing assembly thrusting rearward into the mainshaft (681). In high load applications this rearward thrust can push the mainshaft with enough force to result in damage to the # 22 thrust bearing assembly (686, 687, 688) and output shaft to case thrust and selective washers (695,696). By creating a thrust surface in the front face of the center support, this rearward thrust can be cancelled out at the center support without making it to the mainshaft. The origin of this rearward thrust begins in the torque converter. Pressurized converter charge oil in the torque converter creates a force that acts on the front face of the input shaft (601). The amount of this force (measured in pounds) is calculated by multiplying converter charge pressure by the surface area of the front face of the input shaft. Typically, “corrected”\* converter charge pressure in a high load application will be @ 60 PSI. The surface area of a production input shaft is .785”. This combination results in 47.1 pounds of rearward force acting on the front face of the input shaft and forward clutch housing assembly. This force is then transmitted to the mainshaft at the interface between the forward clutch hub (616), and the mainshaft. This occurs because the front end of the mainshaft acts as a stop for the front end of the forward clutch hub. See Figure 13C-4.

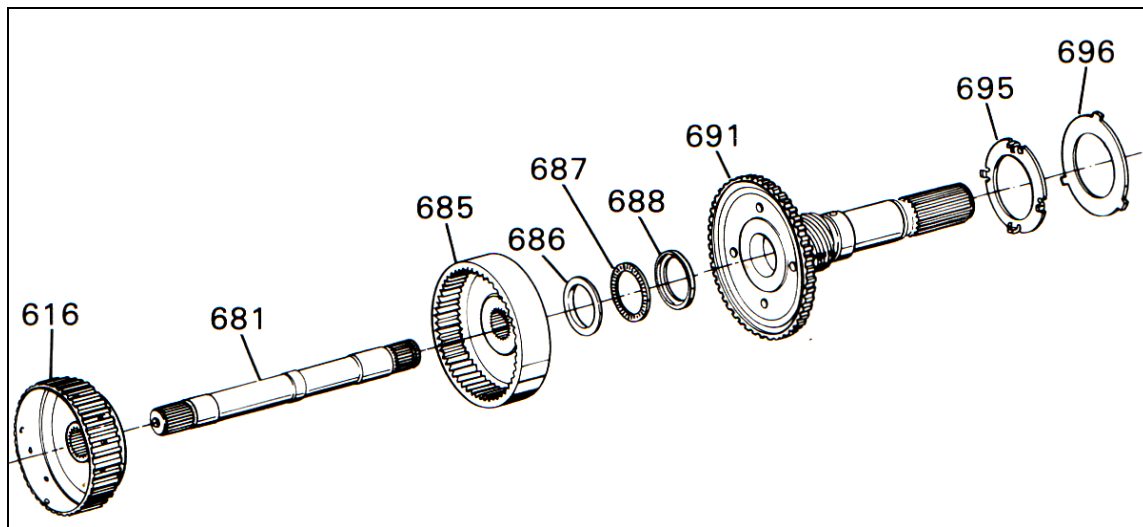
FIGURE 13C-5

From the mainshaft, the force is transmitted to the rear internal gear (685) and # 22 thrust bearing assembly (686,687,688), then to the output shaft (691) and on to the output shaft to case thrust and selective washers (695,696), where it is finally grounded out at the transmission case. See Figure 13C-5. In heavy duty and high load applications this can result in complete failure of the #22 thrust bearing assembly.

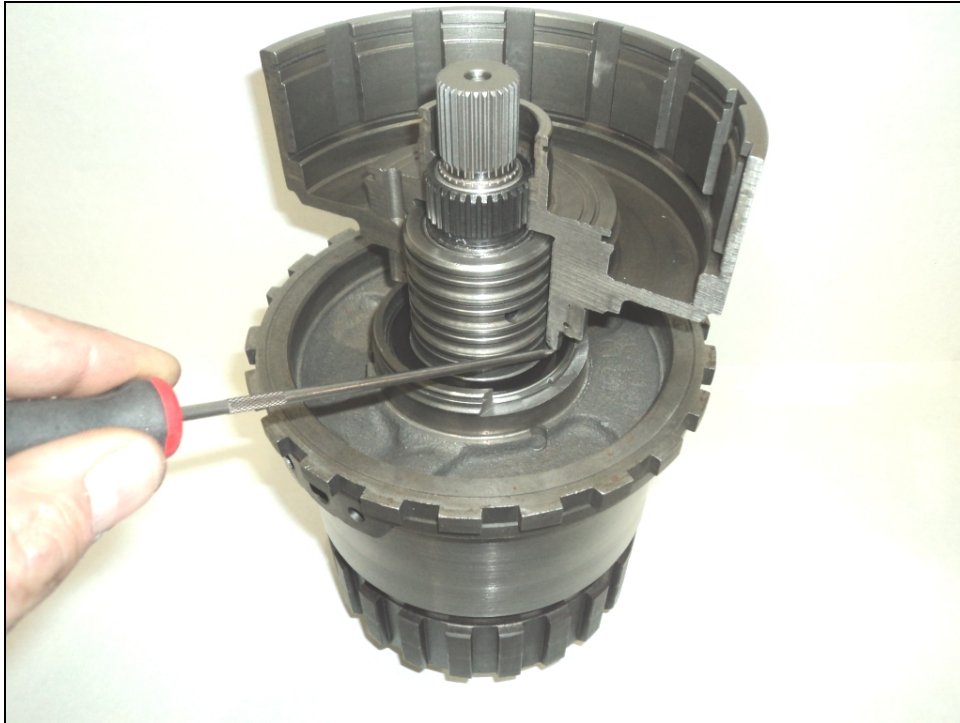
**FIGURE 13C-8**

2. A bearing pocket is machined at the bottom of the snap ring boss recess and fitted with a thrust bearing, permitting the grounding of the direct clutch housing to the center support. See Figure 13C-8. The pocket is machined to a depth of .375" measured from the front face of the boss and to an inside diameter of \$\$\$ and an outside diameter of 2.875".

Selective shims installed between the thrust bearing and the bearing pocket “push” the direct clutch housing off the sun gear shaft stop permitting it to thrust against the center support.
