# SERVICE BULLETIN

Classification: EC04-006a	Reference: NTB04-028a	Date: March 24, 2004
------------------------------	--------------------------	-------------------------

## 2004 MAXIMA & QUEST (5 SPEED A/T ONLY); MIL "ON" WITH DTC P1031, P1051, P1148, P1168 A/F SENSOR HEATER / CLOSED LOOP

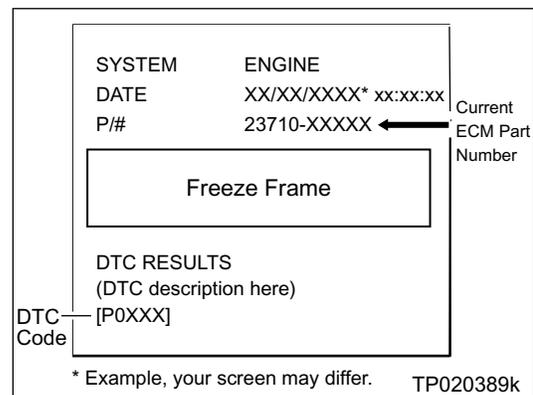
- Figure 1 is an example of the Freeze Frame Data printout.
- The Freeze Frame data that you’ve printed contains the ECM Part Number (P/N).
- You’ll use the ECM P/N to see if this bulletin applies.

3. Check the ECM Part Number on the printout from step 1 (Figure 1):

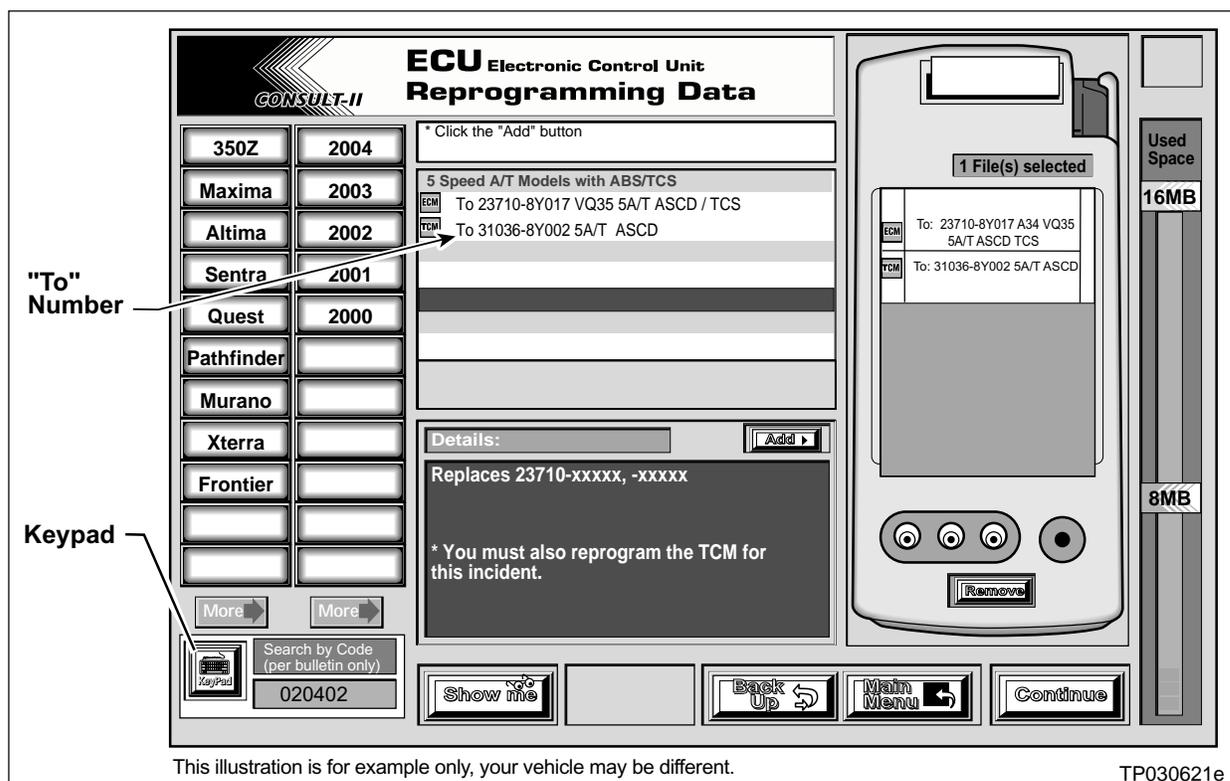
Figure A

1. Click on the Keypad button (see Figure A).
    - A Keypad will pop up, left side of screen.
  2. Using the digit keys on the keypad, enter the correct **ASIST ECM DATA ID CODE**.

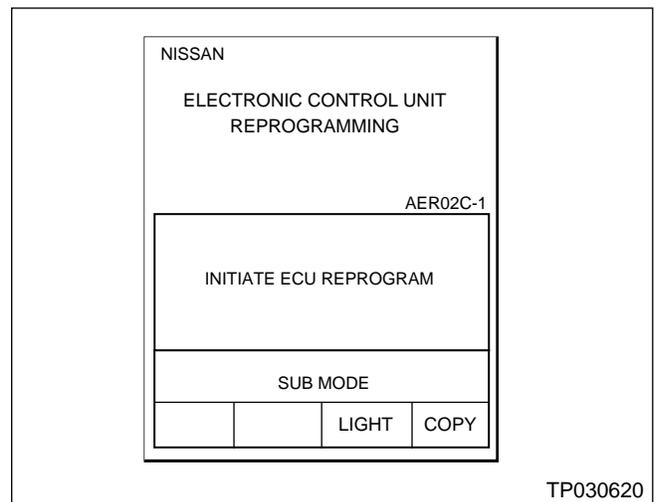
Figure C

2. Press **SUB MODE** (see Figure C) then:
  - a. From the listed items, find and select **BATTERY CHARGE**.

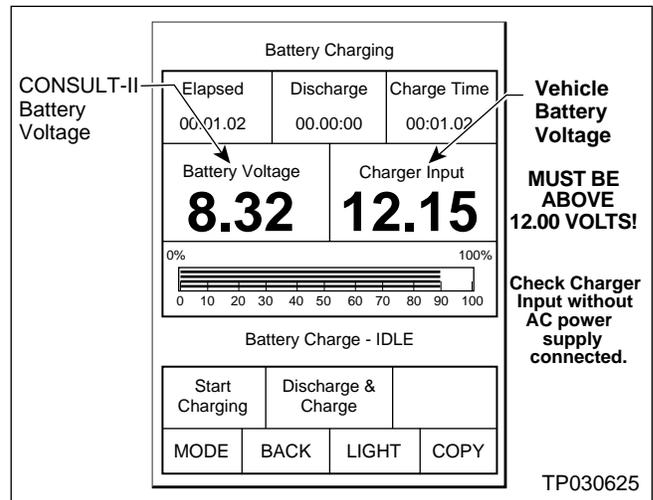
Figure D

3. Check the CONSULT-II's "Charger Input" reading (see Figure D).

- **"Battery Voltage"** is the voltage level of CONSULT-II's battery.
- **"Charger Input"** is the voltage level of the vehicle's battery. **(It must be above 12 volts.)**

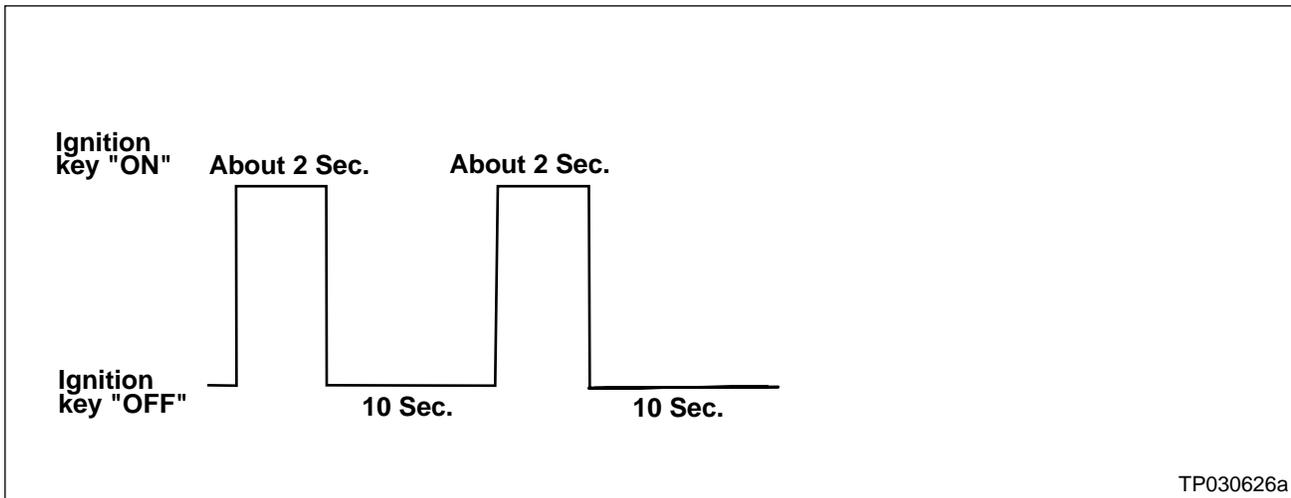
Figure E

1. Turn the ignition switch "OFF" and CONSULT-II “OFF”.
2. Wait more than 10 seconds, then;
  - a. Turn the ignition switch "ON" for 2 second, then
  - b. Turn the ignition switch "OFF" again for 10 seconds (see Figure D).
    - This will reset ECM “self learned” Data.
