## 7 Diagnostics

### 7.1 Preliminary Diagnostics

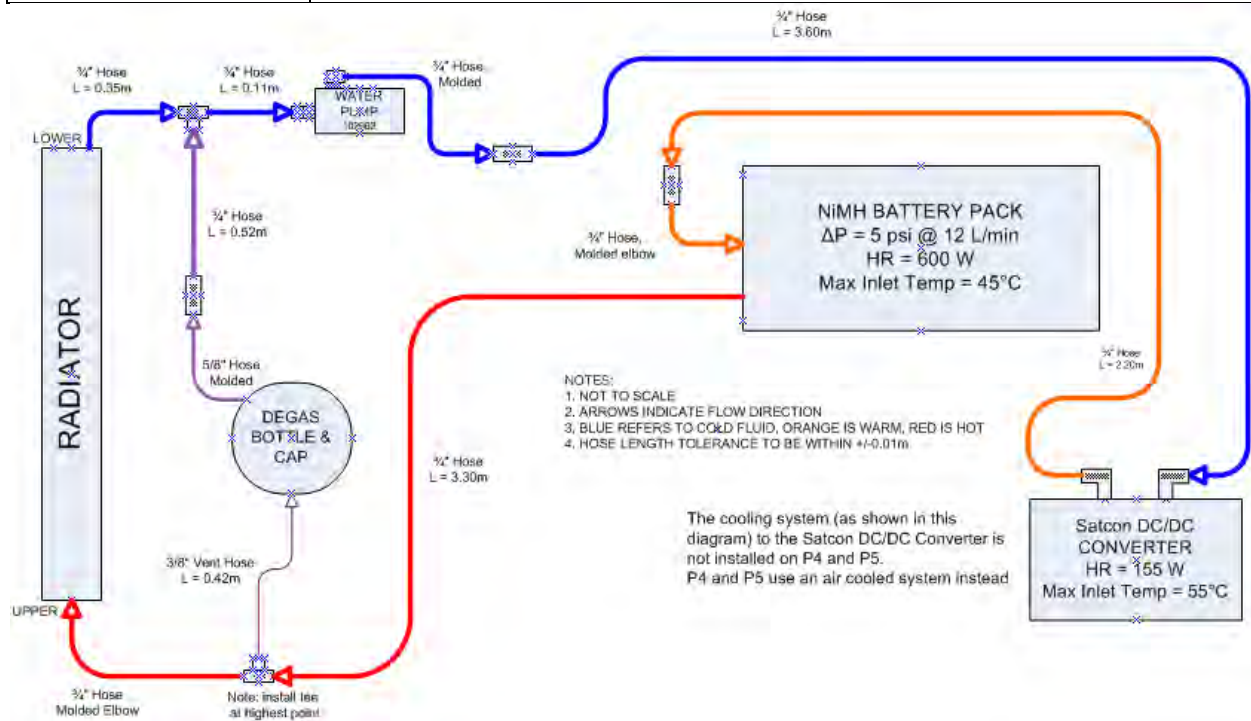
Description:	Maximum ESS module temperature has exceeded 70° C. The temperature will be in the “H”.
Possible Causes:	<ul style="list-style-type: none"> <li>• Low temp coolant pump inoperable.</li> <li>• Radiator fans inoperable..</li> <li>• Low coolant level.</li> <li>• Blocked or kinked coolant hose.</li> <li>• Internal ESS Module failure.</li> </ul>
Diagnostic Aids:	<ul style="list-style-type: none"> <li>• Using Balance Diagnostic tool check for any <a href="#">ESS Info codes</a>.</li> <li>• Using Balance Diagnostic tool check ESS module temperatures. If all temperatures are close to being equal than look for external cooling system issue. If module temperature is greater than 10°C higher than the other modules, replace ESS.</li> <li>• Check Electronics cooling level or kinked hose.</li> <li>• Using the Balance Diagnostic Tool, manually activate the low temperature cooling pump and Radiator Fans to confirm operation.</li> <li>• Check radiator fan fuse F039 (80 amp).</li> <li>• Check Coolant pump fuse F011 (10 amp) and K3 low Temp Cooling Pump Relay.</li> </ul>

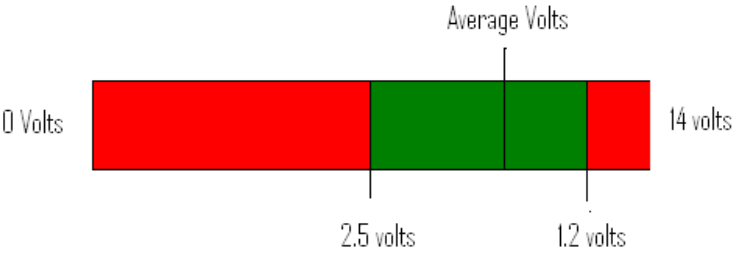
<p>Description:</p>	<p>Difference between average module voltage and maximum or minimum module voltage exceeds predetermined level (greater than 1 volt).</p> <p>One of the following conditions is TRUE for 20 seconds:</p> <ul style="list-style-type: none"> <li>• The average module voltage of the pack minus the minimum module voltage is • 2.5 volts</li> <li>• The maximum module voltage minus the average module voltage of the pack is • 1.2V</li> </ul> <div style="text-align: center;">

</div> <ul style="list-style-type: none"> <li>• Pack modules may be weak or poorly balanced. A single or multiple modules may be failing or have failed.</li> <li>• Internal battery pack fault (module voltages are being misread due to hard or software fault)</li> <li>• This may be more evident during cold (below 0°C) operation or during aggressive operation where there are longer and heavier charge/discharge rates.</li> </ul>
