DDM-2000 OC-3 Multiplexer

Software Release Description

TARP Release 15.0.4

363-206-231
Issue 6
August 2001

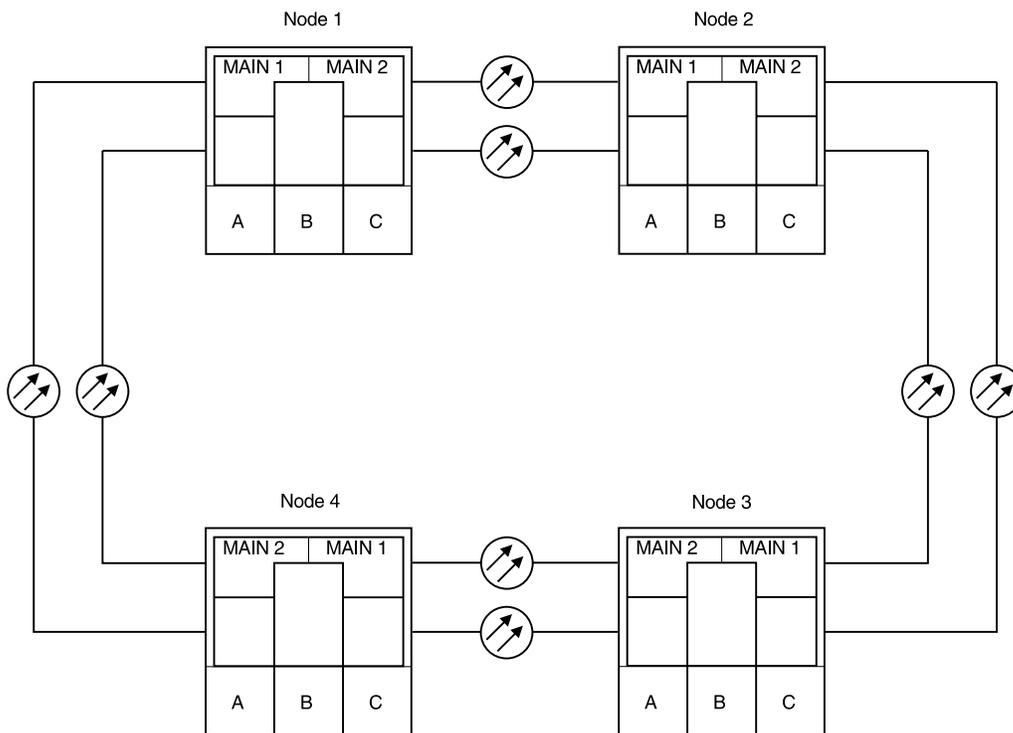
Figure 1 – Example of OC-12 24-Type to OC-12 29-Type Ring Upgrade

**NOTE:**
This procedure uses a 4-node OC-12 ring as an example for the OC-12 **OLI**U ring upgrade (Figure 1). This upgrade starts at Node 1 and proceeds clockwise. Local procedures will have to be written, using the concepts of this procedure, to upgrade the particular configuration that you have.
