TURBO DIESEL BUYER'S GUIDE

A Publication of the *Turbo Diesel Register*

TURBO DIESEL Buyer's Guide

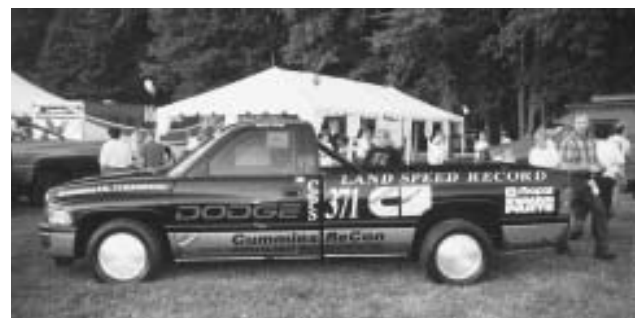
This interesting photo is an early '94 model truck that was modified to run at Bonneville. It successfully set a class record at the 1997 Bonneville speed weeks of 141.256 mph (TDR Issue 15, page 44).

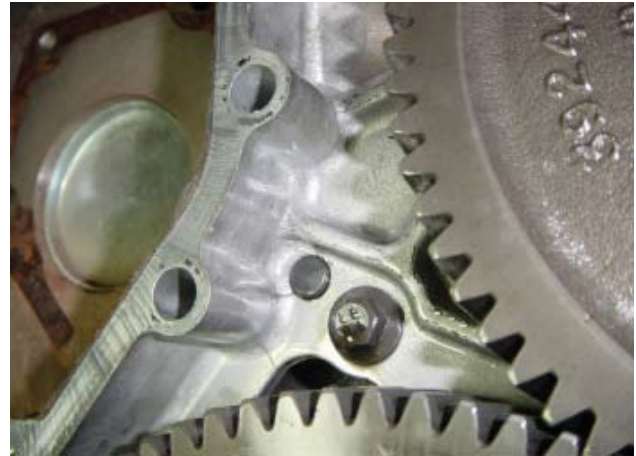
A close-up picture of the dowel pin.

part. There are a number of preventative measures, some of which can be done with hand tools. When replacing the dowel pin, replace the crankshaft oil seal and vice versa due to a seal leak. The fix involves staking the pin, covering the pin with a teardrop-shaped washer placed under a nearby bolt, or removing the pin altogether since it has already served its purpose in locating the housing during engine assembly.

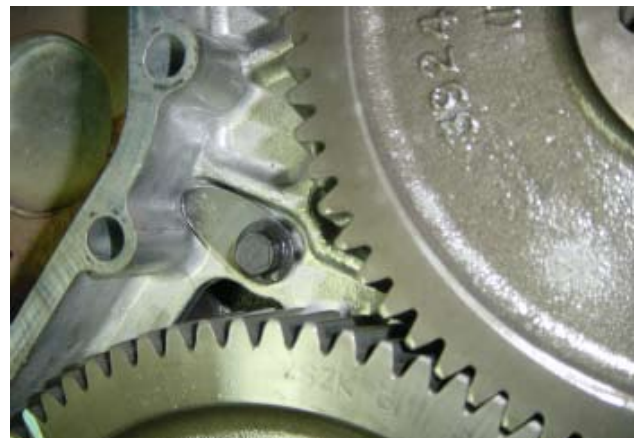
A picture showing an egg-shaped washer that covers the dowel pin.

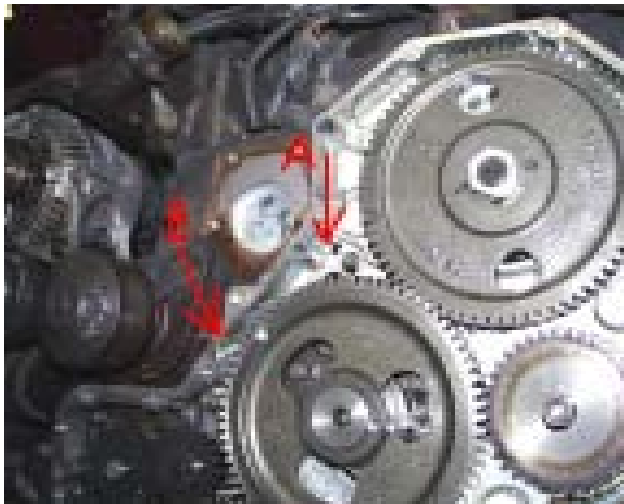
For those not familiar with the dowel pin the arrow shows its location.

Several methods of securing the pin into its bore have been developed by shops that service B-series engines. These methods have been covered in previous TDR magazines (Issue 38, page 136; Issue 33, page 46). Additionally, there is a thread on the TDR web site that takes you through the "how-to" should one wish to use the drill/jig method. However, on a recent visit to TST's shop outside Columbus, Indiana, I discovered yet another way to perform this preventive maintenance type procedure.

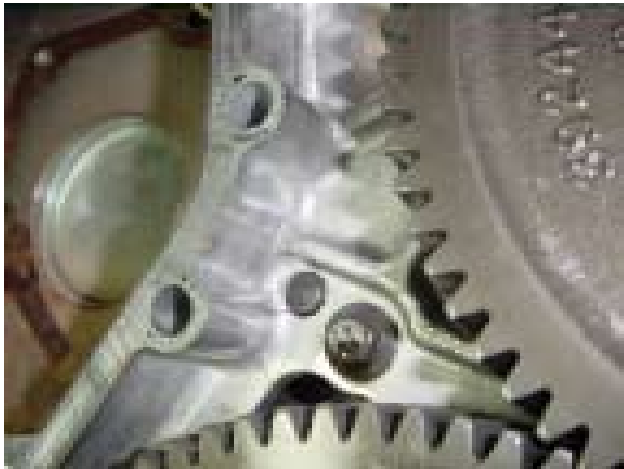
A close-up picture of the dowel pin.

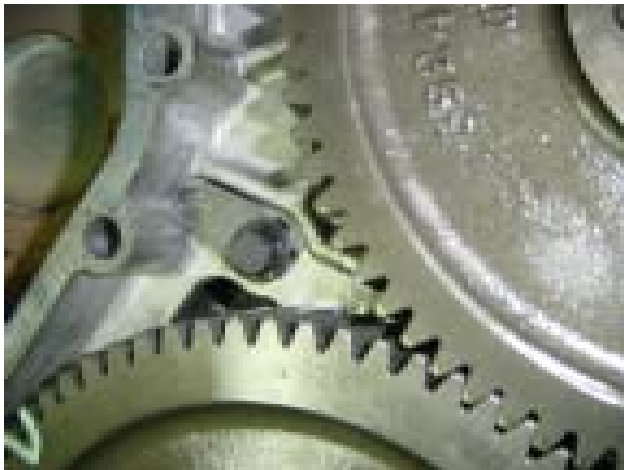
Above is a picture of an egg-shaped washer that is their solution to the problem.

- 13) Lucky step 13! Time to install the special egg-washer, preventive maintenance part. Locate the 10mm bolt next to the dowel pin and remove it, reinstall the longer bolt using the special washer supplied in the kit. This washer will prevent the dowel pin from backing out. Apply loctite high strength (red) thread locker to the threads and torque the bolt to 18 ft. lbs. torque.
- 14) Using a gasket scraper, clean the gear housing gasket surface and the gear housing cover.

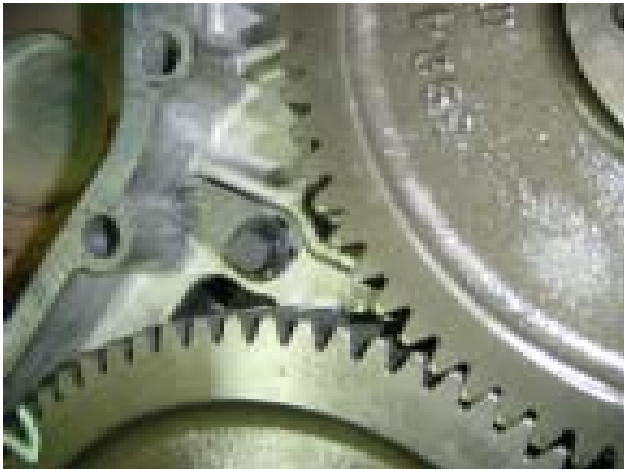
- 12) Locate the dowel pin and look to see if it is fully seated. Most of the pins will be flush with the gear housing or just below flush if they have not backed out. If the pin seems to be backed out find a small punch. With a hammer and punch tap on the head of the dowel pin and drive it into the block as far as possible.

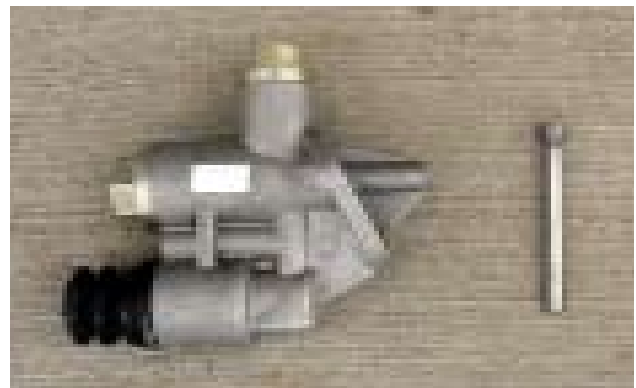
Carter lift pump with plunger removed.

Following the procedure in the Service Manual, the first step is to disconnect the battery terminals. The instructions read to remove the starter motor (Remove the starter . . . there has to be a better way.), place a drain pan below the pump, remove the fuel line fittings at the top of the fuel pump, and fuel heater housing. Next, remove the fuel hose clamps and rubber fuel hose. (You can leave them connected and remove after you have removed the fuel pump and fuel heater.) Remove the two mounting bolts. Remove the fuel pump and fuel heater as one unit. Be careful not to allow the plunger to catch on the edge of the hole in the cylinder block and drop into the engine. As intimidating as this sounds, you would have to try to do this, as the plunger has to be pulled from its bore. Simple enough?

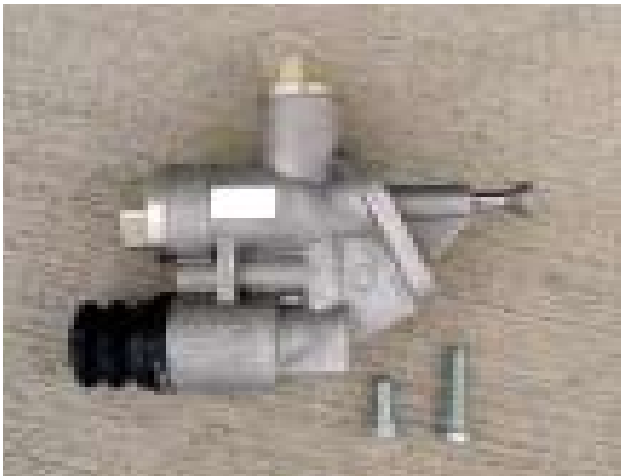
Carter lift pump with regular mounting bolt and longer temporary bolt.

Here is the secret: When you remove the fuel lift pump, take one of the two mounting bolts and find a replacement that is the same metric thread size but about $\frac{3}{4}$ " longer. You probably have one in your parts box or you can borrow one from elsewhere on the engine. When reinstalling your lift pump use the longer bolt as your starter bolt. Once you get the lift pump and fuel heater partially tightened down, install one of the original bolts in the other hole. Once it is partially tightened, remove the longer bolt and replace it with the other original bolt. Tighten the two bolts to 18 ft-lbs torque. (Tighten the two bolts alternately to prevent damage to the fuel pump housing.) I thought this was the easier and less time consuming way than removing the starter and trying to be a contortionist by working my way around the front differential.

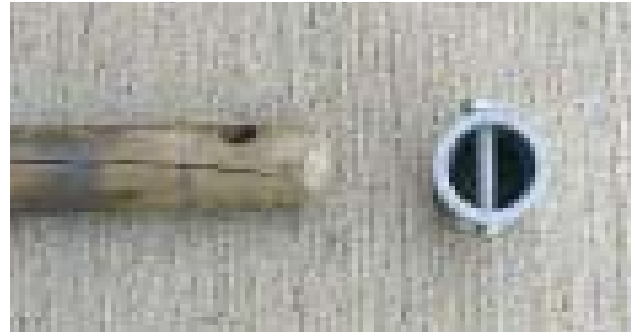
Broom handle, $\frac{3}{4}$ " coupling with hole drilled and bolt.

ton jacks) that has a slot in the center of the open-ended pipe. Another method that's been used at Geno's Garage is using an old broom handle to push the primer button. I decided to make my broom handle a little easier to use by taking a $\frac{3}{4}$ " PVC coupling and sliding it on the end of the broom handle and drilling a hole about a $\frac{1}{8}$ " below the top ridge and installing a bolt in it. This is to help prevent the rubber boot from tearing. This will always come in handy when you have to prime the fuel system. When you hear the fuel hit the pump, try starting your truck.

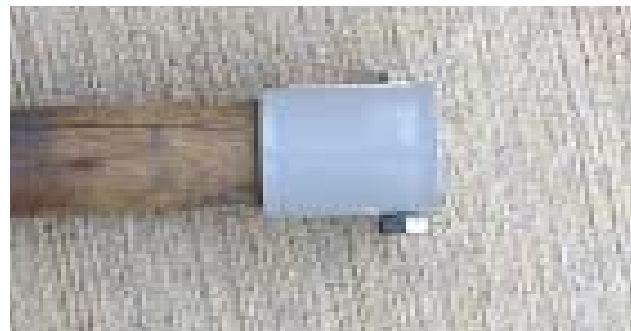
Broom handle assembled.

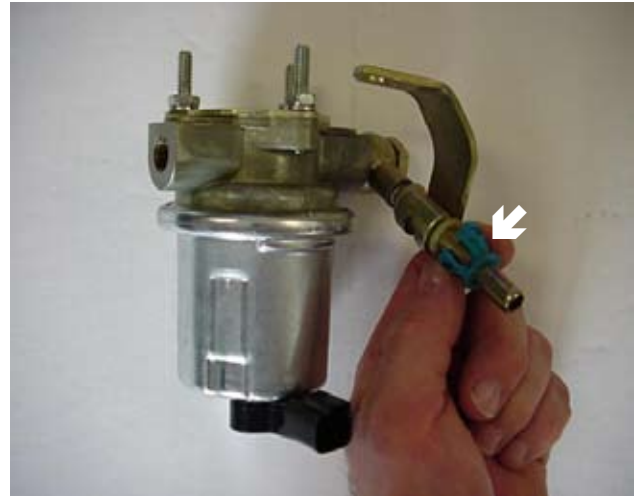
Pinch the blue disconnect and the fuel line will come loose.

Step (2): Remove the fuel supply line from the transfer pump. From the bench-picture you can see the two, blue quick-connects that you push in to release the fuel supply line.

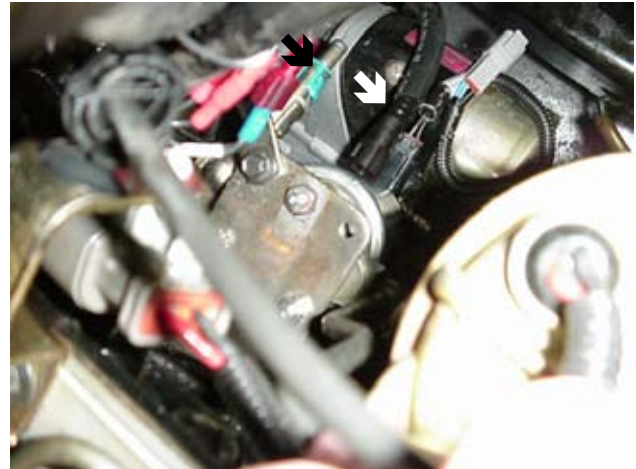
The fuel line to the transfer pump and the fuel line that goes to the fuel tank are pictured here.

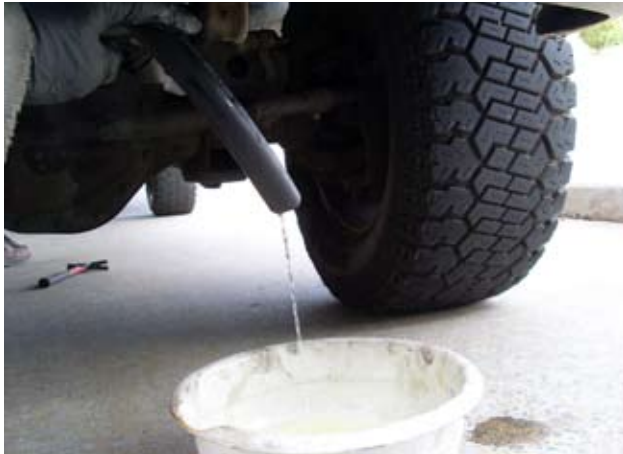
Extend the fuel filter drain hose to save the aggravation of having the fuel drain onto the frame which is caused by the existing short drain hose.

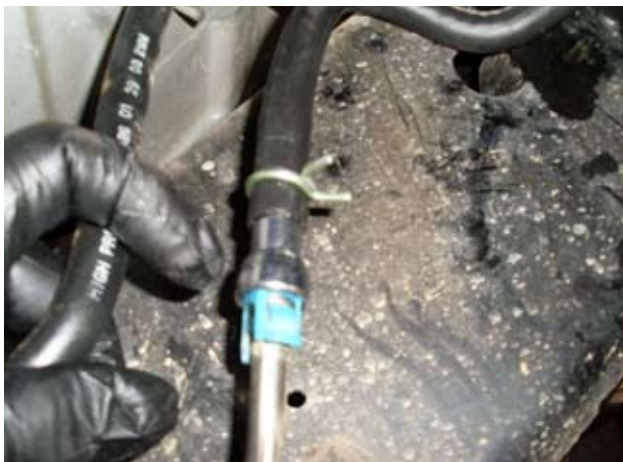
Pinch the outer tangs of the fuel line quick-fitting to separate the rubber hose from the hard fuel line.

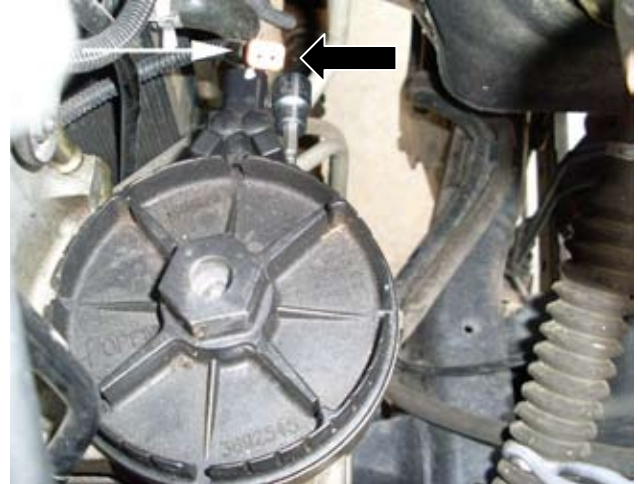
Unplug the water-in-fuel sensor. Note how the wires and cables have been pushed to the side of the fuel filter.

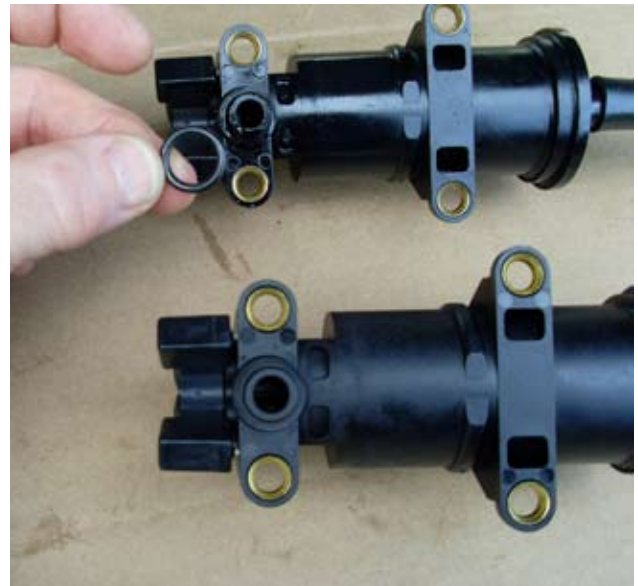
Do not forget to remove the old O-ring. An O-ring on top of an O-ring doesn't work too well. Ask me how I know.

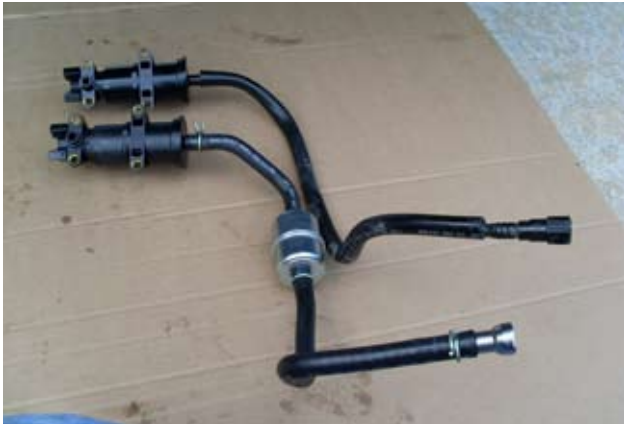
With the old transfer pump and fuel line removed you can see the orientation of the new fuel lines and primary fuel filter.

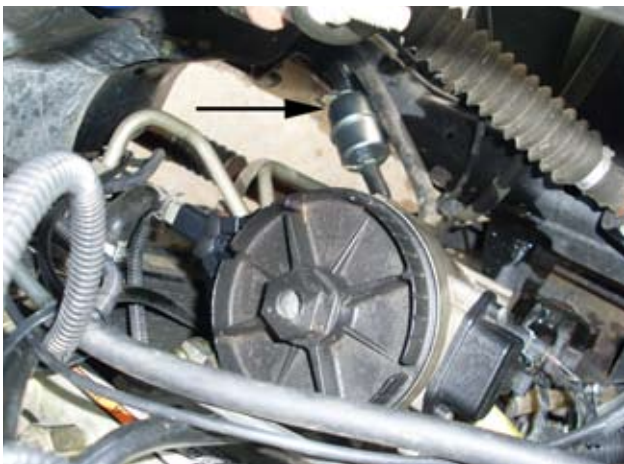
The installed orientation of the new fuel filter.

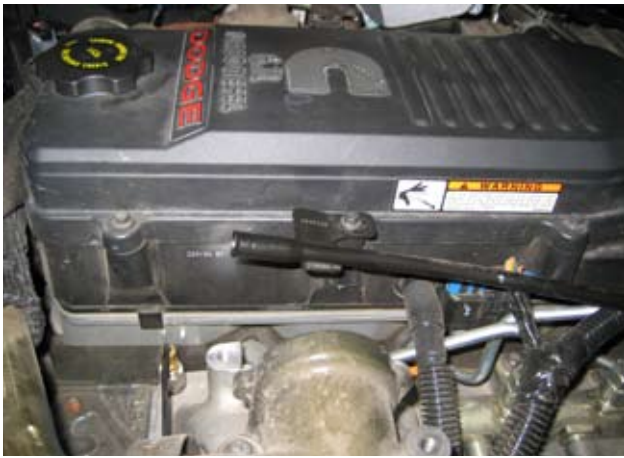
Relocate the oil dipstick tube to the valve cover.

Subsequent fuel filter changes can be done from above if you take the time to move the aforementioned electrical wires, relays and cables to the side. You will have to move the oil dipstick tube to the left and modify the bat wing to accept the new dipstick location.

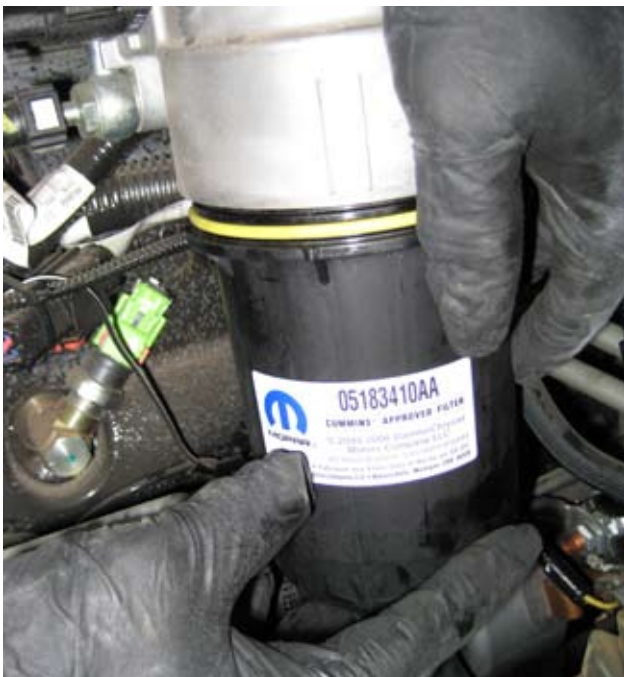
With one hand above and one hand below you can get to the fuel filter from above.

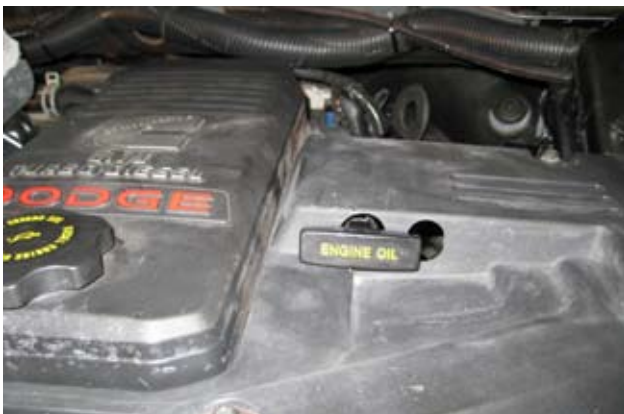
Modified "bat wing" with new dipstick location.

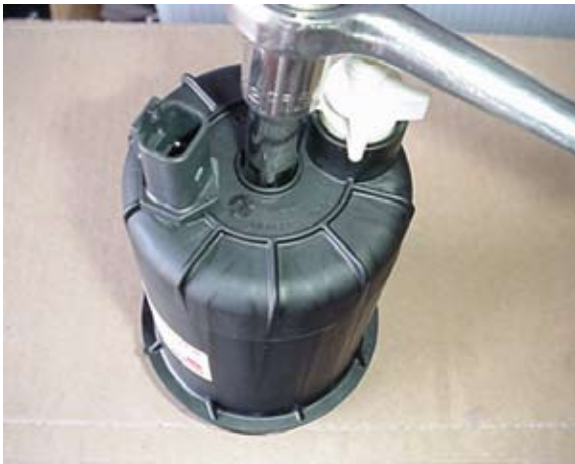
I'll bet you didn't know that there was a 1/2" drive indentation on the bottom of the filter canister.

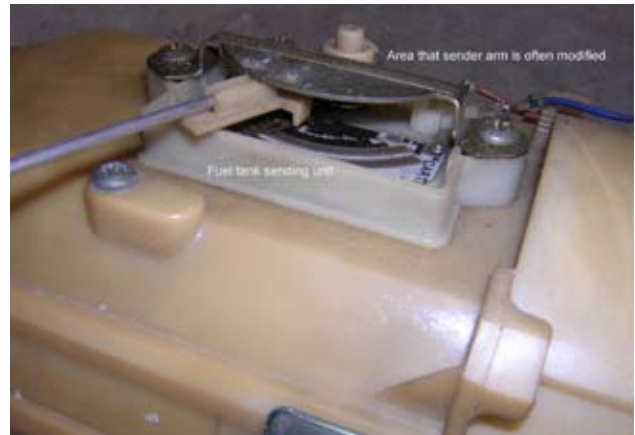
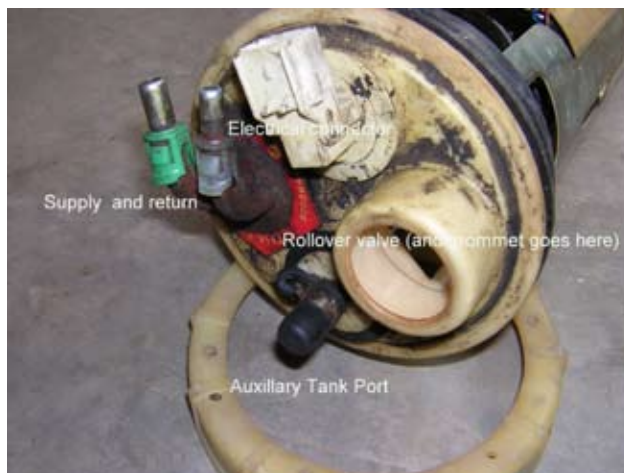
The module has metal pipes exiting the top of the module (supply and return) and has hard plastic tubing coils that extend to the bottom of the module where a removable screen covers the pickup and return. Most of them that I've dissected have a one-way check valve in the fuel pickup to assist in holding fuel prime. Many members have noted that these lines sometimes chafe and develop a pinhole, which allows for fuel aeration, not a good thing! The perforated tubing seems to have rubbed on a sharp edge, or on the mounting hardware for the lower float we previously discussed. The return also returns fuel to the bottom of the module (above tank bottom about 1/4"). This is preferable, as it allows returned fuel to be released into the remaining fuel rather than spraying on the tank's upper surface introducing foam and air.

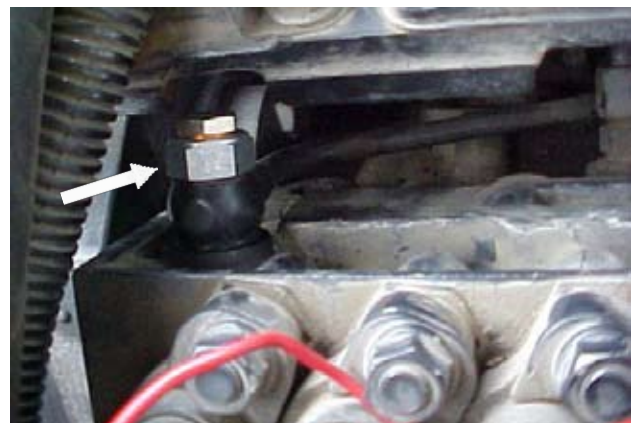
The Bosch P7100 over-flow valve.

The fuel then travels from the filter outlet to the Bosch P-7100 fuel injection pump. This concludes the delivery portion of the tour of the low-pressure fuel system. However, several other items are worth mentioning on the return circuit of the fuel system. On the backside of the injection pump near the front corner of the pump is the location of the Bosch P7100 fuel pump overflow valve. This valve opens and allows fuel return to the fuel tank at approximately 22psi. When diagnosing fuel pressure problems, one can often determine if a lift pump or overflow valve problem exists by doing the following test. Let's assume we see a 12psi reading on our fuel pressure gauge. With the engine idling and a pressure gauge attached, slowly squeeze the rubber return line (this infamous rubber fuel return line is often

problematic, but more on that subject in a minute) that runs behind the fuel filter. If the pressure gauge starts to rise, it means that the lift pump is making good pressure and that the overflow valve may be opening too soon. An overflow valve that opens at too low of a pressure will result in poor performance. Too much fuel will return to the fuel tank which robs the injection pump of fuel pressure that is necessary for proper operation. If the line pinch test makes little or no difference on the fuel pressure gauge, it would suggest that the lift pump is weak.
