# RECALL CAMPAIGN BULLETIN

NTB06-051a

## VOLUNTARY RECALL CAMPAIGN 2003 – 2004 ALTIMA AND SENTRA WITH QR25DE ENGINE CRANK ANGLE SENSOR / ECM REPROGRAMMING

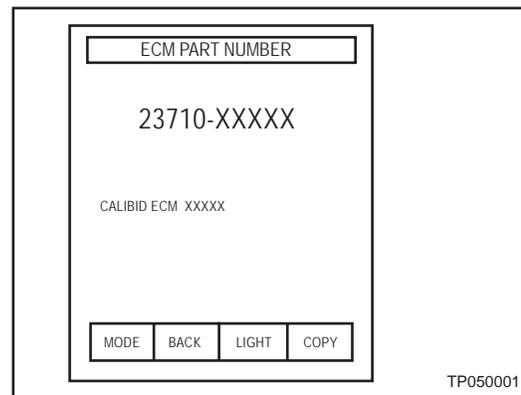
- Figure A is an example of the ECM Part Number printout.

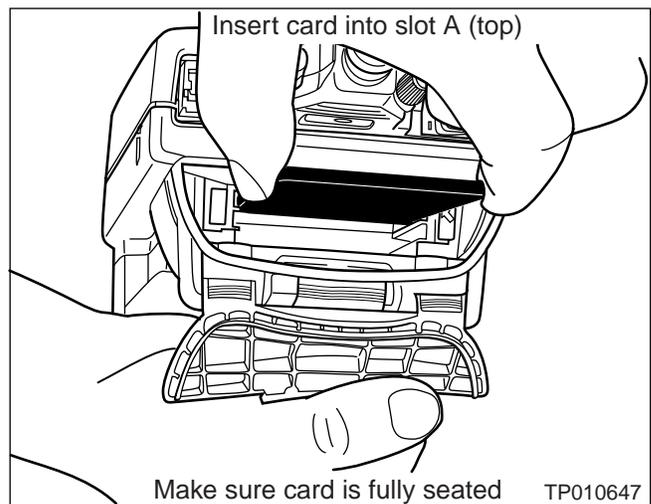
Figure 1

- Make sure CONSULT-II is disconnected from the vehicle and turned OFF.
- The Reprogramming Software Card is the “orange” Card.
- Use slot A—top slot (see Figure 1).

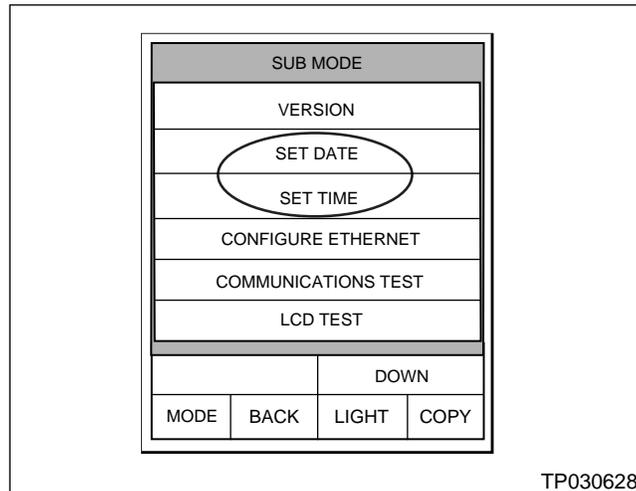
Figure 2

C. Touch **SET DATE** (see Figure 2).

- 1) If the date is not correct, touch the **MONTH**, **DAY** or **YEAR** as needed. Then adjust it by using arrow keys. Once done, press **SAVE**, press **BACK**, and go to step D.
- 2) If the date is OK, press **BACK** and go to step D.

D. Touch **SET TIME** (see Figure 2).

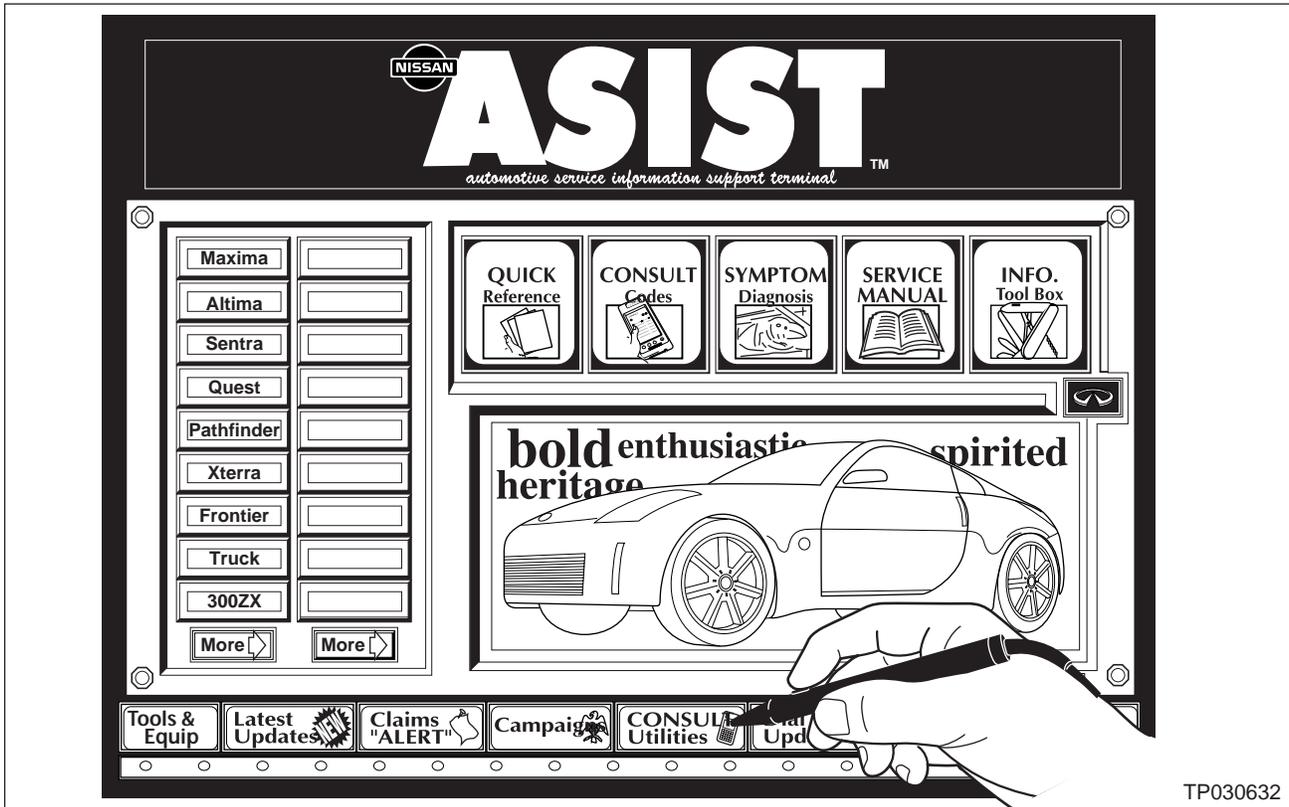
Figure 3

- From the ASIST PC main menu screen, select "**CONSULT UTILITIES**" (see Figure 3).

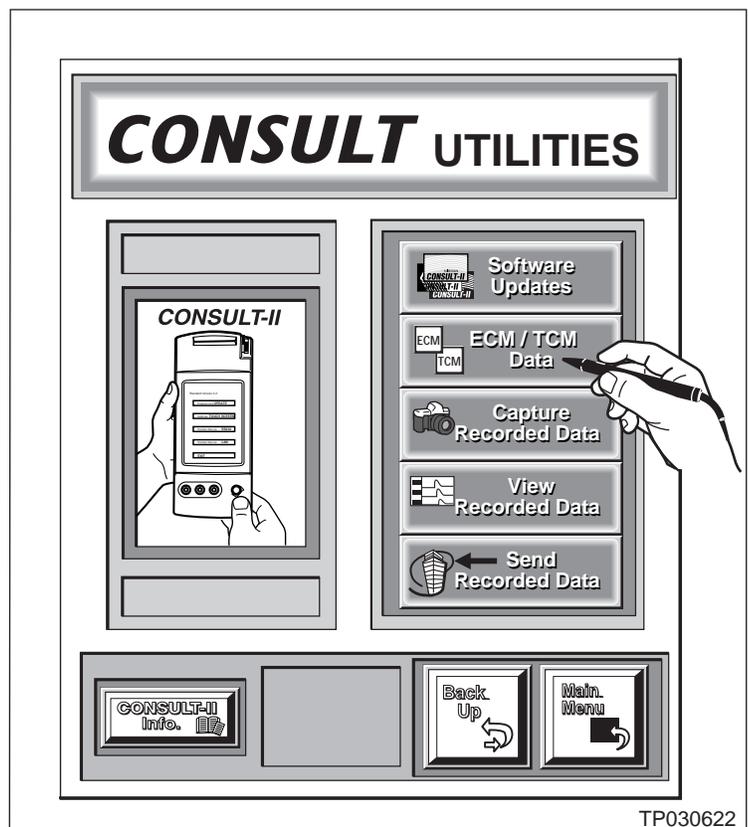
Figure 4

- From the "**CONSULT UTILITIES**" screen, select "**ECM / TCM DATA**" (see Figure 4).

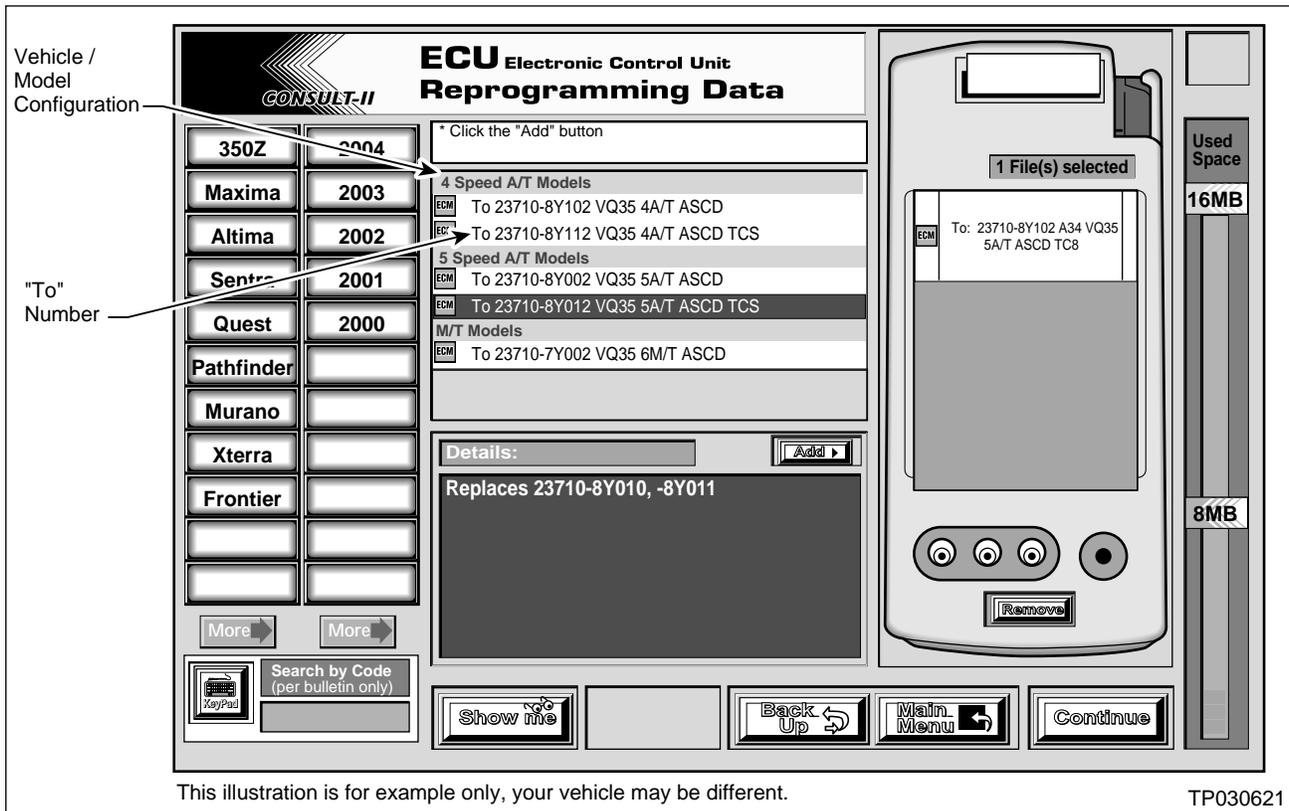
Figure 5

7. Select the "ECU REPROGRAMMING DATA" (see Figure 5) as follows:

A. Select vehicle model and model year.

B. Select the correct reprogramming data:

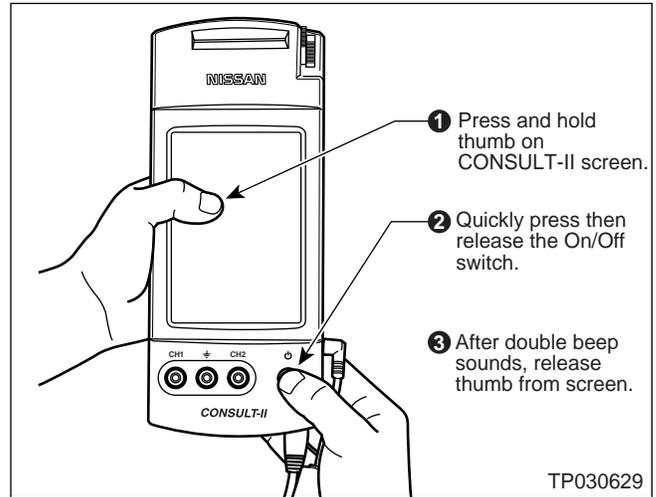
8. Turn "ON" CONSULT-II as shown in Figure 6.

**NOTE:** If you accidentally choose a menu option other than "Transfer Files via LAN"; turn CONSULT-II "OFF", and then back "ON" as shown in Figure 6 above.

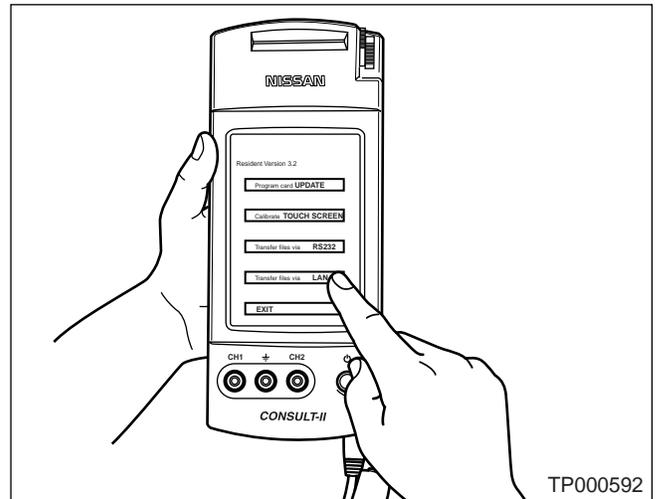
Figure 7

9. Select **Transfer files via LAN** (see Figure 7).

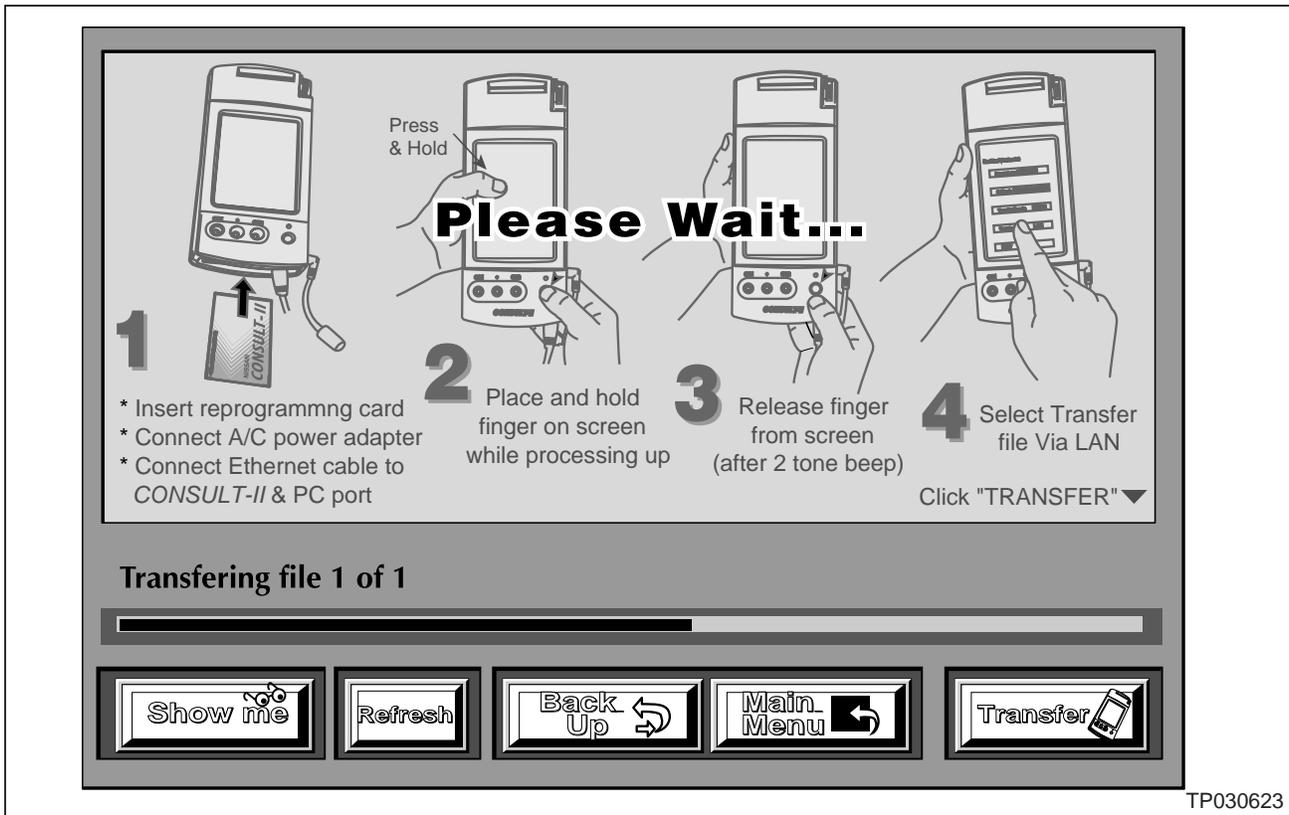
Figure 8

A. On the ASIST screen, click on "**Transfer**" (see Figure 8).

- Data transfer will take about 15 seconds.
- Transfer progress is displayed on the ASIST screen (see Figure 8).

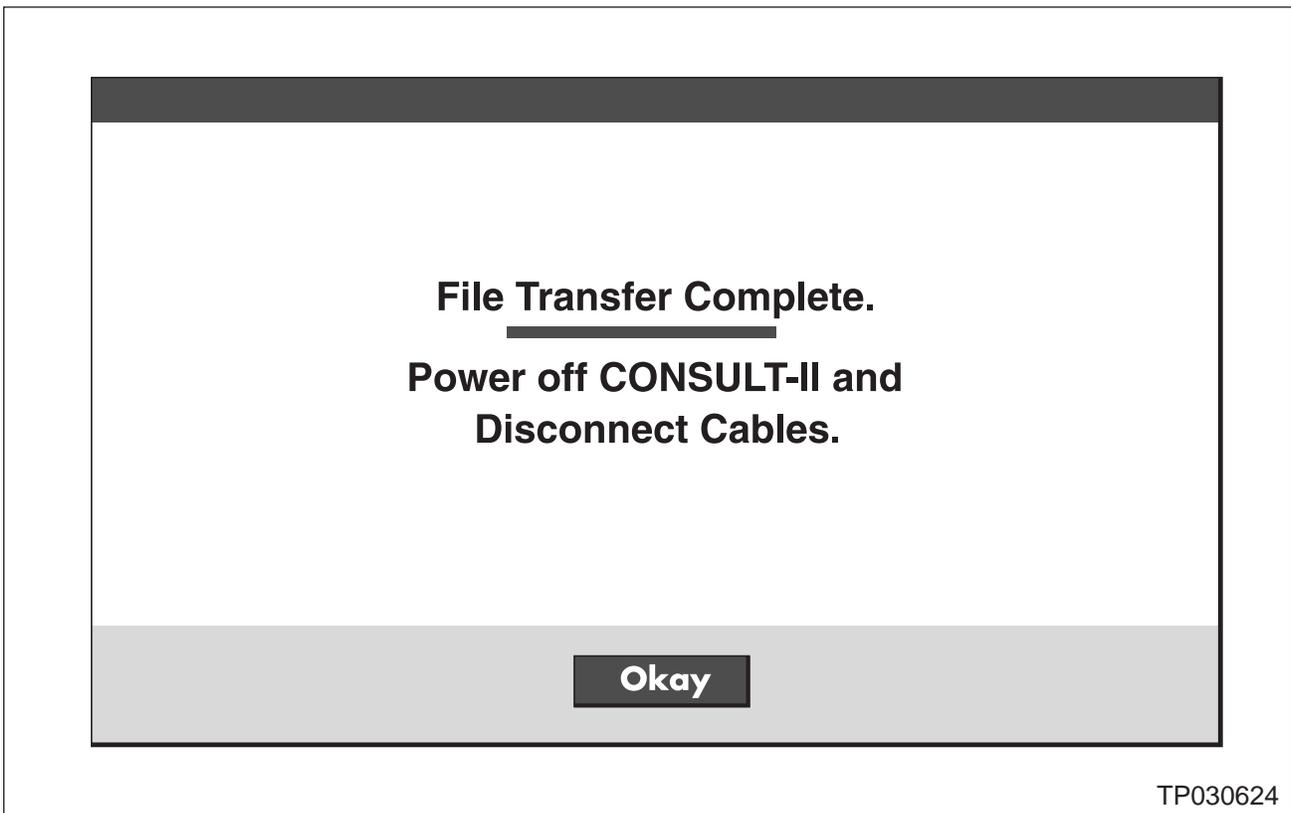
Figure 9

**CAUTION: DO NOT DISCONNECT THE ETHERNET CABLE UNTIL "COMPLETE" IS DISPLAYED AS SHOWN IN FIGURE 9 ON THE NEXT PAGE.**

11. When transfer is complete (see Figure 9):

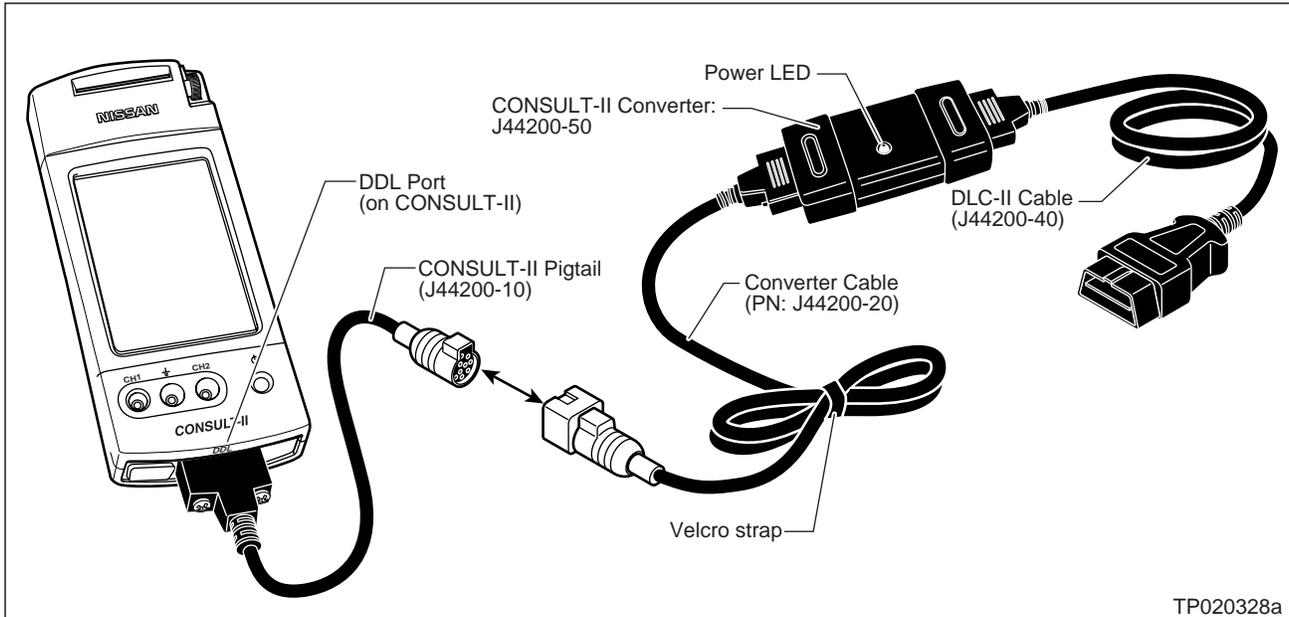
14. Connect CONSULT-II to the vehicle using the DLC-II cable with black Converter Box (see Figure 10 on next page).

- Make sure the DLC-II is straight and fully plugged in to the vehicle.
- Make sure all other DLC-II cable connections shown in Figure 10 are connected properly.

- Nissan requires the use of essential tools shown in Figure 10 when performing ECM reprogramming.
- J44200-10 "Pigtail" should not be removed from the CONSULT-II DDL Port. This "Pigtail" allows use of the stronger "quick disconnect" cable set.
- If cables are very often changed at the DDL Port (base) of the CONSULT-II unit, cable connector pin damage may result.
- If there is connector pin damage, ECM reprogramming may fail. Permanent ECU damage can occur.

- If the vehicles battery voltage (“Charger Input”) is below 12 volts, one or more of the following may be the cause:
  - a. The battery charger you hooked up in section 1 is not charging the battery (poor connection or it is not working).
  - b. The DLC-II does not have a good connection to the vehicle (not straight).
  - c. The DLC-II cable may have a malfunction (damaged wire or pins).
  - d. The CONSULT-II Converter (J44200-50 / black box) is not working correctly (see Figure 10 on page 14).

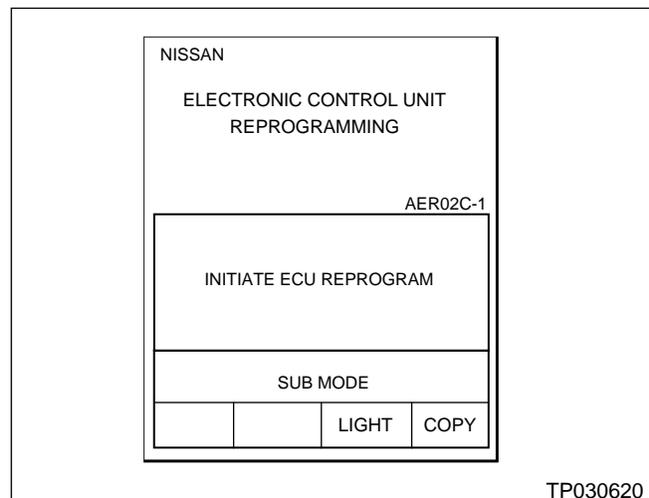
Figure 11

- CONSULT-II will turn "ON" automatically (see Figure 11).
- Confirm that all electrical loads\* (except for the ignition) are "OFF".

17. Press **SUB MODE** (see Figure 11) then:

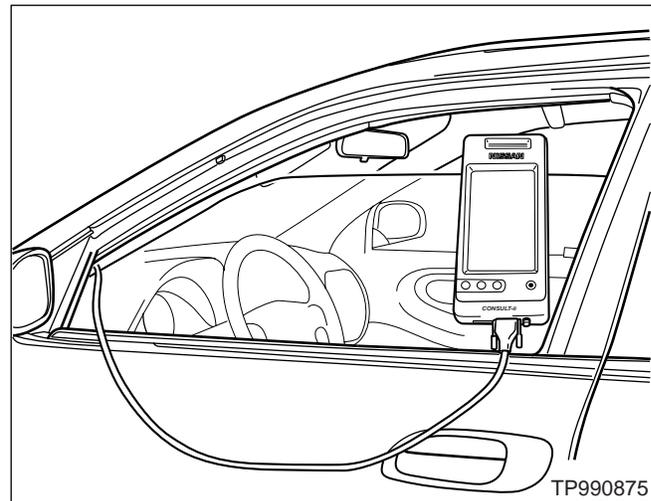
Figure 12

16. Roll down the driver's window part way, exit the vehicle, close the door, and hang the CONSULT II unit on the outside of the window (see Figure 12).

- This step is necessary to ensure the CONSULT-II and DLC-II cable will not be disturbed during reprogramming.

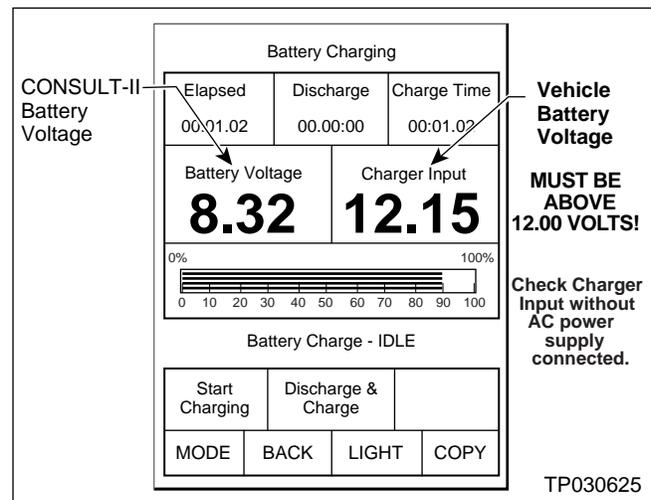
18. Check the CONSULT-II's "Charger Input" reading (see Figure 13).

19. The “Charger Input” reading **MUST** be above 12 volts (see Figure 13 on page 15).

- Do not attempt ECU Reprogramming if the vehicle’s battery voltage is below 12 volts.
- Permanent ECU damage can occur if the vehicle battery does not maintain the minimum voltage during ECU Reprogramming.
- If “Charger Input” is above 12 volts, power from the vehicle battery will keep CONSULT-II’s power supply at the correct level during reprogramming. (see Figure 13).

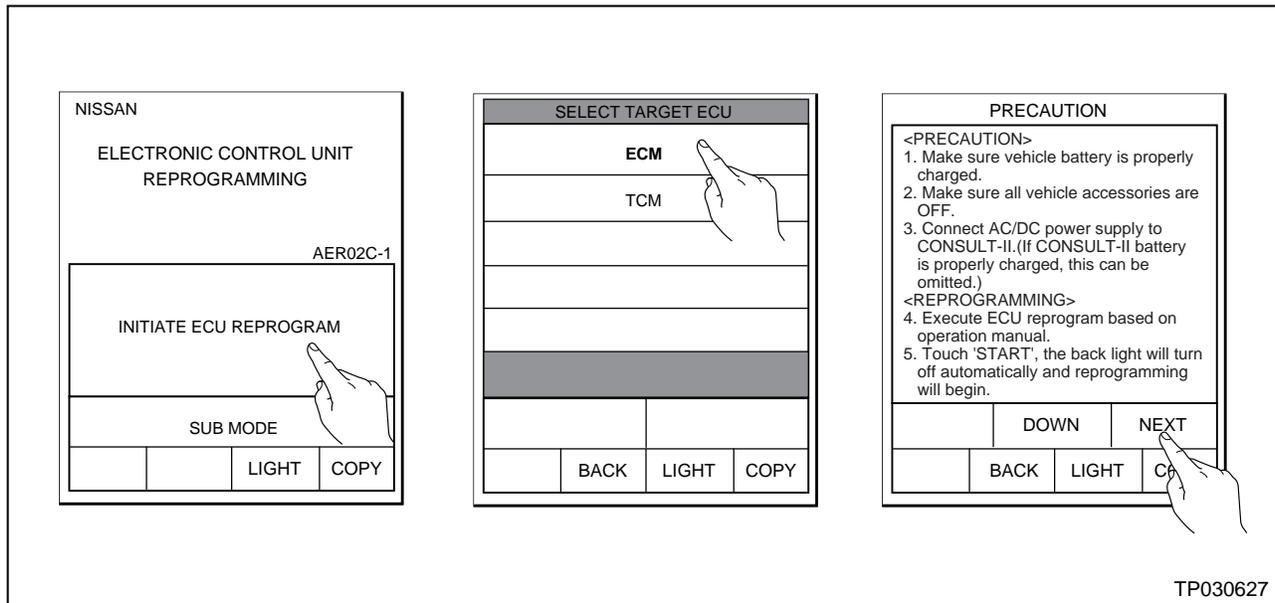
Figure 14

20. Press **INITIATE ECU REPROGRAM** (see Figure 14), then

- A. Press **ECM**
- B. Review the precaution
- C. Press **NEXT**

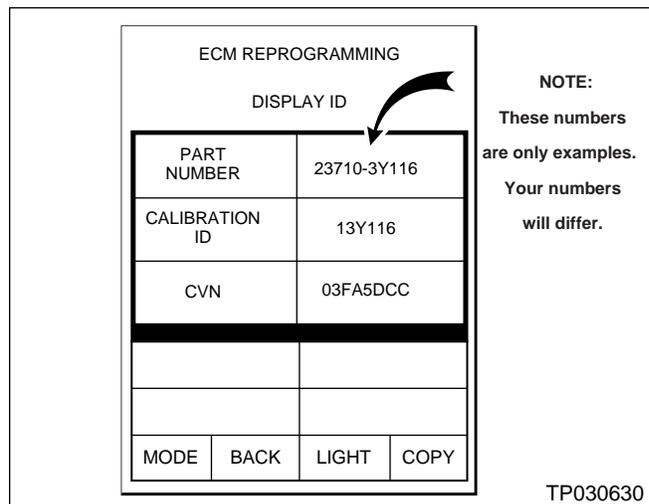
Figure 15

21. Press **CHECK ECM P/N** to “confirm” (take note of) the current ECM part number (see Figure 15).

**NOTE:** This is the vehicle’s ECM part number BEFORE Reprogramming.

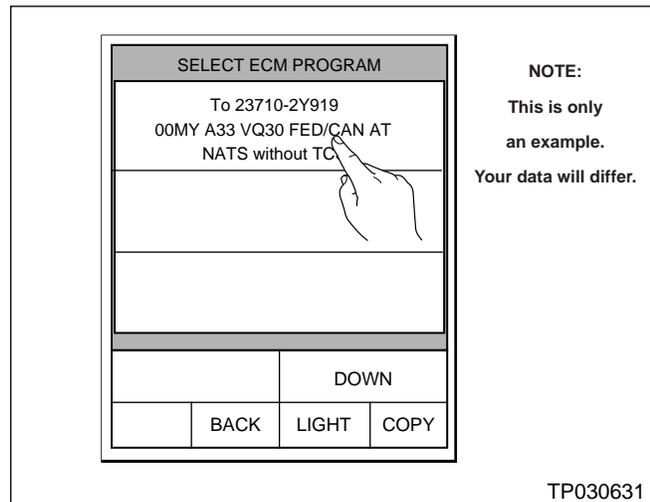
Figure 16

24. Select the ECM program to install (see Figure 16).

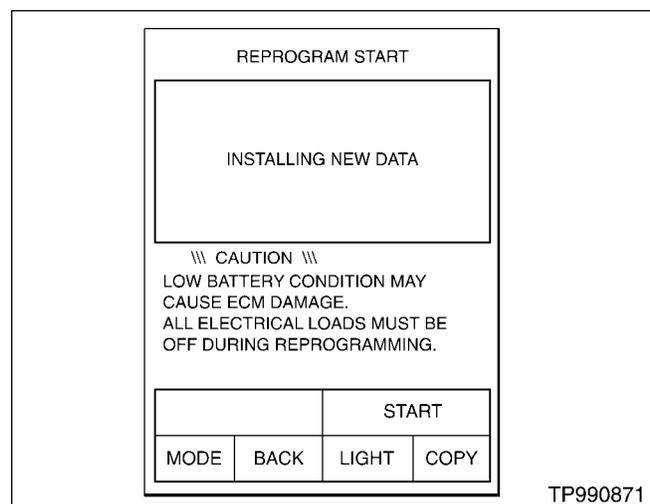
Figure 17

25. The "REPROGRAM START" window should appear (see Figure 17).

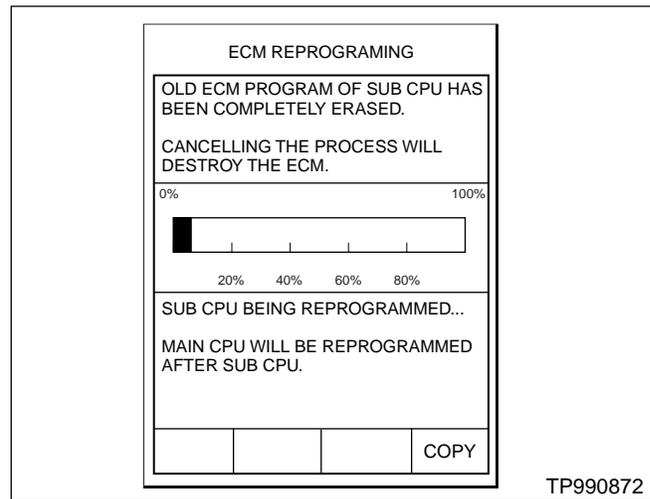
- After a few seconds, the window shown in Figure 18 will appear.
- CONSULT-II will now turn "OFF" its screen backlight.
- When the screen backlight goes "OFF", ECM reprogramming has started.

**NOTE:** This process will take from 10 to 20 minutes.

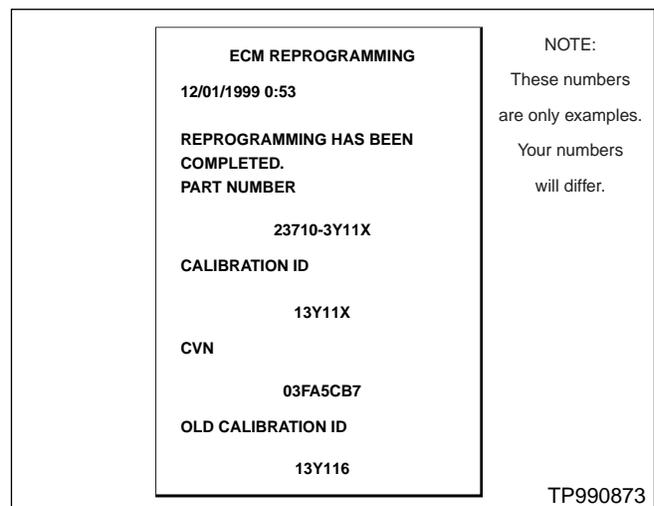
Figure 19

27. When the Reprogramming is complete, CONSULT-II will "beep", turn the screen backlight back ON and automatically print out a report (see Figure 19).

- Remember it may take up to 20 minutes.
- Attach the print-out to the repair order for future reference.

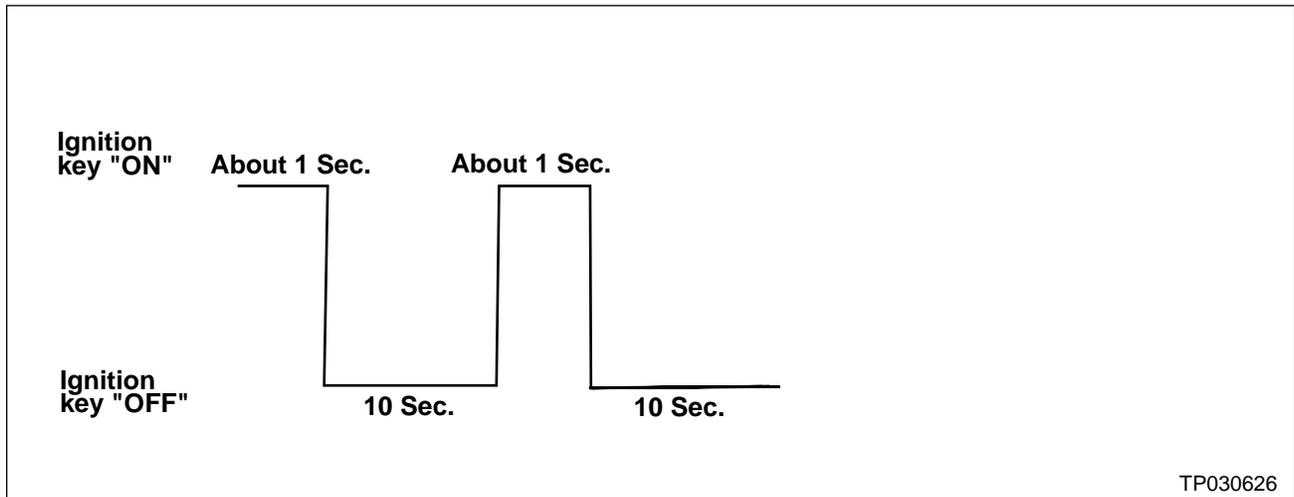
Figure 20

28. Press **END** to return to the main menu.
29. Turn the ignition switch "OFF" and CONSULT-II "OFF".
30. **Wait more than 10 seconds, then turn the ignition switch "ON" for 1 second. Then, turn the ignition switch "OFF" again for 10 seconds (see Figure 20).**
  - This will reset ECM self learned Data.
