Dual-Stage Air Bag Debuts

For the 2001 model year, a supplemental inflatable restraint (SIR) system featuring dual-stage air bags is installed in the Oldsmobile Aurora, Buick LeSabre, Pontiac Bonneville and Chevrolet Impala and Monte Carlo.

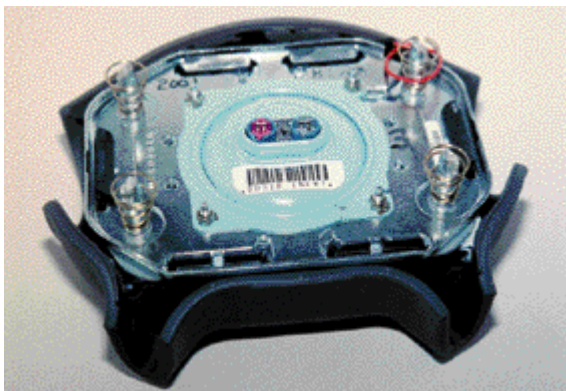
Dual stage airbag is identified by having two electrical connections.

The dual-stage air bag system adds several enhancements to this basic operation. The dual-stage inflator module contains a canister of stored gas, but has two separate initiators, each controlled individually by the SDM. This means that there are two connectors on the module and two sets of wires between the inflator module and

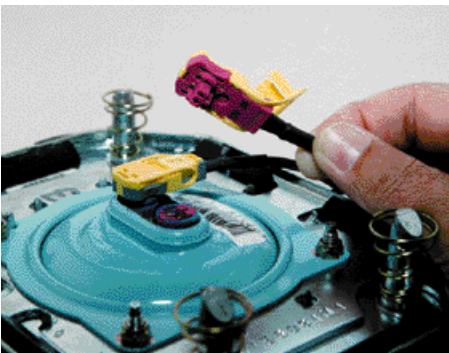
Connectors of the Deployment Harness J-38826-75 are color-keyed.

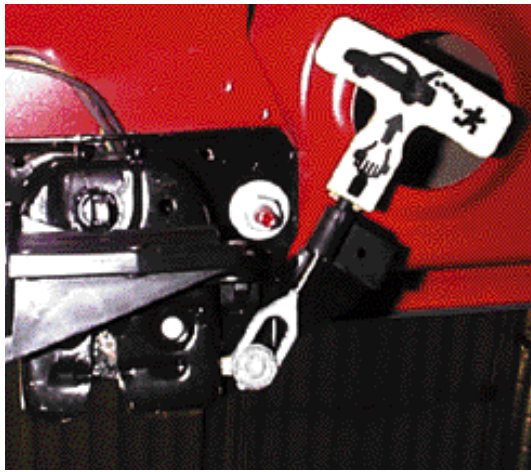
Trunk release handle now in production

The new trunk release handle inside the trunk is located on the trunk latch and is easily identified. The handle will glow in the dark following exposure to a light source, making it easier to locate inside the trunk. By simply pulling the release handle, the trunk will open from the inside.

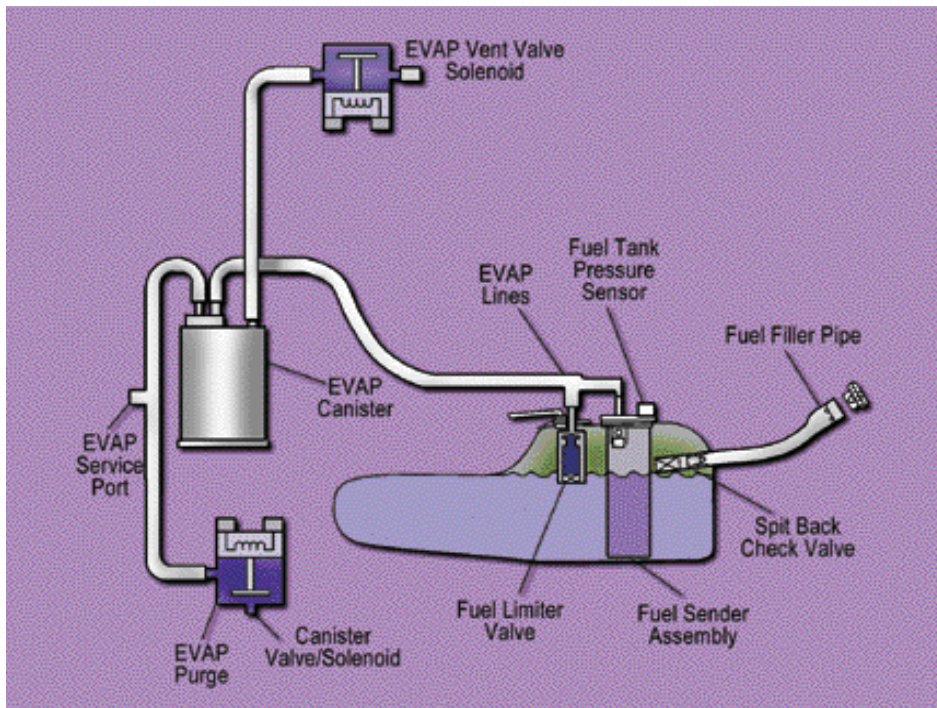
From the EVAP System menu, select System Performance. This test will actuate both the purge and the vent solenoids. What's the anticipated result with the vehicle running? The open purge solenoid and closed vent solenoid should create vacuum in the tank at a level high enough to abort the testing on the Tech 2. If the Tech 2 does not abort the testing at this point, check for a loose fuel cap. If you tighten the cap and then the Tech 2 aborts the test, you have found the source of the DTC P0440.

Using other Tech 2 tests, you can recreate the testing performed by the PCM. Here is another example. On a vehicle with a DTC P0440 – EVAP system large leak detected, your first instinct should not be to tighten the fuel cap, but instead to use the Tech 2.
