## EID TECHNICAL BULLETIN

MODEL/S	DATE	BULLETIN No.	SUBJECT
e-Studio 2040c / 2540c / 3040c 3540c / 4540c	17/09/13	1141	System Firmware Version 3453

- Release of e-Studio 2040c / 2540c / 3040c and 3540c / 4540c System Firmware Version 3453.

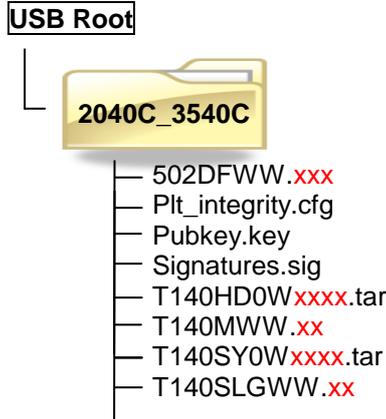
1. Unzip the firmware file and store it with the following structure

Note – 502DFWW.003 is RADF F/W for 2040c/2540c/3040c (Low Spec)  
502DFWW.103 is RADF F/W for 3540c/4540c (High Spec)
