## The Year 2000

### What's Needed for the Next Century

## Precision Control System

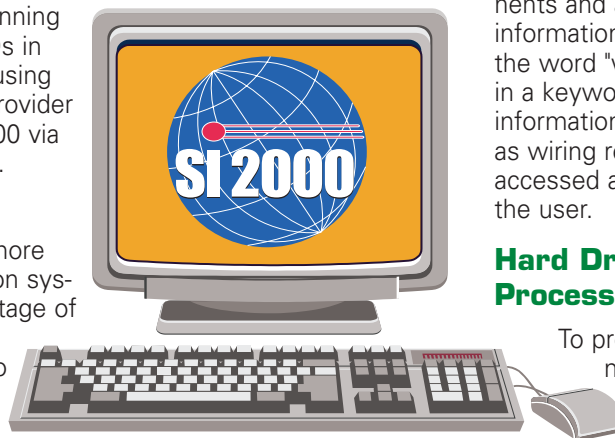
SI 2000 offers a more user-friendly navigation system that takes advantage of the latest software technology in order to more quickly search and access information.

The new VIN feature quickly identifies year/make/model information for the vehicle on which

a technician is working. This information also can be entered by using the available pull-down menus.

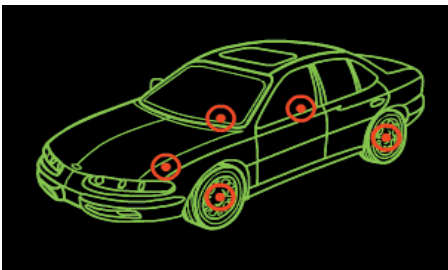
The desired yaw rate is compared with the actual measured yaw rate; the difference is the yaw rate error. PCS keeps yaw rate error to a minimum by applying individual wheel brakes as necessary. Selective brake application is handled by the ABS module. And the

system senses brake pressure to fine tune the operation.

Two vehicle conditions that can bring PCS into play are understeer and oversteer. If actual yaw is less than the desired rate, the vehicle is understeering; the front end pushes to the outside of the turn. Understeer is counteracted by application of the inside rear brake. If the actual yaw is more than desired, the vehicle is oversteering; the rear end wants to come around. Oversteer is counteracted by application of the outside front brake.

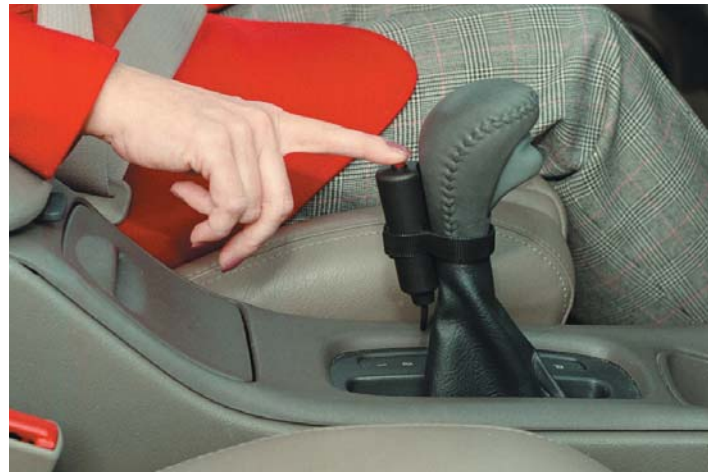
The Data Recorder has the same snapshot recording capabilities as the Tech 2, but there's only one button to press, so the customer doesn't have much to learn. The pushbutton is lighted when the tool is on, and it flashes while the recording is occurring. The tool is designed to turn itself off a few seconds after the ignition is

turned off to preserve battery power. If it does not turn on by itself when the ignition is turned on, press the pushbutton. The Data Recorder will hold four snapshot events, and will overwrite the first one if the cus-
