4.2.2 Error code and message

Messages appear on the Smart Panel program window or on the control panel display to indicate machine status or errors. Refer to the tables below to better understand the meanings of each message, then follow the suggested solution provided on the page that you are referred to.

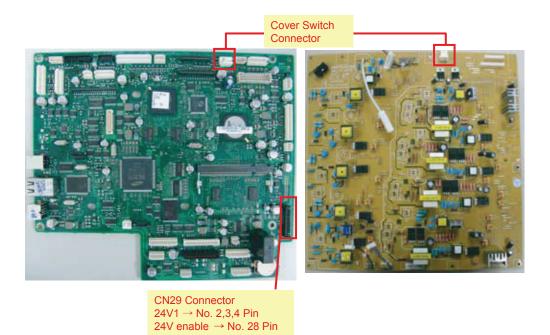
- 1. Ensure the Front and Top Covers are closed properly.
- 2. If the PTB [paper transfer belt] is not installed, install it.
- 3. Check the cover switch harness between Main PBA and HVPS.
- 4. Check the 24V enable signal on Main PBA. If the voltage is high(5V), replace the Main PBA.
- 5. Check the 24V1 on SMPS. If there is no output, replace the SMPS board.

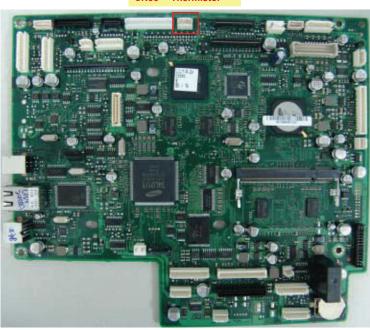
- 1. Turn off the power. And turn on the power.
- 2. If the problem persists, replace the fuser unit.
- 3. If the problem persists after replacing the fuser unit, reconnect the CN35 connector on Main-PBA.
- 4. If the problem persists, replace the Main-PBA.

CN35 →Thermistor

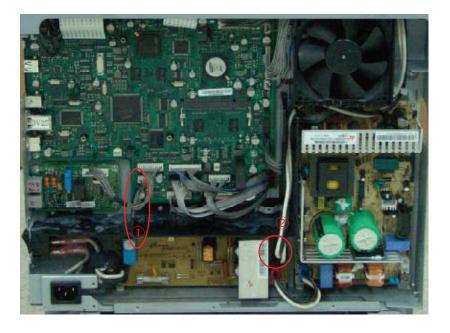
- 1. Turn off the power. And turn on the power.
- 2. Check the connection of the Fuser AC on FDB 2.
- 3. Check the Fuser control harness ①.
- 4. Check the resistance value of the thermostat. If the value is infinite, replace the thermostat.
- 5. If the problem persists, replace the Fuser unit.
- 6. Replace the SMPS board or FDB (Fuser drive board).

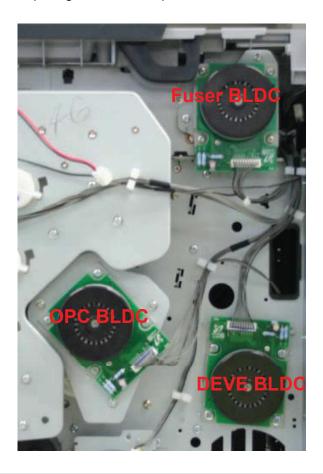
- 1. Check the motor connector. Reconnect the harness.
- 2. If the problem persists, replace the BLDC motor.
- 3. If the problem persists after replacing BLDC motor, replace the Main PBA.

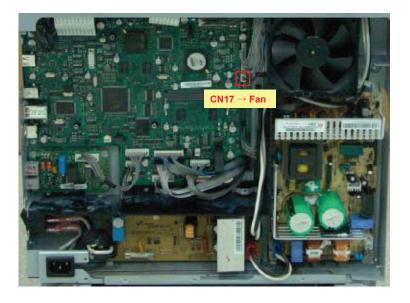
- 1. Check the CN17 connector (FAN) on Main PBA.
- 2. If the FAN is defective, replace it.
- 3. If the problem persists, replace the Main PBA.

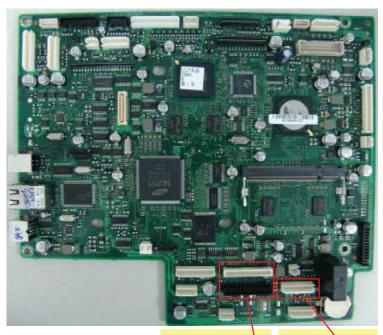
- 1. Check the LSU connector on Main PBA. Reconnect it. If necessary, replace it.
- 2. If the problem persists, replace the LSU or Main PBA.

CN10/11 → LSU LD, Hsync Connector

CN15 → LSU Motor Connector

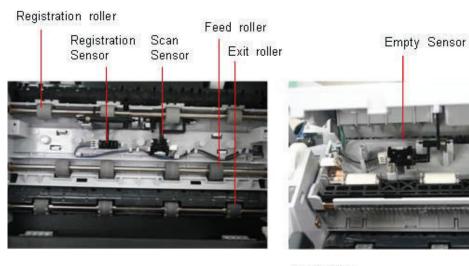
- 1. Check the paper path for a small piece of paper that may have been torn from an original; or foreign materials such as paper clips, extracted staples, etc.
- 2. Check the condition of the Pick-up, Paper Feed Roller and DADF Rubber, it may have reached its PM interval.
- 3. Registration Sensor change
- 4. Registration Sensor drive Board change
- 5. Pick-up Solenoid change

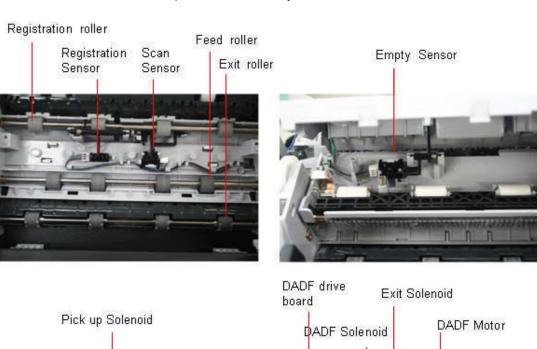
- 1. Check the paper path for a small piece of paper that may have been torn from an original; or foreign materials such as paper clips, extracted staples, etc.
- 2. Check and clean the Registration Roller, replace as is necessary.
- 3. Check and clean the Exit Roller, replace as is necessary.
- 4. Check and clean the Scan Sensor for paper dust, replace as is necessary.
- 5. Check the signals from the Scan Sensor Drive Board, replace as is necessary.
- 6. Check and clean the Exit Solenoid, replace as is necessary.

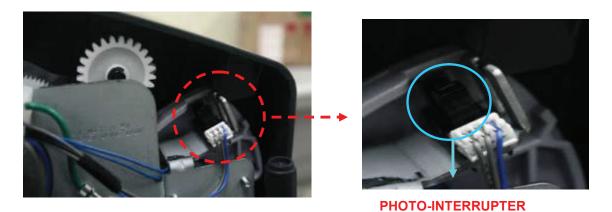
<door is closed>

If opened, close the DADF cover until it blocks the PHOTO-INTERRUPTER.

If UI message is not changed, open the COVER-DADF REAR and replace the PHOTO-INTTERRUPTER.

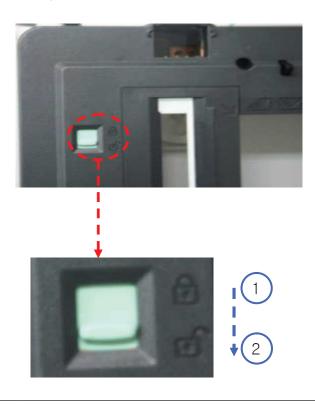
Check if the scanner locking switch is locked.

If the scanner locking switch is locked, move the switch from $\ \textcircled{1}$ to $\ \textcircled{2}$.

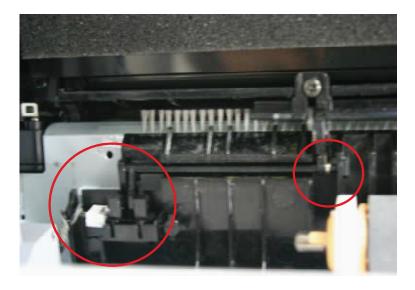
Check if Feed-Actuator works correctly.

- 1. Check the tension spring is properly loaded on the Actuator_Feed.
- 2. Check that the connector for the photo sensor is plugged in securely.

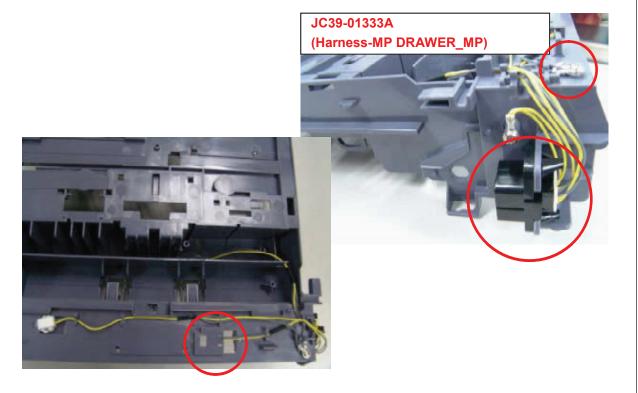
- 1. Open MP Tray.
- 2. Load [Letter] paper in MP Tray.
- 3. If the problem persists, check if the MP_Paper_Detect_Actuator works correctly.
 - a. Check the spring is put in the right place of the actuator
 - b. Check the harness and the connector fit on the photo sensor.
 - c. Check the connection of the Drawer_MP and screw points.

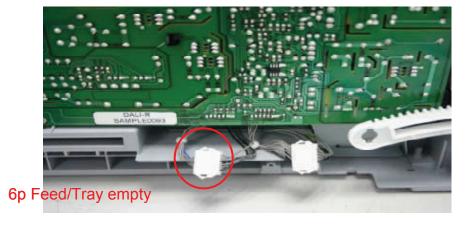
- 1. Check the paper empty sensor connector. Reconnect it.
- 2. Check the paper empty sensor. If it is defective, replace it.
- 3. Check if the actuator is broken.

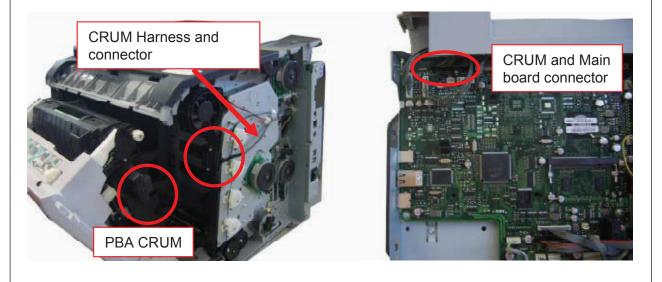
The transfer belt unit is installed in the machine but the machine could not read the information from the CRUM. CRUM information is different from machine.

- 1. Check if transfer belt unit is properly installed.
- Check CRUM PBA connector pins.
 Replace the CRUM PBA with normal thing and test it. If the CRUM PBA is defective, replace the transfer belt unit or CRUM PBA.
- 3. Check if the Transfer Belt CRUM Harness is defective and check that the connector is properly plugged into the Engine Board.
- 4. Replace the Main Board with a known good one and test it. If it works replace Main Board.
