# *Service Manual*

*Stat Profile<sup>®</sup> Critical Care Xpress*

### Nova Stat Profile® Critical Care Xpress Service Manual

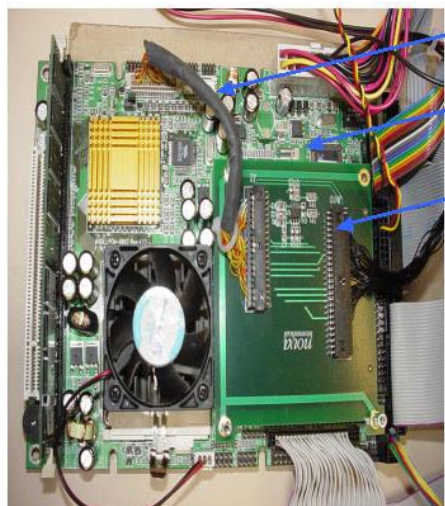
Figure 3.12 Host CPU

1. Remove the analyzer cover.
2. Remove the ground wire from the shield plate.
3. Remove the 3 mounting screws. Then remove the shield.
4. Disconnect the cable connectors.
5. Remove the CPU fan.
6. Remove the mounting screws.
7. Install the board by reversing the steps above.

Manufactured after June 30, 2005

Adapter Cable  
CPU (PN37579)  
Adapter Board (PN38900)  
Complete Set PN40310  
Power Supply Assembly  
FAN CLIP push and release on rear side.

Manufactured before July 1, 2005

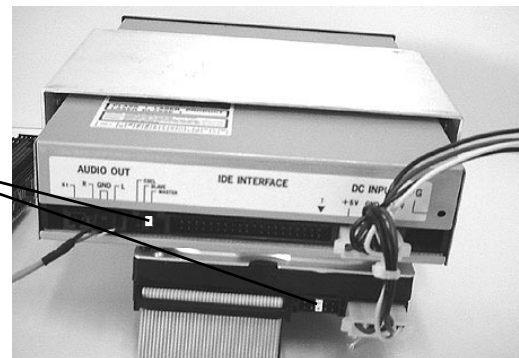
Figure 3.16 Jumper Middle Pins

12. The CD Drive and Hard Drive have jumpers to direct their address signals from the CPU. Ensure the replacement Drive Jumper is in the same place as the one being replaced.
13. Reverse Steps 1-10 to reinstall the Disks Drives and ABG CPU
14. Restore the analyzer to normal operation.

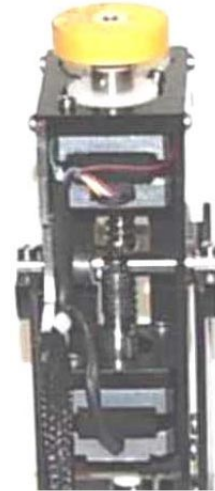
Figure 3.21 Sampler Assembly Motors

1. Remove the sampler assembly.
2. The probe motor is mounted to the top plate. Remove the top plate mounting screws that are located on the side of the plate.
3. Lift the motor and lead screw from the assembly.
4. The motor is attached to the lead screw by set screws and to the top plate by 2 mounting screws at the top.
5. The tilt motor requires the mechanism to be tilted by hand to expose the 4 mounting screws. The motor and worm gear are one assembly.
6. Reverse Steps 2 through 5 to install the new motors.

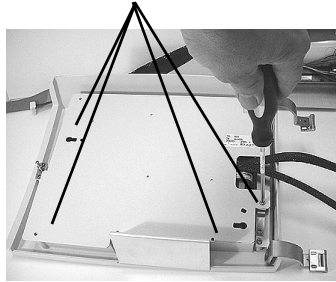
Figure 3.26 Removal 4 Mounting Screws

Mount Screws

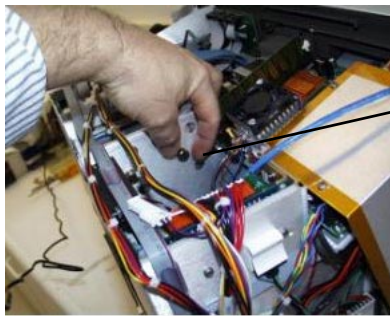
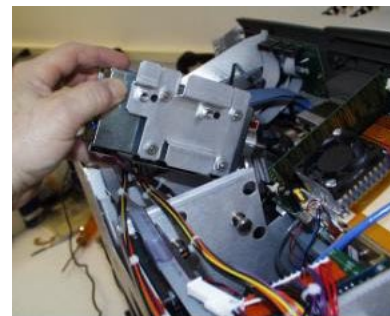
Figure 3.34 Lamp Assembly Removal

**CAUTION:** The Lamp optical cable connects to the Cuvette. Ensure this cable does not become crimped or strained.

3. Disconnect the reference detector board from the front of the Lamp.
4. The Lamp assembly is held to the chassis by 2 thumb screws. These screw are held captive to the chassis. Ensure that you support the Lamp assembly while removing the mounting screws.
5. Remove the 3 Lamp cover mounting screws.
6. Remove the cover.

Mounting Screws

Light Connector  
(Light slides into mount)

Fiber Optic Cable

Reference Detector

Lamp

Cover

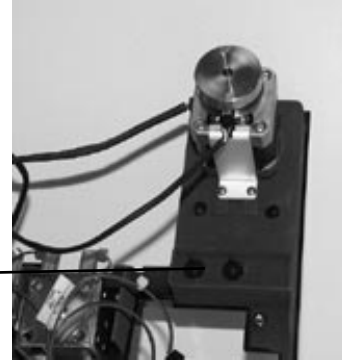
Figure 3.38 CO-Ox Pump Assembly

1. The CO-Ox pump optical detector must be removed prior to removing the pump.
2. The optical detector is mounted to analyzer chassis below the pump. Remove the mounting screws at the bracket.
3. The pump assembly is mounted from the front panel. Remove the corner hex key mounting screws.
4. Remove the pump out the rear of the unit.

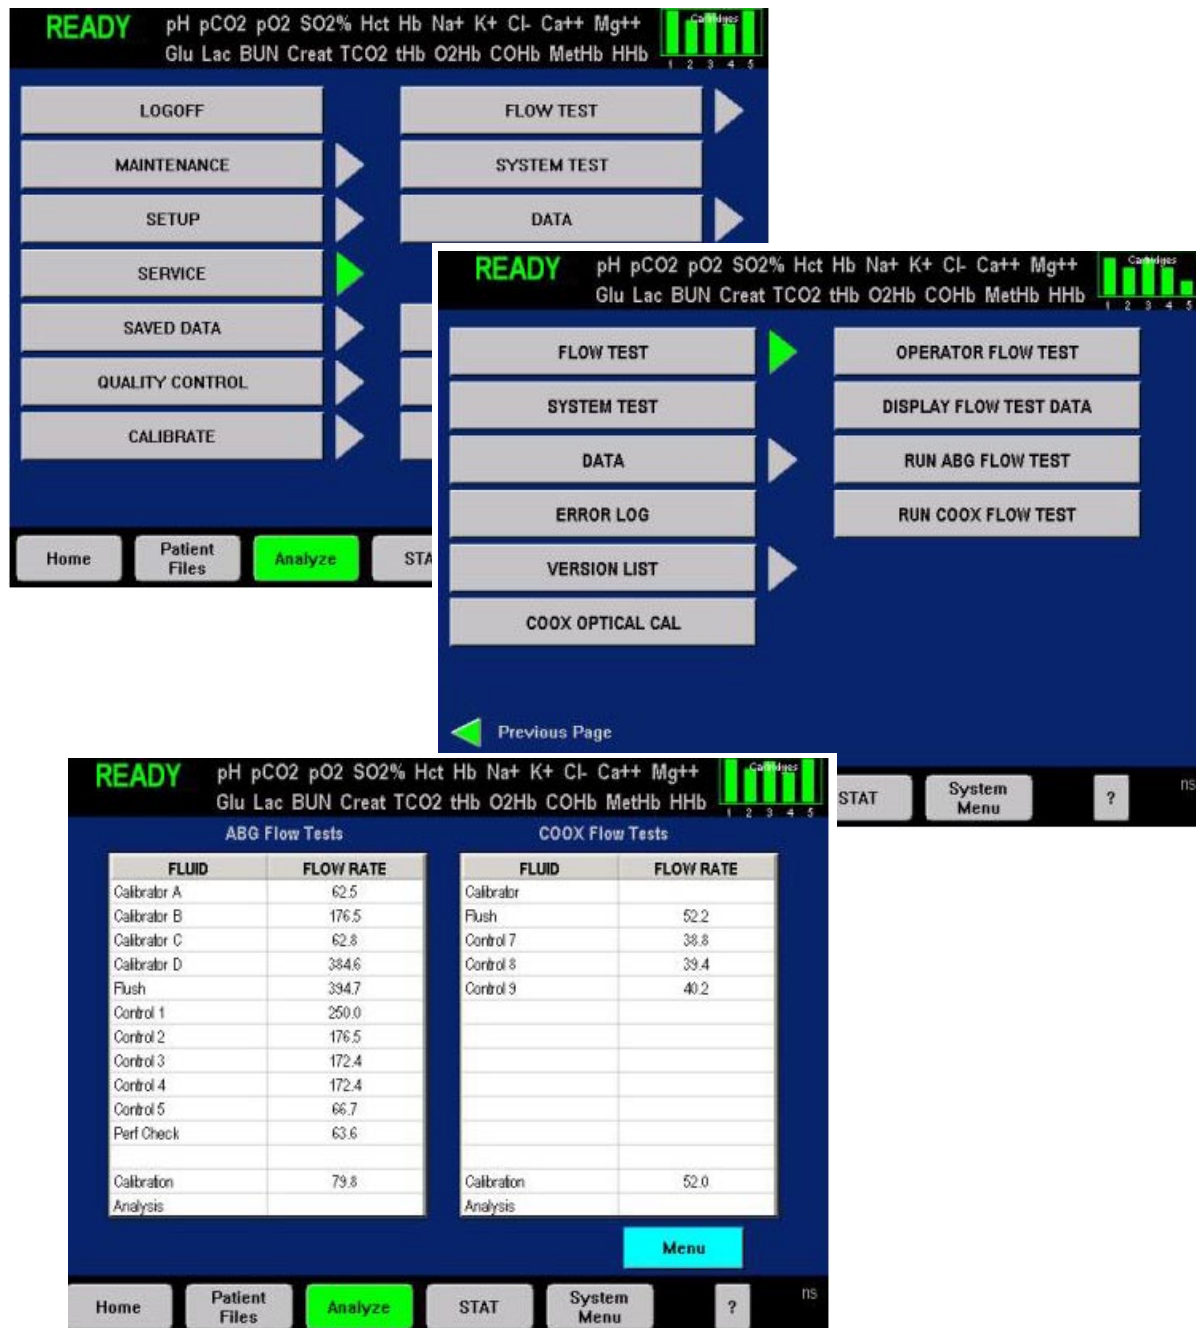
Figure 4.11 ABG and COOX Flow Tests Data Screen

From the Menu, press SERVICE, FLOW TEST, then RUN ABG FLOW TEST or RUN COOX FLOW TEST. At the end of the test, the Results screen appears. If the last flow test results are needed, press DISPLAY FLOW TEST DATA.

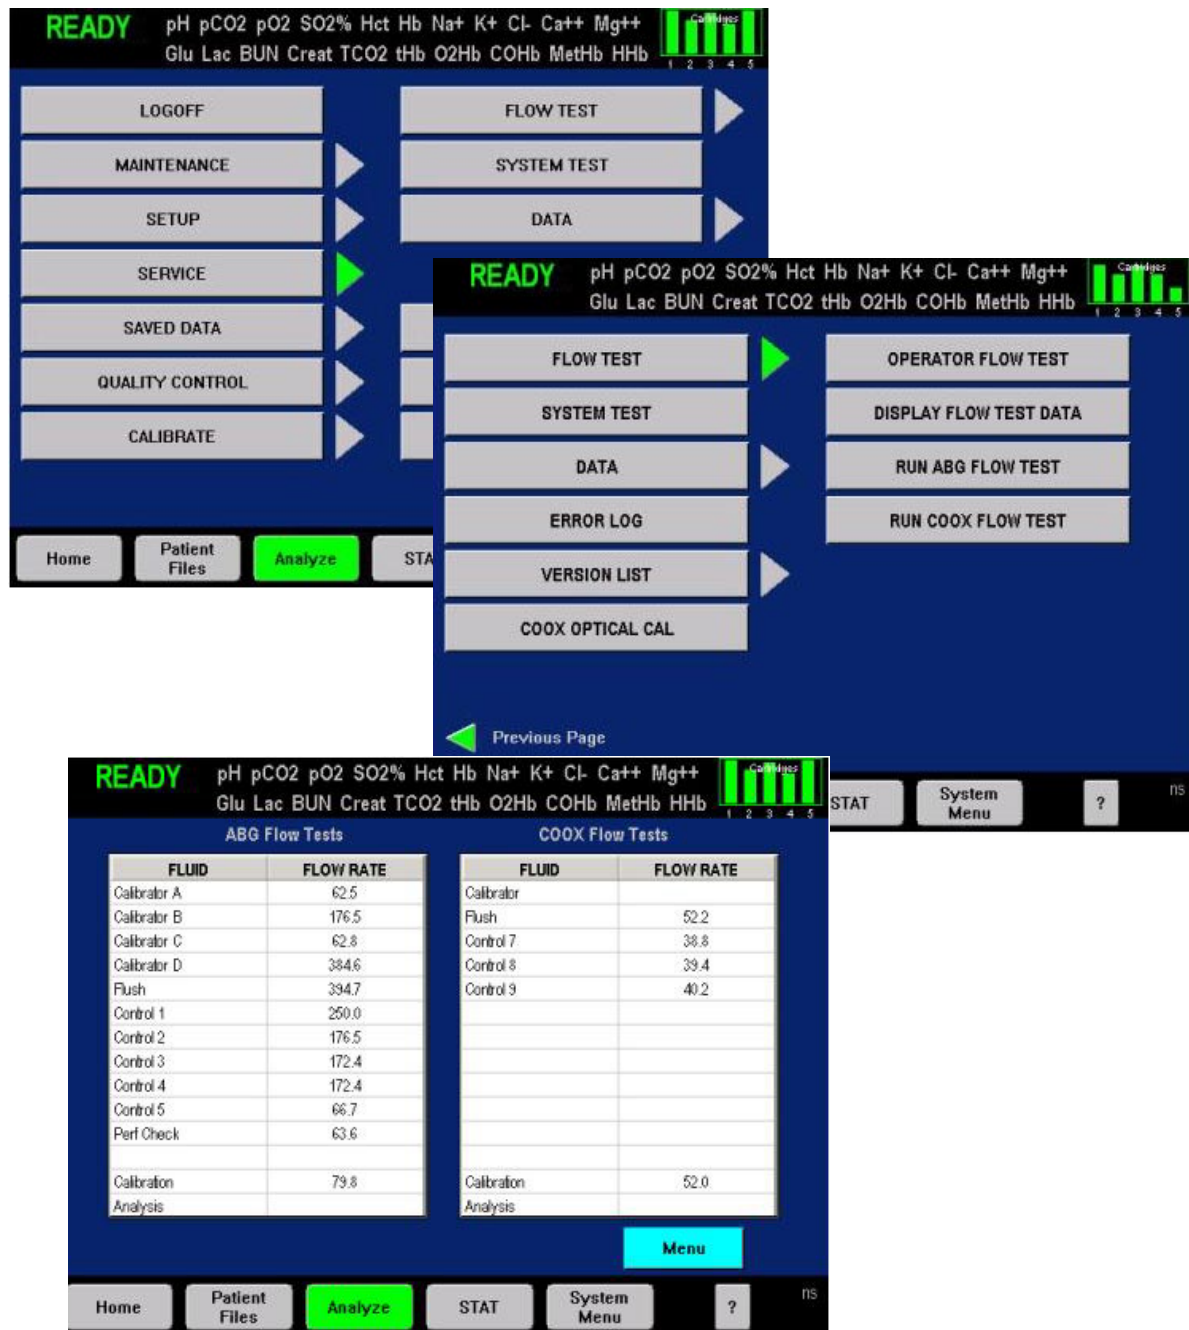
Figure 4.11 ABG and COOX Flow Tests Data Screen

Here is the interpretation of the results:

- Fast or slow rate on an individual fluid indicates a restriction in that fluids tubing.
- Fast or slow rates in multiple fluids indicate an air leak or plug in the common flow path; in the capillary adapter to fluid fountain connection; or a rotary valve problem.

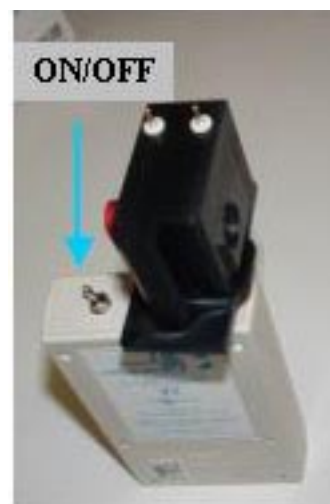
Figure 5.1 Optical Calibration Tool

**WARNING:** *DO NOT look directly at the light source of the calibration tool. Extended exposure to this light can cause damage to the eye. To check that the light source is lit, point it towards a white surface.*

**NOTE:** *The calibration tool should have a fresh 9 Volt battery or line power to assure proper operation.*

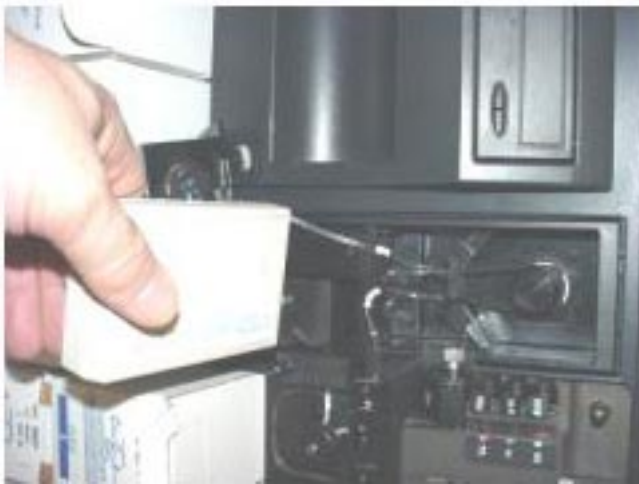
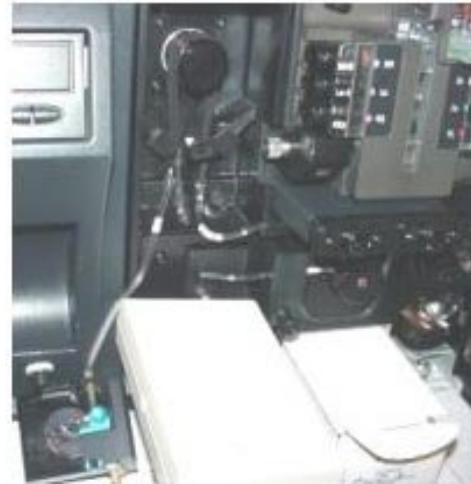
Figure 5.2 Inserting the Optical Calibration Tool into the Cuvette Slide Housing

**CAUTION:** Do not move the calibration tool during the calibration cycle.

5. Remove the tool from the cuvette slide housing. Turn the light source OFF.
6. Reinsert the COOX Cuvette slide and restore the analyzer to operation.

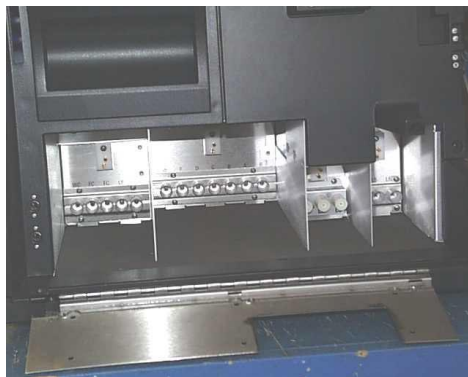
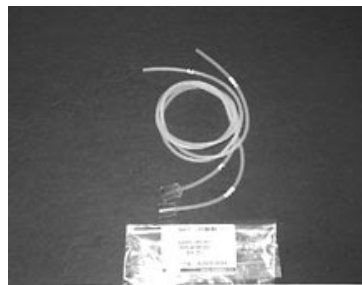
ABG Waste and Reference tubing  
From ABG fluid Pack to the ABG Pump

Change one set at a time to avoid confusion. Each line's fitment is held in place by 2 opposing plates. Remove the top plate and loosen the lower plate to facilitate holding one tube while installing the next. Feed each line through the front of the analyzer. Gently pull on the lines coming out the back of the analyzer. This will help to hold each line in place while inserting the fitment into the bracket.
