Ubigate iBG is registered trademarks of SAMSUNG Electronics.
All other company and product names may be trademarks of the respective companies with which they are associated.

Ubigate iBG series TroubleShooting Manual

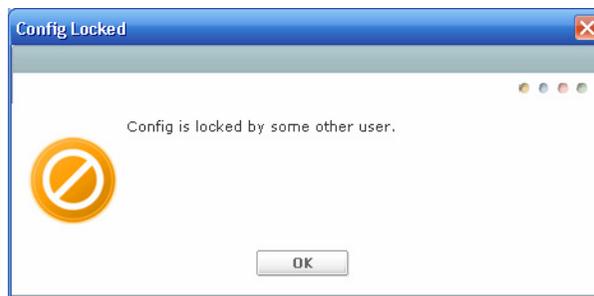
When the user tries to log in to iBG system or some configuration change operation, Config is locked by other user. A dialog pops up.

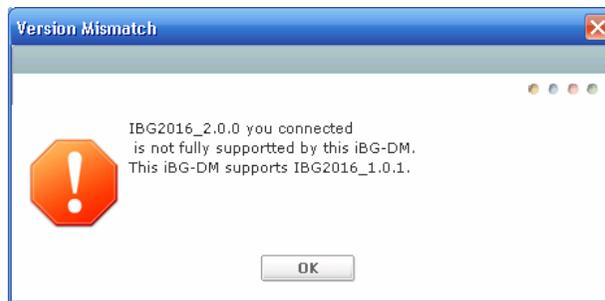
When the user tries to login, the user account ID and password check passed. After that, the Version Mismatch Dialog popped up.

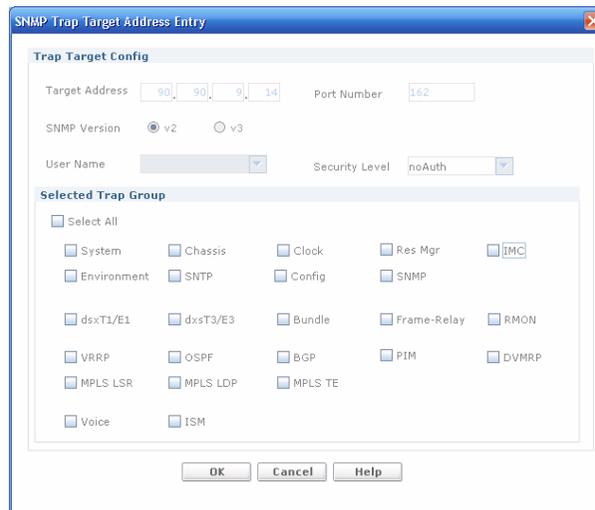
User is Off the trap generation.

Check the TRAP Target settings with system → SNMP Setup → Trap Control.
If the SNMP Trap target is not set, enable the traps using the modify button.

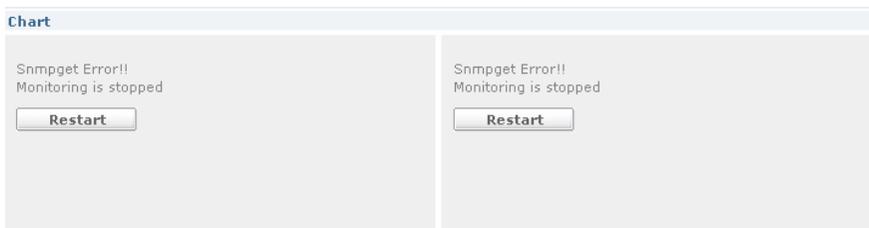
While the user is using performance monitoring an SNMP Error occurred. It displayed SNMP get error message instead of chart.

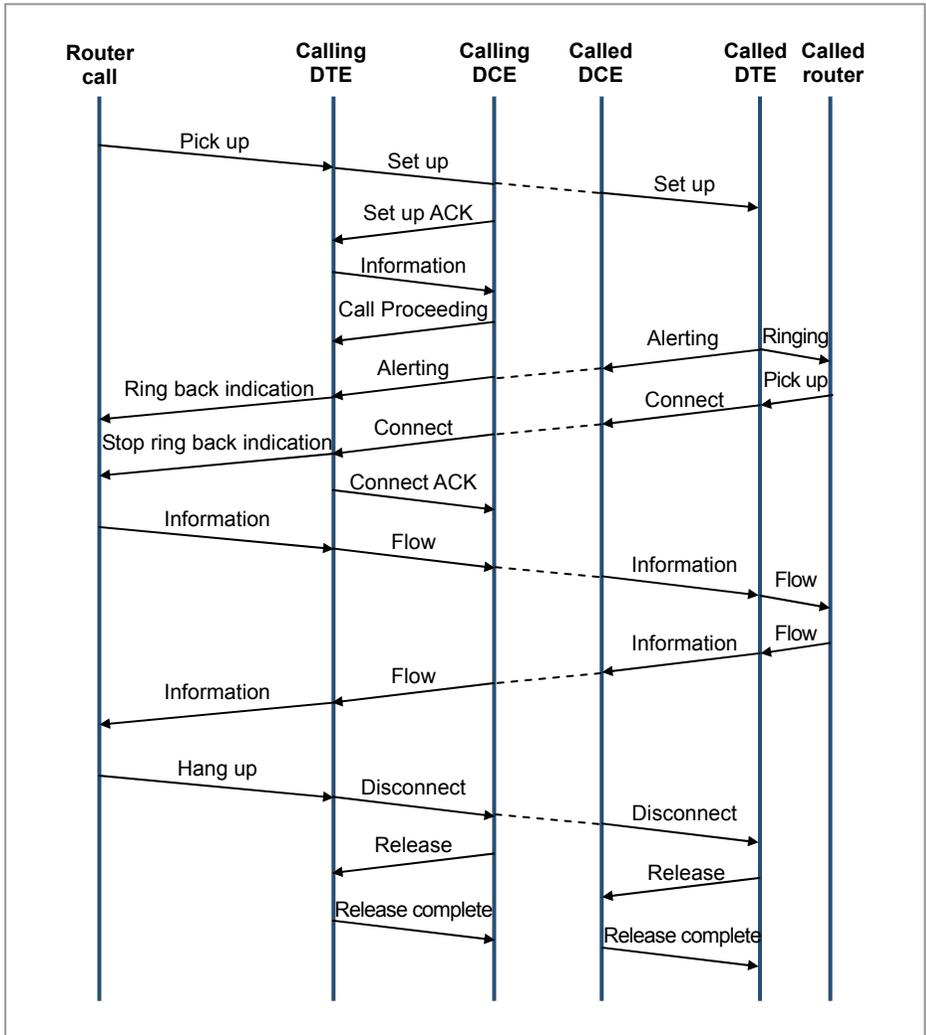
ISDN Messages

This is the overview of the Q.931 messages which are commonly used in a normal ISDN call. For more information on Q.931 messages, see the ITU-T Recommendation Q.931.

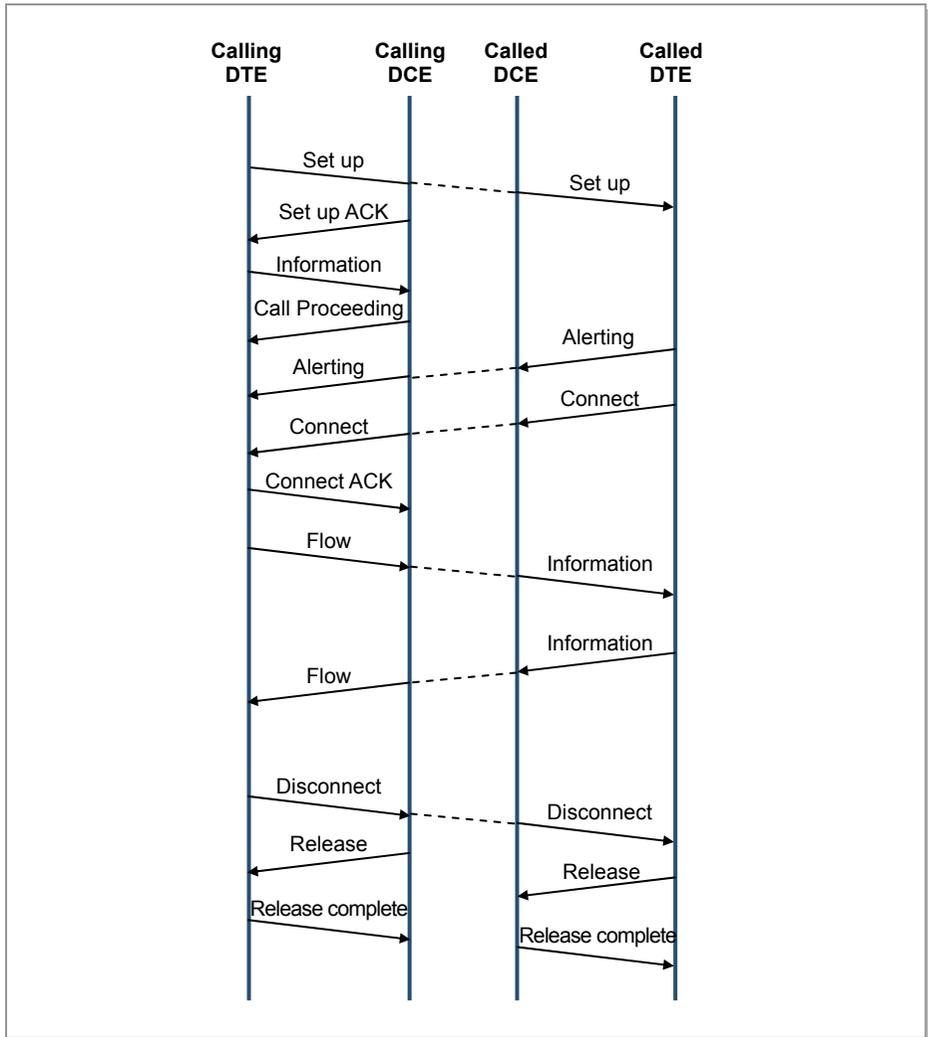
ISDN Messages

This is an overview of the Q.931 messages which are commonly used in a normal ISDN call. For more information on Q.931 messages, see the ITU-T Recommendation Q.931.
