# Technical Tips and Tricks | AlliedWare Plus™ Managed Layer 3 Switches

This document contains useful technical tips and tricks for AlliedWare Plus Managed Layer 3 switches.

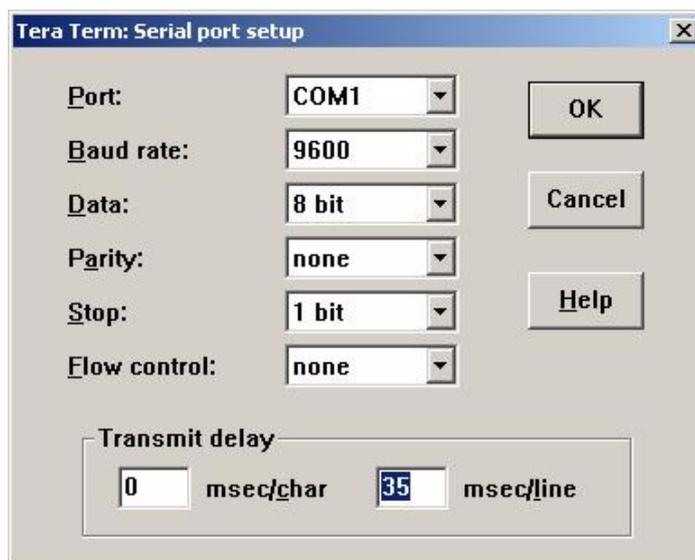
1. The best practice is to copy in as a file using TFTP.
2. If you do have to paste to conf t, you can void the issue by breaking the configuration down into smaller portions, and pasting in a portion at a time.
3. Another practical solution is to change your terminal program's setting to introduce an end line delay period. One example, using Linux minicom, involves setting a **Newline Delay** (using Ctrl-a, t, d) of at least 150ms to fix the issue.

Also, hyperterminal offers this setting on connection:

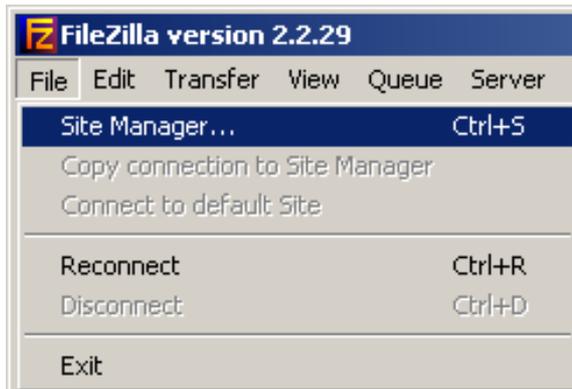
Within Filezilla, you need to create an FTP site definition that uses SFTP to connect to your switch.

1. Select **File > Site Manager...**

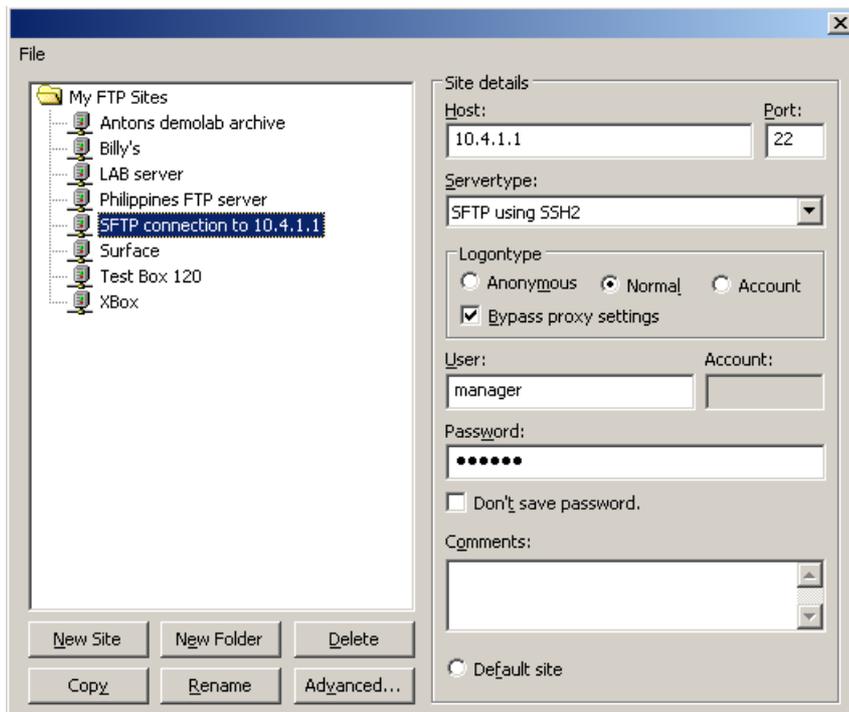
2. Create an FTP site that uses the **servertype** "SFTP using SSH2". Filezilla automatically selects port 22 as the TCP port for this FTP site:

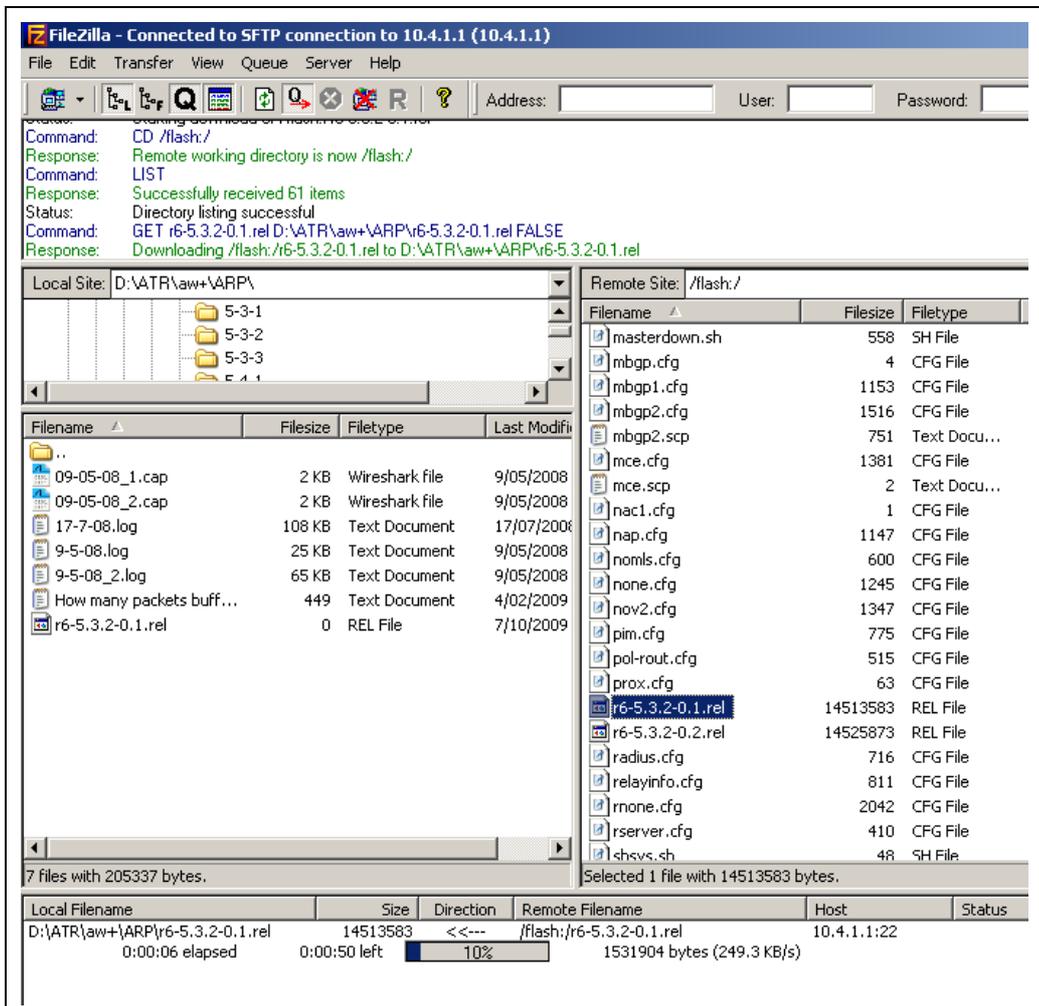
- Connect to the site. The contents of the file system on the switch are displayed in the **Remote Site** pane. Files can be transferred to and from the switch in the same way as they can be transferred to any FTP site by Filezilla:

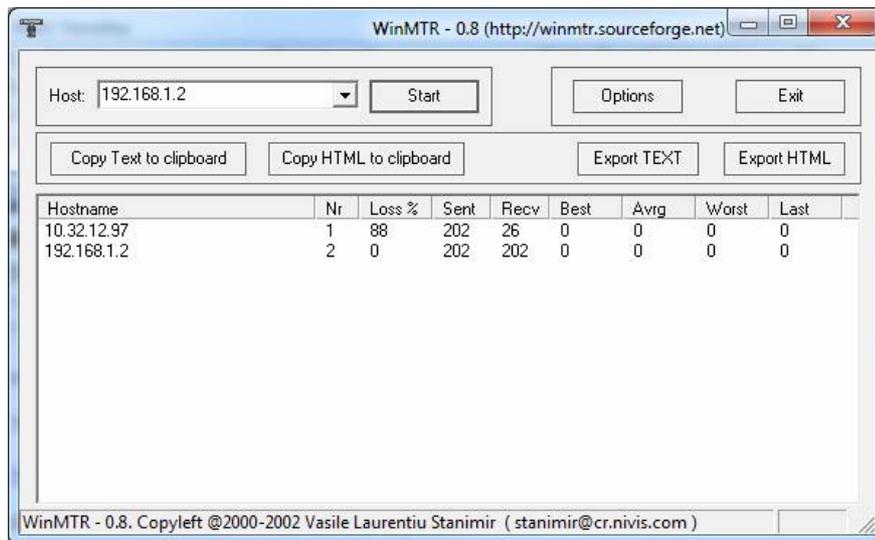
2. When we run this test (ICMP packets at 100ms interval), MTR to 192.168.1.2 shows

enormous packet loss:

3. MTR sends two frames every 100ms. These are ICMP echo requests, destined for 192.168.1.2. One has a TTL of 1 and the other has a TTL of 2.
4. The packet with a TTL of 2 reaches its destination and an ICMP echo reply is sent. This is correct.
5. The packet with a TTL of 1 reaches the AlliedWare Plus switch (10.32.12.97) and the TTL expires, so the switch sends back an ICMP Time-to-live Exceeded message. This is also correct.

However, the Linux kernel employs ICMP rate limiting for certain ICMP packets. This means that only around 1 in 10 TTL expired packets will actually result in an ICMP Time-to-live Exceeded message in this scenario. This explains why MTR reports about 88% loss to the SwitchBlade x908.
