Maintenance Best Practices for Direct-Attached SCSI Solutions

Revision 1.1

July 20, 2005

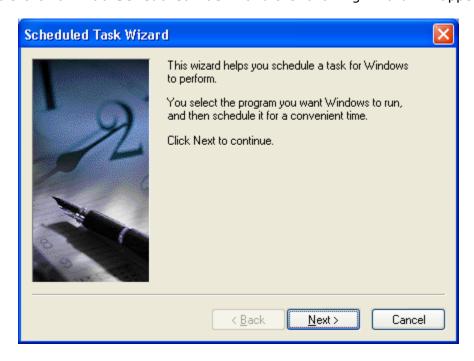
1. For systems with a Windows OS system and *Array Manager* installed, you can use the '*Scheduled Tasks'* option from the menu under the '*Accessories'* folder. Double-click on '*Add Scheduled Task"* and the following wizard will appear:

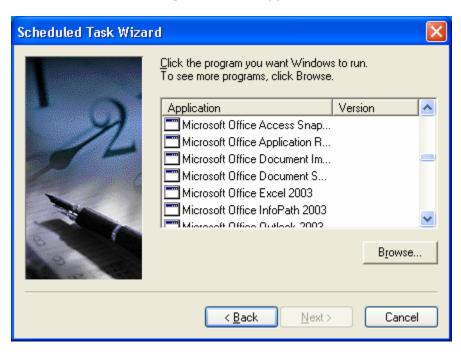
2. Click 'Next' and the following screen will appear:

- 3. Click '**Browse'** and locate the file 'amcli.exe'. The AMCLI executable is located in the Array Manager installation directory.
- 4. Select the file and click 'OK'.
- 5. Click 'Next' and the following screen will appear:

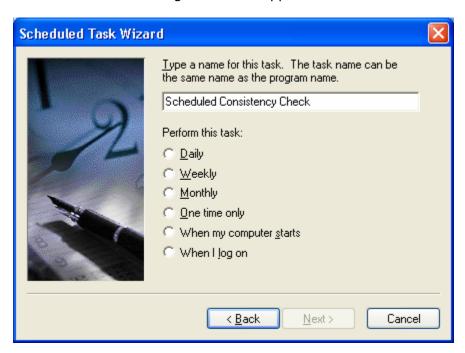
6. Enter a name for this task and select how often the task should be run. The minimum recommendation for this task is to be run at least once a month.

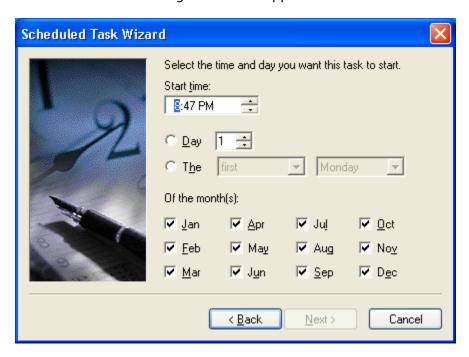
7. Click 'Next' and the following screen will appear:

- 8. Select the time at which the Consistency Check should run. Remember that there will be a system performance impact so you want to run this at a low traffic time.
- 9. Click '**Next'** and the following screen will appear:

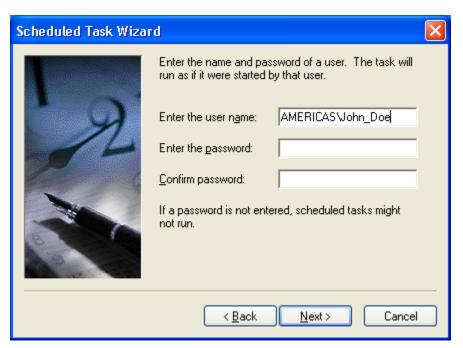
10. Fill in the name and password fields appropriately so the task can be executed correctly.

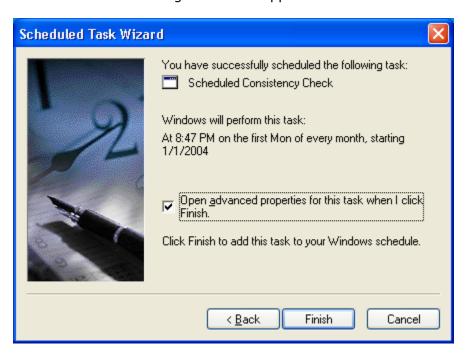
11. Click 'Next' and the following screen will appear:

12. Select the checkbox for 'Open advanced properties for this task when I click Finish.'

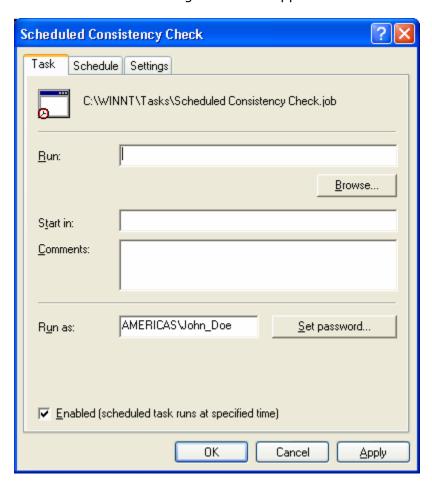
13. Click 'Finish' and the following screen will appear:

- 14. In the '**Run**' textbox you can type different parameters. The following is example syntax for scheduling a check consistency on virtual disk 1. '
 - "C:\PathName\amcli.exe" /c1 ' where PathName is the path to the AMCLI executable. This will be the command executed by the scheduler every time it runs this event.
- 15. To run a consistency check the parameter is **amcli /c**n where the **c** option indicates "consistency check" and *n* is the number of a virtual disk as displayed in the Array Manager tree view.

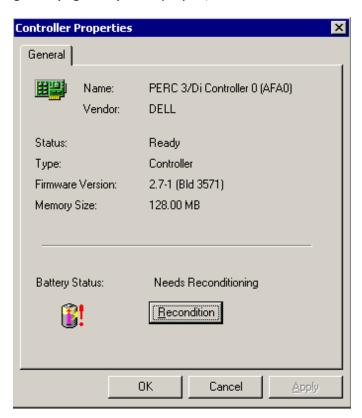
Using *Array Manager* to recondition the battery simply requires right-clicking on the controller icon and the selecting the "*Properties*" option. Once the "*Controller Properties*" dialog box (Figure 6) is displayed, click the "*Recondition*" button.

Once the reconditioning has started, the status of the battery displayed in Array Manager may not change. To get an accurate status reading, close Array Manager and then re-open it or perform a controller rescan from within *Array Manager*.

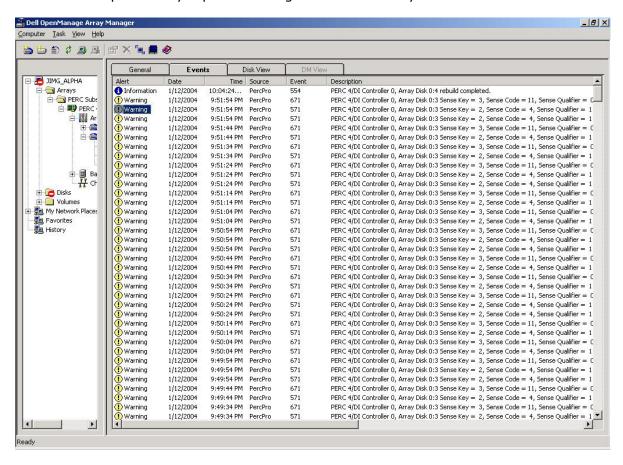
Regularly check the Array Manager Event Logs for corrected media errors. Corrected media errors are normal but an excessive number within a short time period may indicate that a drive should be proactively replaced during a maintenance cycle.

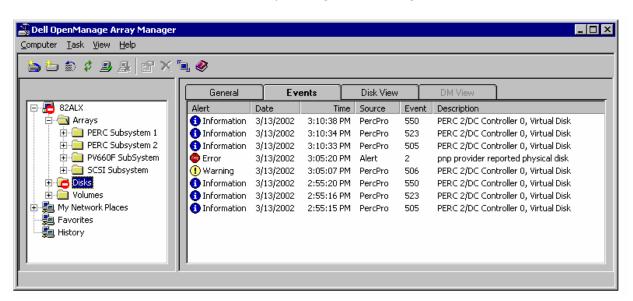
You will also be able to get the events from any Netware server with the Windows console. These events will be shown on the *Array Manager* Event Log.

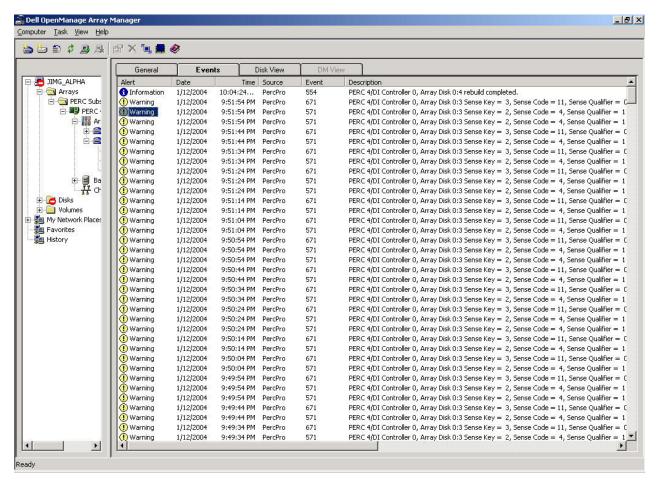
Screenshot for Array Manager showing multiple media errors (03 11) with a "rebuild completed" message:

When a media error is found during a rebuild, the PERC RAID Firmware will not complete the rebuild process. The new HDD is marked failed, and the Virtual Disk is kept in degraded state. The behavior in this scenario between a RAID 1 and a RAID 5 are different.

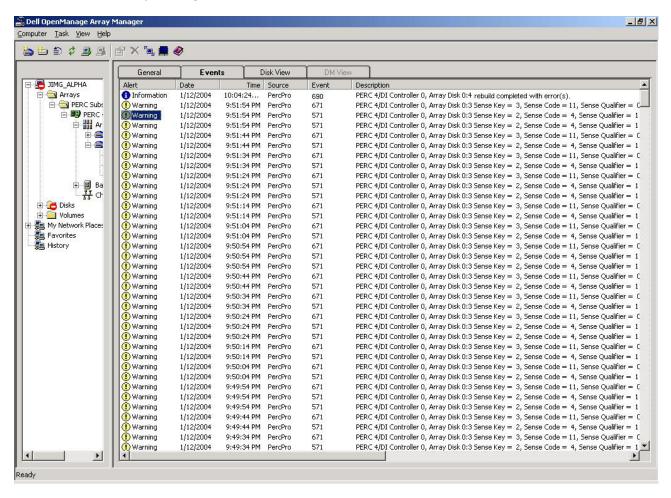
Screenshot for Array Manager:

For the May release, the PERC Firmware, and Array Manager has changes introduced to improve the customer experience in the RAID rebuild scenario.

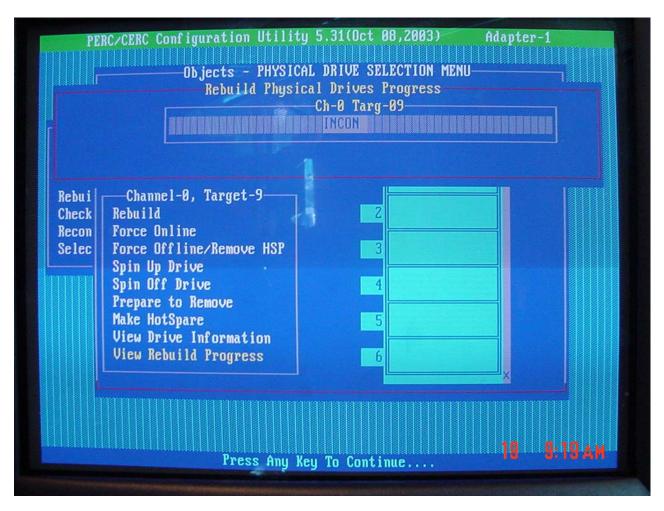
The administrator will see the percentage increase from 0% to 100% and change to "INCON" as follows:

As in the case of Ctrl-M application, DellMgr does not message when media errors are found during the rebuild. The administrator can run DellMon in the Linux system to obtain further events and notifications related to the RAID subsystem.

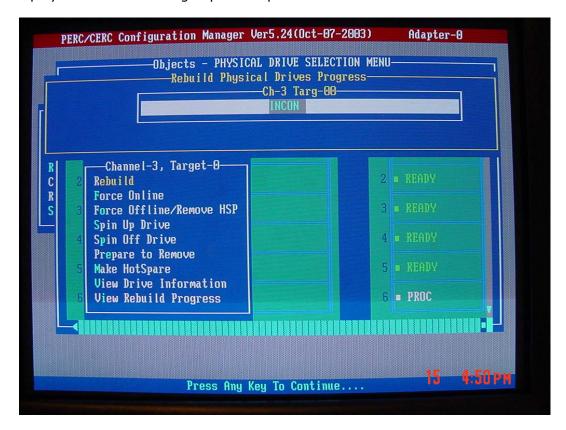
Administrator can monitor the rebuild process from Ctrl-M screen. The screen will show the percentage completed during the rebuild process until a 100% is displayed. If a media error is found during the rebuild, the Ctrl-M utility will not communicate that to the customer, but it will display a "INCON" message upon completed as shown here

The PERC 3\SC\DC\QC and the PERC 4\SC\DC\Di RAID controllers can also be managed with the Ctrl-M utility. This utility is accessed during the booting process by pressing Ctrl-M.
