## Seagate, part 2

### F3 architecture

#### Drive families: Barracuda 7200.11 and Barracuda ES.2

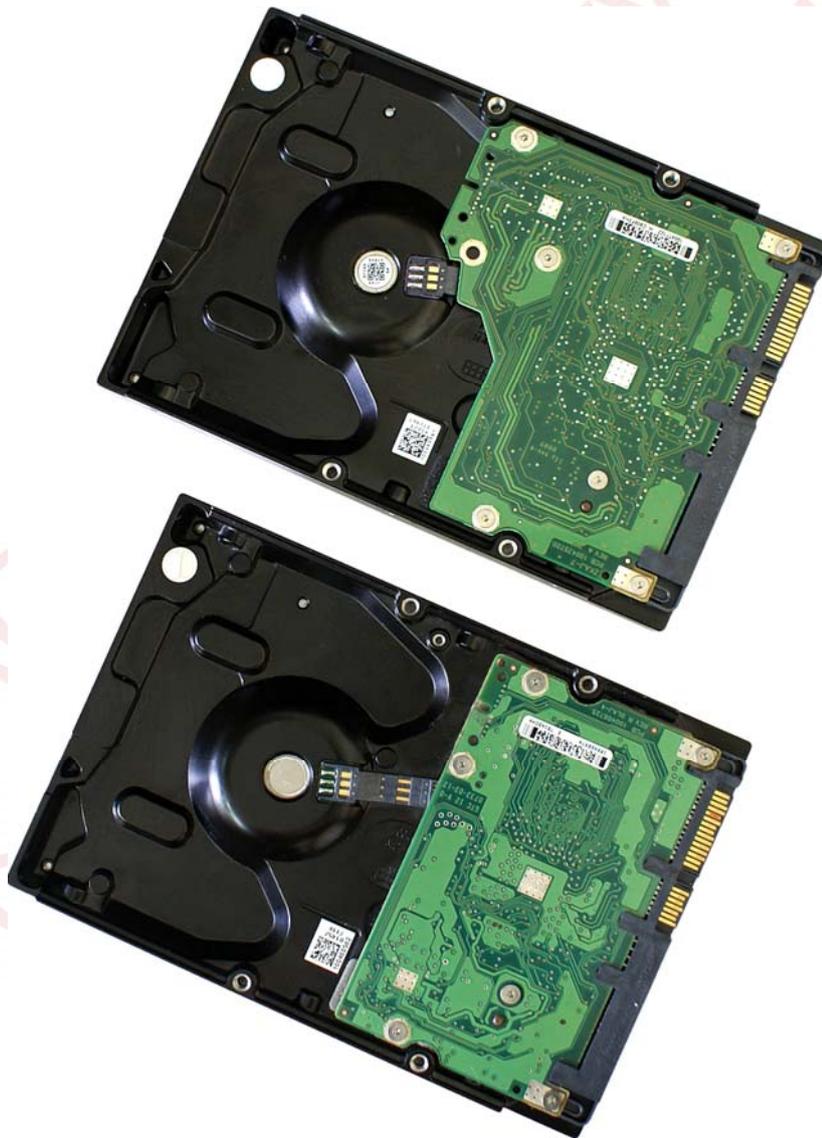
**Fig. 1. Barracuda ES.2 (upper) and Barracuda 7200.11 HDD (lower).**

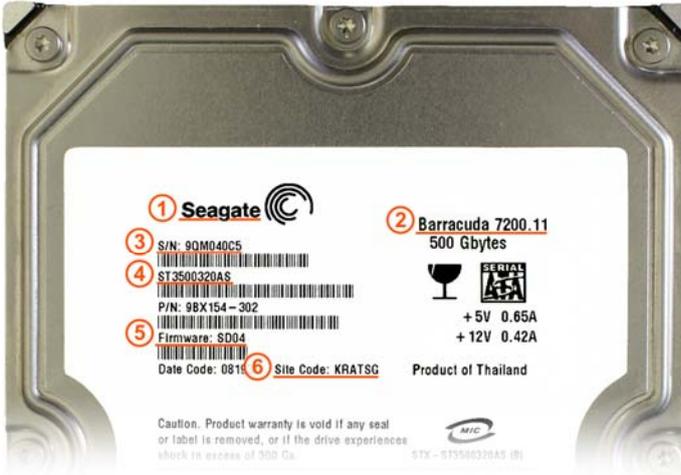
- 1 – manufacturer – Seagate
- 2 – drive family – Barracuda 7200.11
- 3 – serial number – 9QM040C5
- 4 – model – ST3500320AS
- 5 – FW version – SD04
- 6 – Site code (code of the manufacture location) – KRATSG

Fig. 2. Barracuda 7200.11. HDD label

**ATTENTION!** HDD ROM contains adaptive data. Carefully check to ensure that the controller board matches the heads and disk assembly (HDA). To do that, you can even use a board disconnected from HDA, which returns HDD ID information via the ATA interface anyway. Having read HDD ID, you can compare the model and its serial number to the information printed on HDA label<sup>1</sup> (Fig. 2, 3).

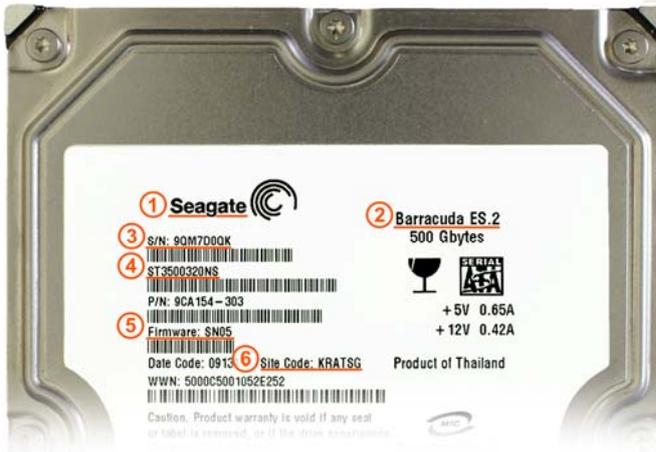
- 1 – manufacturer – Seagate
- 2 – drive family – Barracuda ES.2
- 3 – serial number – 9QM7D0QK
- 4 – model – ST3500320NS
- 5 – FW version – SN05
- 6 – Site code (code of the manufacture location) – KRATSG

Fig. 3. Barracuda ES.2. HDD label

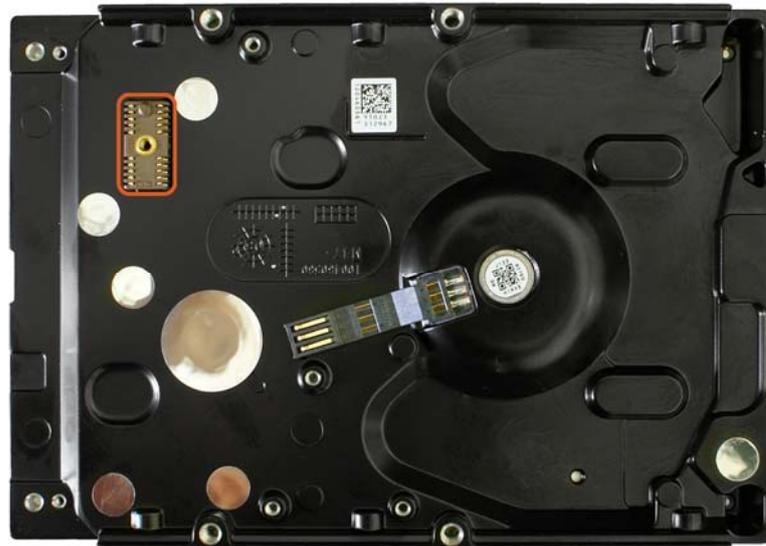
Fig. 8.

- non-native controller board;
- damaged read/write heads in the HDA;
- broken contact between the controller board and HDA in the connector of the commutator preamplifier (oxidized contacts, etc.) (Fig. 8);
- damaged service information (SMART, G-List, translator...).

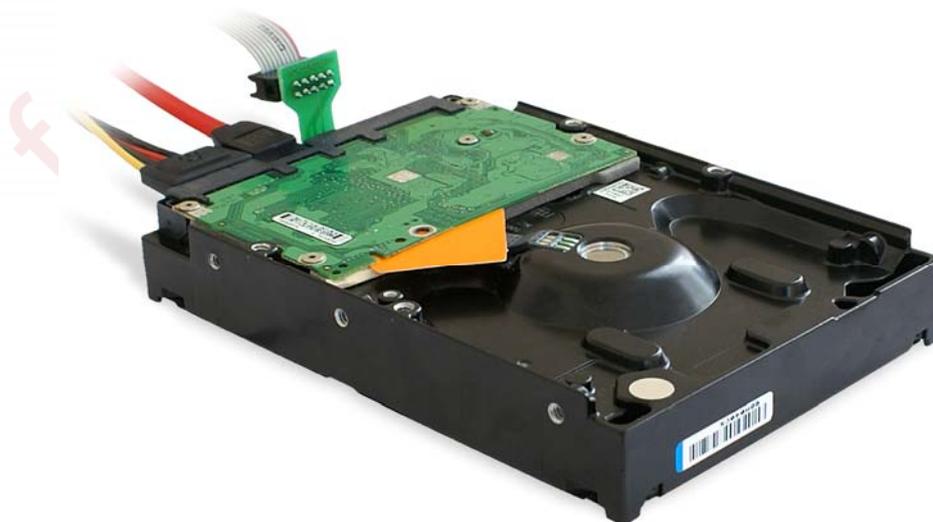
Fig. 15. Insulation of the spindle motor connector.

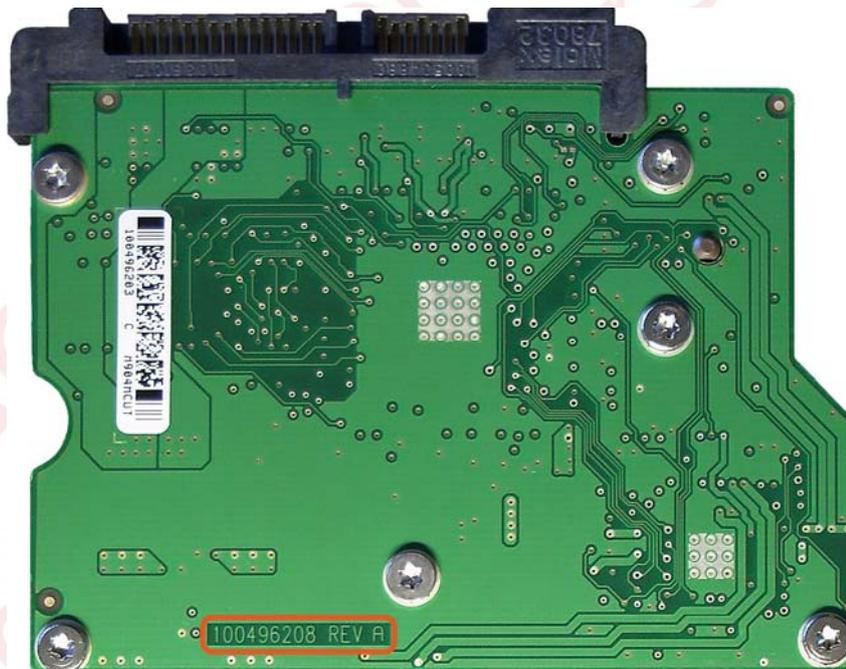
Besides, to analyze the controller board condition, you can use the PCB swap method. Boards with the same revision should be selected for the swap procedure (Fig. 20).

**Fig. 20. HDD controller board, revision 100496208 REV A.**

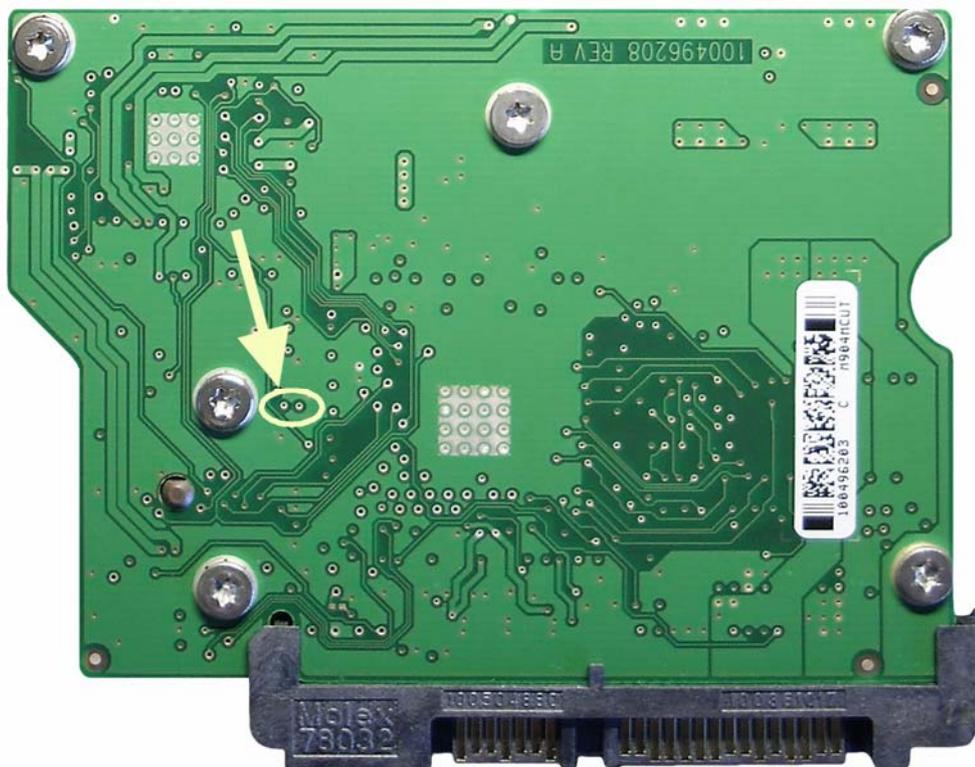
### 10.2.5. PCB 100496208 REV A

Fig. 32. Board view from the external side. Connection points are marked in yellow.
