**KDP-57XBR2**

# **Projection Television Troubleshooting**

**RA-3/3A, RA-4/4A, RA-5A, RA-6 Chassis**

**Course: TVP-14**

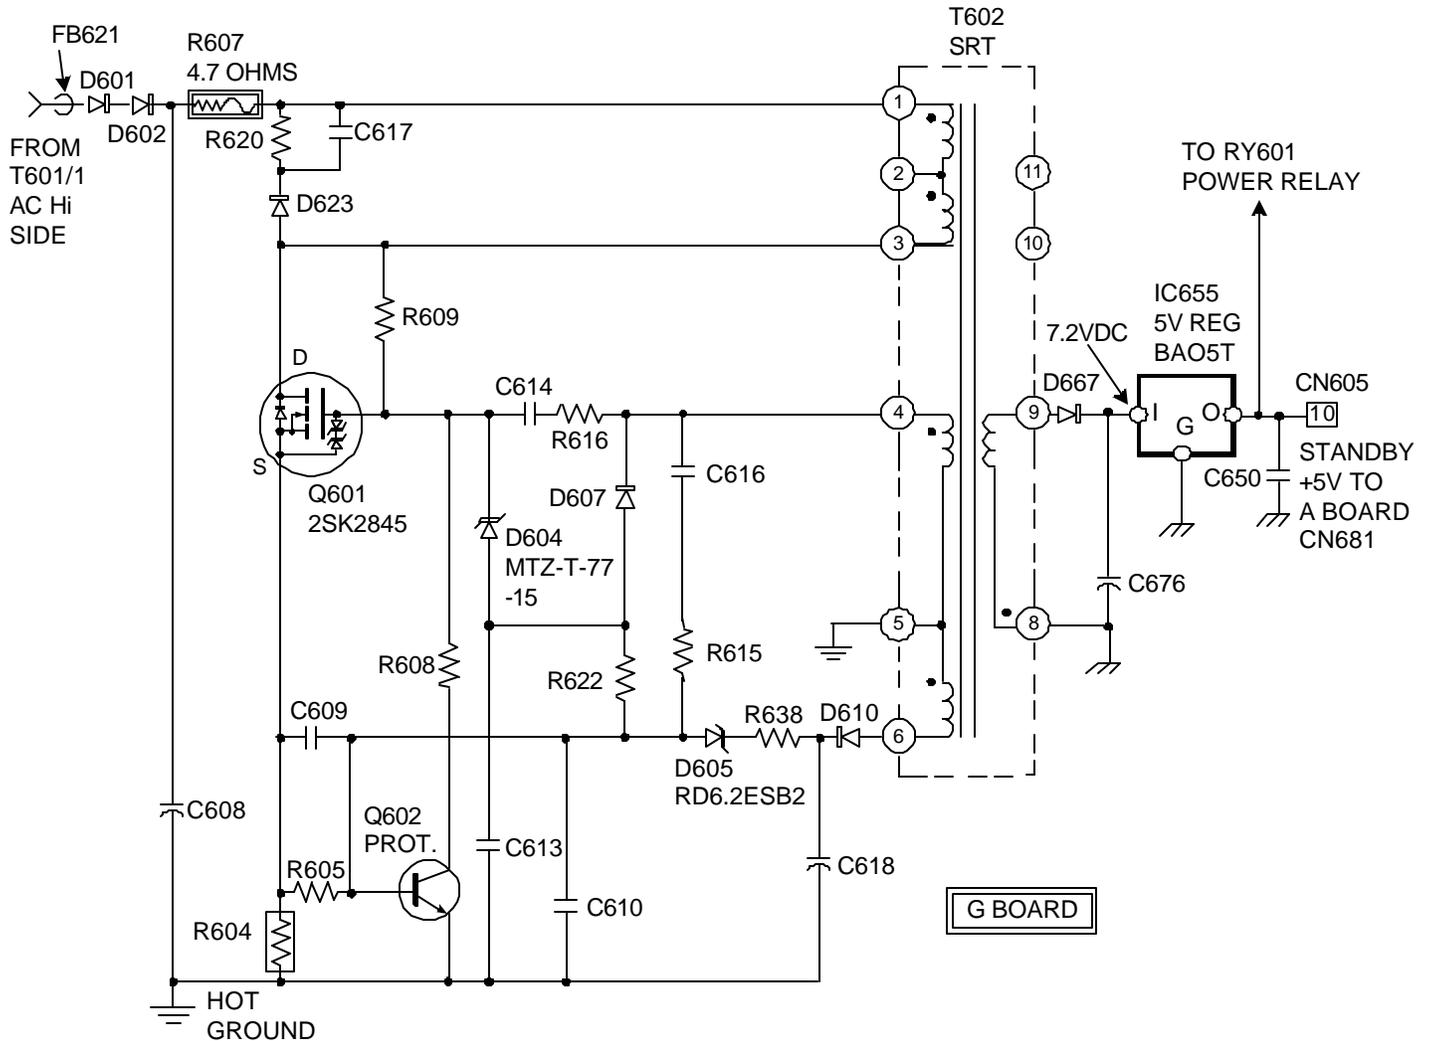
2TVP14 7/11/02

Referring to Figure 3-1, the supply works by supplying unregulated B+ through the primary of T602 to the drain of Q601, which will provide the needed ground path via R604 to provide current for the transformer. Q601 G will need a kick-start and that will be provided by R609. The FET will now begin conducting and current will begin to flow through the primary. The feedback winding at pin 4 of T602 will now start generating a positive voltage, thereby charging C614, which will drive the FET harder. This increases current in the primary, which further increases the feedback voltage, which further increases the conduction of the FET. This event will continue until two things occur: Q601 reaches saturation and C614 charges. This is how the on time of Q601 is controlled to change the frequency.

C616 will route the feedback voltage via R615 to Q602B. This voltage will be smoothed out by C610 and C609 to provide a rising sawtooth to control the on time of Q602. Q602 will now become part of the RC network of C614, R608 and R616. If current demand on the secondary of T602 decreases, voltage levels in the transformer will rise accordingly. This will cause a rise of the feedback voltage and will cause Q602 to conduct harder and alter the RC time constant. C614 will now charge more rapidly and Q601 will turn off earlier. By shutting the FET off earlier, the on time is decreased along with the duration of the field collapse in T602. Shorter conduction time and field collapse equals faster switching cycles and, hence, higher frequency. The higher the frequency, the lower the output voltages at the secondary.

Q602 will also provide protection against over-voltage or over-current situations. If the current rises dramatically, a voltage drop will occur across R604. When it rises to 0.6V or more, Q602 will conduct to raise the frequency, or, in severe cases, momentarily stop oscillation. This would cause the familiar "ticking" noise as the supply keeps trying to re-start.

Should the regulator loop fail, zener diode D605 will monitor the voltage stored by C618, which is charged by D610 during the field collapse periods. If this exceeds 6.2 volts, D605 will fire into Q602B and produce the same reaction as an over-current condition.

FIGURE 3-1 - STANDBY SUPPLY

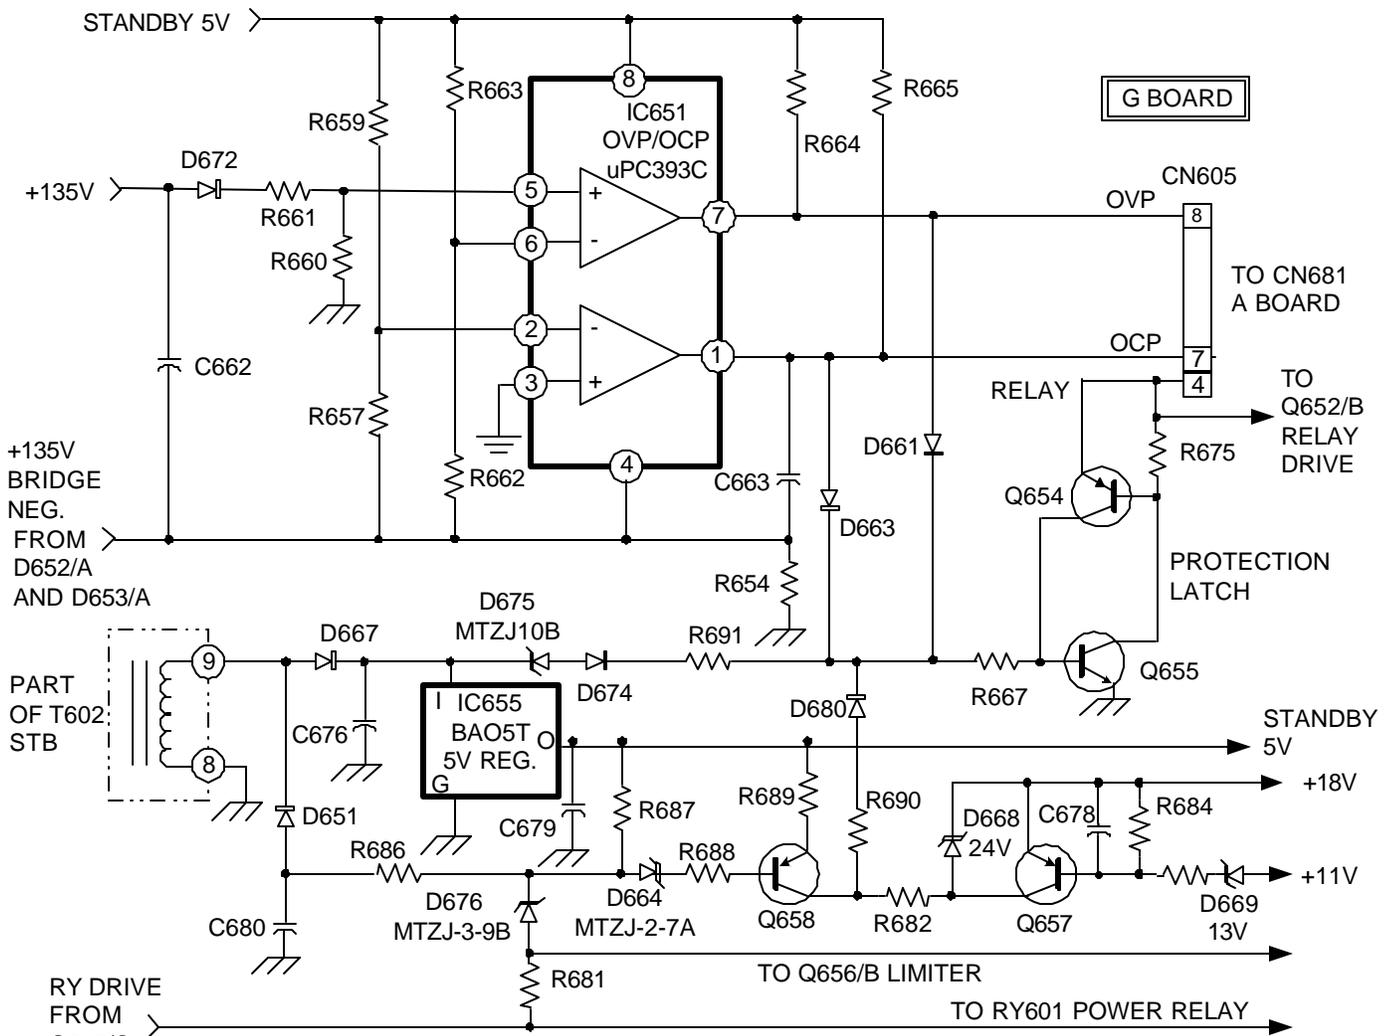
**The Standby 5V Circuit:** Monitor the anode of either D675 or D674 while applying AC power. An oscilloscope or peak-hold DVM is preferred, but this can be done with a standard DVM. If anything higher than 600mv appears at this point (you will see 10V or more if this circuit is firing), the input voltage to IC655 is exceeding 10V and firing D675. Troubleshoot the standby supply regulator circuit described earlier in this manual. If D675 is not firing, read the voltage across Q658 B-E. If it is 600mv, the OCP circuit is activating. Locate excessive load on standby 5V circuit. If Q658 B-E remains at less that .6V, monitor Q658 collector while re-applying AC. The voltage here should be zero. Any rise indicates excessive 18V or loss of 11V.

**18V and 11V Protect:** Monitor the voltage at D669 cathode while applying AC power. If voltage peaks at 11VDC, suspect 11V line failure or shorted D669. Normal voltage should be around 18V. If the voltage at Q657-E is higher than 24VDC, the 18V line is too high. If both voltages check OK, look for leaking or shorted zener diodes D669 or D668. Q657 may also be leaking or shorted.

FIGURE 4-1 - POWER SUPPLY PROTECTION

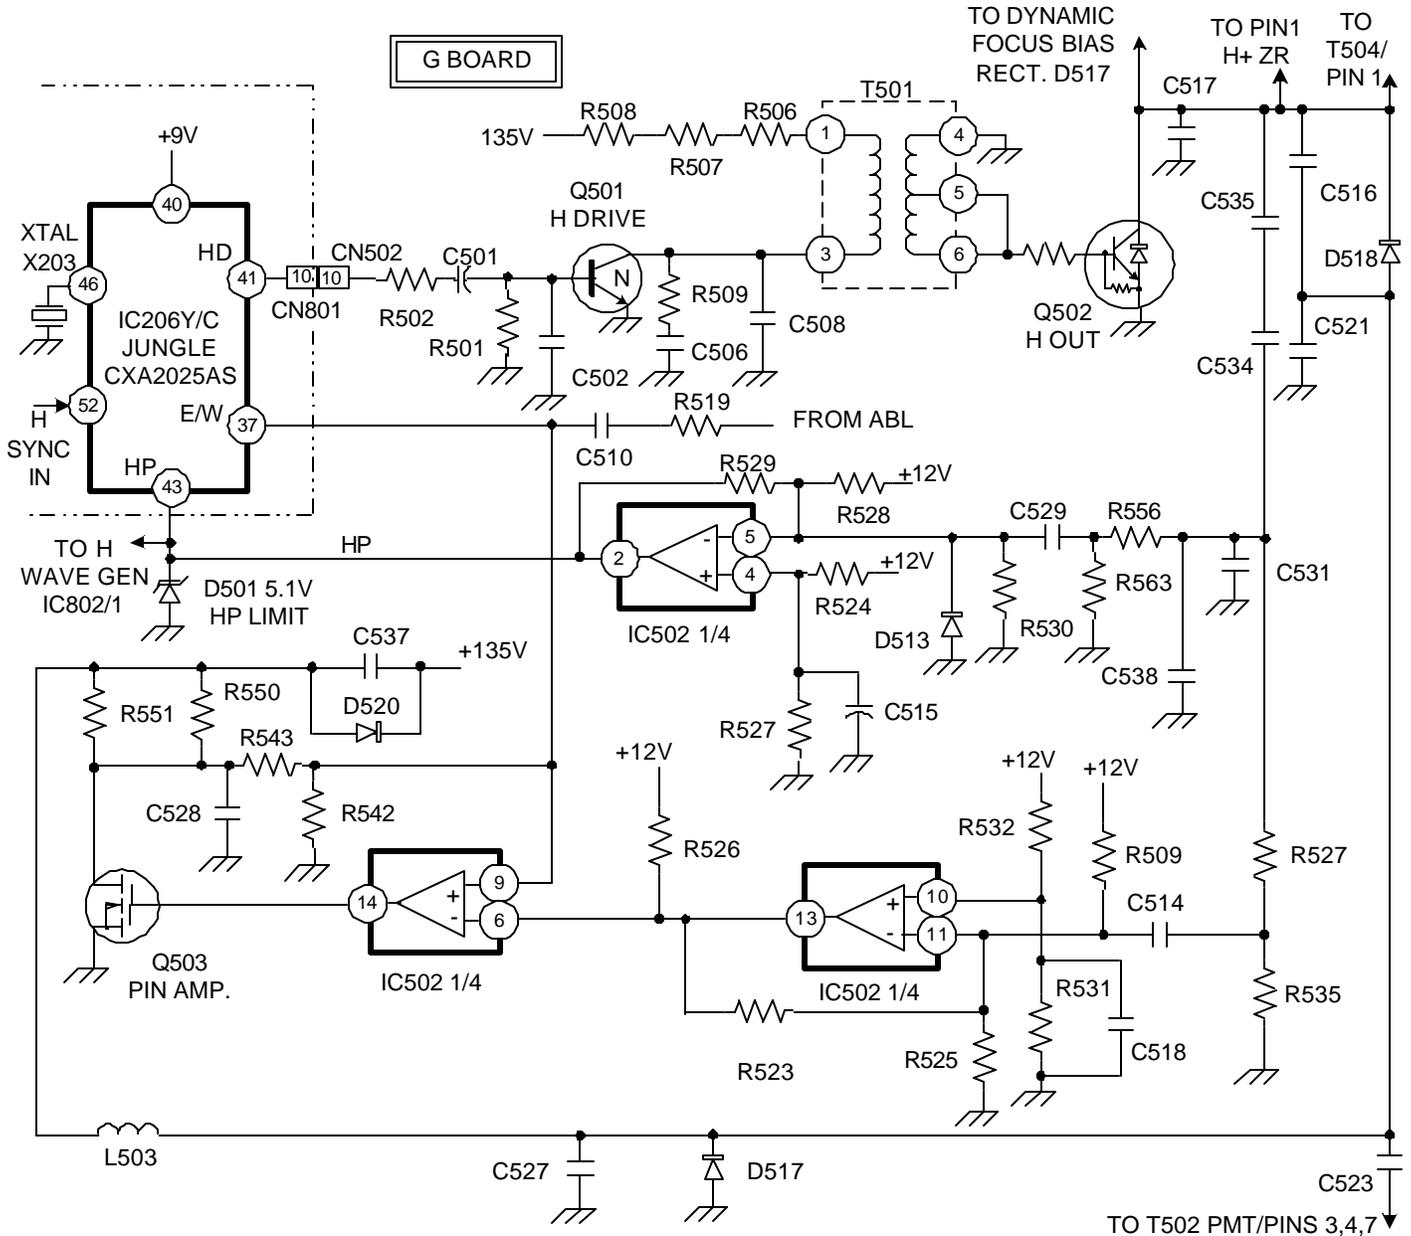
5.1ATVP14

Like the RA-2 chassis, the RA-3 utilizes a simple deflection circuit design much like those found in many of the direct-view models. Figures 5-1A and 5-1B illustrate the simplicity of this design. High voltage and horizontal sweep are accomplished with a single horizontal output transistor driving a flyback transformer and deflection yokes. This helps to simplify CRT protection and the need for horizontal sweep loss protection is not required since there will be no high voltage to burn the tubes. The vertical deflection circuit remains relatively the same as those in previous years.

FIGURE 5-1A - HORIZONTAL DEFLECTION (PART 1)

As seen in Figures 5-1A and 5-1B, this circuit is relatively simple in its operation (as there are a small number of components). It still manages to give technicians a tough time based on the number of requests for technical assistance. A lack of understanding is possibly the main reason. Here are some proven techniques to quickly locate the possible cause:

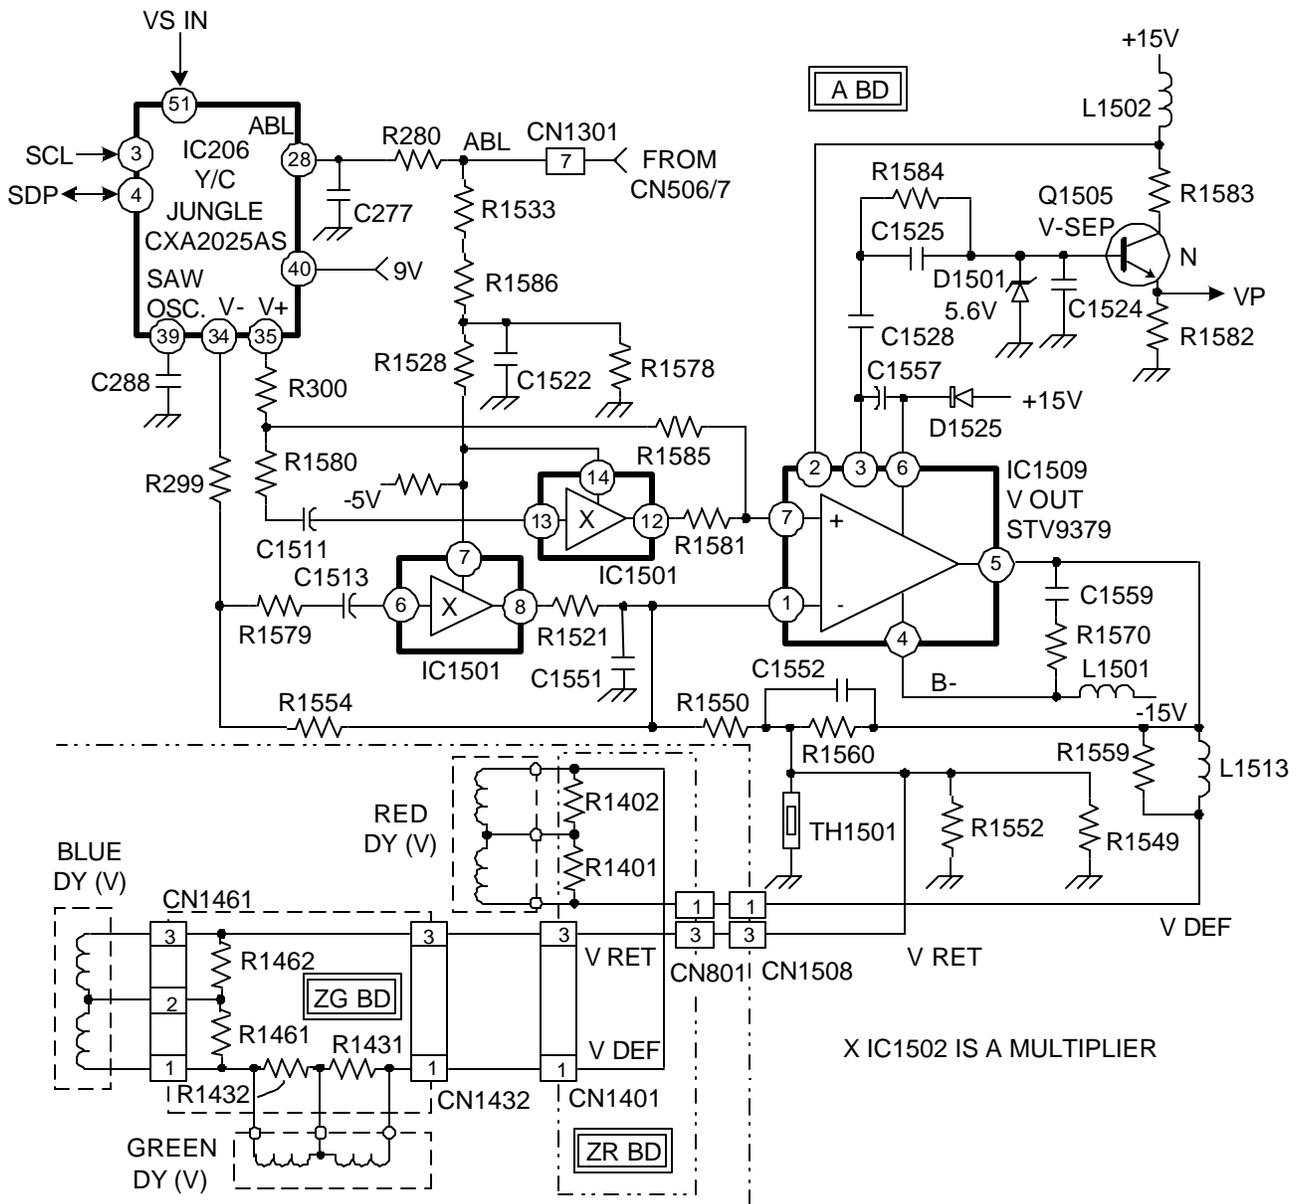
5.2TVP14 1449 6/17/02

Not much has changed in the vertical deflection design over the last few years. Looking at Figure 5-2, the RA-3 still utilizes the traditional vertical output IC utilizing negative feedback from the deflection yoke return to maintain linear amplification of the drive signal. It is simple and works quite well. You rarely see vertical linearity problems with this design. As with the pincushion circuit, the vertical circuit seems to cause problems in the field and a significant number of calls come in on the tech support line about this.

The one major change in the design on this chassis is the addition of IC1501. It provides shading correction for the light level changes due to the angle of the outer CRTs and, functions as a “zooming” control for the vertical. This part of the IC monitors flyback current from the ABL circuit at IC1501/pins 7 and 14 and helps to minimize vertical size fluctuations during rapid light to dark transitions of the programming. The addition of this circuit does not change the troubleshooting approach much, other than to add an additional path for the vertical signal.

The Y/C Jungle IC206 will output vertical drive regardless of whether output and feedback are operating properly. This makes troubleshooting much easier than it was on circuit designs from many years ago in which the entire vertical circuit was dependent on feedback to even oscillate.

FIGURE 5-2 - VERTICAL DEFLECTION

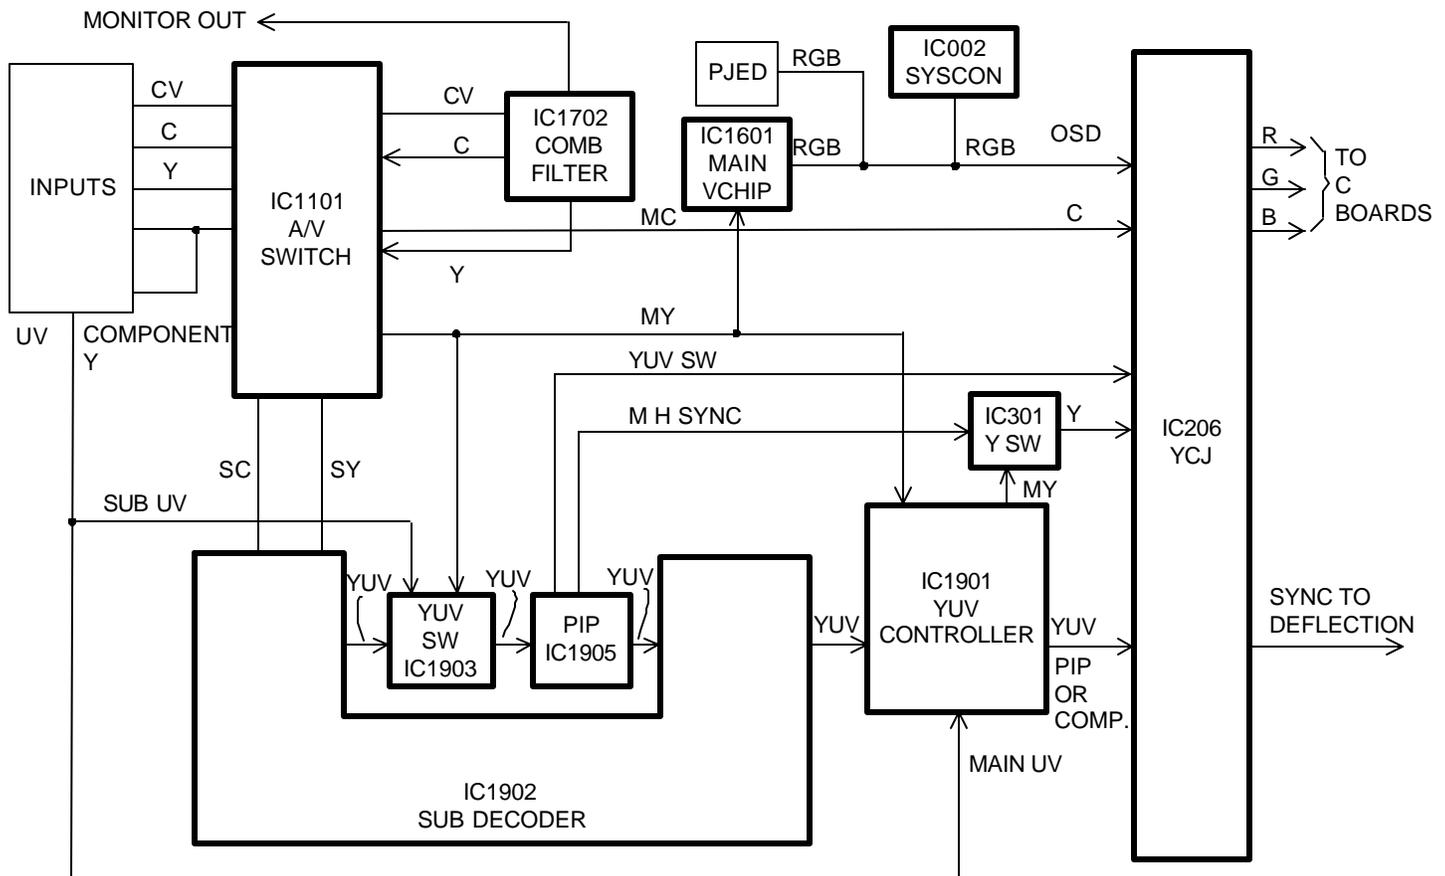
6.1TVP14 6/26/02

As illustrated in Figure 7-1, the main difference in this model series is the lack of a 3D comb filter, using a glass type instead. It also utilizes a simple PIP circuit which overlays a second video source on top of the main picture. This box can be moved around the screen and its size can be varied by the user. Since a 3D comb filter is not used, the main video path will not be processed by a decoder circuit. Any S video sources will head directly to the YC/Jungle IC206 after passing through some switches. The switches are necessary in order to toggle the source of the main (or parent picture) and the sub (child picture) path. Since a component video source is available at video 4 input, a YUV controller, IC1901, is utilized to switch the component source directly into the YC/Jungle IC206.

The sub video path does not utilize any type of comb filtering but it does go through a decoding process by IC1902. This is necessary since this path will enter the PIP processor, IC1905 and the 3.58MHz carrier must be removed. The block diagram in Figure 7-1 is rather crude but it serves its purpose well as you can get a good

FIGURE 6-1 - S MODELS VIDEO BLOCK

Another useful tool is to apply a component signal to the video 4 input. By looking at the block diagram in figure 6-1, you can see how this signal path bypasses almost all of the process circuitry.

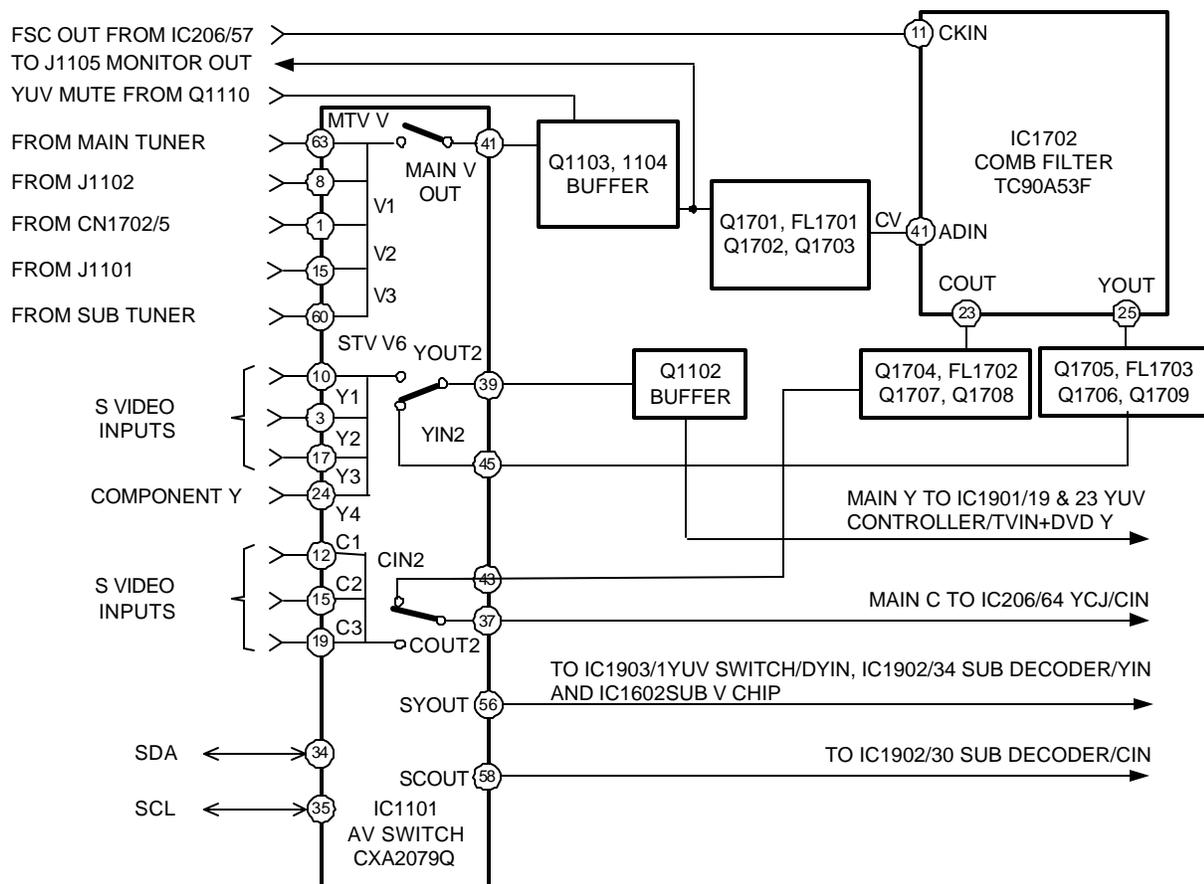
6.2TVP14 5/22/02

FIGURE 6-2 - SWITCHING AND COMB FILTER (S MODELS)

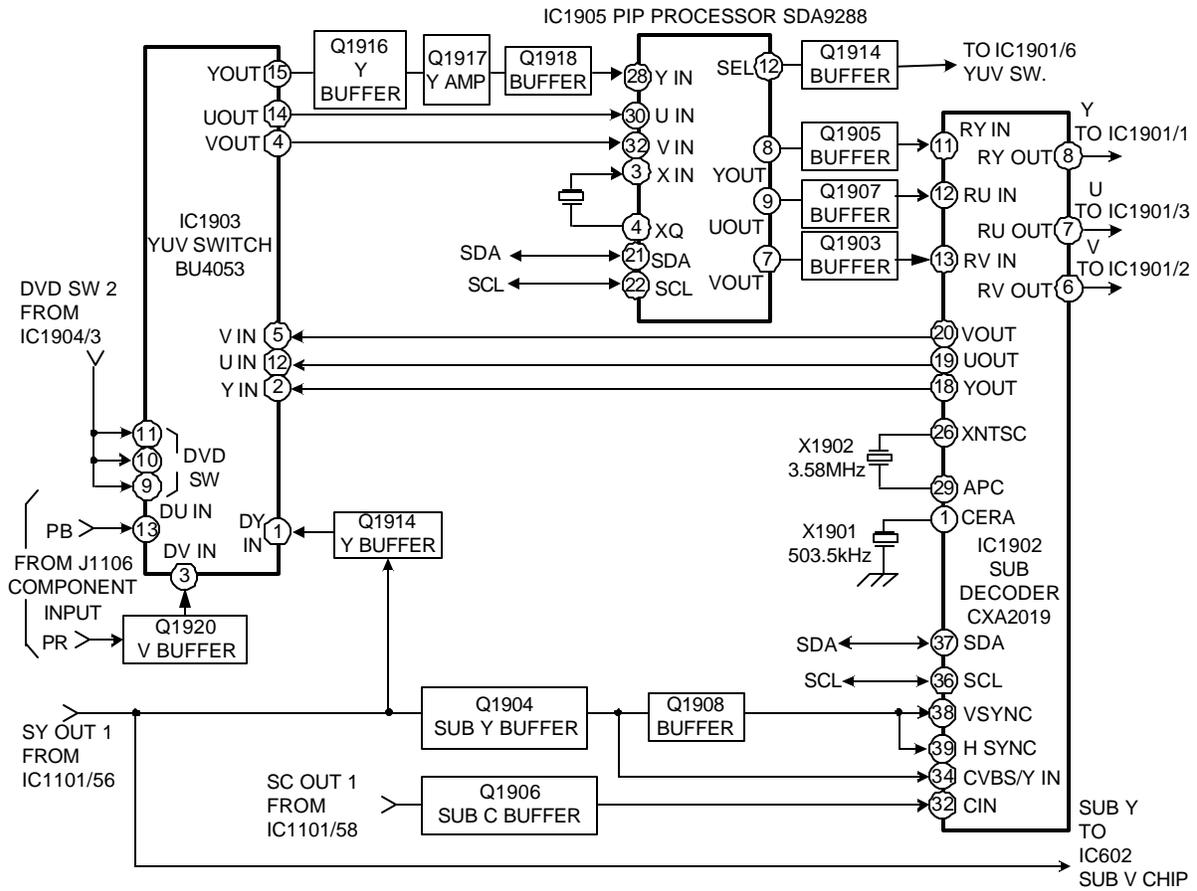
6.3TVP14 5/22/02

FIGURE 6-3 - PICTURE IN PICTURE (S MODELS)

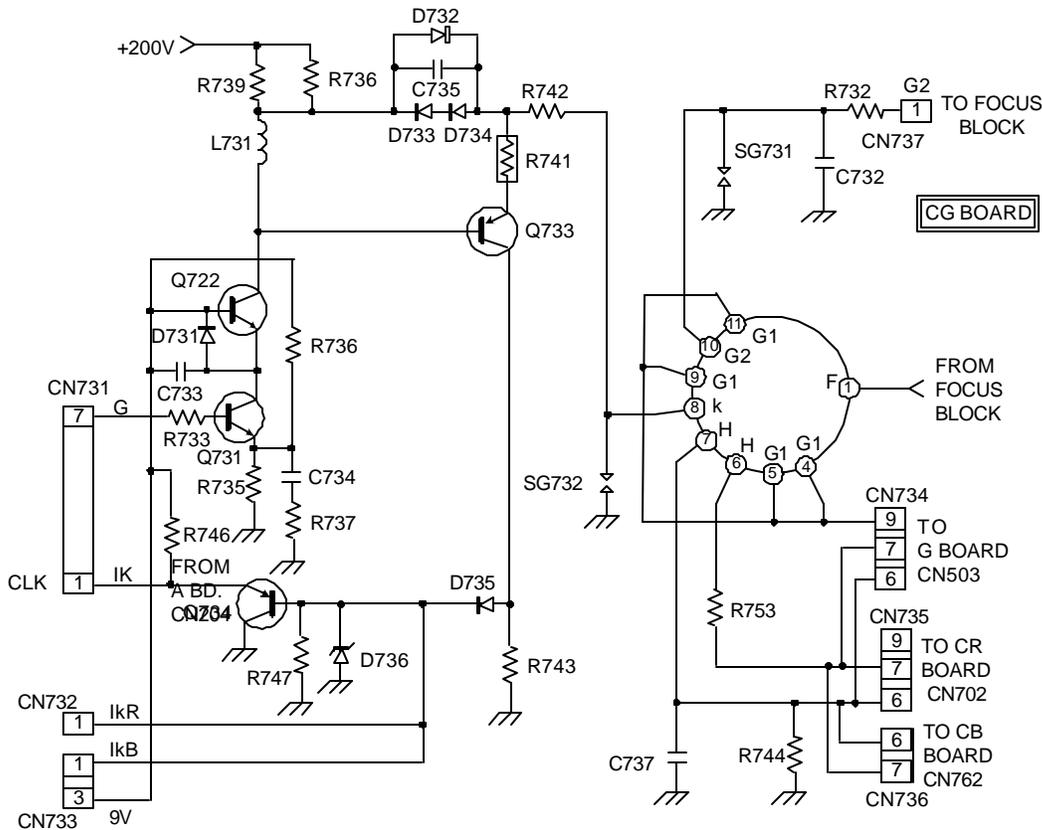
6.4TVP14 5/22/02

the timer LED flash in sequences of five, which will help steer you in the right direction. A prime example of this is the failure of Q706, Q733 and Q764 on the CR, CG and CB boards. Figure 6-4 shows the CG board with Q733 as an example. These transistors, which are responsible for monitoring cathode current, would short or leak if the CRT arced. All three of the transistors are connected to the IK return line via Q734 buffer. If one or more of these current monitors failed, the IK return line would be "swamped" with DC voltage. IC206 would now be fooled into thinking that insufficient pulses were being fed back and, depending on how much the current detect transistor was leaking, would generate a overly bright picture. In some cases, that would cause the set to go into over-current protect. The best way to isolate this problem is to read the collector voltage of each IK monitoring transistor. Approximately 2VDC should appear there. If one of the transistors is leaking, you will see 5VDC since there is a zener diode D736 at Q734B that prevents this line from going any higher. Service Bulletin #443 (E08921862) deals with this issue.

FIGURE 6-4 - CRT DRIVE (CG)

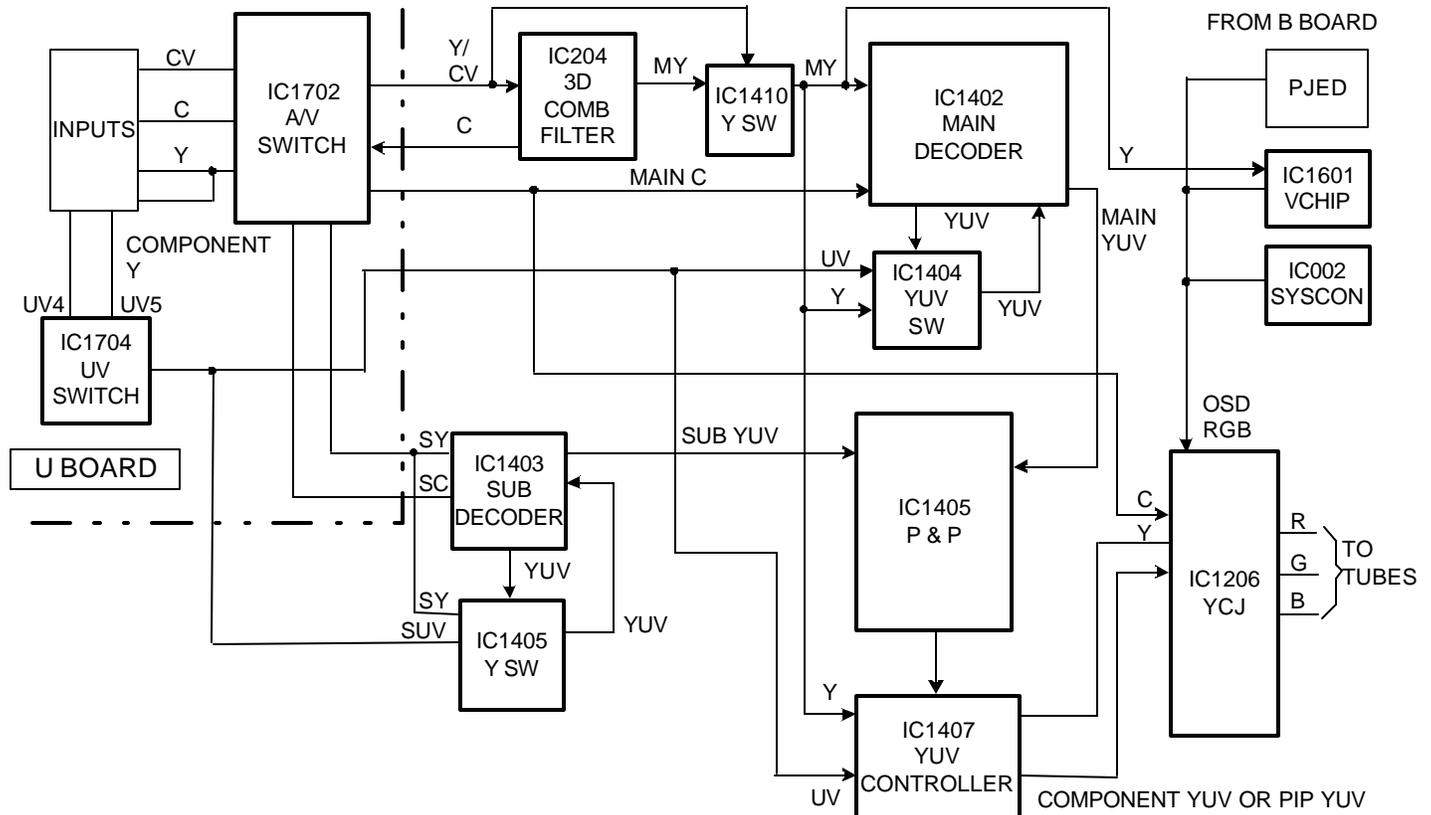
6.5TVP14 6/26/02

These models have several additional features not found on the lower-end sets. A 3D comb filter provides higher quality cross-talk separation along with noise reduction circuitry for the Y component. This is why the S video inputs are routed through the comb filter. Only the component inputs will bypass this circuit. A decoder circuit has also been added to the main video path after it exits the comb filter since it is going to be routed to a Picture and Picture processing IC along with direct input to Y/C Jungle IC206. This will provide twin picture viewing in a side-by-side fashion rather than a main picture with a small inset box. There is also an additional component source available at the video 5 input. Figure 6-5 illustrates the basic paths of the main and sub video and provides the key source for isolating video problems. Figures 6-6 and 6-7 illustrate block diagrams with more detail to aid in isolating problems.

FIGURE 6-5 - V MODELS VIDEO BLOCK

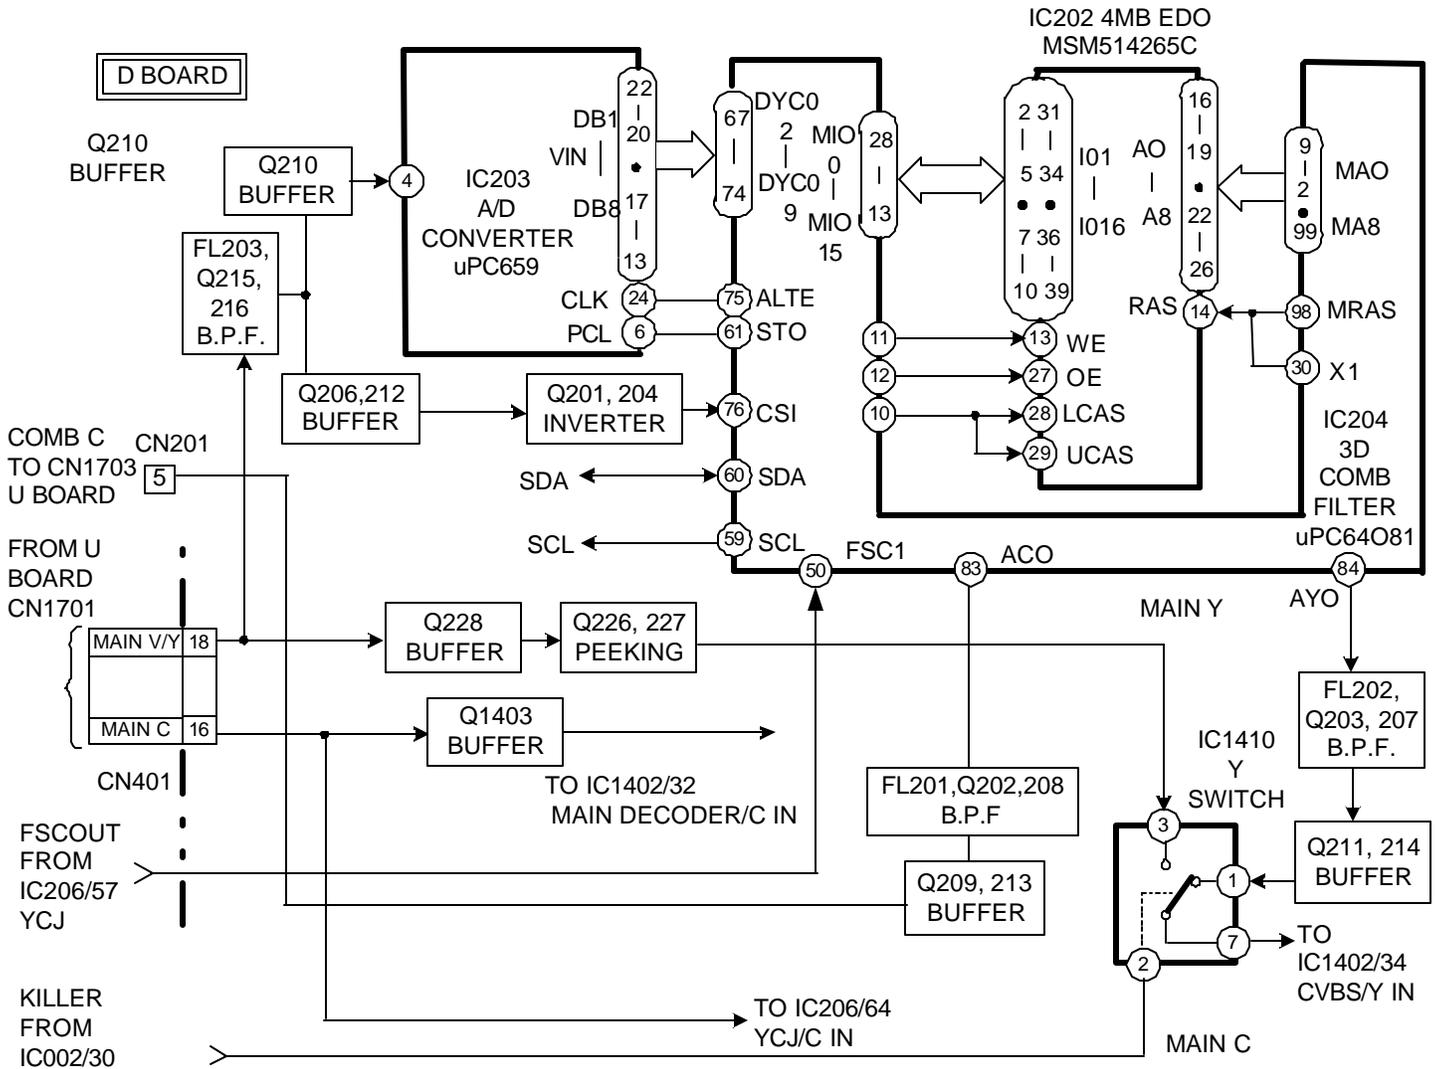
6.6TVP14 5/22/02

FIGURE 6-6 - COMB FILTER (V MODELS)

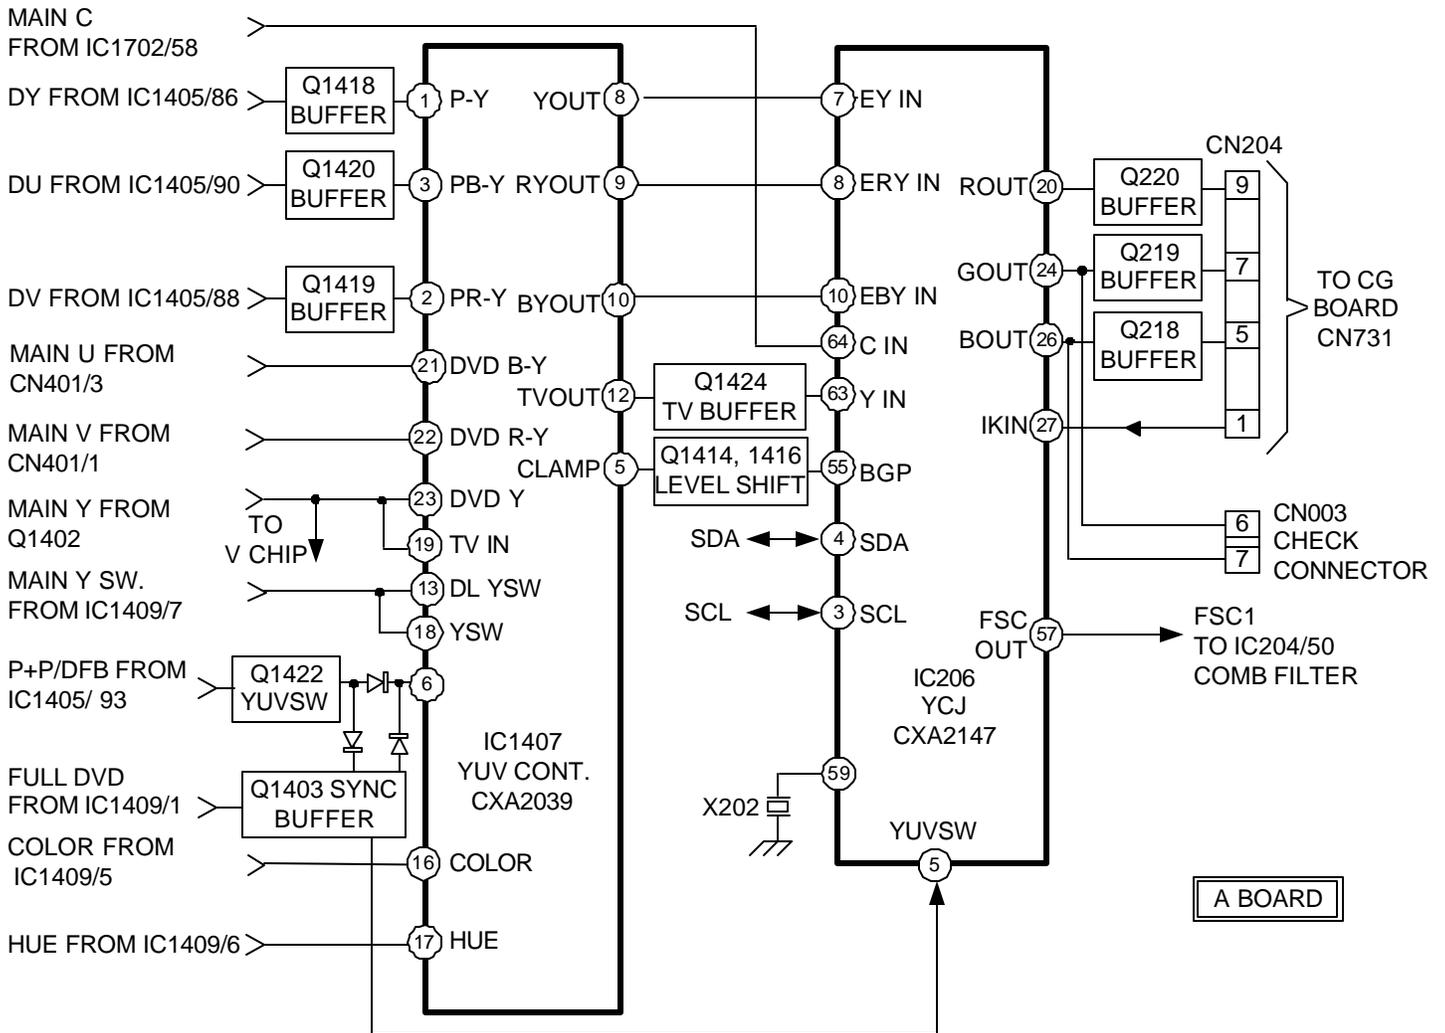
6.7TVP14 5/22/02

FIGURE 6-7 - VIDEO PROCESSING (V MODELS)

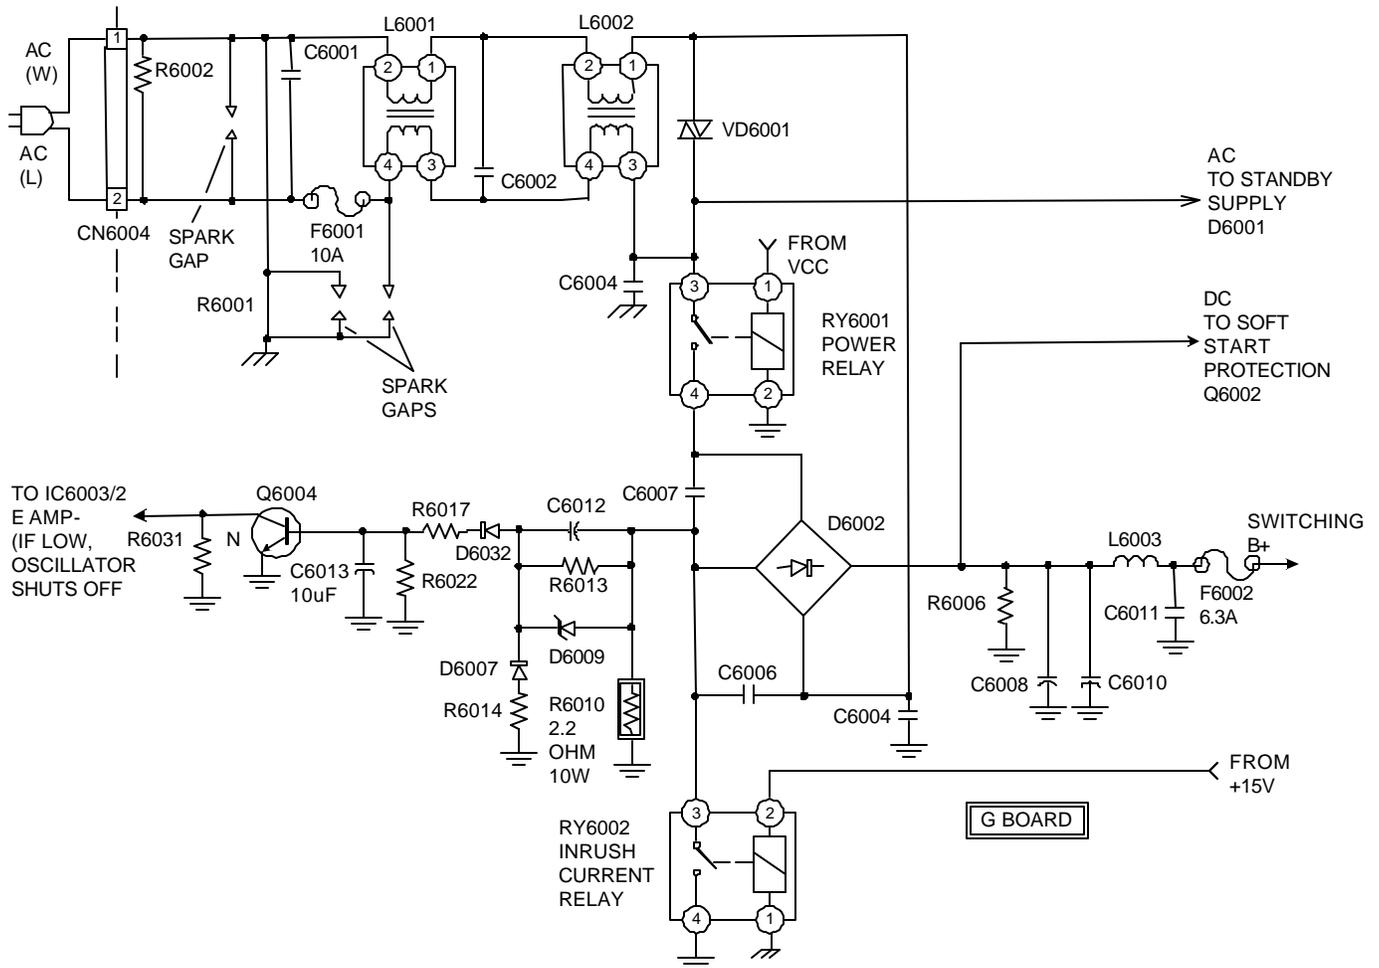
8.1TVP14 6/26/02

FIGURE 8-1 - AC INPUT & SWITCHING B+

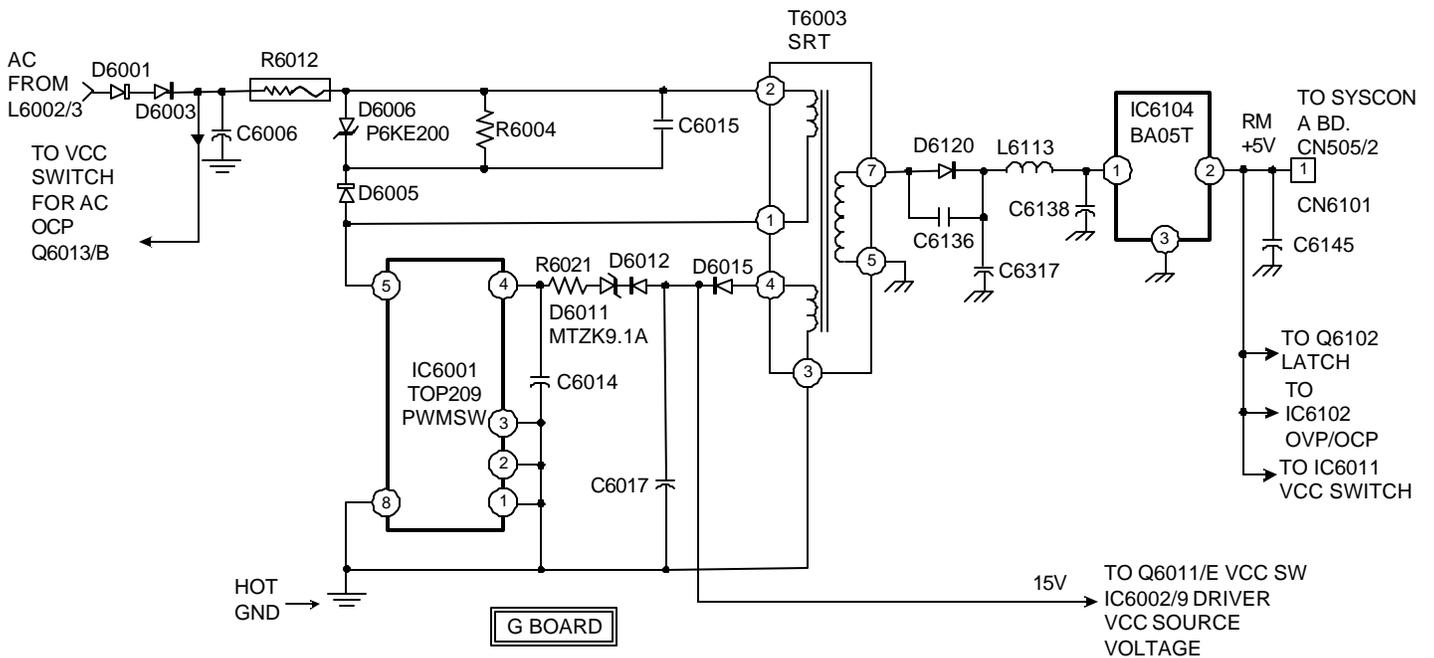
8.2TVP14 7/11/02

The standby supply consists of T6003 and IC6001 as the main components to provide oscillation. Pin 5 of IC6001 will provide the current return through the primary to ground. Unregulated B+ is provided by D6001 and D6003 through fusible resistor R6012. The circuit is self-oscillating at this point. Voltage regulation will be achieved by monitoring the feedback line from T6003/pin 4 through the rectifiers and charging C6014. This will provide an average DC level to monitor and control the oscillator frequency. Notice the voltage tap between D6012 and 6015. Approximately 15VDC occurs here to provide voltage for the main relay, RY6001 and the VCC switch circuit. Pin 7 of T6003 will provide 7.5VDC for the 5V regulator IC6104 to power the main microprocessor and other various circuits needed for standby operation.

Failures in the standby will usually cause a completely "dead" set. There will be no relay clicks heard and no timer LED flashing on the front panel. It is simply a matter of checking for input voltage at IC6104 and, if present, 5VDC at the output. If input voltage to IC6104 is not there, verify the oscillator circuit is running. As mentioned earlier, this oscillator is not dependent on feedback to run and does not require a start circuit. As long as B+ is present at T6003 primary and pin 5 of IC6001, the likely defective components are IC6001 or the protect circuit components consisting of D6005, D6006, C6015 and R6004.

FIGURE 8-2 - STANDBY SUPPLY

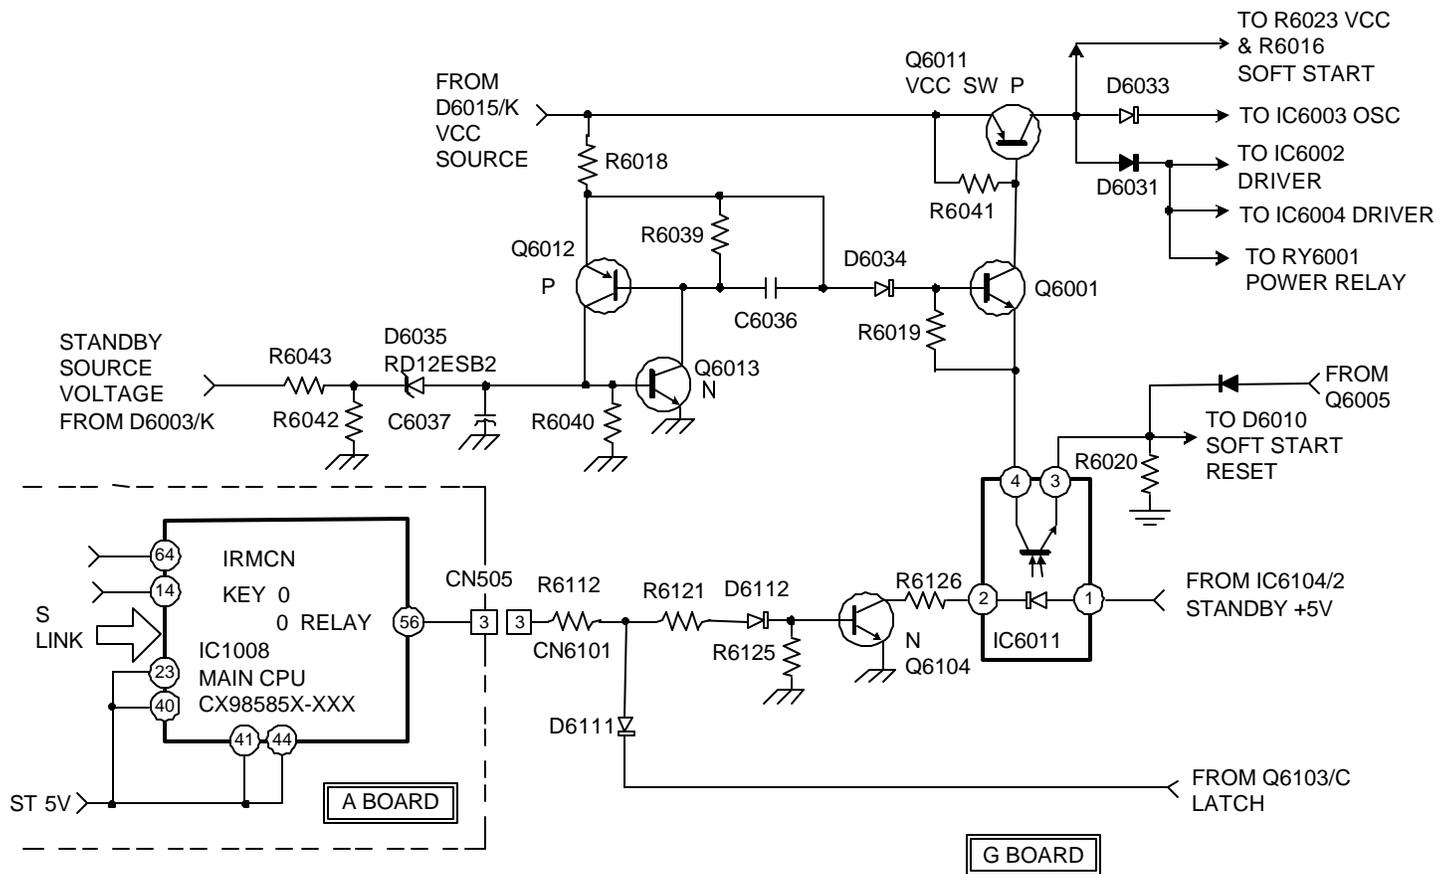
8.3TVP14 7/17/02

This circuit is responsible for supplying power to the main relay along with the main oscillator and power switching circuits. It is quite different from conventional designs used in previous models. In Figure 8-3, it is shown that rather than using the relay high command from the CPU to directly control a relay drive transistor, an optical-isolator, IC6011, is turned on by Q6104. A ground return will be provided to Q6001-E, turning on Q6011. This transistor will provide power to the above circuits, which includes direct power to the main relay, which is tied to ground. Notice the latch circuit consisting of Q6012 and Q6013. This is not the same latch circuit that would put the unit into conventional protect mode. It is only activated if the unregulated B+ for the standby supply rises above an acceptable level, which is monitored by the divider network R6042 and R6043 along with D6035. A variac with the capability to output 150AC was unable to trip this circuit so it is assumed that it is there to prevent accidental application of 220VAC to the unit.

FIGURE 8-3 - VCC SWITCH

No relay clicks heard: There should be two, distinct, rapid clicks heard. If none are heard, troubleshoot the circuit starting from the relay high command from the CPU through the VCC switch circuitry and even the main relay itself. Refer to Figure 8-3 to troubleshoot this circuit.

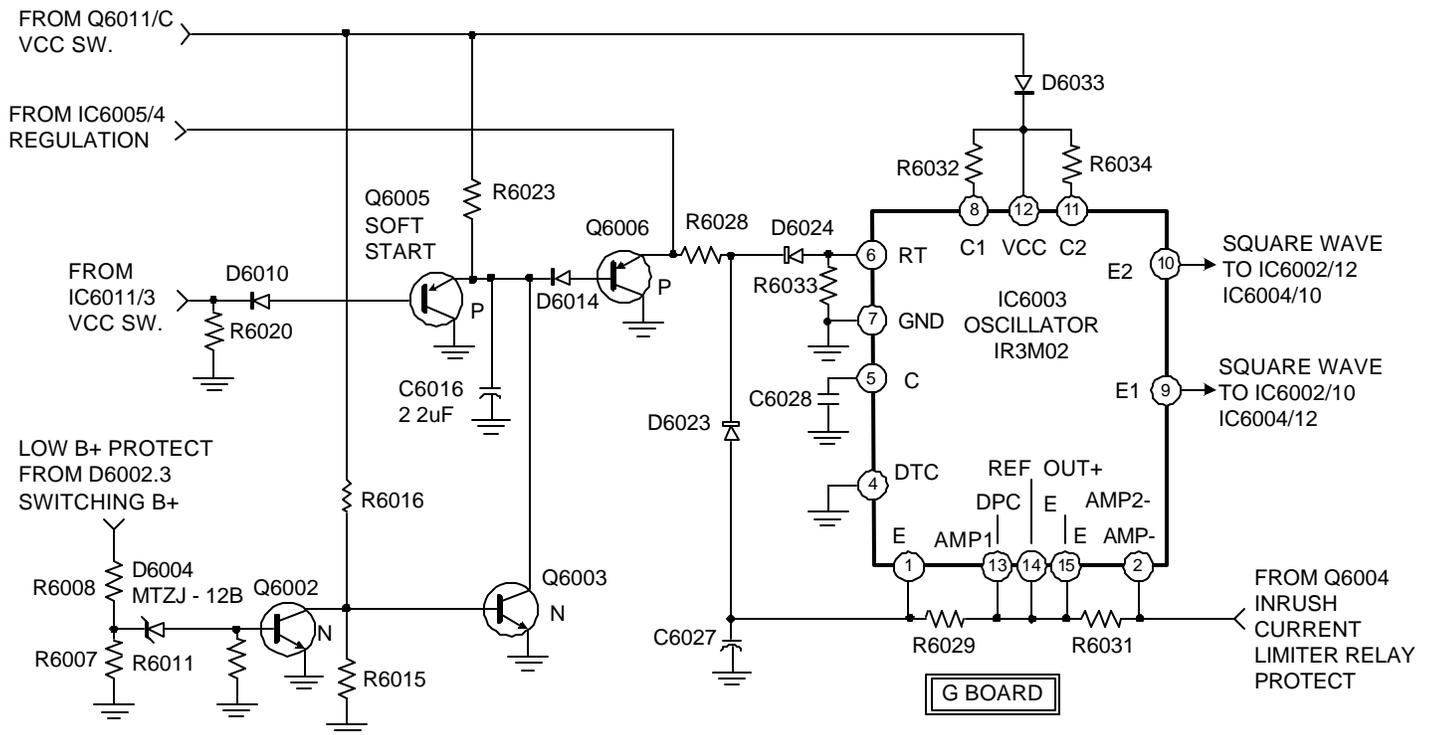
8.5TVP14 6/26/02

FIGURE 8-4 - OSCILLATOR & SOFT START
