**KDP-57XBR2**

# **Projection Television Troubleshooting**

**RA-3/3A, RA-4/4A, RA-5A, RA-6 Chassis**

**Course: TVP-14**

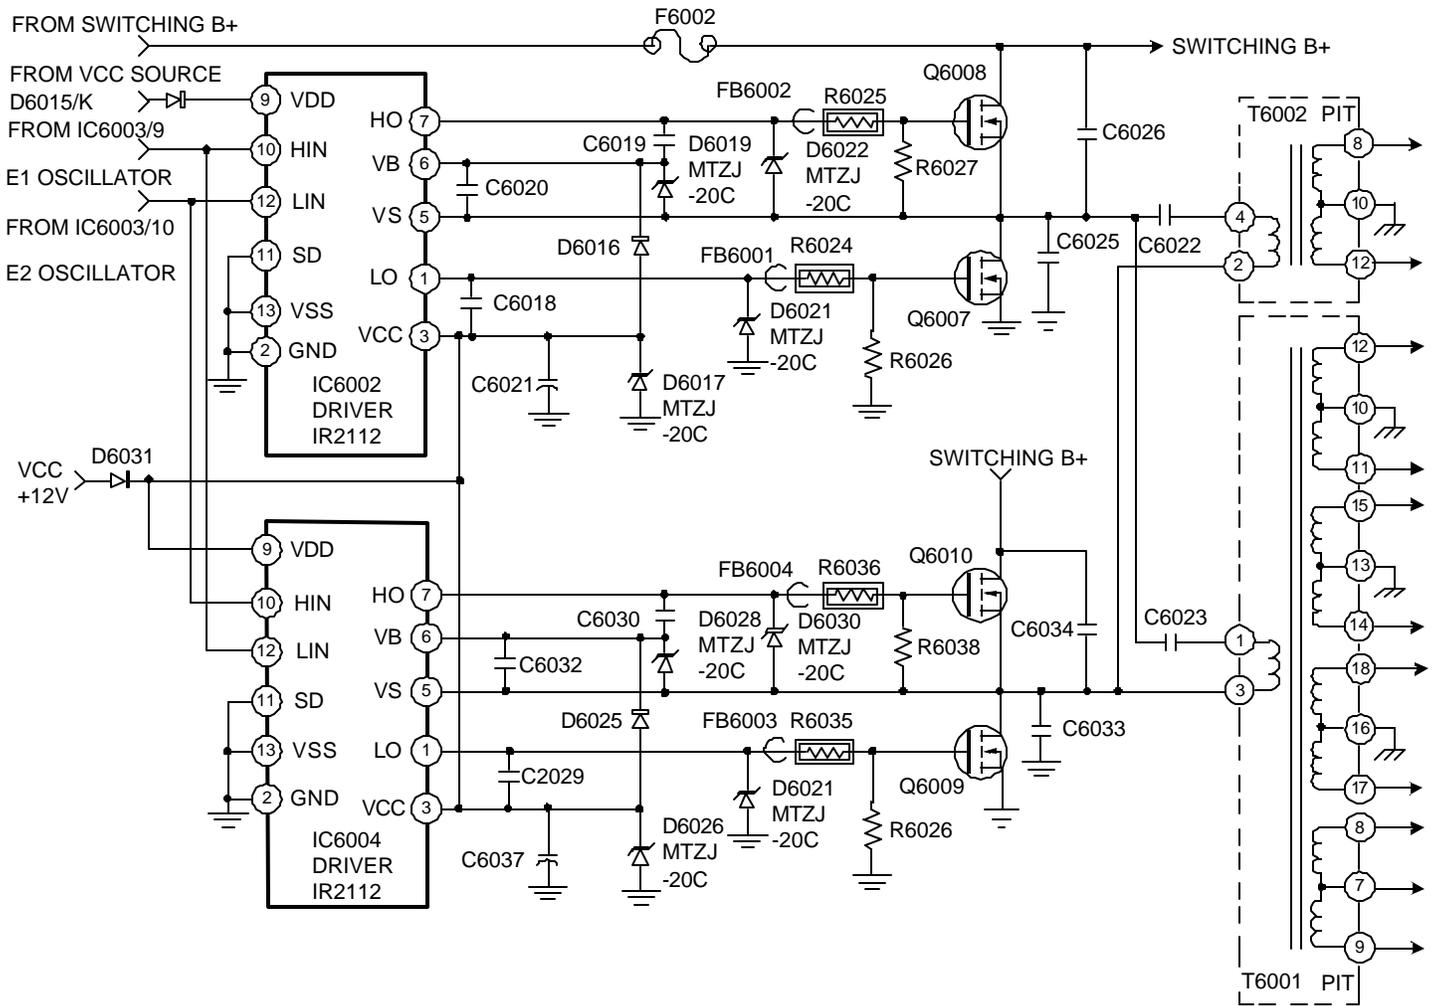
8.5TVP14 5/22/02

Referring to Figure 8-5, IC 6002 and 6004 receive the square waves from IC6003 and utilize them to drive the switching transistors Q6007, Q6008, Q6009 and Q6010. These transistors work in pairs to send current in both directions through the primaries of T6001 and T6002. As an example: When pin 7 of IC6002 goes high, pin 1 of IC6004 will also be high. Current will now flow from Q6008 through C6022 into the primary of T6002 and follow a parallel path to C6023 into T601 primary. The ground return path will be provided by Q6009. The process reverses with Q6010 and Q6007 working together to reverse current.

FIGURE 8-5 - CONVERTER

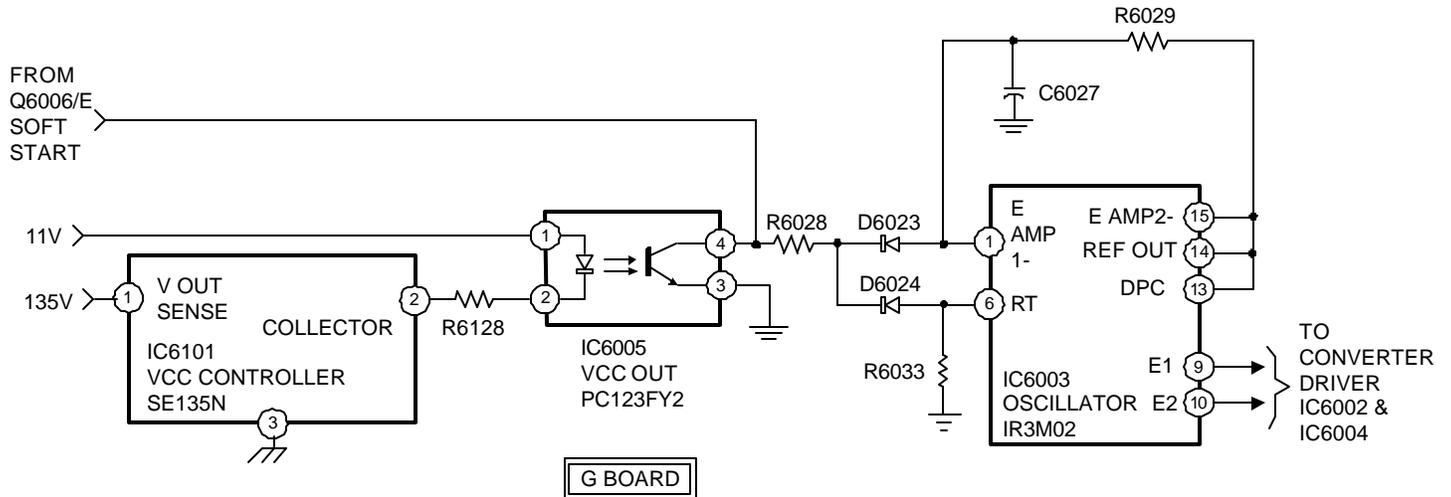
8.6TVP14 6/18/02

As illustrated in Figure 8-6, the regulator stage is quite simple in design. IC1601 monitors the 135V line. It acts as an inverter so any rise in the B+ will cause the output to go lower and vice-versa. Controlling the brightness of the LED inside the photo-optical coupler will vary the DC voltage at pin 1 and 6 of IC6003. The more the voltage is pulled down, the higher the frequency the oscillator will run.

FIGURE 8-6 - REGULATION

If shorting pin 2 of IC1601 does not stop the over-voltage problem, short pin 4 of IC6005. If the voltage now drops, replace IC6005. If it still does not drop, IC6003 or one of the input components may be open.

**Low B+:** Check the voltage at IC6005, pin 1 and 2. There should be at least .6VDC difference with pin 2 being the lowest. If there is, the optical isolator is being told to increase the frequency. If there is little or no voltage potential across pins 1 and 2, disconnect pin 4 of IC6005. Turn the unit on and it should go into over-voltage shutdown. If B+ is still low, check components at error input of IC6003 and if OK, replace the IC.

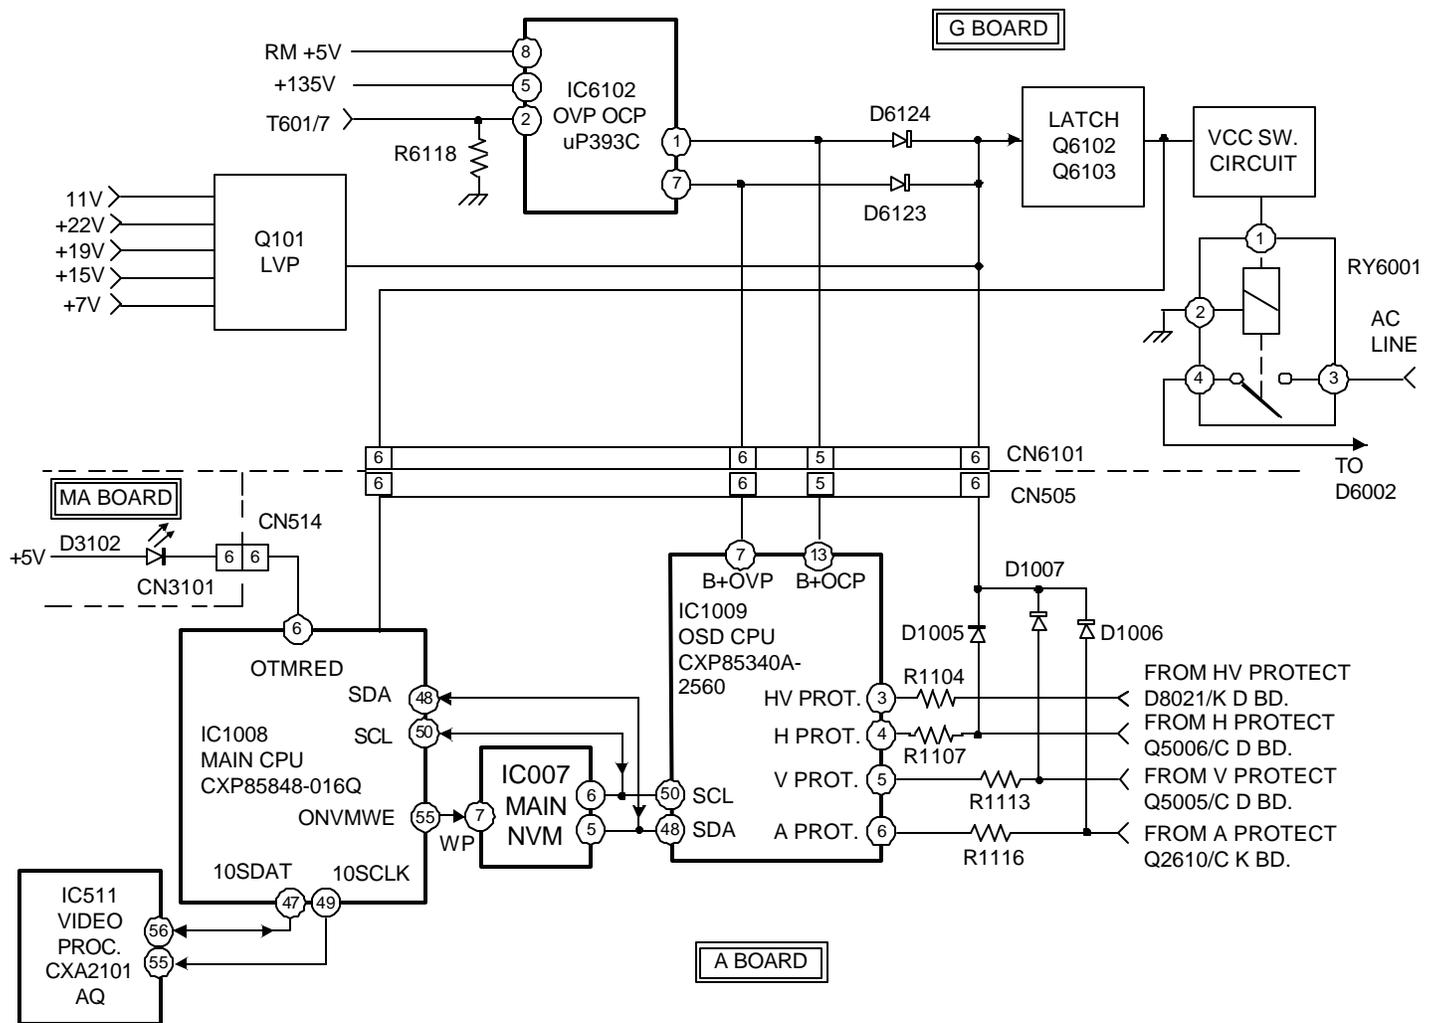
9.1TVP14 5/23/02

The block diagram shown in Figure 9-1 illustrates an overall view of the circuits that are monitored. Notice that all of the protect items that appear on the diagnostic screen are connected to IC109 along with routing to the relay latch transistors. If a problem develops on any of these lines, IC109 will communicate this information to the main CPU, IC1008 and the failure written to NVM along with the appropriate flash sequence of the timer LED.

FIGURE 9-1 - PROTECTION BLOCK

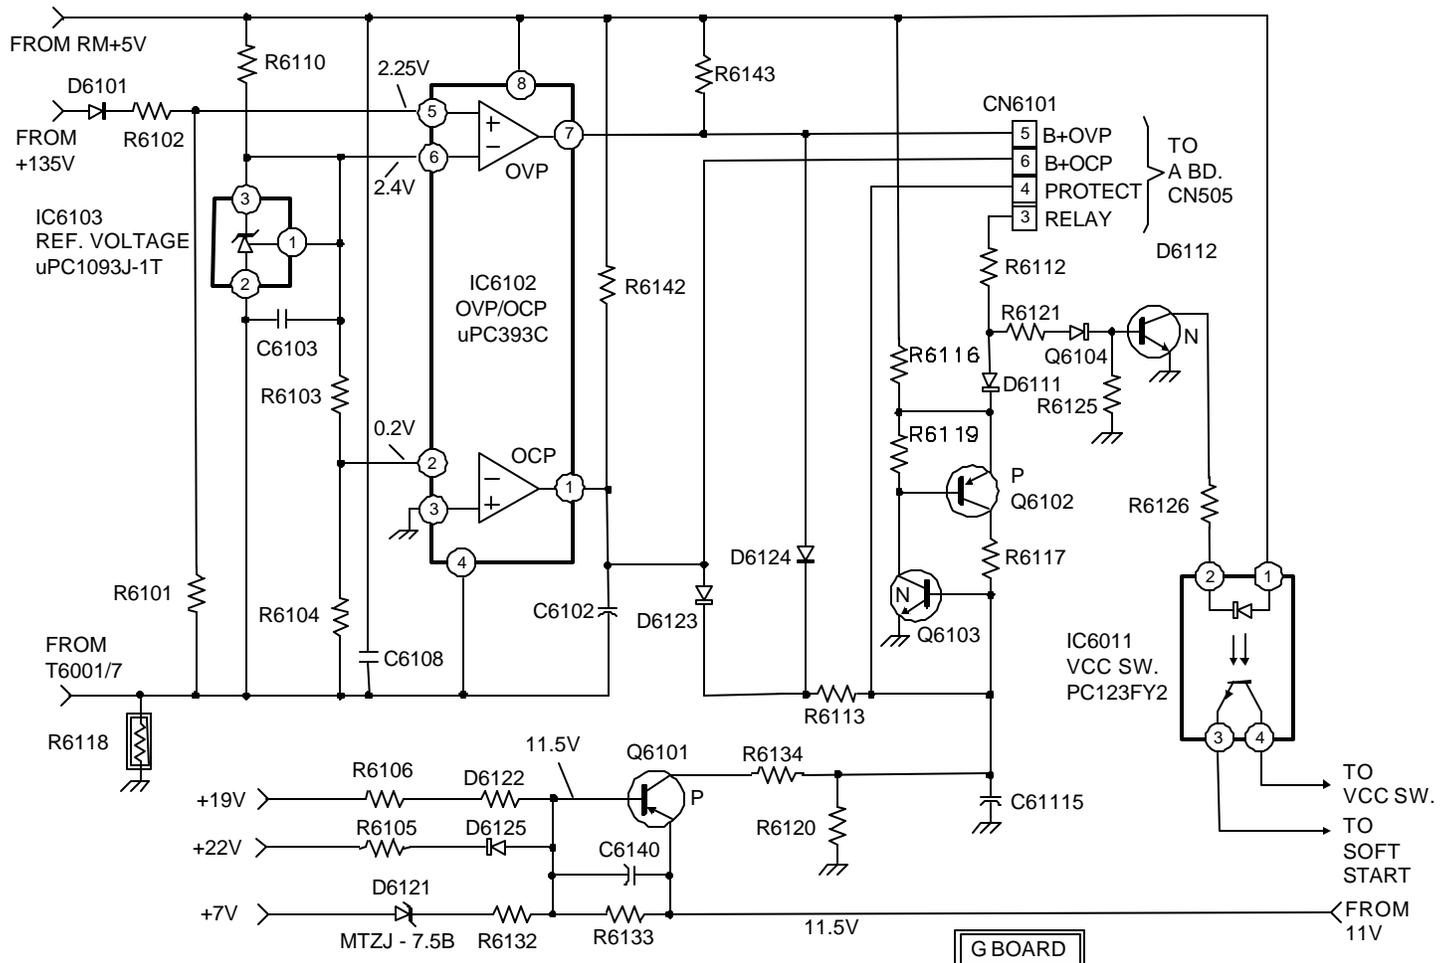
9.2TVP14 5/23/02

The other lines monitored are not detected by IC1009 and, therefore, will not be indicated by the self-diagnostics. Figure 9-2 provides a detailed view of these. This includes over-current (or loss of) the +19, +22 and +7 volt lines. The 11V is protected against over-voltage. The base of Q6101 is kept high by the 11V line through R6133. If the +19V or +22V drops below 11.5V, diodes D6122 and D6125 will forward bias, pulling Q6101 base down and turning it on. This will activate the relay latch circuit (Q6102 and Q6103). The same will occur if the +7V is lost by causing D6121 to fire. If the +11V line rises to 15.1V or more, D6121 will also participate by firing and holding the base of Q6101 steady while the emitter rises. This will also turn on Q6101 and the latch circuit.

Most protect circuits that monitor multiple lines are arranged in this manner. Troubleshooting consists of checking the voltages across the blocking diodes. Since they are normally reverse biased, the voltages across them will be greater than .6V. Even a DVM without peak hold can detect this. For example: If the +19V failed, the meter would read a maximum of 0.6V across D6122. Under normal conditions, approximately 8.5V would appear. By monitoring blocking diodes for 0.6V and zener diodes for their rated voltages, one can test each of these while turning the set on and quickly locate the source of the protection event.

FIGURE 9-2 - DC PROTECTION

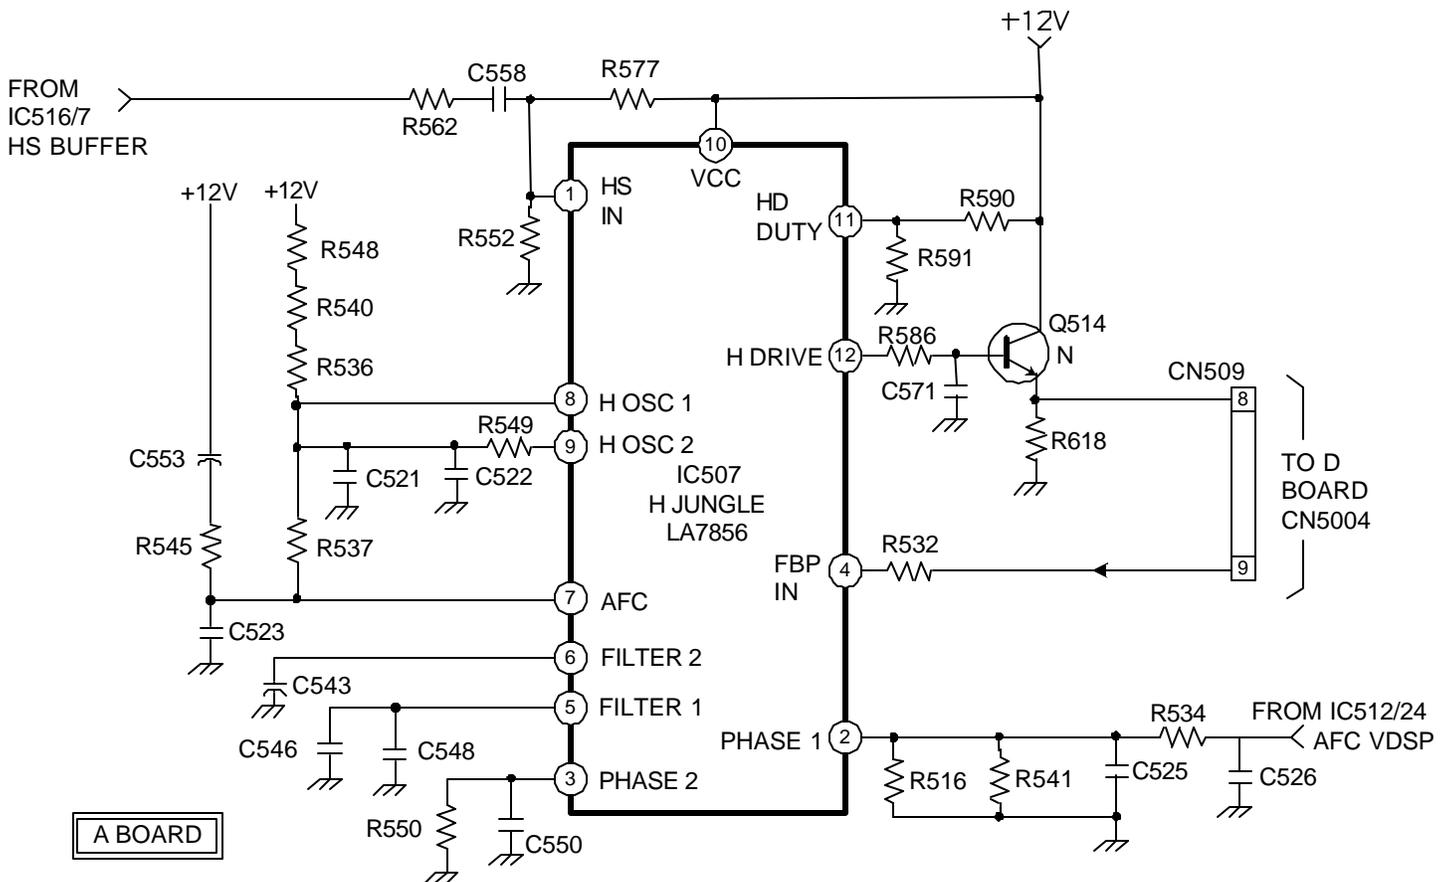
10.1TVP14 5/24/02

Figure 10-1 illustrates how horizontal scan is developed. IC507 is solely dedicated to this. Since the 480i signals received by the set are up-converted, IC511 will provide H sync at 31.5KHZ to pin 1. Capacitors C521 and C522 will provide the necessary tuning for the oscillator to free run at the correct frequency. Pin 4 will receive the H pulse for phase locking.

FIGURE 10-1 - HORIZONTAL JUNGLE

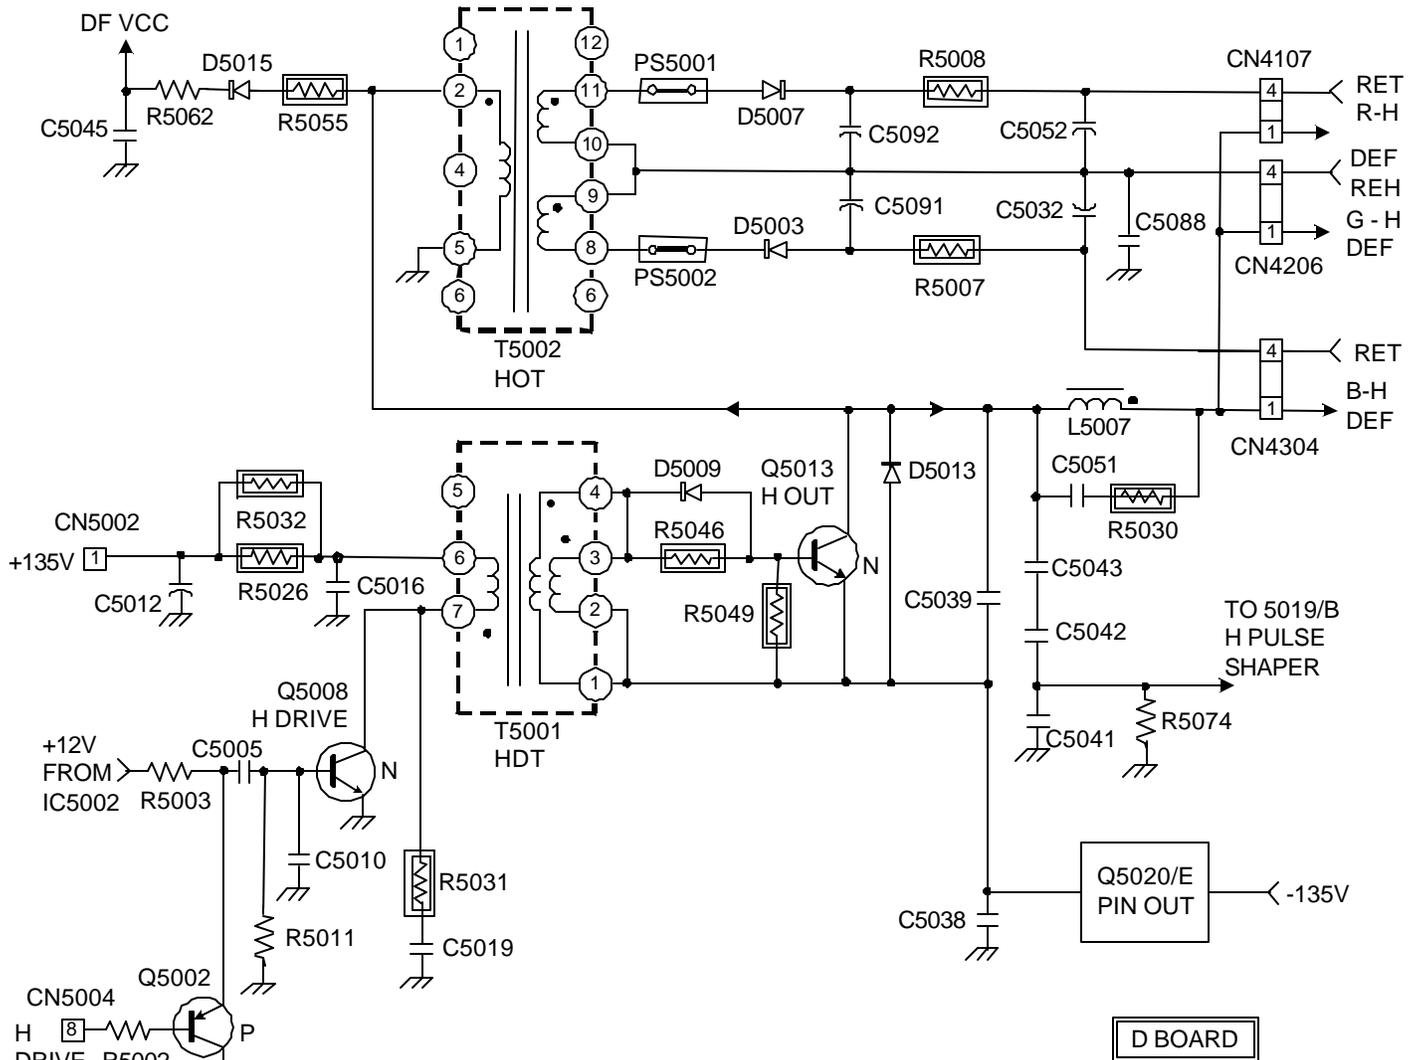
10.2TVP14 7/11/02

Figure 10-2 illustrates the output section of the horizontal deflection stage. Since no flyback transformer is utilized, pulses will be generated by the collapse of the field in the horizontal deflection yokes and T5002. This transformer will provide a boosted voltage for the dynamic focus correction circuit via R5055 and D5015. It also generates a positive and negative voltage source that will be applied to the red and blue CRTs. This will provide the necessary offset for centering since these tubes are not in the center of the optical path. Notice that the collector of Q5013 does not have a B+ source. A negative 135V source is applied at the emitter and this voltage will vary based on conduction of the pincushion output transistor, Q5020. Pincushion correction will be discussed later.

FIGURE 10-2 - H OUT

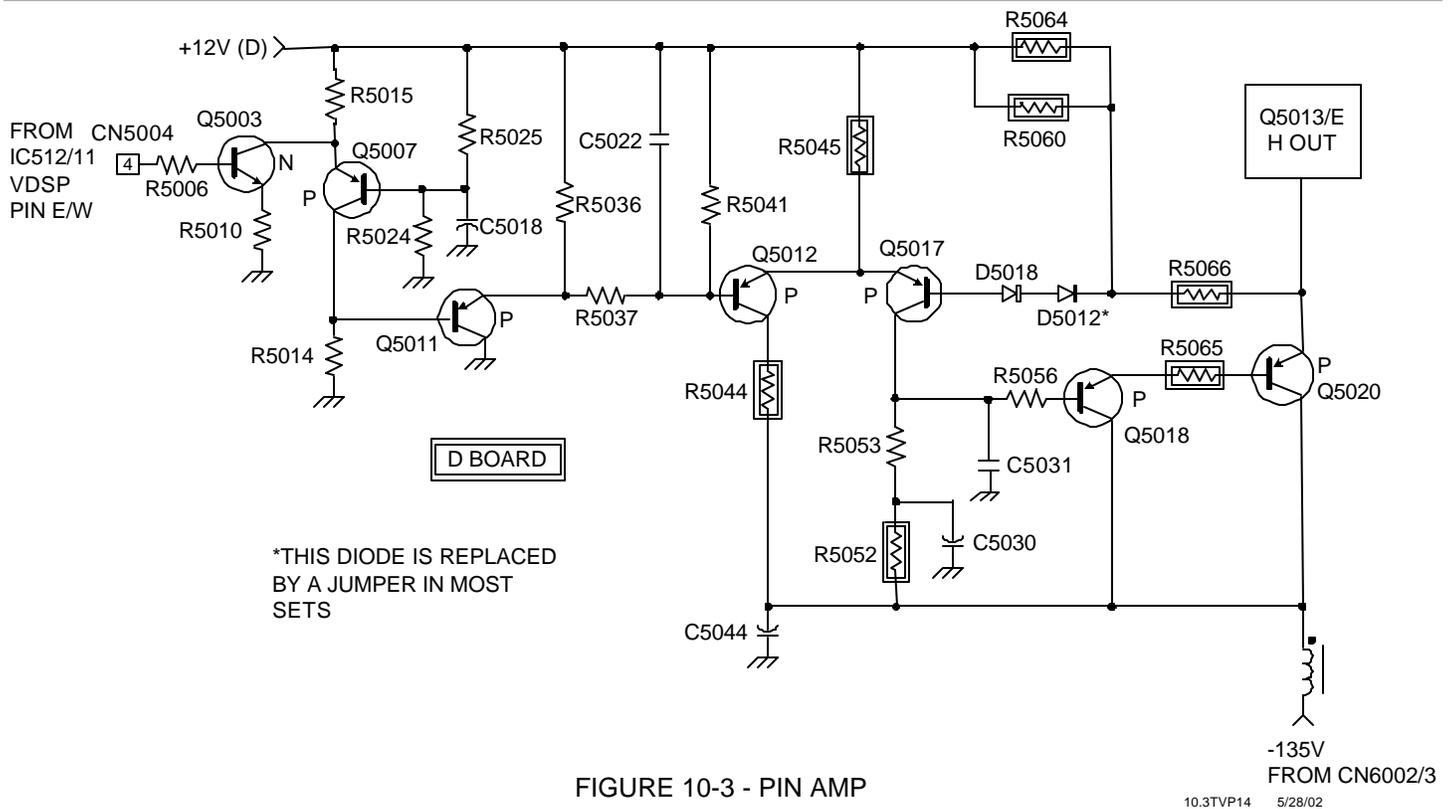
Failures in this pincushion circuit usually involve the shorting of the pin driver, Q5020. Due to the DC coupling, one or more of the other transistors down the line may be damaged. On numerous occasions, the technician will replace a shorted pin driver only to still have problems. There is an old audio amplifier troubleshooting method that works quite well for this situation.

Use your DVM and read across the B-E junctions of the transistors in the circuit. There are two things to look for: Zero volts or more than 0.6V. This will assist in locating any transistors that are biased on or have a shorted or open B-E junction. Voltage readings across the E-C junction are also useful in locating open/off or shorted/saturated transistors. Since none of these devices run at saturation, so any voltage readings at 0V or supply level indicate a problem. The object is to find a transistor that is fully on or off to determine if that transistor is defective or being switched on or off by the previous one.

FIGURE 10-3 - PIN AMP

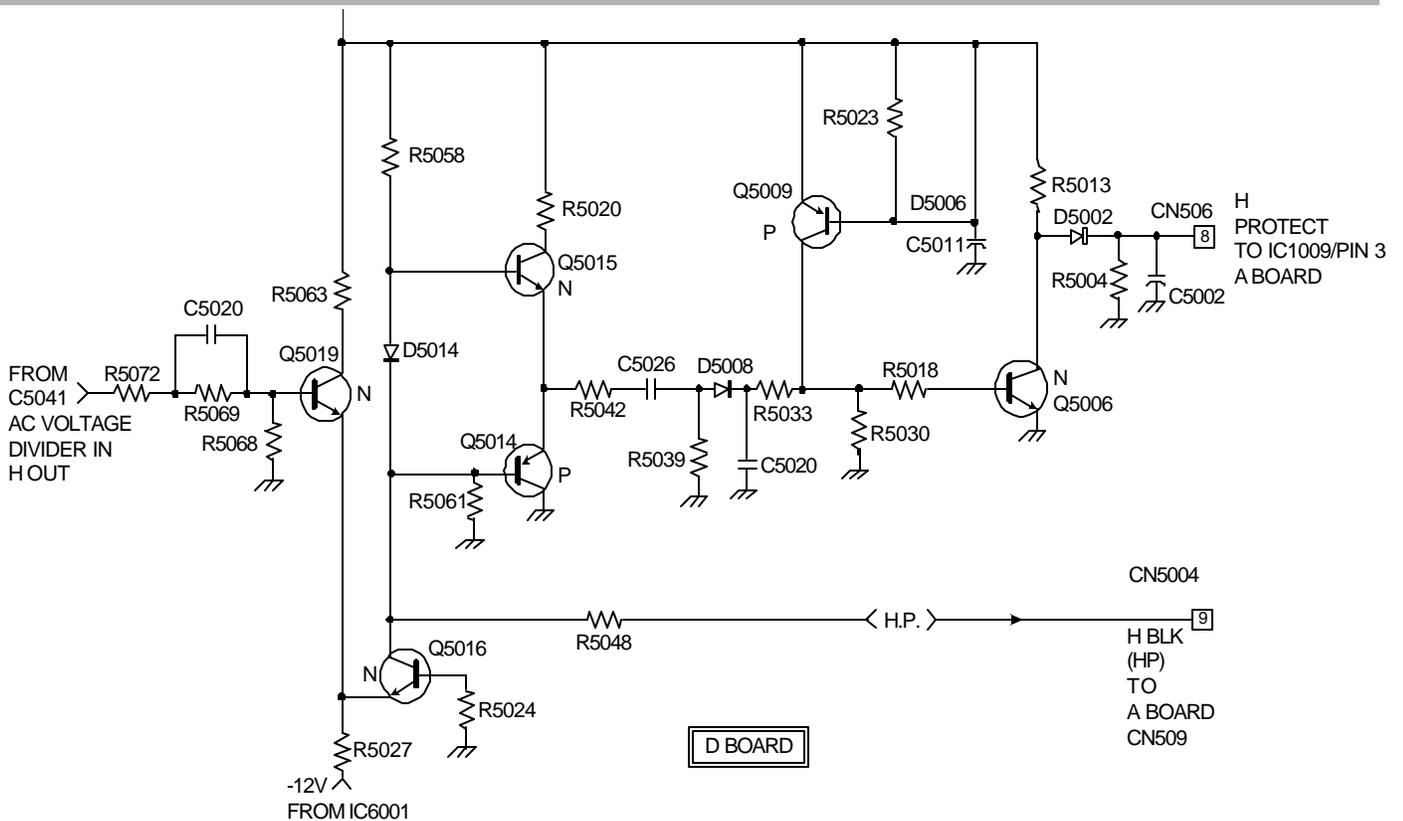
10.4TV/P14 7/17/02

Troubleshooting this circuit requires extreme care. Since the unit goes into immediate shutdown, there may be instances where the protect circuit will need to be overridden in order to dynamically troubleshoot it. **Always disconnect the C boards from the CRTs when working on this circuit!**

Since the circuit has a mute transistor to delay it from activating at turn on (Q5009), the first step is to scope Q5019-B for the momentary presence of horizontal pulses. This will verify if the horizontal deflection is working or not and will assist in determining a legitimate sweep failure or a malfunctioning protect circuit.

FIGURE 10-4 - H PROTECT / HP

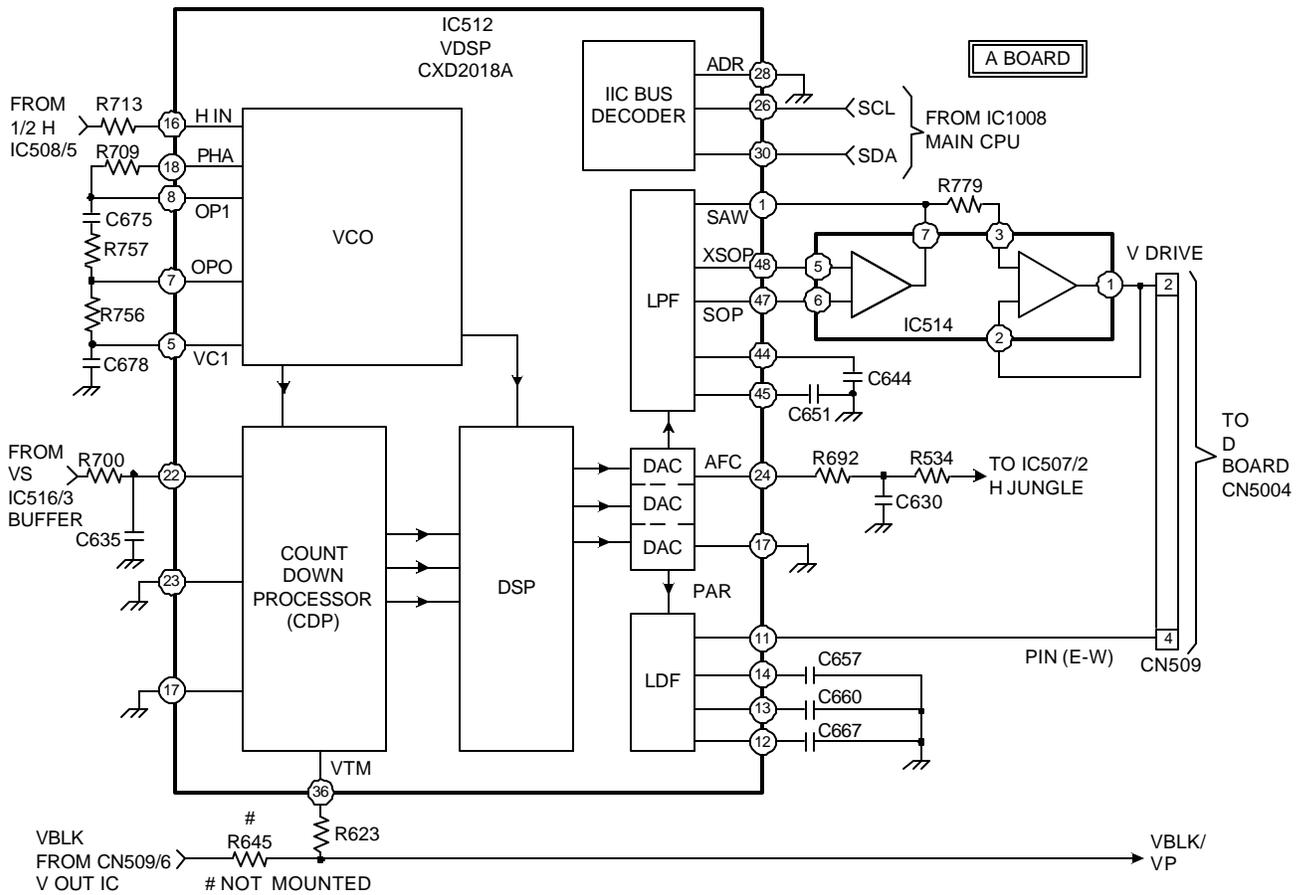
10.5TVP14 5/28/02

Figure 10-5 illustrates the vertical processing circuitry primarily created by VDSP IC512. Synchronization is achieved by VS entering pin 22. Notice the 1/2 H signal entering at pin 16. Since this unit generates internal, interlaced, horizontal scan, the vertical must be phase locked to start the odd and even scan in the proper location. The parabolic pincushion correction waveform exits pin 11 and vertical drive is output at pin 1 as a sawtooth.

FIGURE 10-5 - VDSP

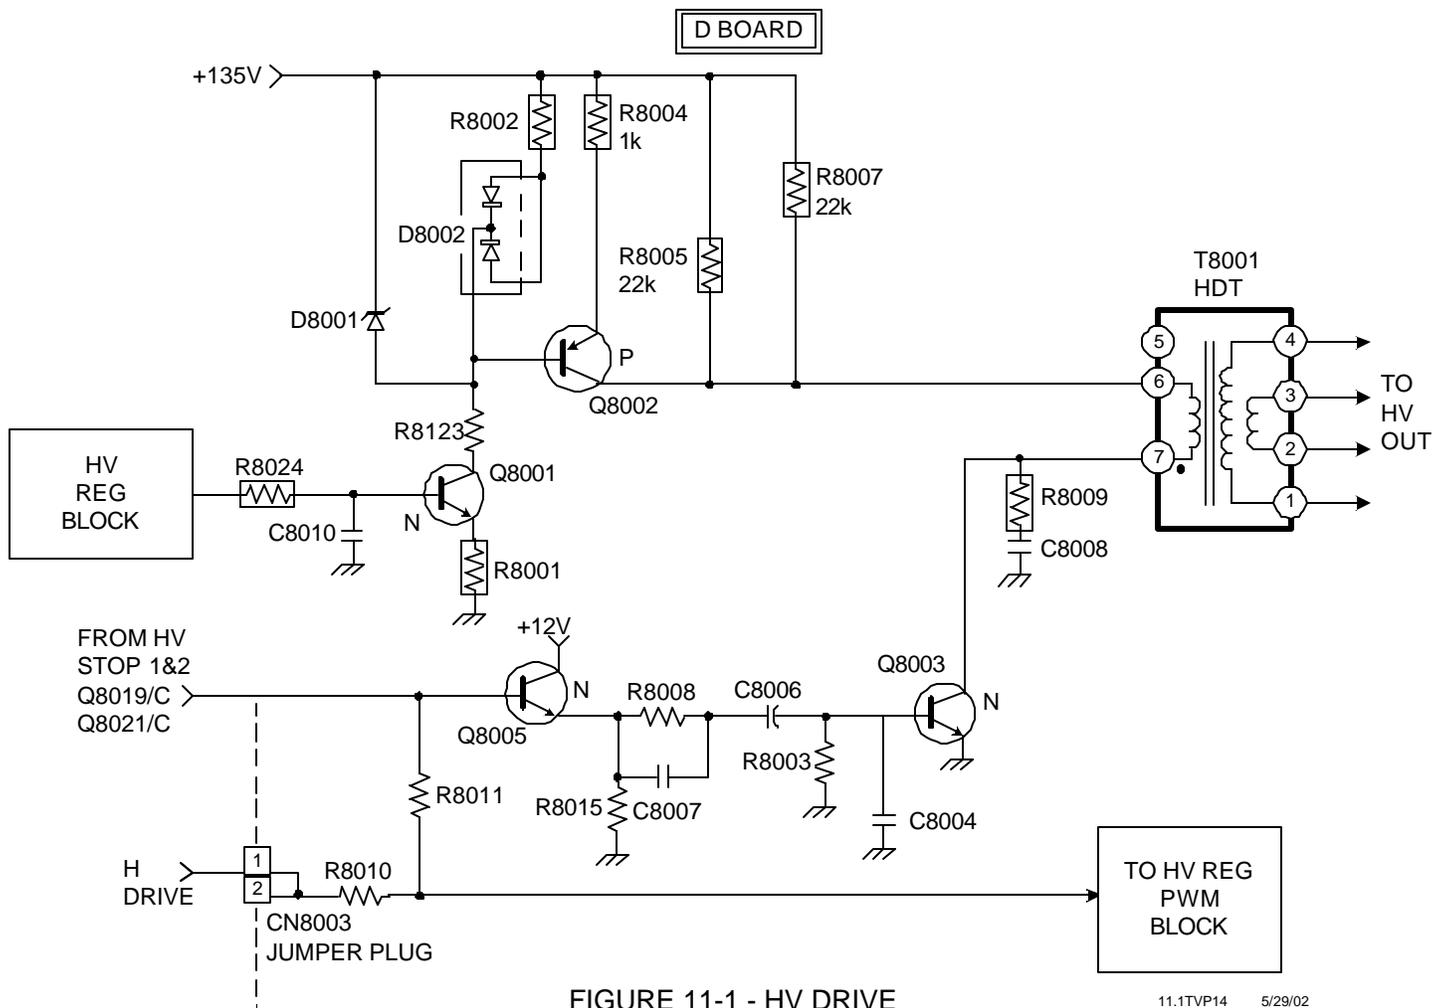
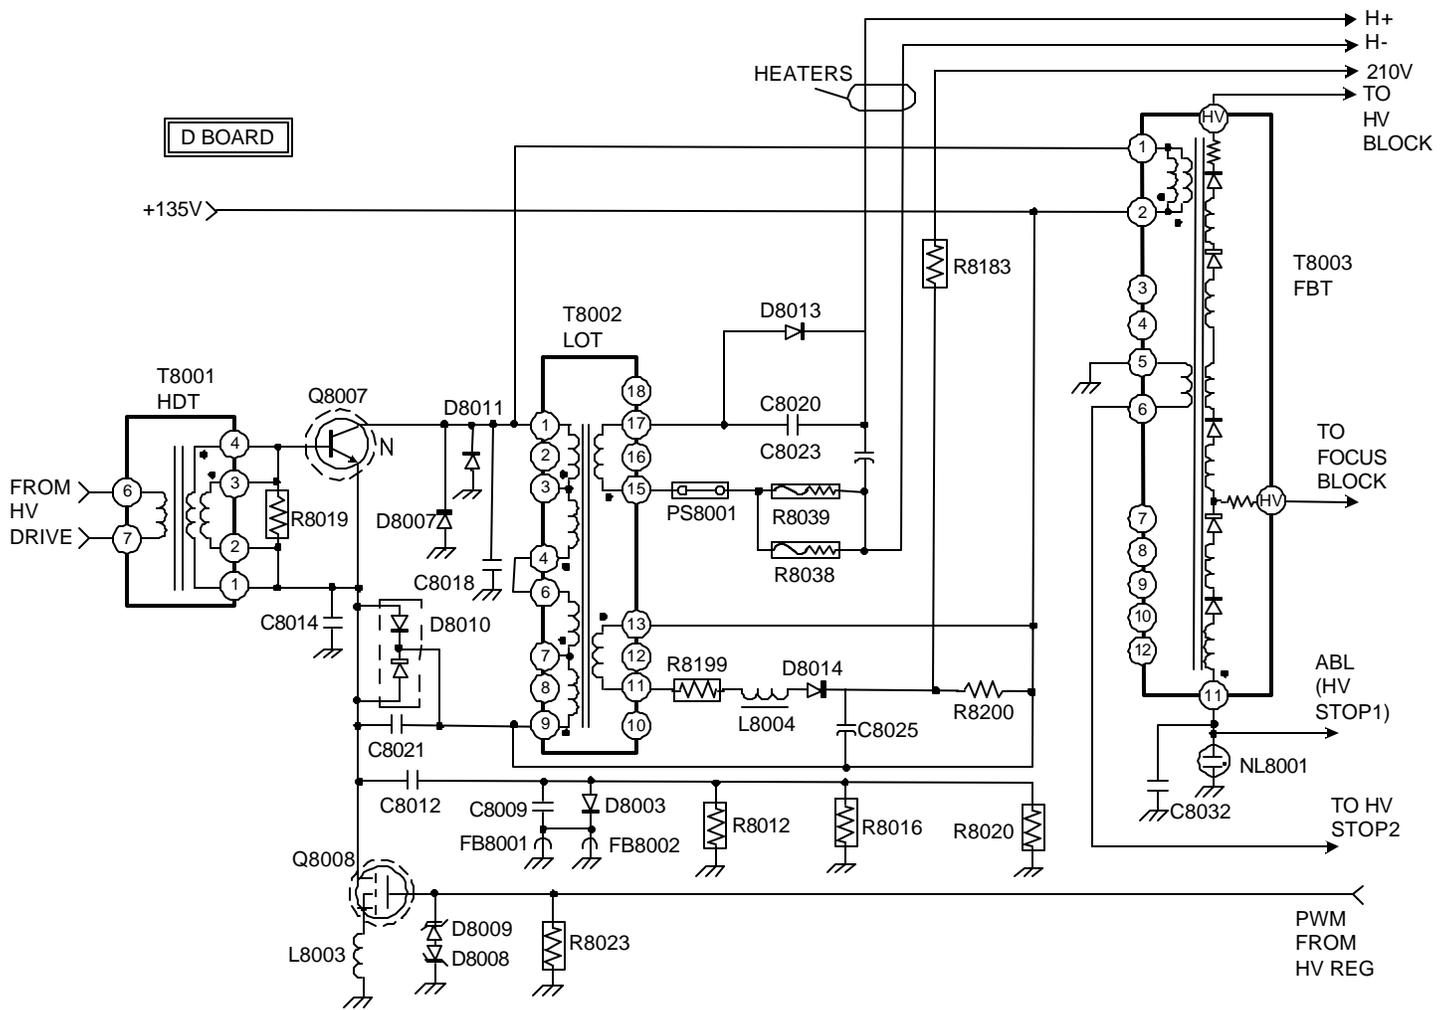
FIGURE 11-2 - HV OUT

Regulation is performed at the driver and output stages. Figure 11-1 illustrates the drive circuitry. The B+ supplying T8001 and Q8003 is varied by a PWM controlled regulation stage that controls Q8001 and Q8002, which functions as a variable resistor across R8005 and R8007.

Figure 11-2 shows how the circuit is similar to flyback circuits found in other units and shows the regulation of the output stage. The same PWM circuit that controlled the regulation in the drive section will control Q8008. This FET will vary the ground return for Q8007 emitter. The circuit drives the flyback transformer, T8003 and T8002 that will generate the heater and 200V bias voltage for the CRT cathodes. The regulation and protect circuits will be reviewed later in the troubleshooting of shutdown.

**Shorted HV Output Transistor:** As with all horizontal output transistors, care must be taken to avoid failure of the replacement part. Always check Q8008 since it can be easily damaged by the large current surge if Q8007 shorts. There is even the possibility that Q8008 was the cause of the failure. Disconnect or short the B-E junction of Q8002. This will run the driver stage at low level. The output regulator will now try to compensate so it must also be disabled. This can be done by unsoldering the gate of Q8008. The main relay can now be jumped and power can be applied with the variac while monitoring the pulse at Q8007 collector. This is a little extra work but it is better than losing the replacement part(s) and it is part of a critical safety circuit.

Place your scope probe somewhere near the HV output transistor or flyback. Most scope probes are not able to handle the direct spike level from the flyback so this is a safe method. Just turn up the gain a little on the scope and you will easily see the retrace pulse. Apply full AC power with the variac and watch for the pulse (assuming it appears) before the circuit shuts down. If the flyback is defective, one of two waveforms is likely to appear. The first may look like a sinusoidal waveform with a distinct ringing appearance. This definitely indicates flyback problems. The second phenomenon will be a retrace pulse with a second, lower level, "phantom" pulse. It is sometimes normal for this "phantom" pulse to appear at low B+ input levels but it should disappear quickly as you increase AC voltage. Monitor the AC current level closely while doing this. If the phantom pulse remains and current starts to rise, it is time to replace the flyback. One last situation that might occur is that the retrace pulse looks great but as you approach higher AC input, it begins to jitter and dance on the scope screen. The current will also be higher than normal. Back off the AC power quickly as this usually indicates excessive loading of secondary lines. In this unit, it can be loads on T8002. Measure for shorts on the filament and 200V line. The flyback T8003 only has two load circuits and they are the HV and focus blocks

The PWM will be output to Q8016 and provide control of the conduction of Q8008 at the emitter of HV output Q8007 (Figure 11-2). Since Q8008 is a FET, its gate has high impedance at its input. Q8015 will assist in pulling the signal down to maintain a uniform pulse shape. The signal will also be sent to HV drive stage to control the voltage at Q8003 (Figure 9-1).

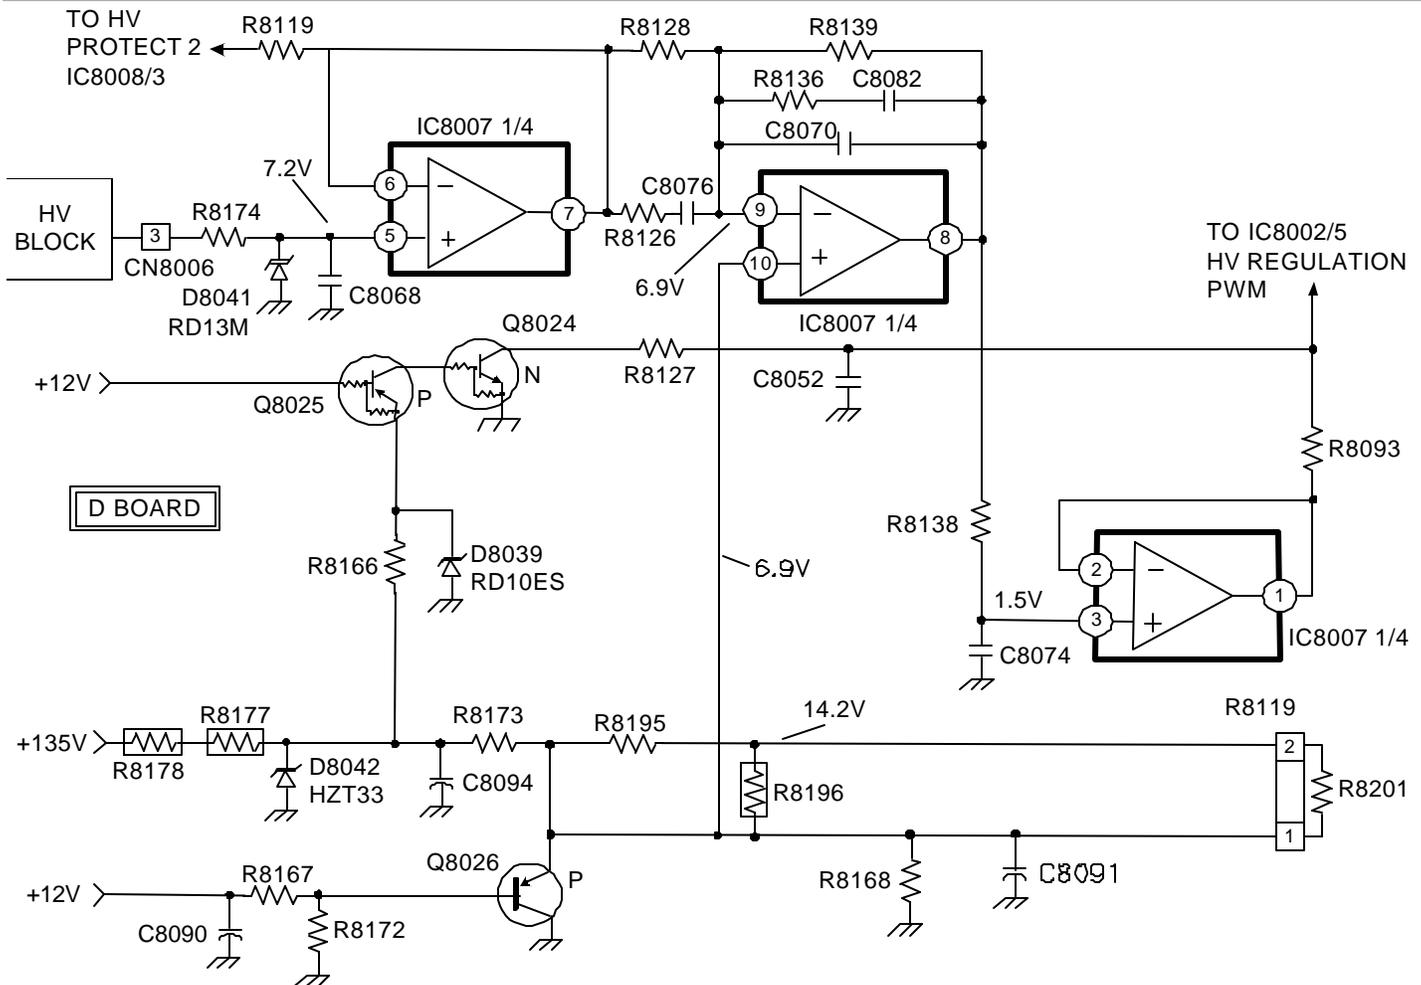
FIGURE 11-3 - HV REGULATION CONTROL

A PWM circuit is used to control high voltage at the driver and the output stage. It consists of two stages: One to sample the high voltage from the HV distribution block and the other to monitor this voltage and generate the appropriate PWM control.

**High Voltage Monitor Stage:** In Figure 11-3, this diagram illustrates how a sample of the HV level is taken from the HV distribution block and applied to pin 5 of IC8007, a buffer, and output to pin 9 where the voltage is compared to a 7VDC source divided down from the 135V B+. It is once again buffered and sent out by pin 1 to the PWM comparator. The nominal voltage at this point is 1.5VDC. This is a good monitoring point for high voltage troubleshooting. The voltage will react inversely to the actual high voltage in the HV block. By monitoring IC8007/pin14, the HV sample feedback will indicate if the excessive high voltage is originating at this point. If the voltage reads lower than 1.5VDC during a HV protect, the HV block and the paths routing through IC8007 are OK since they are sending correct feedback. The regulator output stage shown in Figure 11-4 may be at fault. Shorted or open filters may be present at HV output Q80087. If the voltage is higher than 1.5VDC, the HV block or IC8007 is at fault.

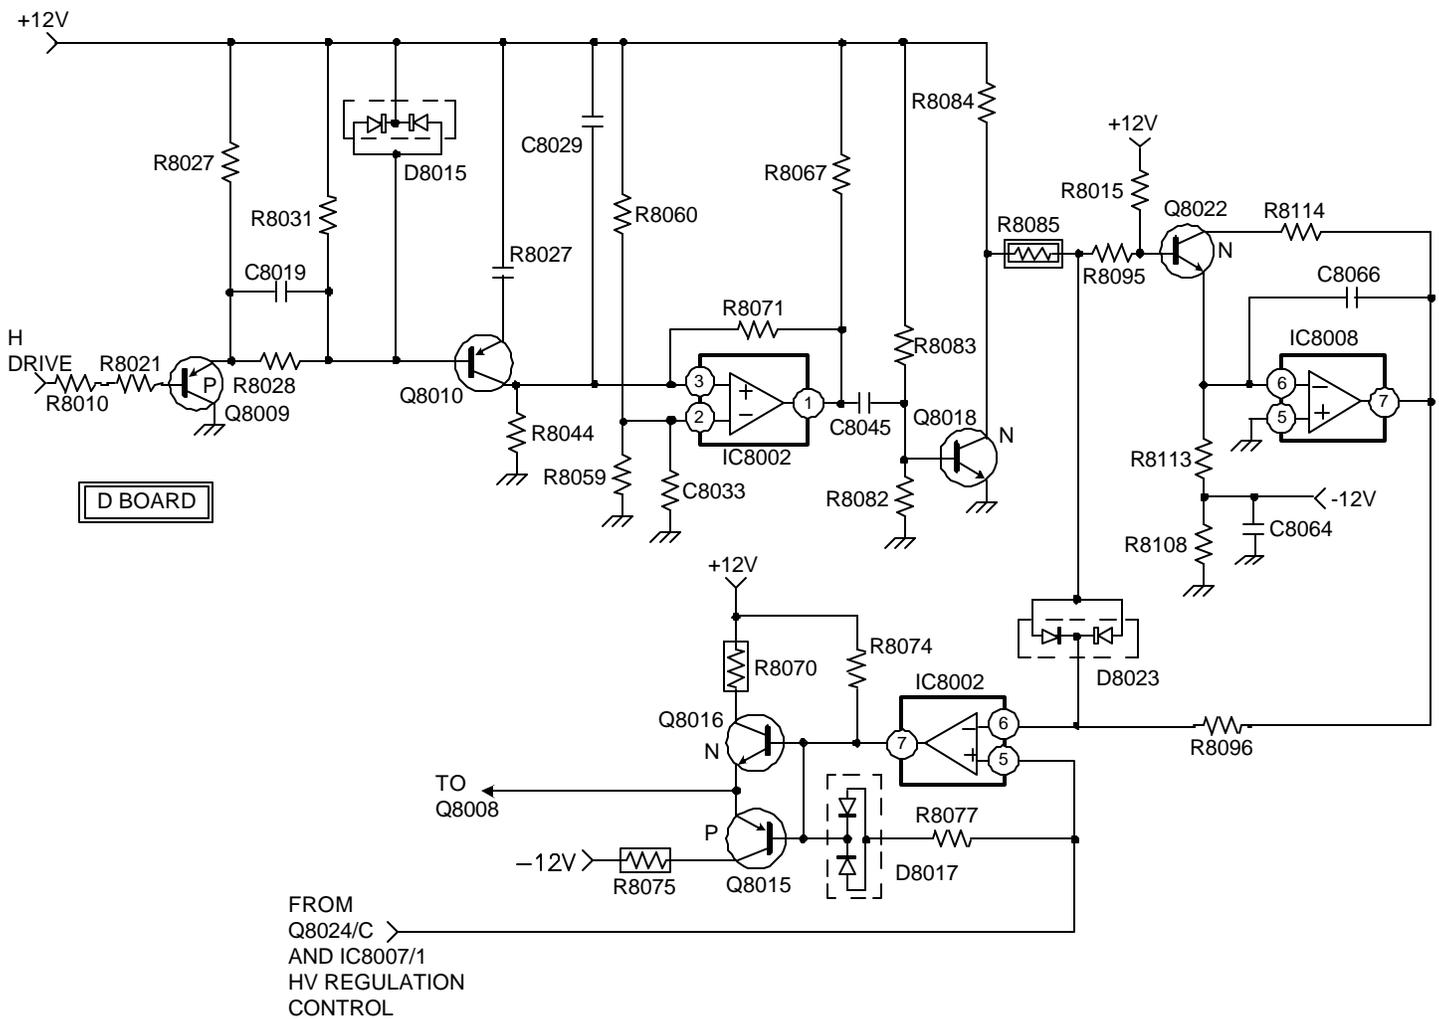
FIGURE 11-4 - HV REGULATION PWM

**PWM Stage:** Figure 11-4 illustrates the second half of the HV regulator. There are two must-haves for a PWM circuit to function: The first is a sample of the voltage to be regulated, and a sawtooth or triangular shaped waveform. The horizontal pulse is utilized to provide the stable timing of the sawtooth signal applied at pin 6 of IC8002. The pulse will be amplified and shaped by peaking and integrators located in the upper half of the diagram. Pin 5 of IC8002 will receive a sample representing high voltage level from the circuit previously described in Figure 11-3. Since the sawtooth signal is applied to the inverting input of IC8002/pin6, any rise of the DC voltage at the non-inverting input at pin 5 will cause the comparator to output a high only when the level of the sawtooth is greater than the DC voltage input. Since the sawtooth enters the inverting input, the positive duration of the pulse is increased and the HV regulator driver, Q8008, will be turned on for a longer period.

This pulse can be used to control the on time of an amplifier (such as in this case), or filtered to provide a DC correction voltage. This is the essence of how all PWM regulators function. An incorrect DC monitor voltage or incorrect level, shape and frequency of the sawtooth reference will generate erroneous PWM timing pulses. Since the reference signal is generated from the H pulse, frequency deviations are unlikely in this circuit.

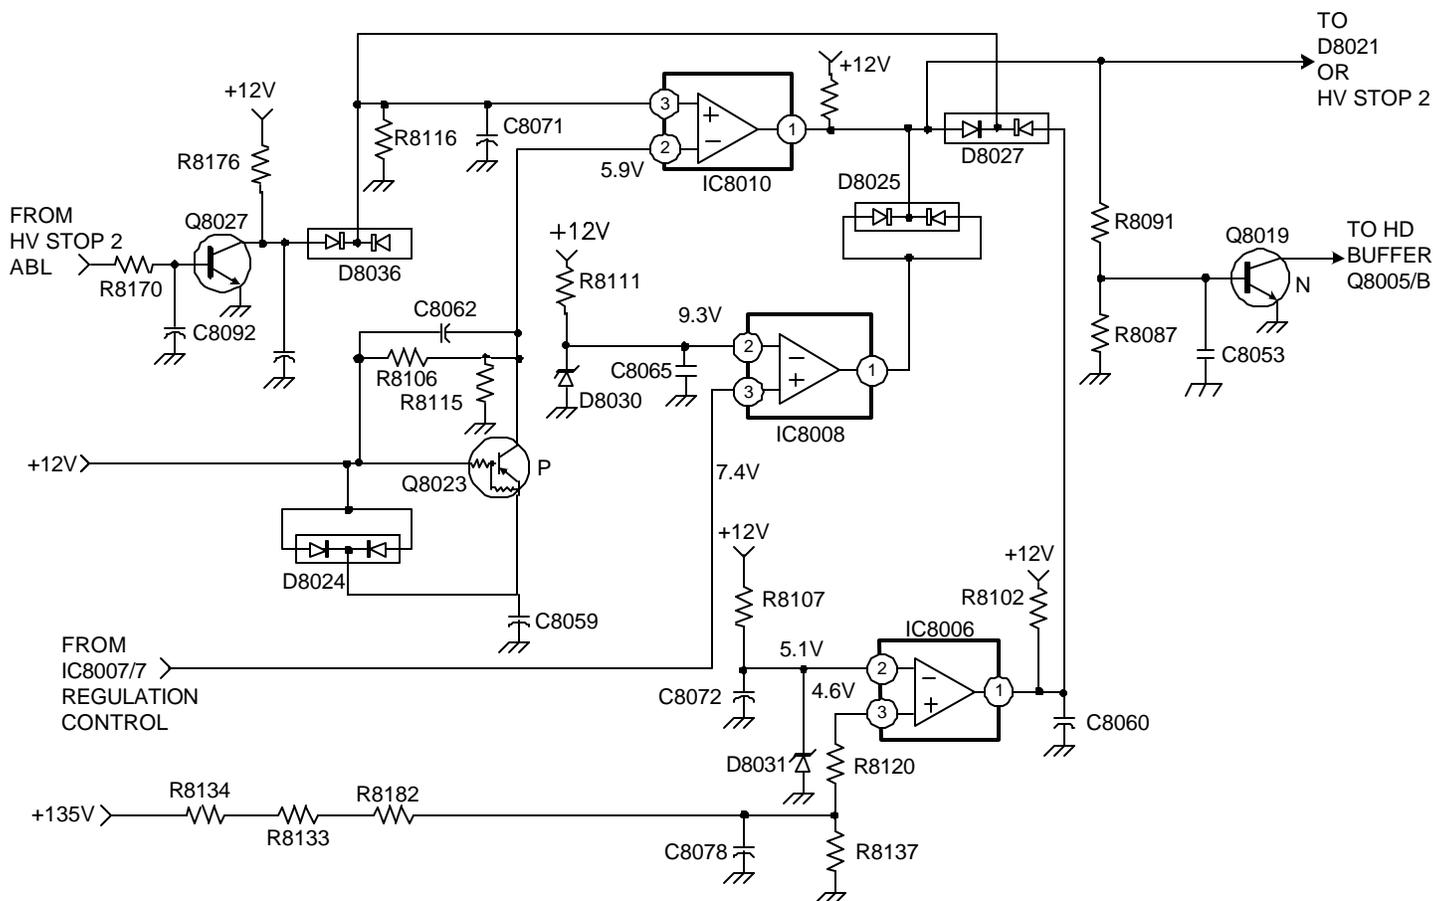
FIGURE 11-5 - HV STOP 1

**HV Stop 1:** Figure 11-5 contains the paths for the first set of protection components. HV level is monitored from the HV block by pin 3 of IC8008. This is compared to a reference of 9.3VDC at pin 2. If the high voltage rises above acceptable levels (34KV), pin 3 will exceed the reference. Pin 1 will go high. The H pulse driving the HV circuit will be grounded by Q8019 and the high signal will sent to OSD CPU IC1009 to flash the timer LED in sequences of seven.

Flyback transformer current is monitored by applying the ABL voltage to Q8027. Under normal conditions, ABL is a positive voltage between 2VDC and 6VDC. If the current rises to an unacceptable level, the ABL voltage will go lower. Once it drops below .6V, Q8027 will turn off, sending a high to pin 3 of IC8010. The H pulse will be cut off and IC1009 will respond the same way as the over-voltage condition described above.
