**KDP-57XBR2**

# **Projection Television Troubleshooting**

**RA-3/3A, RA-4/4A, RA-5A, RA-6 Chassis**

**Course: TVP-14**

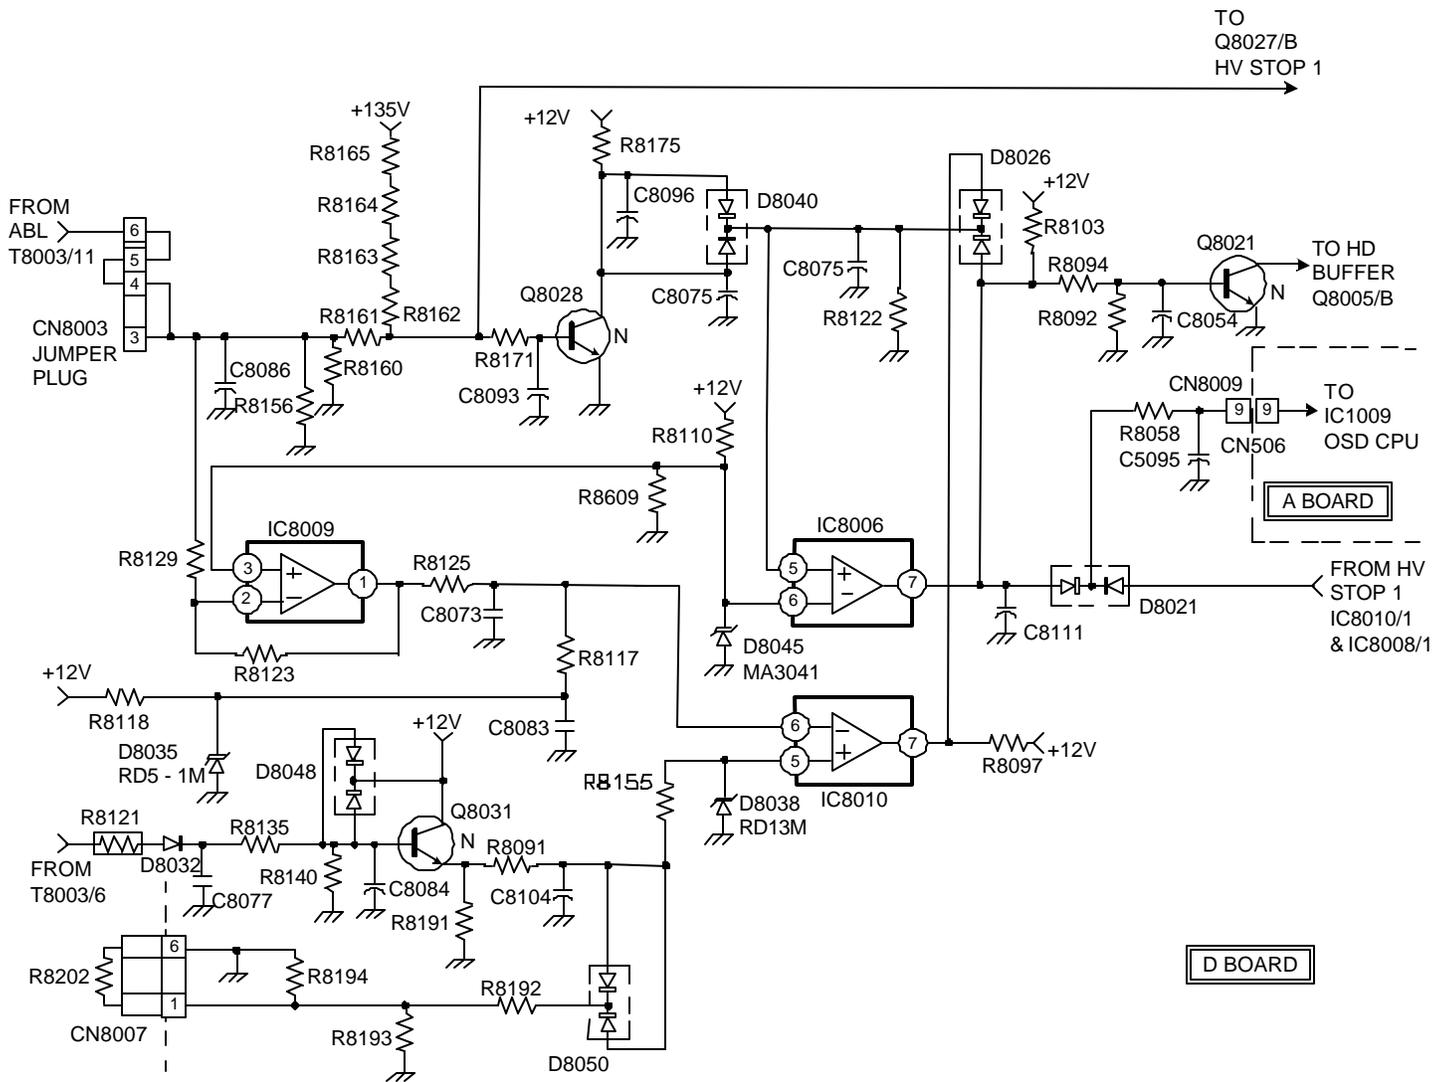
FIGURE 11-6 - HV STOP 2

HV Stop 2: Referring to Figure 11-6, the second HV protect circuit is shown. It functions in a similar manner as HV stop 1 with a few differences. Q8031 monitors voltage from the flyback transformer rather than the HV block assembly. Pin 5 of IC8010 will receive this signal and, instead of comparing it to a fixed reference, the ABL voltage is used. The reason behind this design is to shut down the high voltage quickly if it is rising and flyback current is simultaneously increasing. This severe condition can damage multiple components. The ABL voltage at pin 6 will drop, while the HV sample at pin 5 increases. Q8028 will monitor flyback current in the same manner as HV stop 1.

**Troubleshooting Tips:** Since there are two sets of protect circuits, isolating which one is activating is the first step. This is easily accomplished by monitoring either anode of D8021 in Figure 11-6 to determine which circuit is sending the high signal. This may only be useful if a problem exists within one of the devices in either protect circuit. A legitimate high voltage problem may trigger both protect circuits. If high voltage and current levels have been absolutely verified to be within specifications, this is the only time when it is safe to defeat these circuits for troubleshooting purposes in order to locate the component causing the false shutdown.

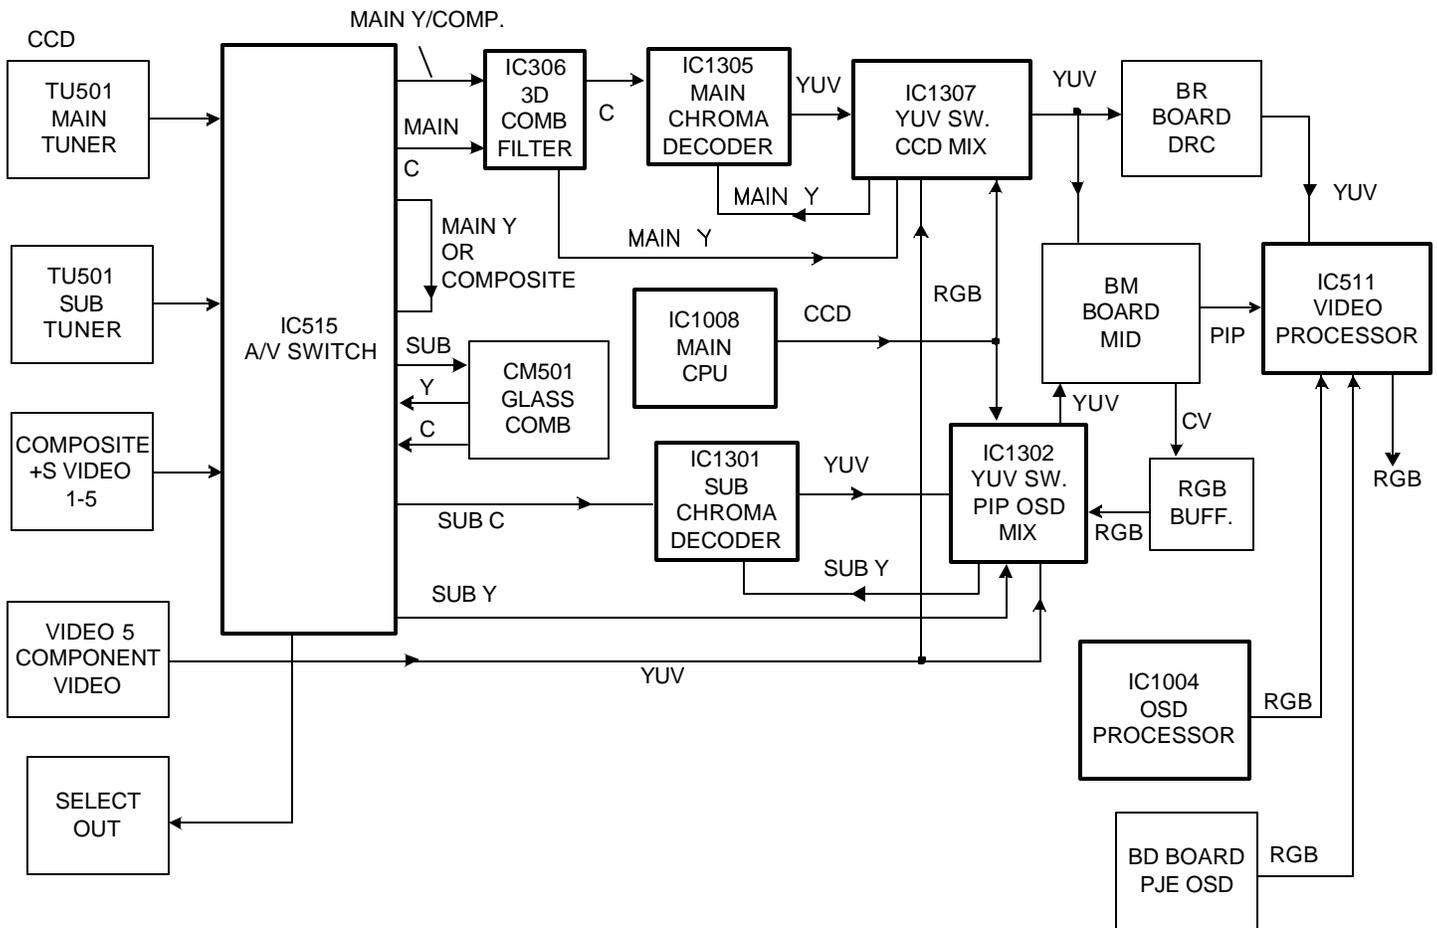
FIGURE 12-1 - VIDEO PATH BLOCK

Figure 12-1 will be the main diagram to be used for isolating video problems. It provides a great overall view of the key video processing circuits and the different paths the various inputs and features will follow. The ability of this chassis to accept component video allows the customer to take advantage of the higher chrominance resolution capabilities of this format. It also provides a great troubleshooting path for bypassing most of the video circuitry.

Referring to Figure 12-1, it can be seen that A/V switch, IC515, controls all of the video selection except for component sources that can be connected to the video 5 input. Any signal that is not a component format will have the possibility of traveling either one of two paths: The main or the sub. All non-component video for main viewing will route through the A/D converter, IC1309 (not shown on this diagram) and into the 3D comb filter, IC1306. Even S video sources will be routed here. The 3D comb filter contains noise reduction circuitry for the luminance signal and this will be done for S video sources. Composite signals will have chrominance separated from the luminance. This is all performed in a digital format and then D/A converted within IC1306 to output separated luminance and chrominance.

The sub video path will be processed along a different path. A conventional comb filter is used and chrominance will be decoded by IC1301. The sub component signal now enters a YUV switch, IC1302. This IC performs several functions. It allows the insertion of closed caption information, main CPU OSD, and provides a point to route a component video source to the MID™ processor.

IC1004 supplies on screen graphics such as user menu and input/channel information. The BD board (auto registration) supplies RGB information since it generates its own menu during convergence alignment along with dot and crosshatch patterns.

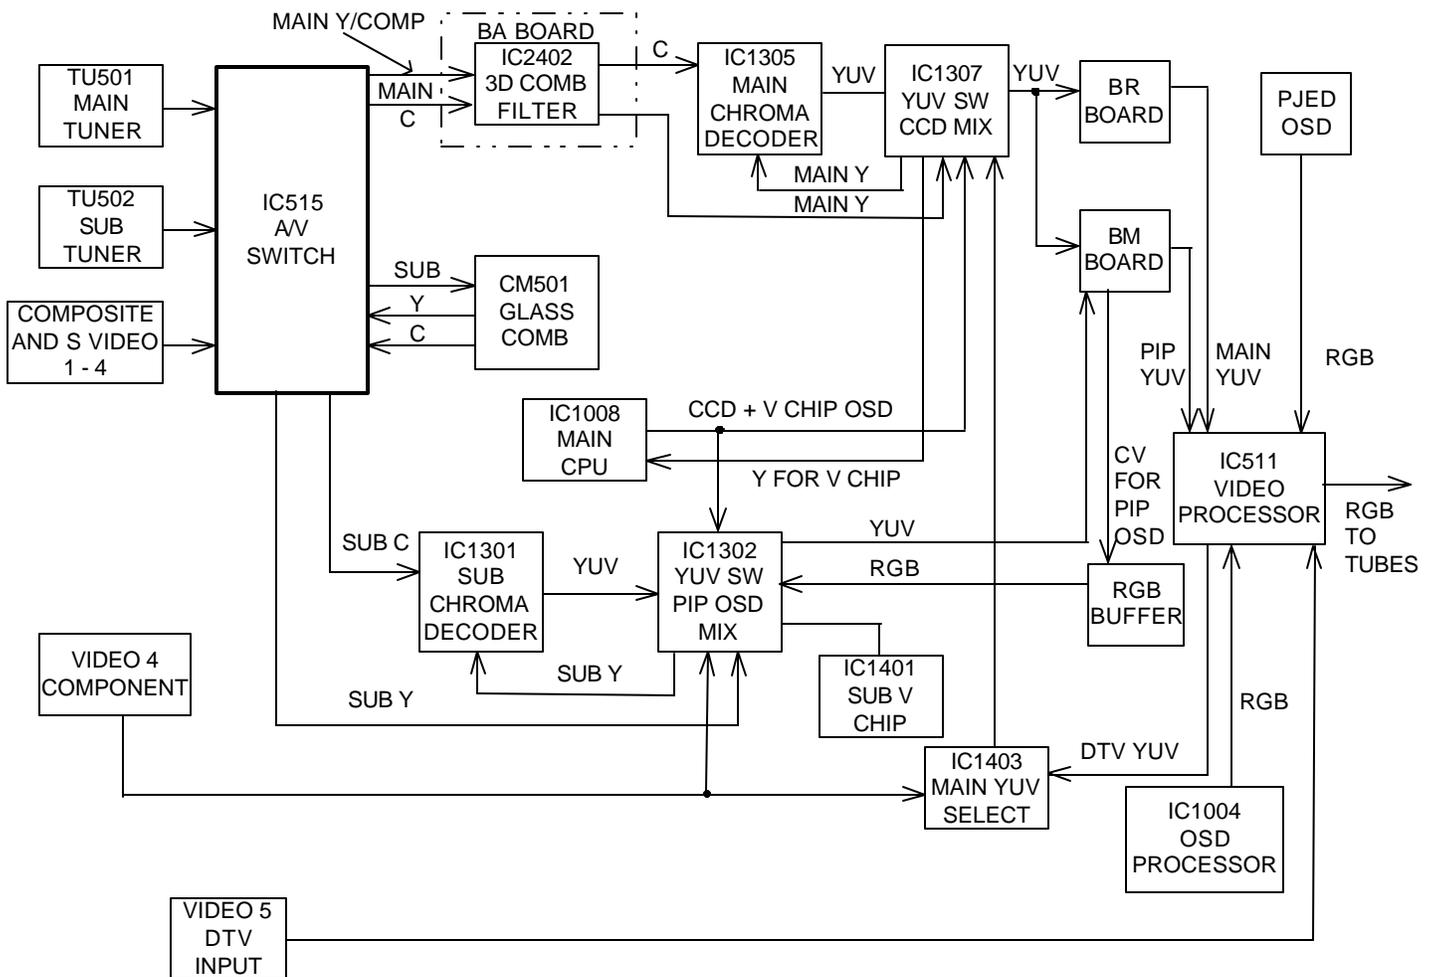
FIGURE 14-1 - RA-4A VIDEO PATH BLOCK

As illustrated in Figure 14-1, many of the same processes are performed to the incoming video signals. All composite and S video sources are routed through the 3D comb filter and chroma decoder for the main video signal. The sub video will pass through a glass comb filter and sub decoder. This will provide the necessary sources for P & P processing for the multi image driver. The main video source will continue on to the BR board where the DRC circuitry will perform line doubling for 960i display.

Video 4 input allows non-HD component video to bypass the decoder and comb filter for line doubling by the DRC. Although the video 5 input illustrated in Figure 14-1 appears to head directly to the video processor IC511, non-1080i signals are still sent through the DRC™ by switching the signal out of IC511 to the DRC™ and back by detecting the sync frequency of the source. This is illustrated in Figure 14-2. This allows for direct processing of 1080i sources by the video processor. If the main CPU IC1008 detects a 480i signal source from video 5, it will instruct IC511 to route the video to IC1403. The CPU will toggle the signal to IC1307. It will then be sent to the BR board for line doubling.

The main CPU IC1008 will generate closed caption, XDS and V chip graphics for display to the main video. Parental control of the sub video path will be provided by IC1401.

Using the block diagram in Figure 14-1 provides an excellent overall view of the stages of video processing to utilize the various features of this chassis to assist in localizing failures. Since this chassis has four additional boards attached to the A board, the steps to follow are needed just to find which board is causing the problem!

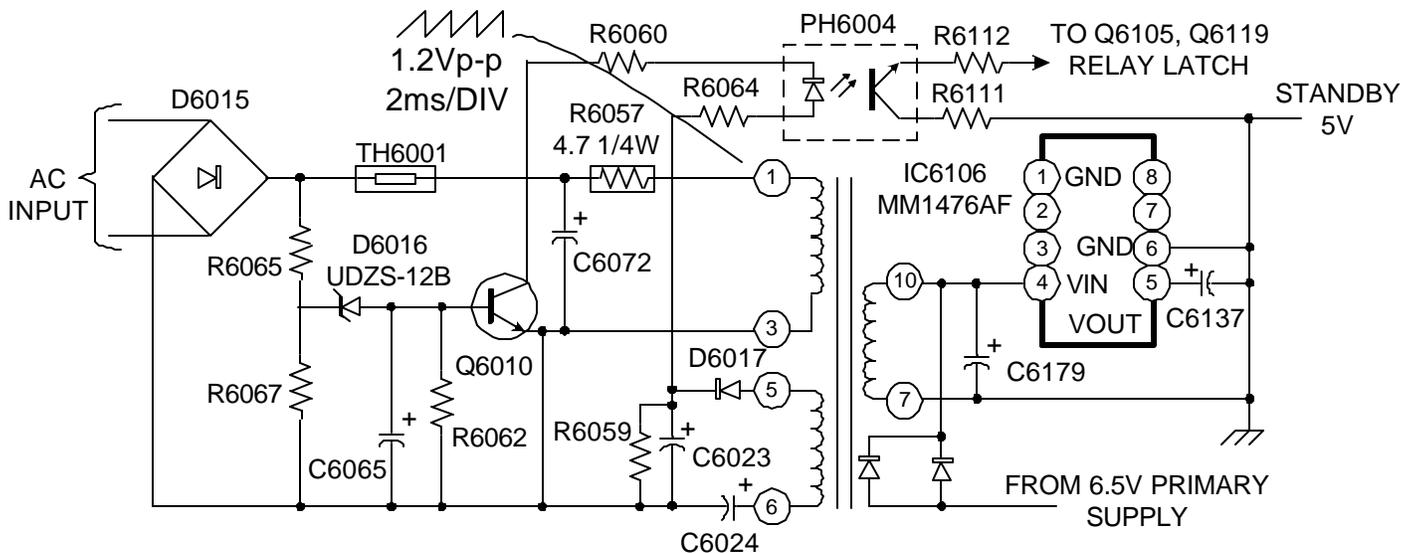
FIGURE 16-1 - RA-5A CHASSIS STANDBY SUPPLY

As illustrated in Figure 16-1, the standby power supply is rather unique in that the incoming AC voltage is rectified before being applied to the primary side of T6003. The DC pulses from the rectifier are used to fluctuate the current in the primary winding. The secondary supplies unregulated B+ to 5V regulator IC6106. Zener diode D6016 monitors the rectified AC for excessive voltage. If the voltage at the divider consisting of R6065 and R6067 rises above 12V, Q6010 will turn on. The LED inside PH6004 will light and cause the phototransistor to output a high to the main AC relay latch circuit to shut the unit down.

1. AC In OVP: The unregulated B+ in the standby supply primary is monitored by Q6010 and will turn on PH6004 to activate the protect latch. This is illustrated in Figure 16-1 in Chapter 16...
2. Audio Protect: The speaker lines are monitored for DC component by Q2608, Q2609 and Q2610 on the K board.
3. 15V OVP: Monitored by Q6101 and D6121 as shown in Figure 17-2.
4. 22V OCP: Excessive current on or loss of +22V also monitored by Q6101 and D6126.
5. 19V OCP: This voltage is generated by the secondary supply and monitored by Q6101 via D6122
6. HV Protect: The HV circuit is monitored for excessive HV or current by IC8006 and IC8007 on the D board. Troubleshooting this circuit will be covered in Chapter 18.

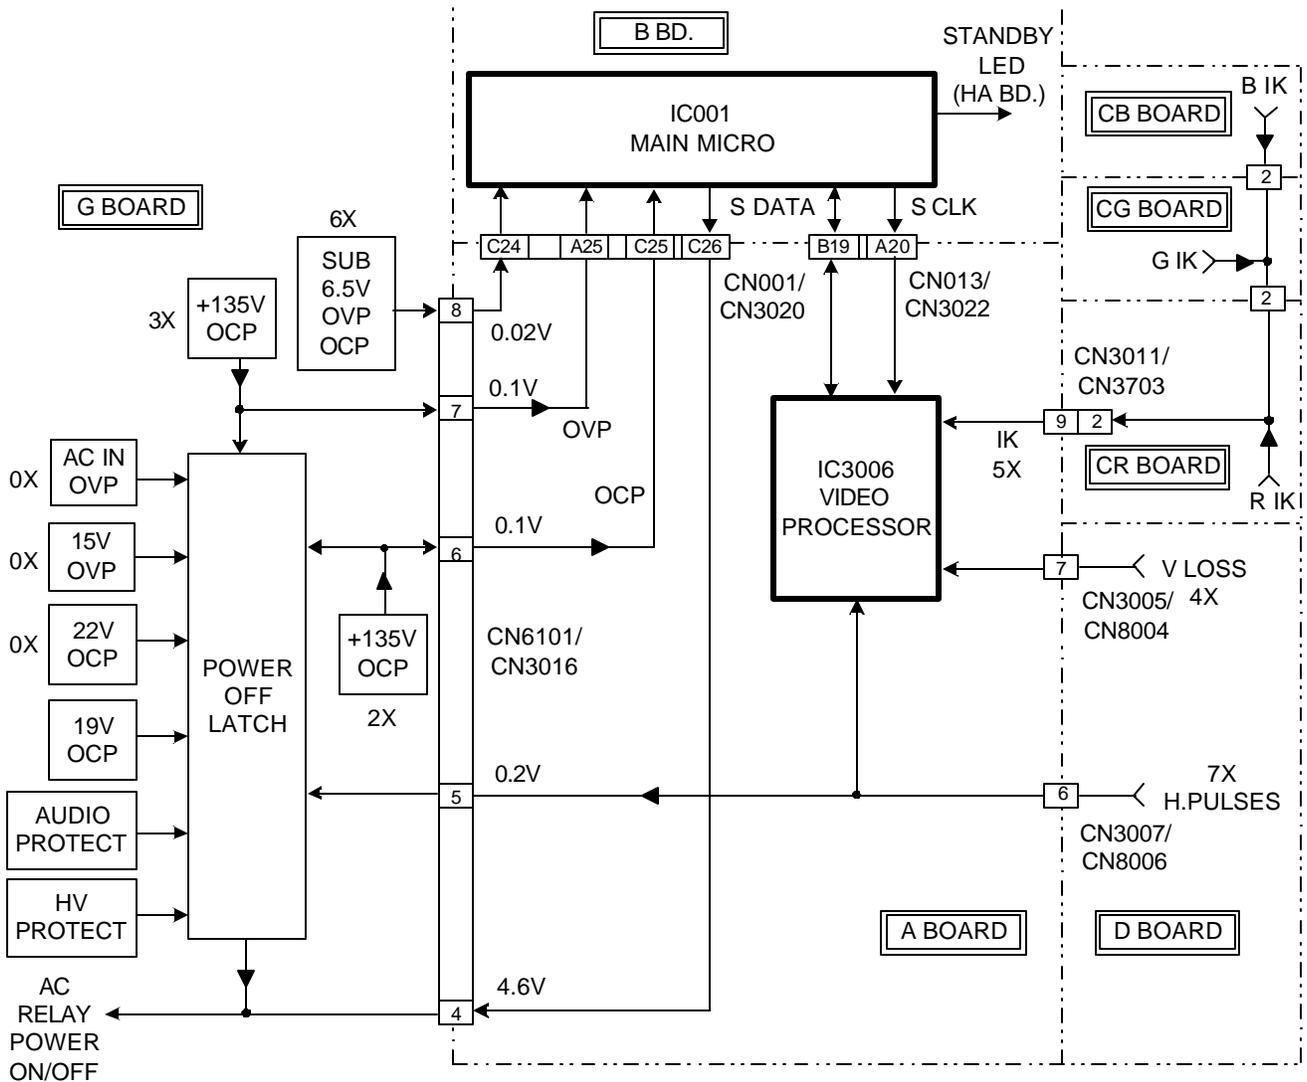
FIGURE 17-1 - PROTECTION BLOCK - RA-5A CHASSIS 17.1TVP14 1464 6/24/02

These monitoring circuits will cause the unit to go into protective shutdown by generating a high signal to the latch circuit without diagnostic indicators. It has been found that failures in any of the protect circuits can cause protection event indications in the diagnostics mode. As an example: A HV shutdown will sometimes register an AKB error. It is a good idea not to rely heavily on the diagnostics but to use it as a guide.

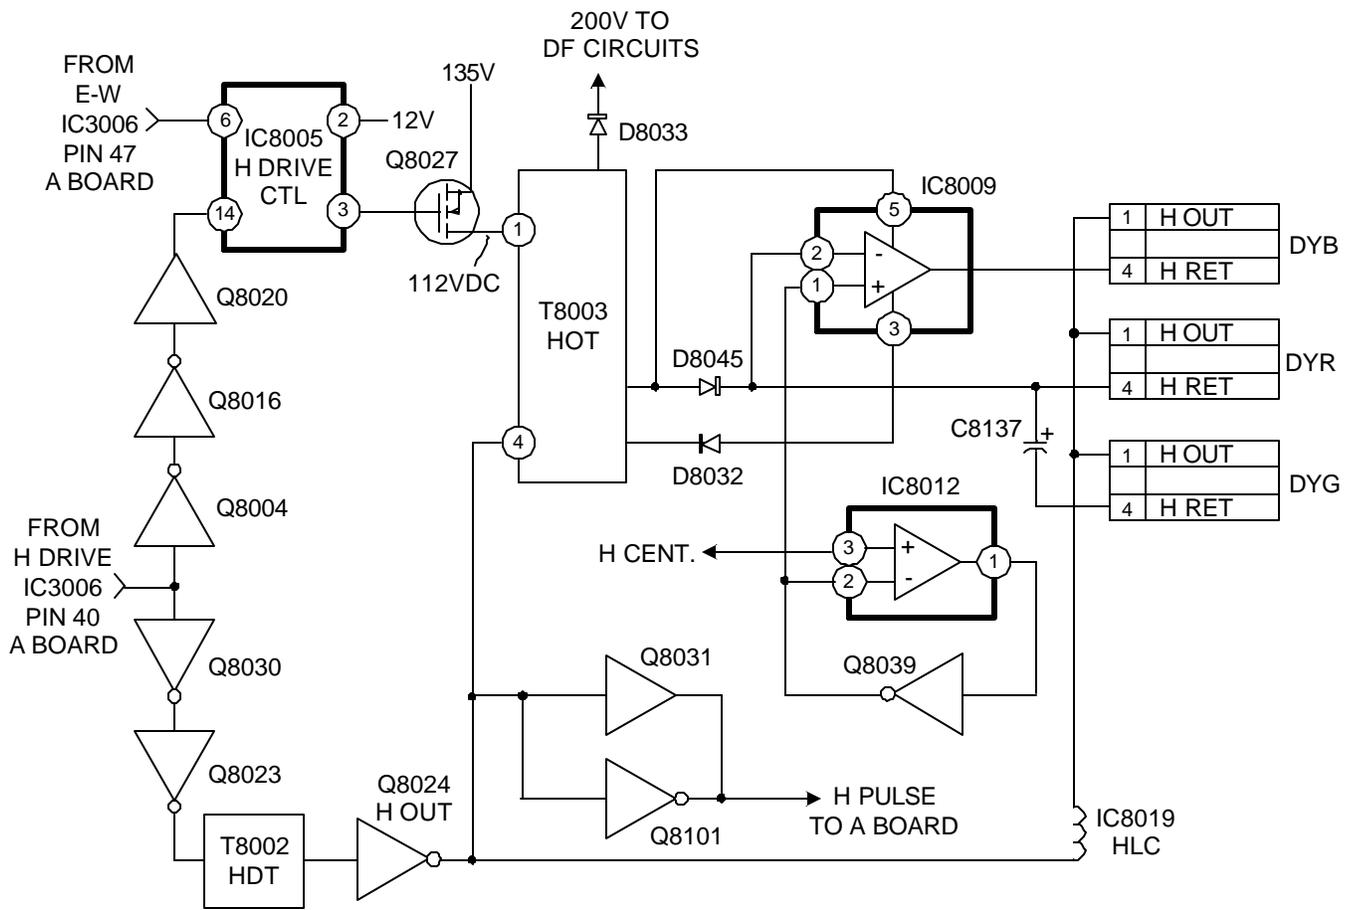
FIGURE 18-1 - HORIZONTAL DEFLECTION RA-5A CHASSIS

Referring to Figure 18-1, horizontal sweep is generated in the conventional way using an H pulse from pin 40 of IC3006 on the A board. It is amplified and transformer coupled to the horizontal output transistor Q8024. The deflection yokes and T8003 are driven. T8003 generates 200VDC for the dynamic focus correction circuit and a  $\pm 100V$  source to provide offset of the red and blue deflection yokes for centering to the green CRT. Horizontal centering control is also provided by IC8012 and Q8039.

Picture Too Wide: Q8027 is not modulating the scan width accordingly and is either shorted or in saturation. There should be approximately a 15V difference between the source and the drain. Shorting the gate of Q8027 will aid in determining whether IC8005 is overdriving it or the transistor is at fault. If the picture width is substantially reduced, check IC8005 for missing H pulse at pin 14 before replacing.

Insufficient Width: Q8027 is open or not receiving pin correction signals. Check for a parabolic signal at the gate. If not present, verify the E –W signal is at pin 6. If it is, check the associated components around IC8005 before replacing it. Pay close attention to the components supplying feedback to the operational amplifiers in this IC. Beware that the NVM IC storing the pincushion correction data has caused problems in some previous models.

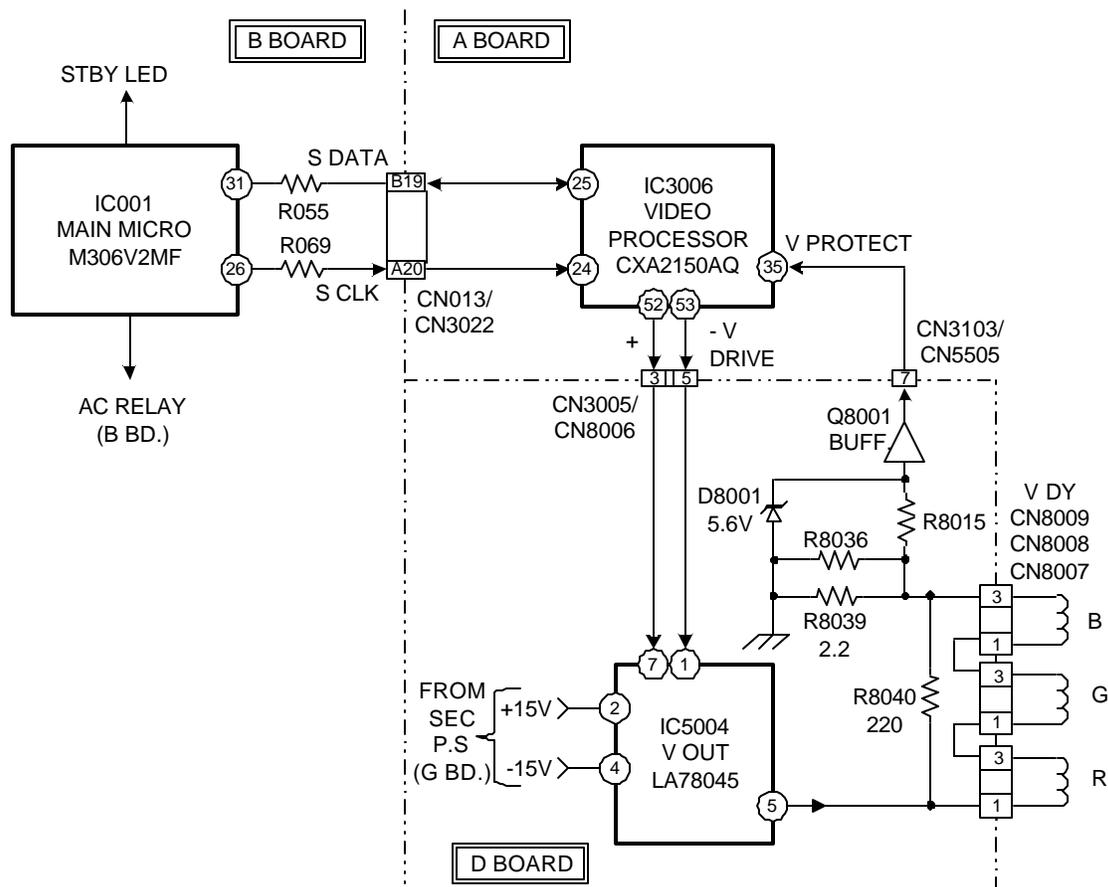
FIGURE 18-2 - VERTICAL DEFLECTION RA-5A CHASSIS

**Insufficient Vertical Height:** Either the vertical output IC is being told what height to display and is unable to comply, or it is receiving erroneous drive information. Due to the nature of the operational amp within IC5004, it is rare for it to not be able to amplify properly. Operational amps have massive amounts of gain, which is why they need negative feedback to keep them under control. Suspect IC5004 as the last possible cause. Gain problems can be caused by improper supply voltage (very rare) or problems in the feedback line (more likely). This is why you should always scope the feedback line when height or linearity problems arise. In this chassis, the best point is the top end of the ground return resistors (R8036 or R8039). What should normally be here is approximately 1VPP of vertical rate sawtooth. If there is a problem, you will observe one of two things: A significantly larger sawtooth level or horizontal frequency contamination in the sawtooth. A large sawtooth indicates one or more of the ground return resistors or the thermal compensator TH8001 has opened. The negative feedback of the operational amplifier will respond by reducing gain. If there is a large amount of horizontal component in the feedback, the amp will also reduce gain since the average DC level will be higher at this frequency. The vertical deflection yoke windings are right next to the horizontal windings so it is very easy to induce this into the vertical return. Suspect an open C8001 or C8023 at this point.

Should the feedback line check OK, you now have a possible input problem. IC3006 can cause this and it is difficult to verify without replacing it. Beware that faulty NVM ICs have been known to cause vertical height problems.

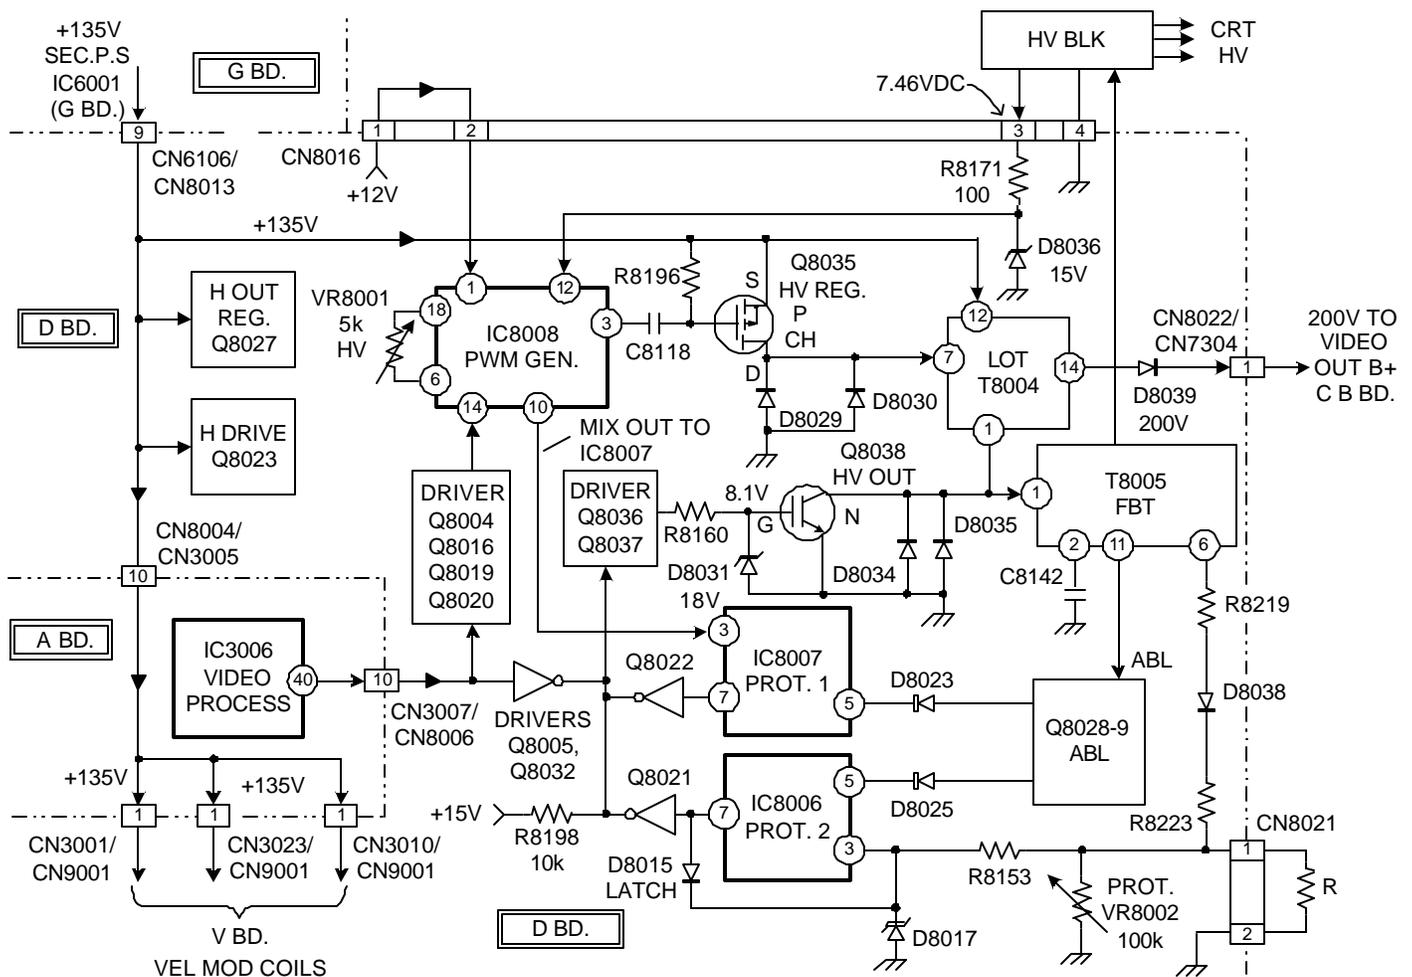
FIGURE 19-1 - HIGH VOLTAGE STAGE - RA-5A CHASSIS

Figure 19-1 illustrates a block diagram to give an overall view of the circuitry on the D board for generating high voltage. The main components consist of a regulator stage to vary the B+ level to the flyback transformer for HV level control, a driver and output stage to switch the flyback on and off, a flyback transformer to generate HV and a LOT transformer to generate heater voltage and 200VDC for CRT cathode bias.

IC8008 is a PWM generator and driver to control the on and off time of HV regulator Q8035. The sawtooth waveform for the PWM generator is synchronized to the horizontal drive pulse at pin 14 to provide a stable reference. A sample of HV level is taken from the HV block assembly and enters pin 12 to provide an error loop by which to vary the duty cycle of the drive pulses to Q8035. Q8038 provides the necessary switching to turn T8004 and T8005 on and off and maintain a HV level of 31KV.

HV level and current are monitored by IC8006 and IC8007. They will stop high voltage generation to provide protection for the HV components, CRT's and X radiation level. This is accomplished by disabling the H drive pulse from video process IC3006. Both the HV level and shutdown threshold are shown as adjustable by VR8001 and VR8002 but these controls are sealed with epoxy at the factory and are not adjustable.

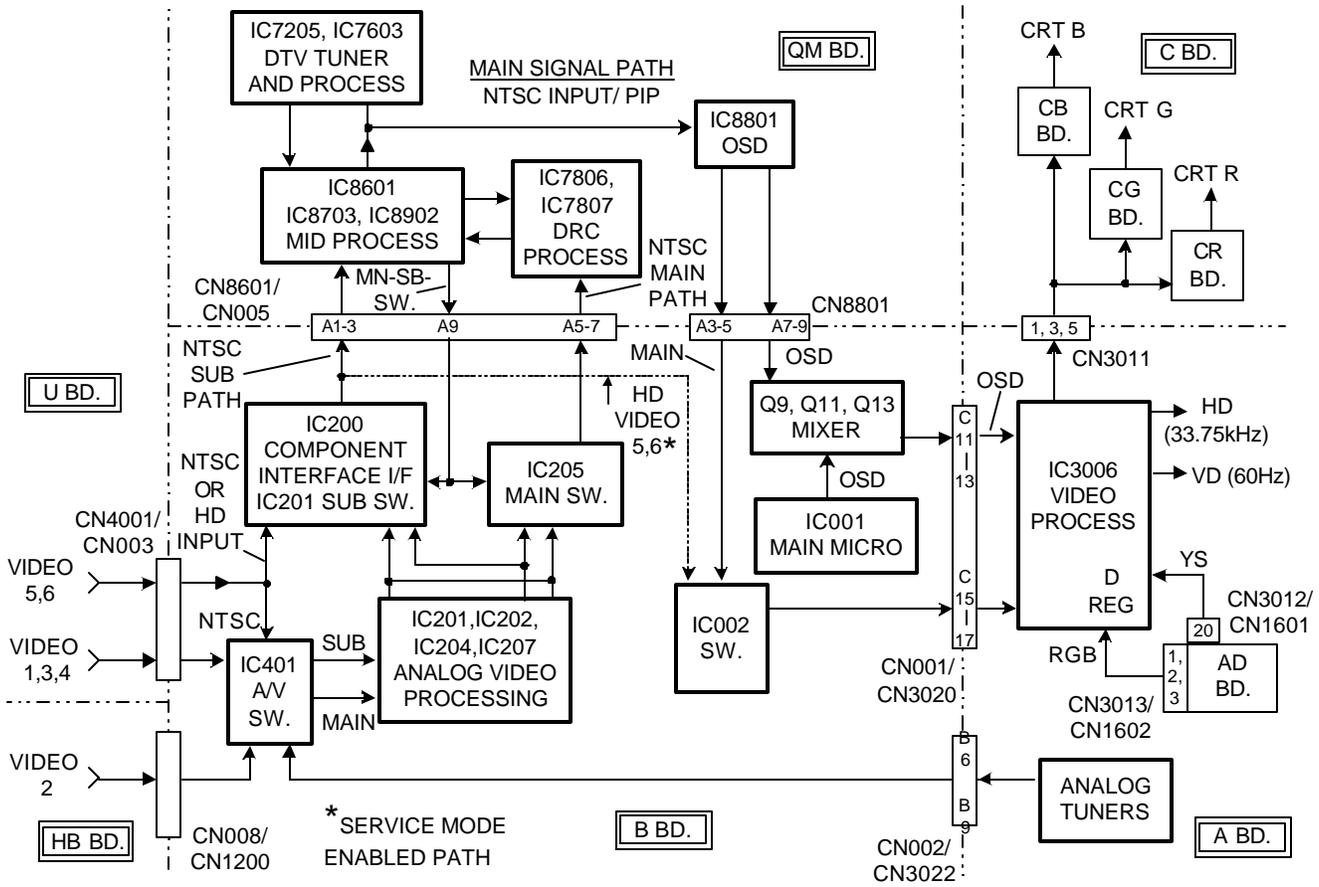
FIGURE 20-1 - VIDEO BLOCK - RA-5A CHASSIS

Although the video signals are routed through many different paths depending on the type of signal being received, these different pathways can be used to an advantage when diagnosing video failures. The picture & picture (Twin Picture) feature provided by the MID™ circuitry provides a useful diagnostic tool. Since it is able to display two video signals simultaneously, isolating which stage is causing the problem can be accomplished easily. This feature will be used extensively in the troubleshooting procedures to follow.

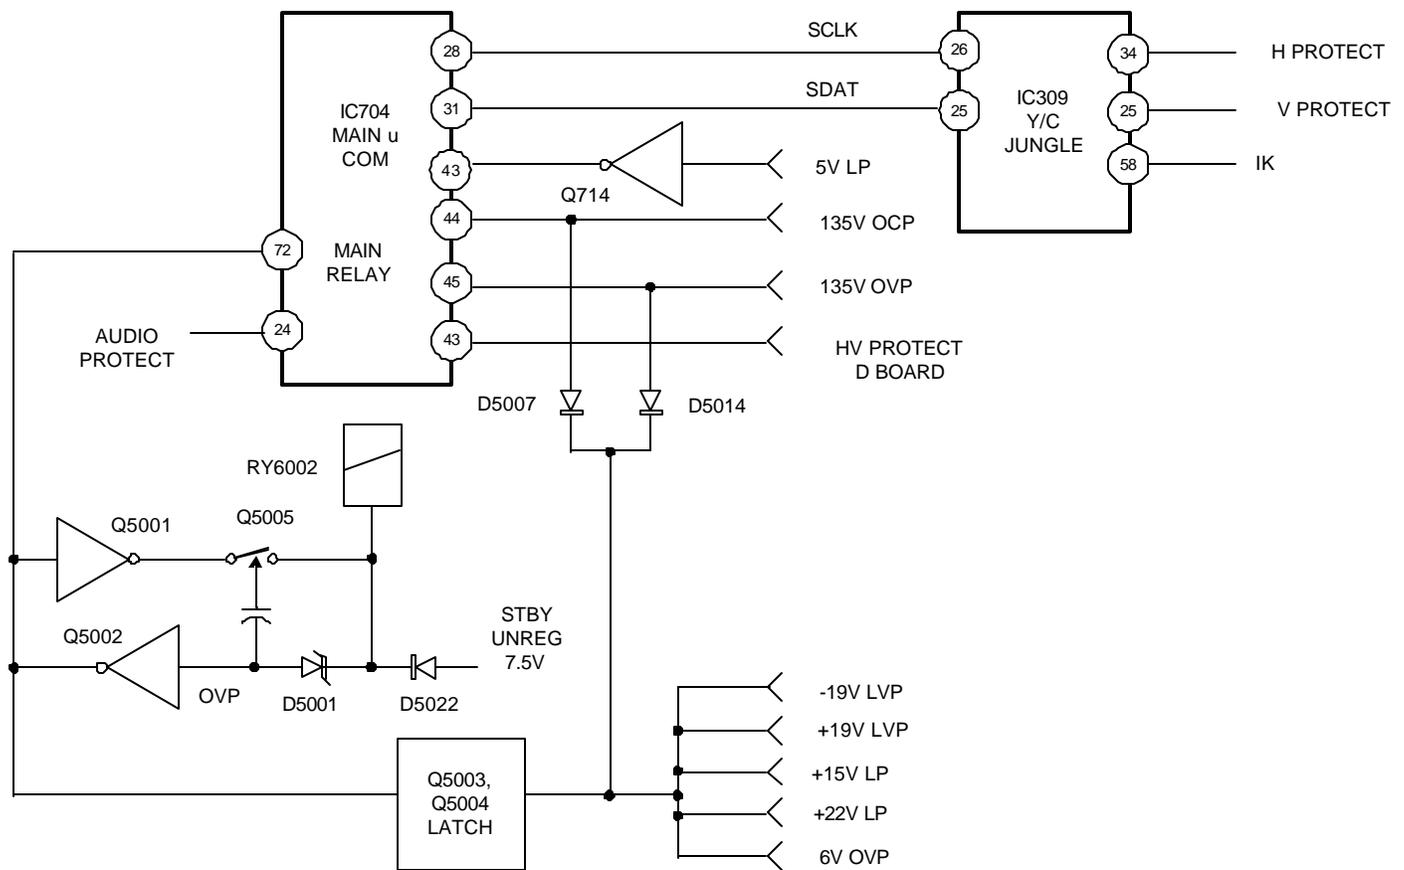
FIGURE 23-1 - PROTECT CIRCUITS RA-6 CHASSIS

The above protection circuits have dedicated communications, directly or indirectly, with the main micro controller, IC704, located on the A board. The 135V OCP/OVP, Low B, H Stop, HV and AUDIO lines have direct connections. V Stop and AKB notify IC709 by way of the video process IC309, which announces the event via the data bus line. The remaining protect circuits have no communication ties with the main CPU IC709, but will also generate six blinks of the timer LED. They are:

1. Audio -19V LVP monitored by D5026
2. -15V LVP monitored by D5023
3. +15V, AU +19V, and +22V LVP monitored by Q5007 and D5083
4. Reg 6V OVP monitored by D5019
5. Standby unregulated B+ monitored by D5001
6. Unregulated B+ for low or excessive level monitored by V Sense at pin 1 of IC6003.

As illustrated in Figure 23-1, several circuits are monitored for protection. Some lines are monitored by the self-diagnostics feature while others are not. The self-diagnostics feature can assist in isolating a particular circuit. Below is an example of the diagnostics page which is entered by pressing “DISPLAY”, “5”, “VOL –”, and “POWER”:

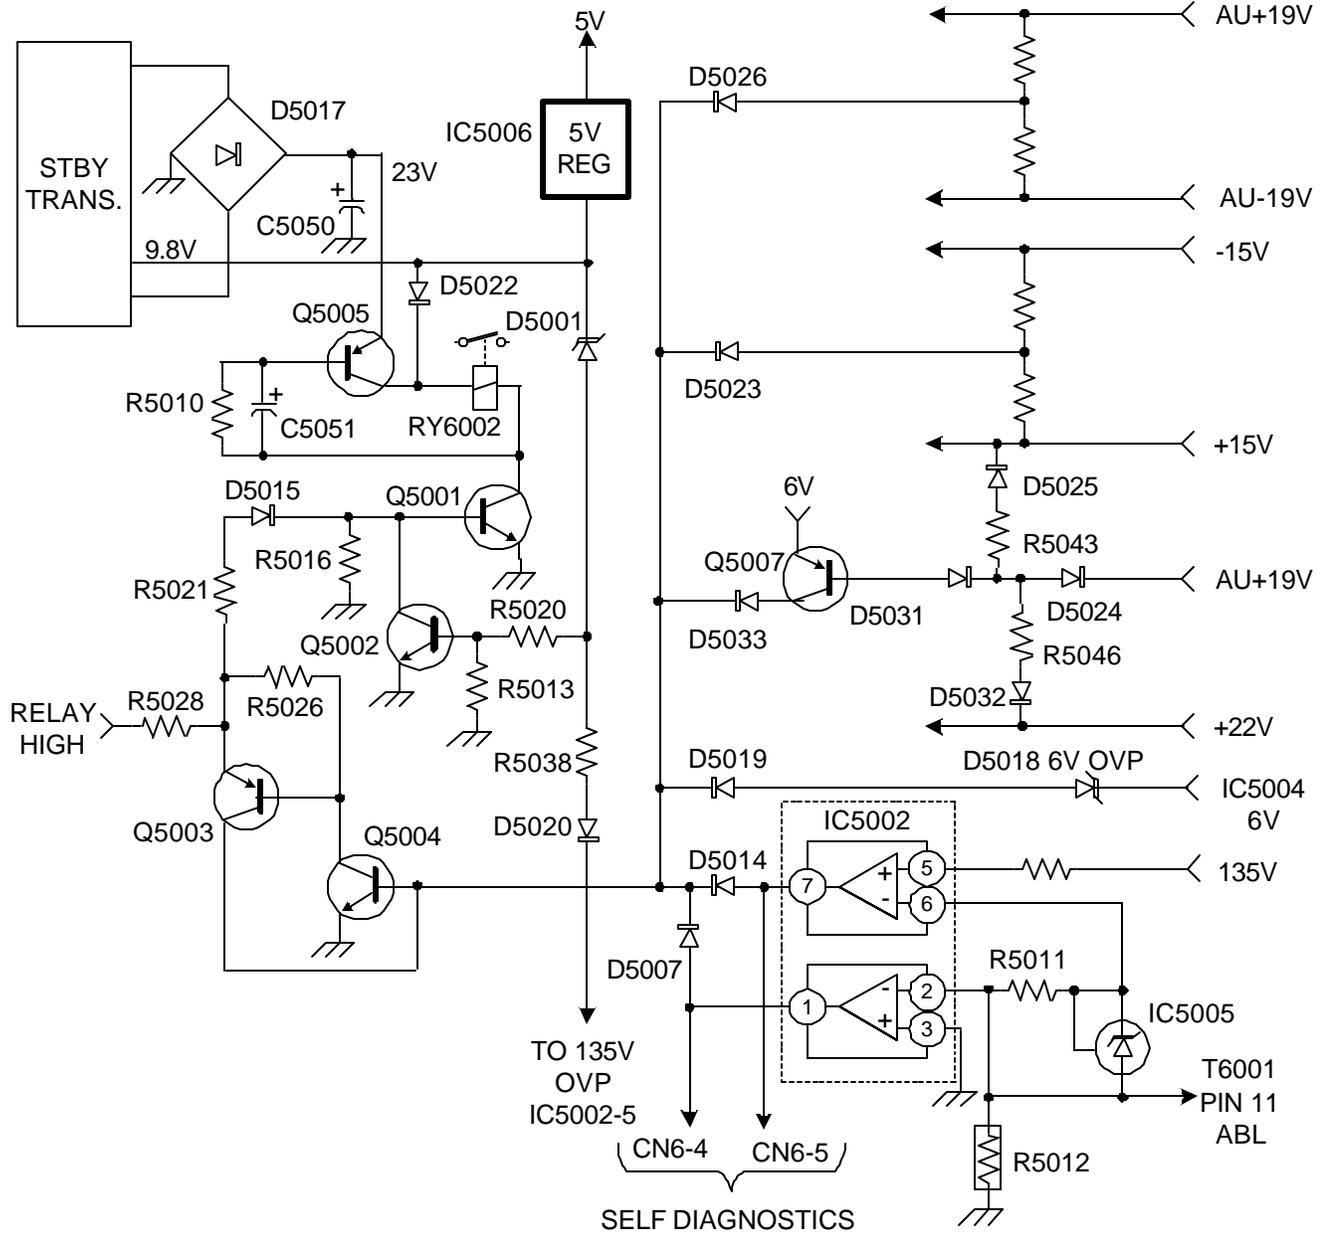
FIGURE 23-2 - PROTECT CIRCUITS RA-6 CHASSIS

8X Flashes: High voltage has exceeded specified limits or there is excessive current in the flyback transformer. Refer to Chapter 25.

9X Flashes: The audio output IC has shorted or the protect components on the A board have failed

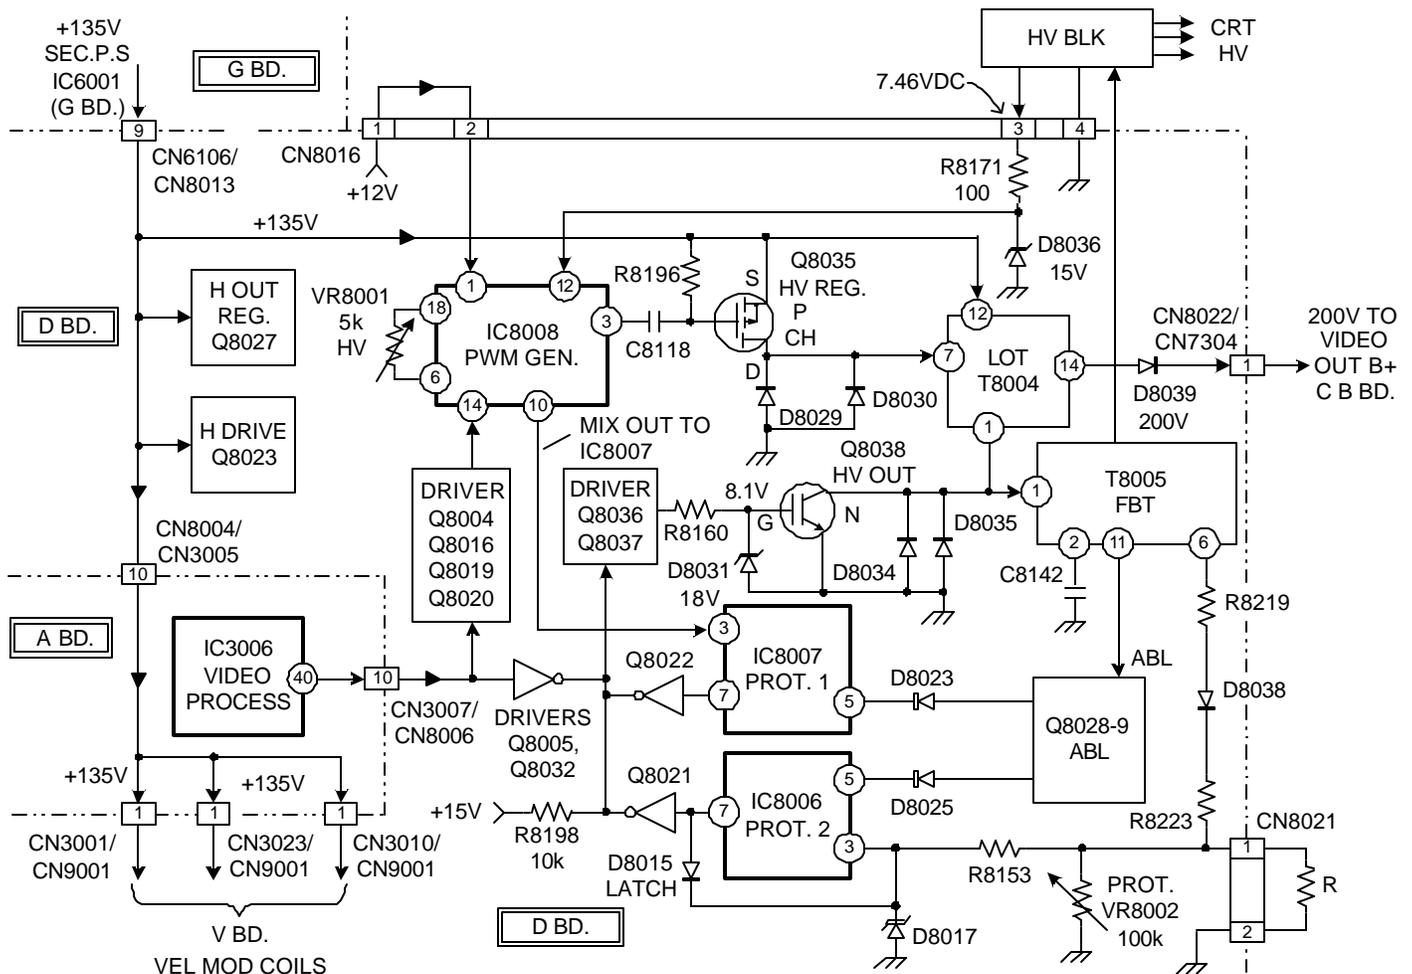
FIGURE 25-1 - HIGH VOLTAGE STAGE - RA-6 CHASSIS

Figure 25-1 illustrates a block diagram in order to provide an overall view of the circuitry on the D board for generating high voltage. The main components consist of a regulator stage to vary the B+ level to the flyback transformer for HV level control, a driver and output stage to switch the flyback on and off, a flyback transformer to generate HV and a LOT transformer to generate heater voltage and 200VDC for CRT cathode bias.

IC8008 is a PWM generator and driver to control the on and off time of HV regulator Q8035. The sawtooth waveform for the PWM generator is synchronized to the horizontal drive pulse at pin 14 to provide a stable reference. A sample of HV level is taken from the HV block assembly and enters pin 12 to provide an error loop by which to vary the duty cycle of the drive pulses to Q8035. Q8038 provides the necessary switching to turn T8004 and T8005 on and off and maintain a HV level of 31KV.

HV level and current are monitored by IC8006 and IC8007. They will stop high voltage generation to provide protection for the HV components, CRTs and X radiation level. This is accomplished by disabling the H drive pulse from video process IC3006. Both the HV level and shutdown threshold are shown as adjustable by VR8001 and VR8002 but these controls are sealed with epoxy at the factory and are not adjustable.

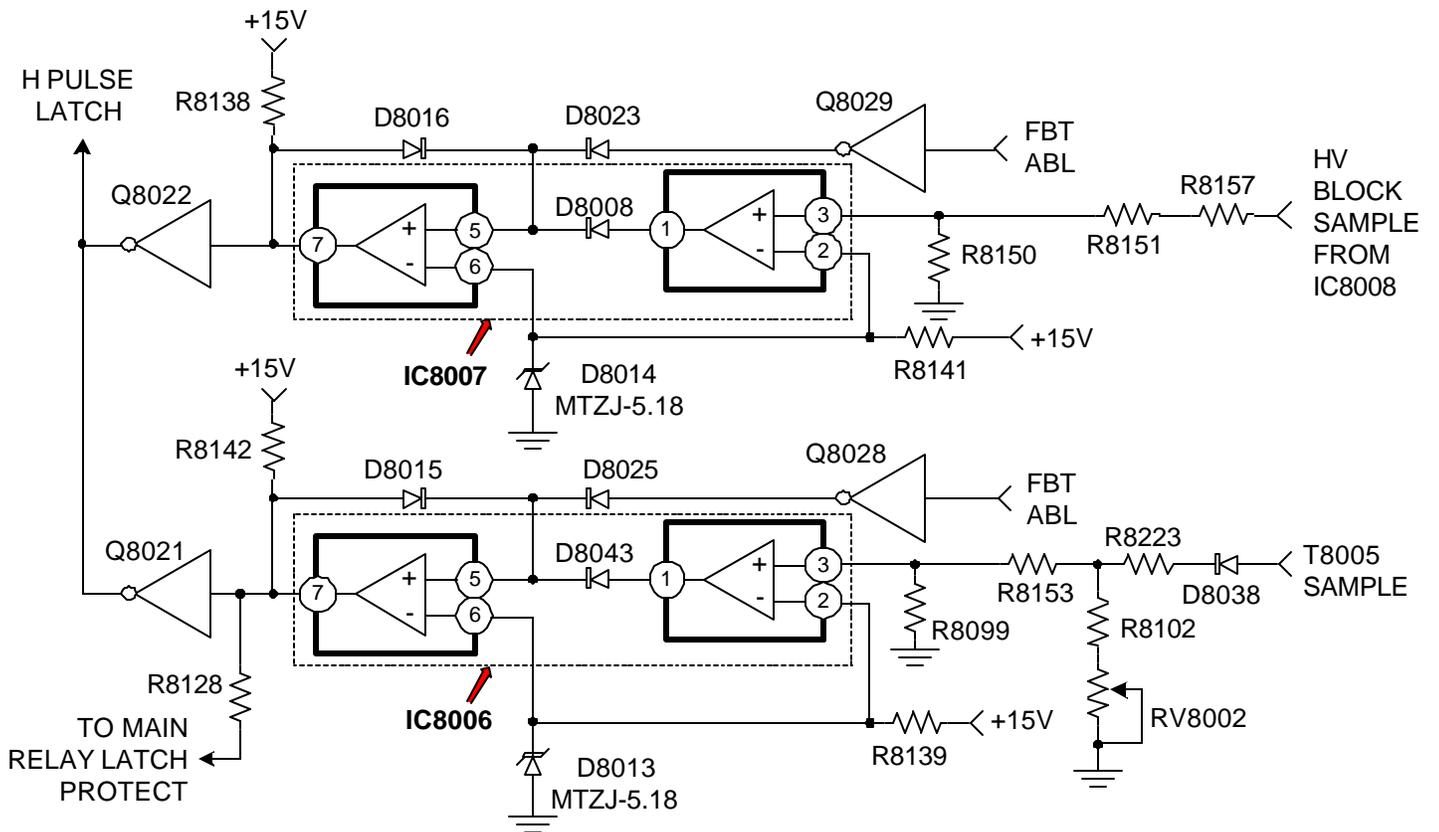
FIGURE 25-2 - HV PROTECT CIRCUITS RA-6 CHASSIS

High Voltage Reads Approximately 31.5KV: The regulator stage is assumed to be working correctly. The protect components are inappropriately firing. If the unit is going into full shutdown, troubleshoot IC8006 and its associated components. If the unit is only shutting down the HV circuit, check IC8007 and its components. As illustrated in Figure 25-2, both IC8006 and IC8007 use a 5.1VDC reference at pins 2 and 6. Pin 3 of IC8006 monitors a voltage sample of T8005. Pin 3 of IC8007 monitors a HV block sample from PWM IC8008. FBT ABL is monitored by Q8028 and Q8029. These transistors are normally on unless FB current becomes excessive and the ABL voltage approaches zero volts.

Check for proper reference level if 5.1V at the inverting inputs of both ICs. If OK, check for voltages at the non-inverting inputs that exceed 5.1V. If none exceed 5.1V and pin 7 of either IC is high, replace the IC.
