**KDP-57XBR2**

# **Projection Television Troubleshooting**

**RA-3/3A, RA-4/4A, RA-5A, RA-6 Chassis**

**Course: TVP-14**

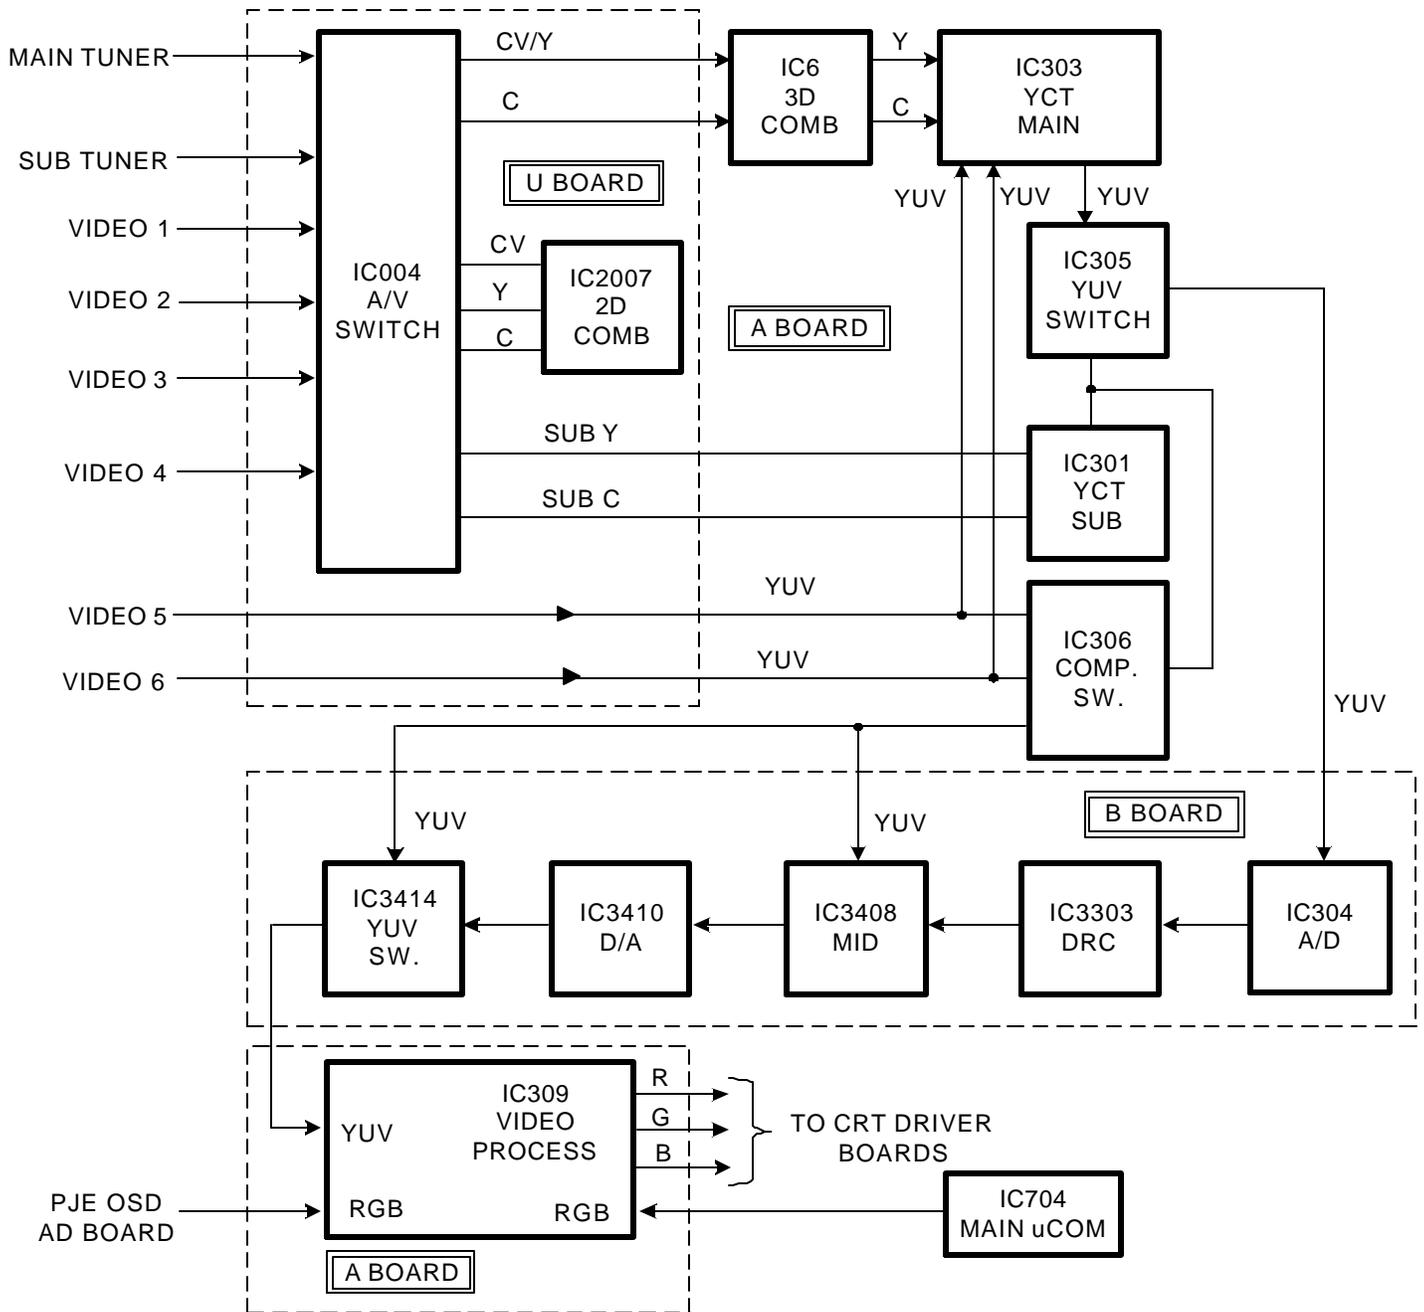
FIGURE 26-1 - VIDEO PATH RA-6 CHASSIS

Figure 26-1 illustrates an overall view of the video path. All composite and S video sources in the main path are processed by 3D comb filter IC6. In the sub-video path, composite sources are sent through a 2D comb filter IC2007. S video is passed straight through to IC306. Both video sources are stripped of sync and chroma sub-carrier by IC303 for the main, and IC301 for the sub. The main will split into two paths, one to the DRC and the other to the MID. Sub-video only goes to the MID to provide a second picture source for P & P and PIP.

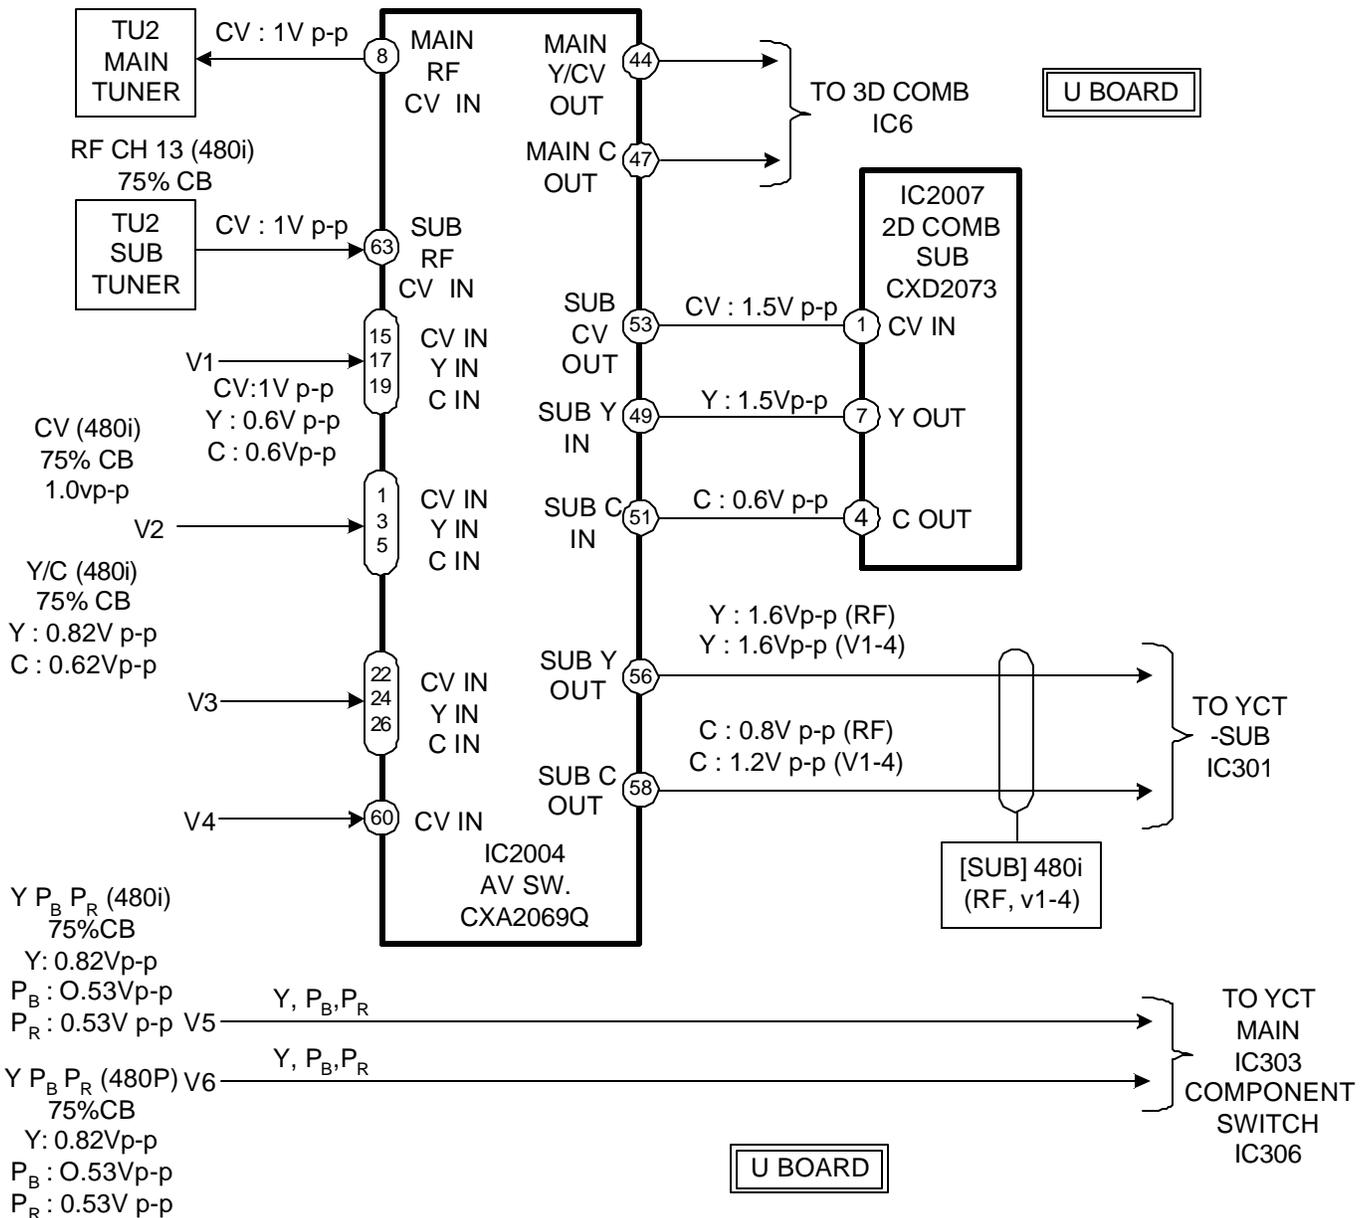
FIGURE 26-2 - VIDEO SWITCHING RA-6 CHASSIS

Figures 26-2, 26-3 and 26-4 provide detailed blocks with pin locations and video signal levels with color bar input at 75% white level.

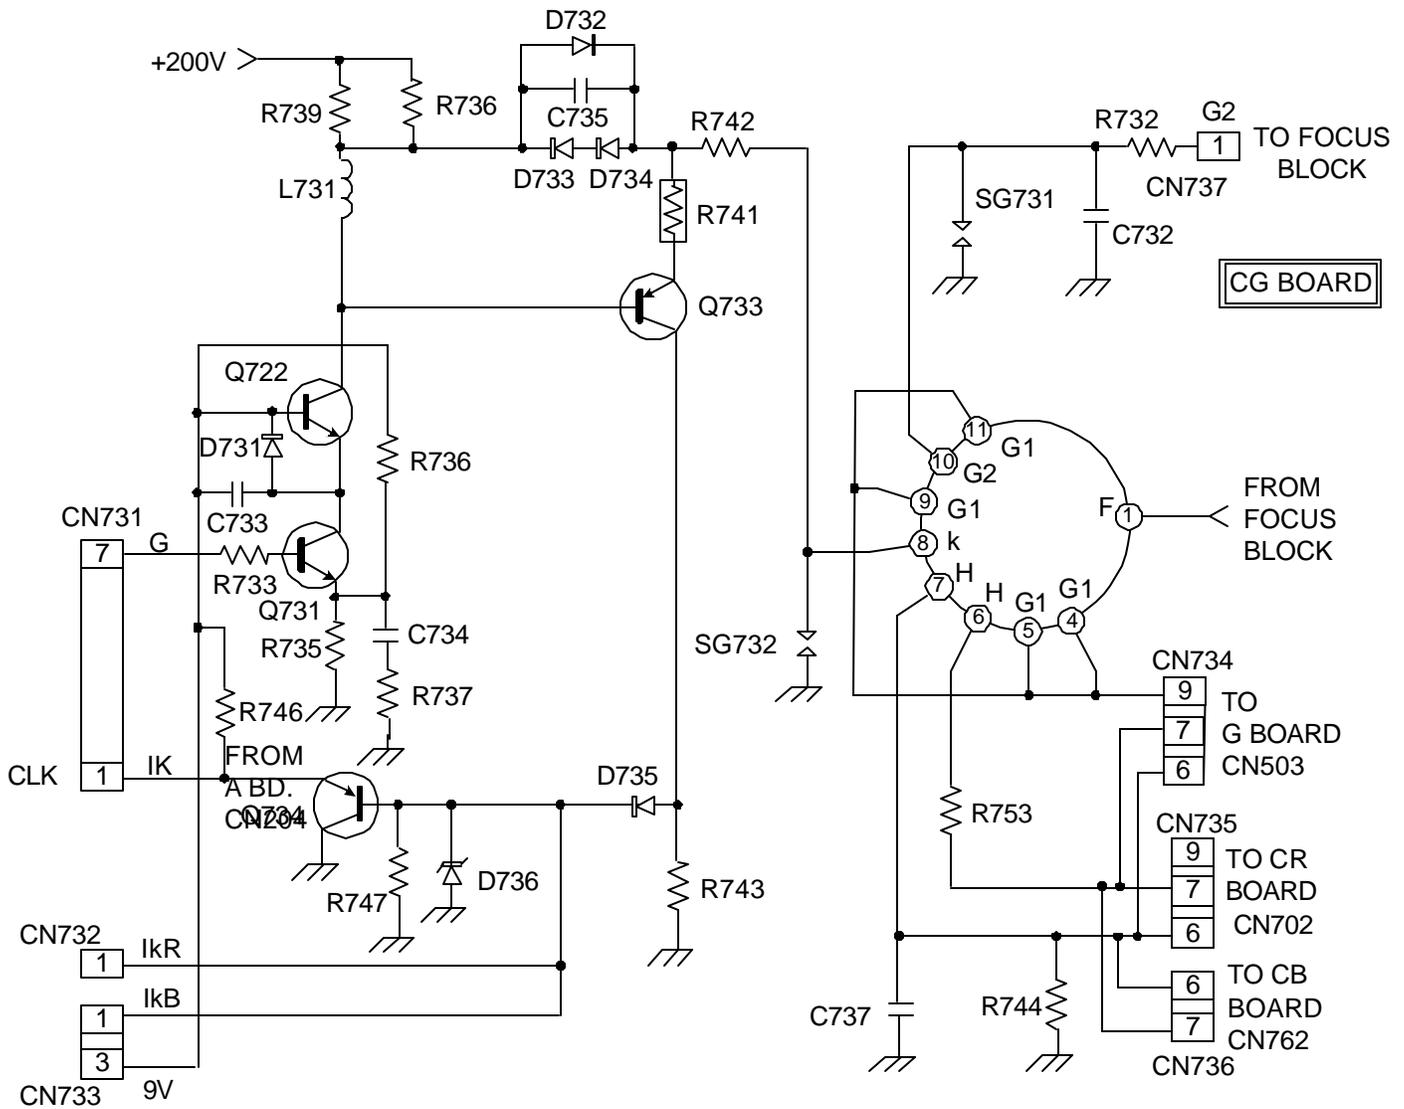
FIGURE 27-1 - CRT DRIVE (CG)

Each of the pulses returned by the cathodes are combined into a single return line and sent to the video processing circuit for the AKB section to analyze. Figure 27-1 provides a clear illustration of how this works. It is a diagram of the CG board found in the RA-3 chassis. Since discrete components are used, a clear explanation of how the cathode returns current information can be described. Most television designs, particularly the newer sets, use an IC for driving the cathode(s) and all of the components for current detection are located inside of it.

Q733 provides the necessary pull-down of the cathode bias to control electron emission. The collector is connected to ground by R743. The more current drawn, the greater the voltage drop across R743. This creates a voltage level reference of the current. The voltage drop consists of an AC component since Q733 is driven by a video signal. This video signal “image” is sent to Q734-B where the signals from the red and blue CRT are merged with it. The signal at this point resembles a composite signal but it is actually a combination of the RGB video, therefore, it is technically not a conventional signal since composite video does not contain the G component. Included in this signal are the three IK pulses from each cathode. Since the video process circuits provided the location timing for each pulse, it will simply extract and analyze each one for cathode current level.

When the unit is first turned on, the cathodes are cold and no current is being drawn. The IK pulses at each of the RGB drive outputs of the video processor will be high in amplitude since no return pulses are being received. As the cathodes warm up, the output pulses will begin to drop in amplitude as each cathode returns the expected pulse level. This event is an important tool to use for troubleshooting intermittent AKB problems and will be covered later in this chapter.

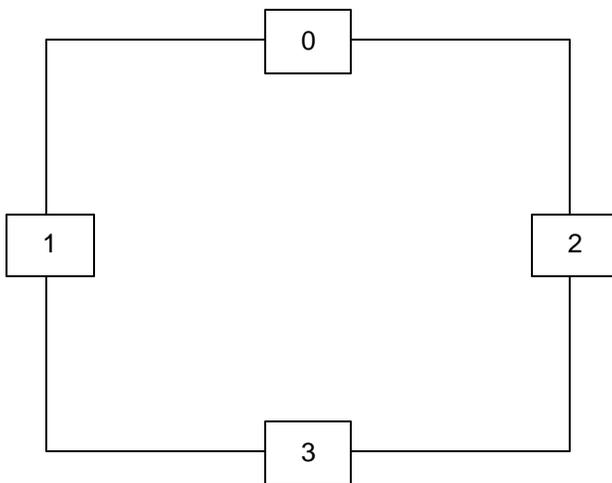
FIGURE 28-1 - SENSOR LOCATION AND NUMBER

It is quite frustrating to receive an error message while attempting to write sensor offset data after a lengthy convergence session. In some cases, errors occur after minor touchups in the fine mode. In order to obtain a better grasp on dealing with this situation, it is necessary to have a basic understanding of how this circuit functions. Figure 28-1 illustrates the screen and the sensor locations.

Although earlier designs incorporated eight sensors, the four-sensor arrangement is more common, used in all of the newer sets and will be used for illustration purposes.

Sensors 0 and 3 are used for horizontal centering, skew and limited vertical size control. Sensors 1 and 2 are used for vertical centering, skew and limited horizontal size control. It is important to know the numbers of these locations since they are identified when an error occurs during Flash Focusing. If the model uses eight sensors, the adjustment section of the service manual will illustrate the sensors and their identification numbers.

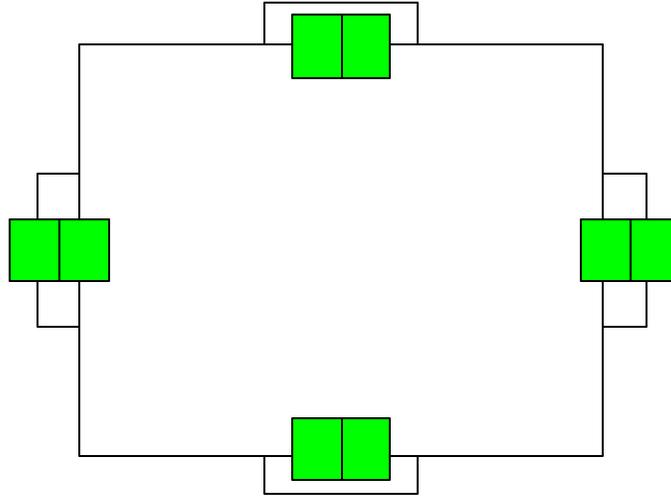
FIGURE 28-2 - CONVERGENCE FLAG DISPLAY 1

Figure 28-2 demonstrates a somewhat exaggerated view of the green flags displayed while Flash Focusing. The sensors are shown in their normal location outside the screen bezel. The flags do not appear simultaneously as shown. They “dance” from side to side and top to bottom. The pair starts near the left side of the sensors and moves to the right to establish an offset voltage based on the light received by the sensors for each pair of flags. When Flash Focusing in the service mode, the offset voltage is read and compared to the adjustment data you have written in memory. This will establish the necessary offset data to be written so when the customer uses the Flash Focus™, the sensors will know where to position each color to the previous service alignment. In the customer mode, they will stop when the correct offset is matched to that in memory.

The configuration shown will adjust horizontal centering and skew based on the top and bottom sensors and horizontal size by using the left and right pair. Vertical centering, skew and vertical size will occur by the flags changing their position by 90° for the next step as illustrated in figure 28-3. Each procedure is always performed twice since centering and skew adjustments will sometimes affect size.

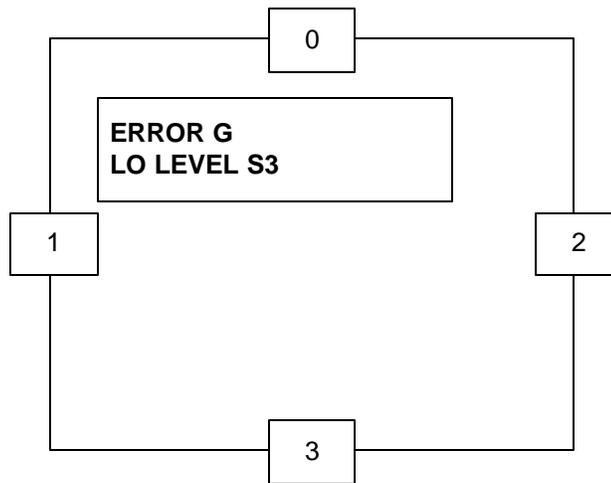
FIGURE 28-4 - FLASH FOCUS™ ERROR DURING SERVICE MODE

Figure 28-4 illustrates what will appear on the screen if an error occurs. This error message only appears while in the service mode. Any errors that arise during a Flash Focus™ will be stored into the NVM and can be read in the PJE mode under “PJE ERR”. This is shown in Figure 28-5.

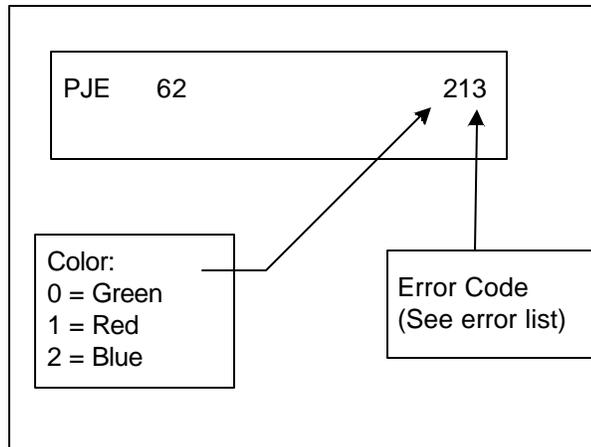
FIGURE 28-5 - ERROR CODE STORED IN NVM

Note: Once an error occurs it will remain in the PJE ERR slot. It can be cleared by scrolling to the error code and moving the remote control cursor to the left.
