2730 Release Notes

for Software Version J200R05

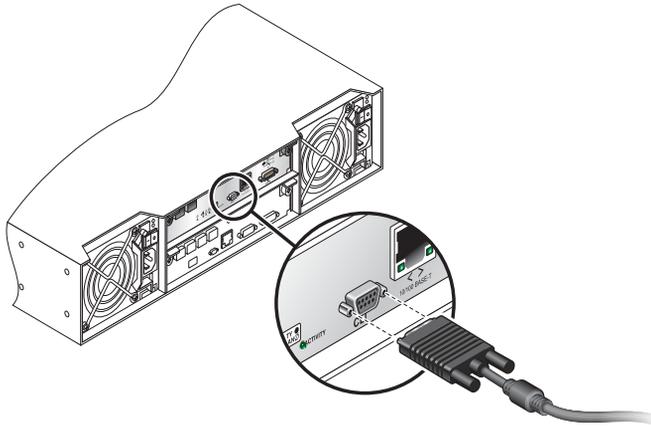
1. Refer to the list of network parameters that you recorded in Step 3 of “Recording IP Addresses” on page 10. You need the IP address, subnet mask, and gateway IP address for controller A and controller B.
2. Use the provided micro-DB9 serial cable to connect the management host to the CLI port on controller A.

Your installation package contents included a micro-DB9-to-DB9 serial cable. If necessary, use a DB9-to-DB25 adapter (not included) for connecting the serial cable to a DB25 serial port on the host computer.
