# Desktop 3rd Generation Intel<sup>®</sup> Core<sup>™</sup> Processor Family

Specification Update

*September 2013*

*Revision 015*

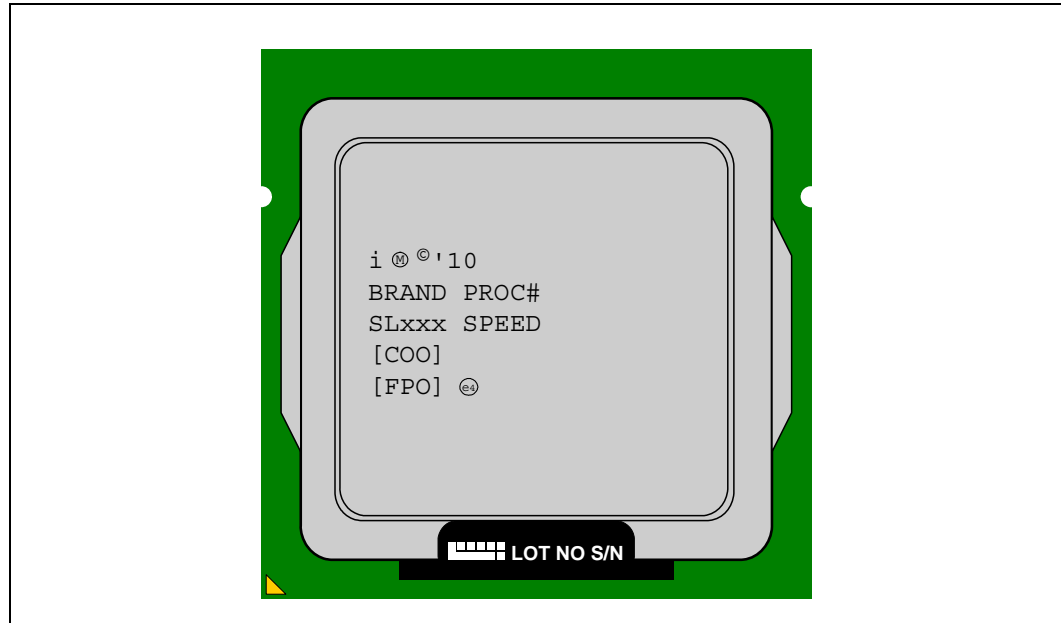
**Figure 1. Processor Production Top-side Markings (Example)**

The processor stepping can be identified by the following component markings.
