# Patch sr264-03 for AT-8600 series switches

## Introduction

This patch release note lists the issues addressed and enhancements made in patch sr264-03 for Software Release 2.6.4 on existing models of AT-8600 series switches. Patch file details are listed in Table 1.

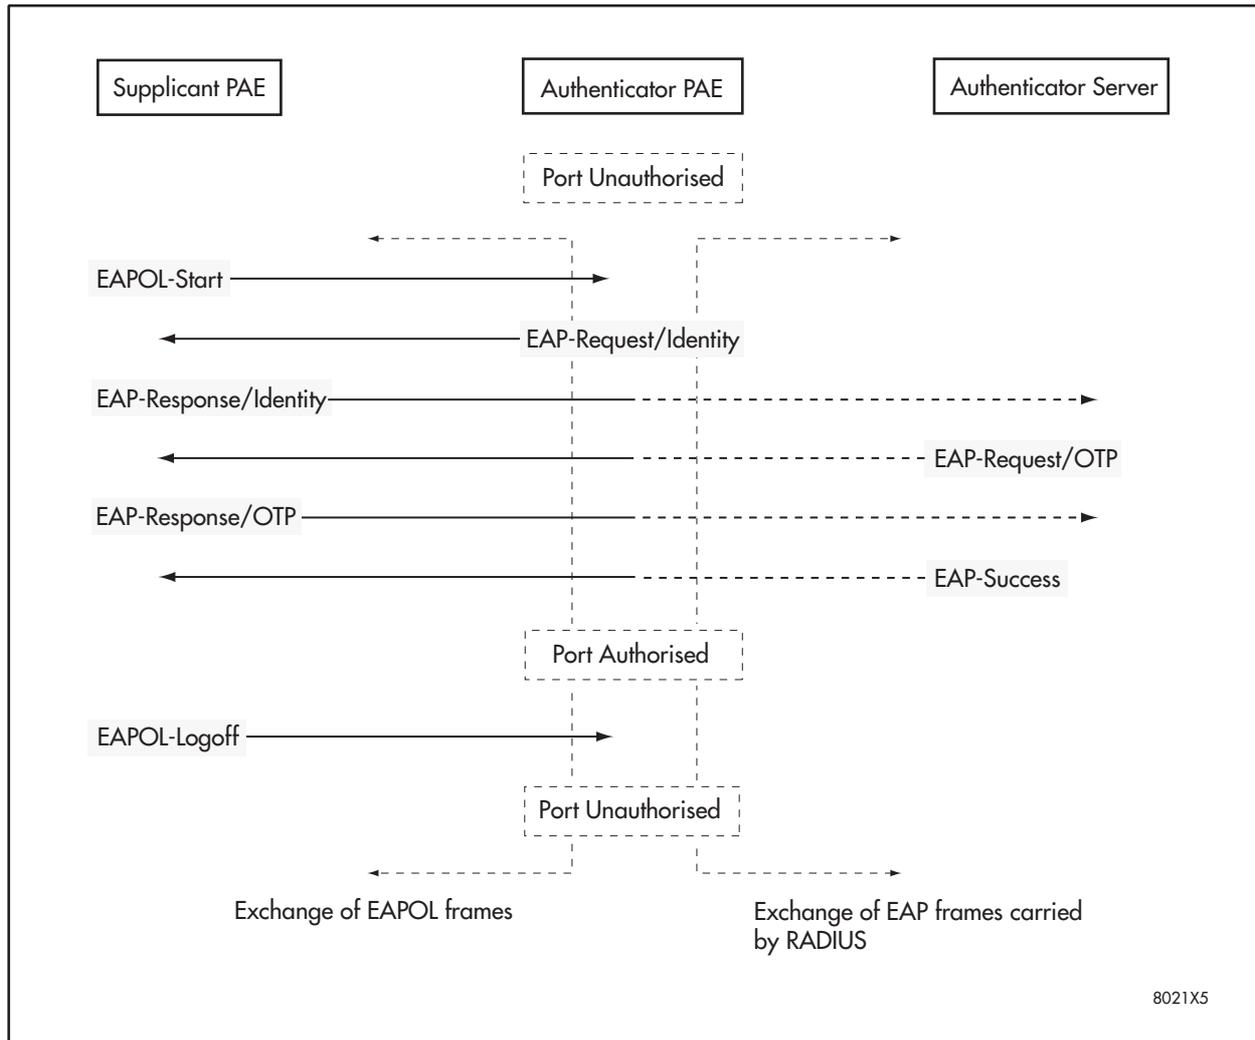
**Figure 1: Authentication Messaging Exchange Initiated by the Supplicant.**

*To minimise the risk of denial-of-service attacks by issuing EAPOL-Logoff messages to an Authenticator Port Access Entity (PAE) from a third party device, we recommend that 802.1x not be used in a shared media LAN.*
