PowerFlex[®] 755 Drives (revision 3.005)

These release notes correspond to major revision 3, minor revision 5 of firmware for PowerFlex 755 drives.

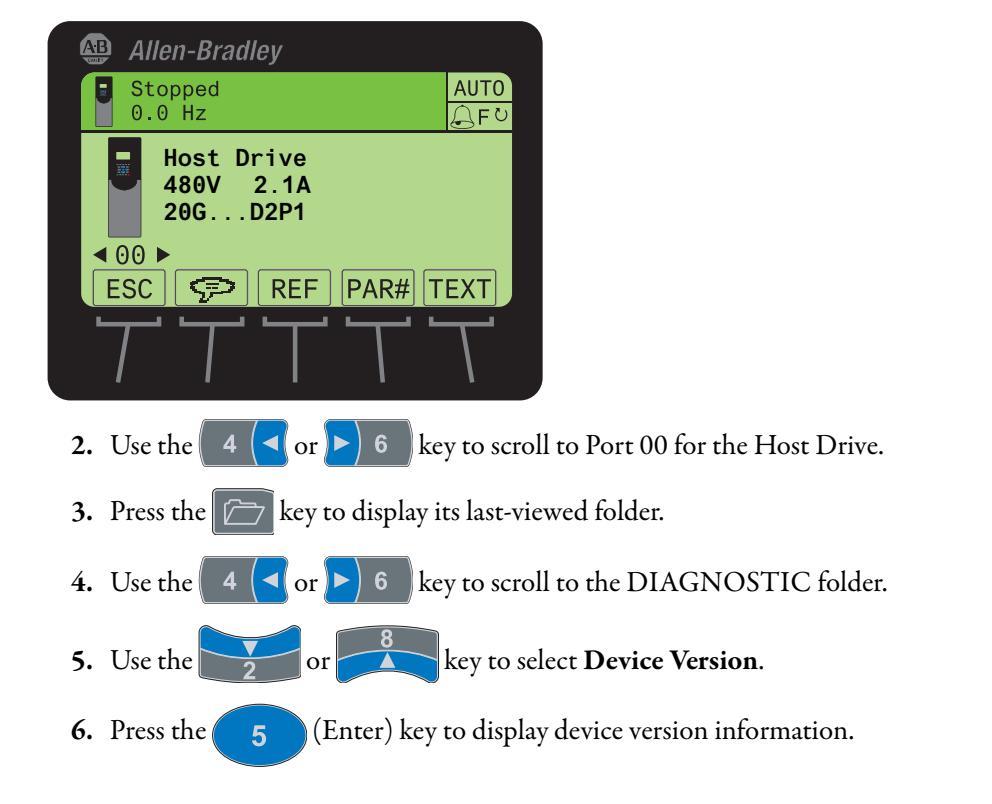
Figure 1 - Status Screen

1. Access the Status screen, which is displayed on HIM power up.

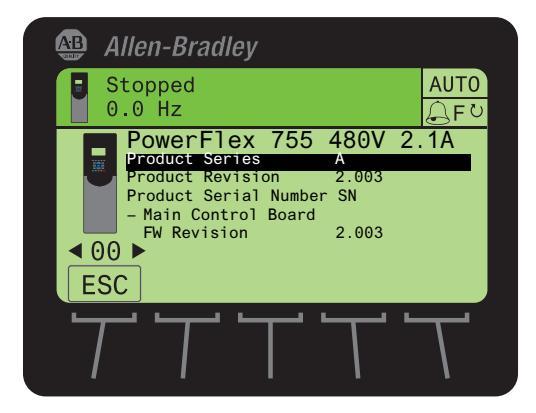
Figure 2 - Device Version Information Screen

FW Revision is listed under -Main Control Board; see Figure 2.

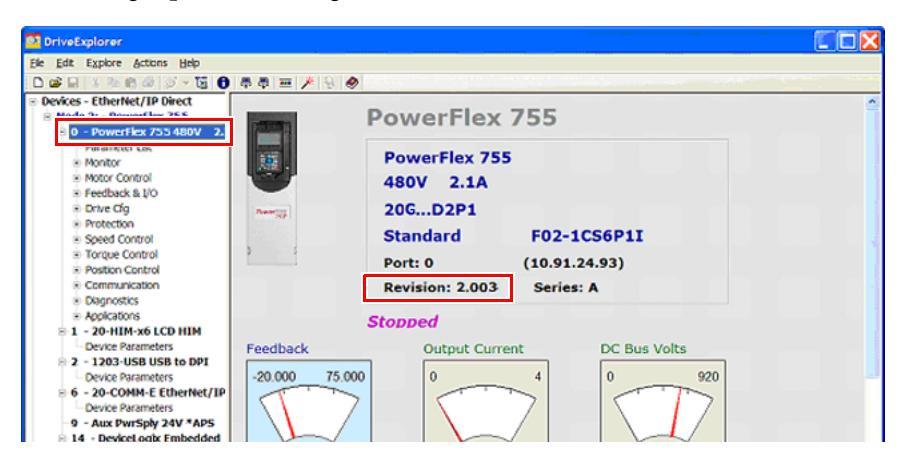
- 1. Launch DriveExplorer and go online with the PowerFlex 755 drive. To connect to the drive, use a 1203-USB converter, a 1203-SSS converter, or an EtherNet/IP network connection.
- 2. In the Devices hardware view, select the PowerFlex 755 drive.

Once selected, information regarding the PowerFlex 755 drive is shown in the right panel including the current firmware revision number.

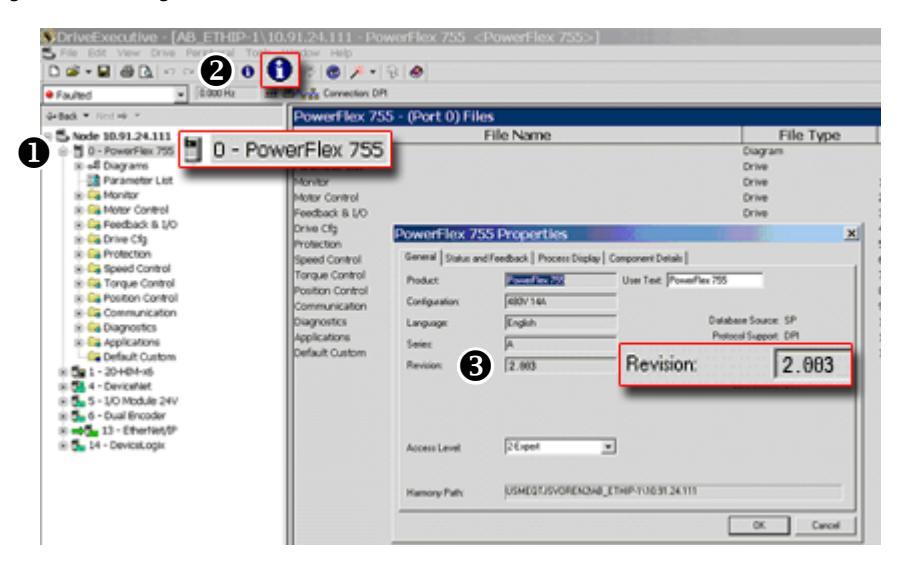
Figure 3 - Accessing the PowerFlex 755 Drive Firmware Revision Number

- 1. Launch DriveExecutive and go online with the PowerFlex 755 drive. To connect to the drive, use a 1203-USB converter, a 1203-SSS converter, or an EtherNet/IP network connection.
- In the Drives hardware view, select the PowerFlex 755 drive (1 in Figure 3 on page 4).
- 3. Click the information icon (2 in <u>Figure 3</u>) to display the drive's Properties dialog box.

In the Properties dialog box the "Revision:" field (③ in <u>Figure 3</u>) will show the drive's current firmware revision number.

- 1. With the Flash Kit installed (see Installing the Flash Kit), launch DriveExecutive and go online (via a 1203-USB or 1203-SSS converter) with the PowerFlex 755 drive.
- 2. In the Drives hardware view, select the PowerFlex 755 drive (**0** in <u>Figure 3</u> <u>on page 4</u>).
- 3. Click the information icon (2 in Figure 3) to display the drive's Properties dialog box.

- 4. In the Properties dialog box, click the Component Details tab (3 in Figure 3).
- 5. With the PowerFlex 755 drive selected, click Flash Update.

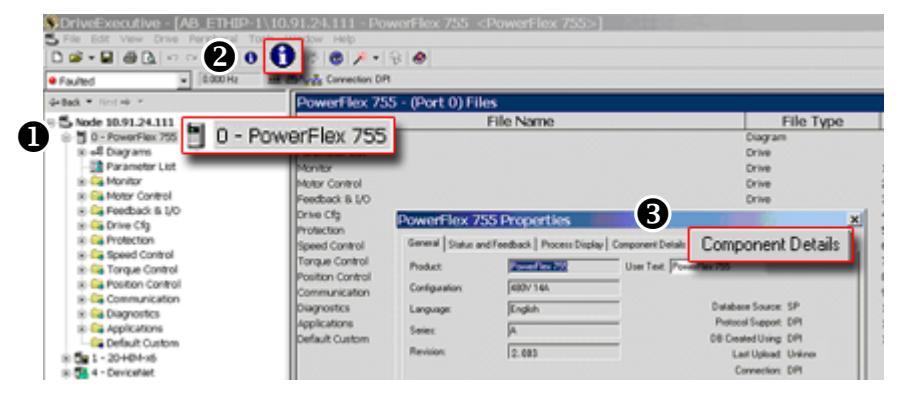
Figure 4 - Accessing the Component Details Tab of the Properties Dialog Box

- With the Flash Kit installed (see <u>Installing the Flash Kit</u>), launch DriveExecutive and go online (via a 1203-USB or 1203-SSS converter) with the PowerFlex 755 drive.
- 2. In the Devices hardware view, select the PowerFlex 755 drive (1) in Figure 4).
- 3. Click the information icon (2 in <u>Figure 4</u>) to display the drive's Properties dialog box.

In the Properties dialog box, click the Component Details tab (③ in Figure 4).

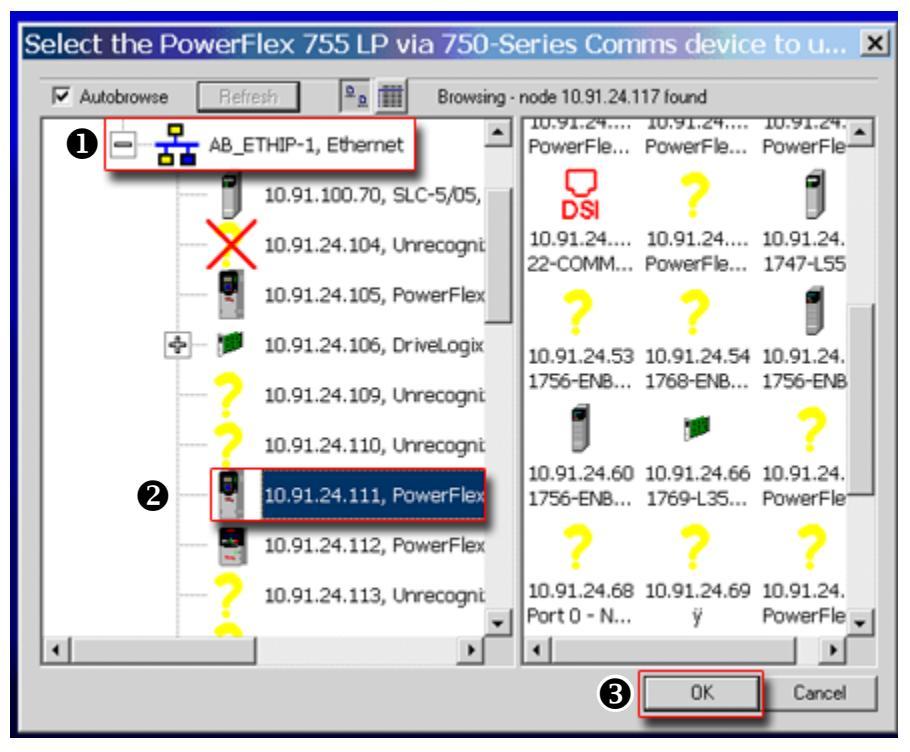
- 4. Now that the correct communication device has been selected, you must select which device is being updated. With the Select the PowerFlex... dialog box displayed, follow these steps.
- a. Expand the hardware view for the communication path you are using (1 in Figure 5).
- b. Select the drive icon that represents the PowerFlex 755 drive you are updating (2 in Figure 5).
- **c.** Click **OK** (**6** in <u>Figure 5</u>).

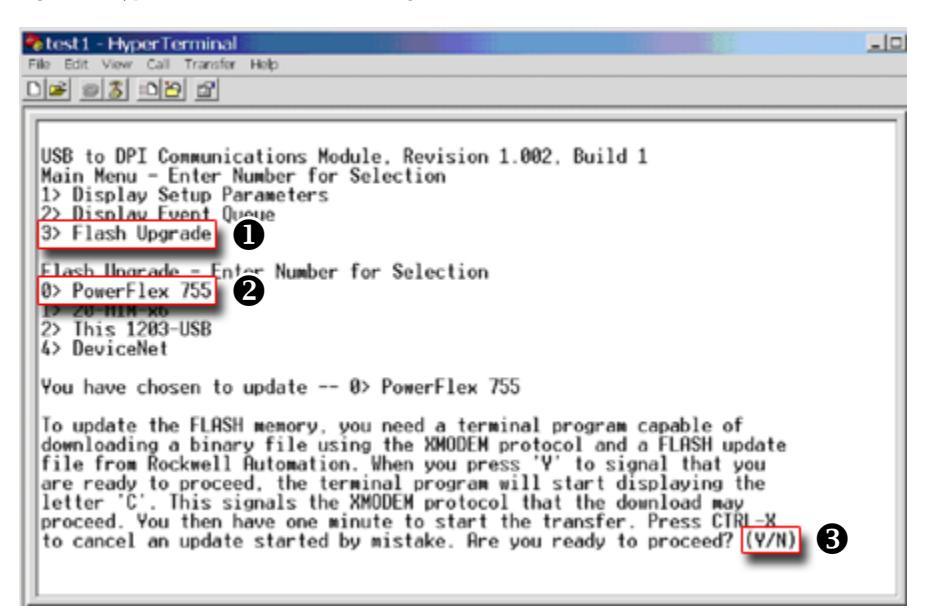
- 6. From the Main Menu, select the flash upgrade (● in <u>Figure 6</u>) by pressing the number 3 key on your computer keyboard.
- Additonal text appears. From the Flash Upgrade menu, select the PowerFlex 775 drive (2 in Figure 6) by pressing the number 0 key on your computer keyboard.
- Additonal text appears. After reading the conditions, select Yes (③ in Figure 6) to proceed by pressing the letter Y key on your computer keyboard.
