MANUAL PART NUMBER: 400-0438-005

DS801-110

**INTERA[®] COMPUTER/COMPONENT
VIDEO + AUDIO
TWISTED PAIR (UTP) TRANSMITTER**

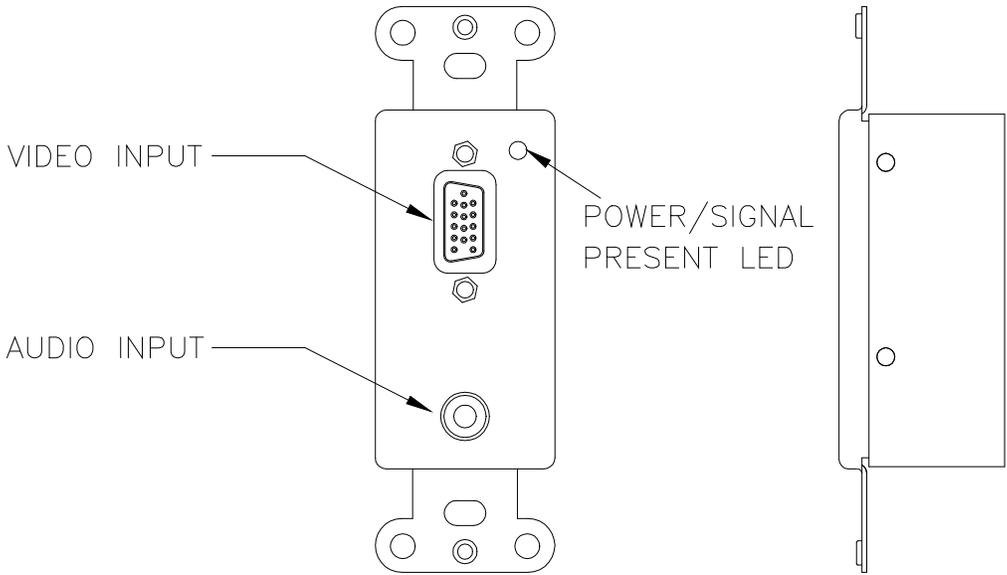
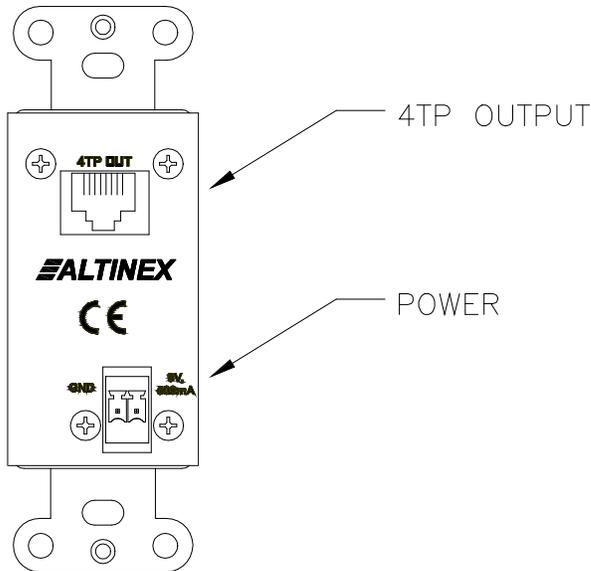
PRODUCT DESCRIPTION

The **DS801-110** offers a female 15-pin HD input with native Plug & Play compatibility. The 3.5 mm stereo audio jack is used for audio input. The female TP main output provides distributed drive to the UTP cable. The Signal Detect feature shows when a signal is present.

- Step 2.** Apply power to the 2-pin terminal block on the rear of the **DS801-110**. The Power/Signal Present LED should be on and red.
- Step 3.** Connect the video source to the input of the **DS801-110** using a high quality video cable. The Power/Signal Present LED should change from red to green indicating a signal is present.

- Step 4.** Connect the audio input source to the audio jack on the **DS801-110**.
- Step 5.** Run a UTP-type (CAT-5/CAT-5e) cable from the 4TP OUTPUT on the rear of the **DS801-110** transmitter to the 4TP INPUT on the TP Receiver.

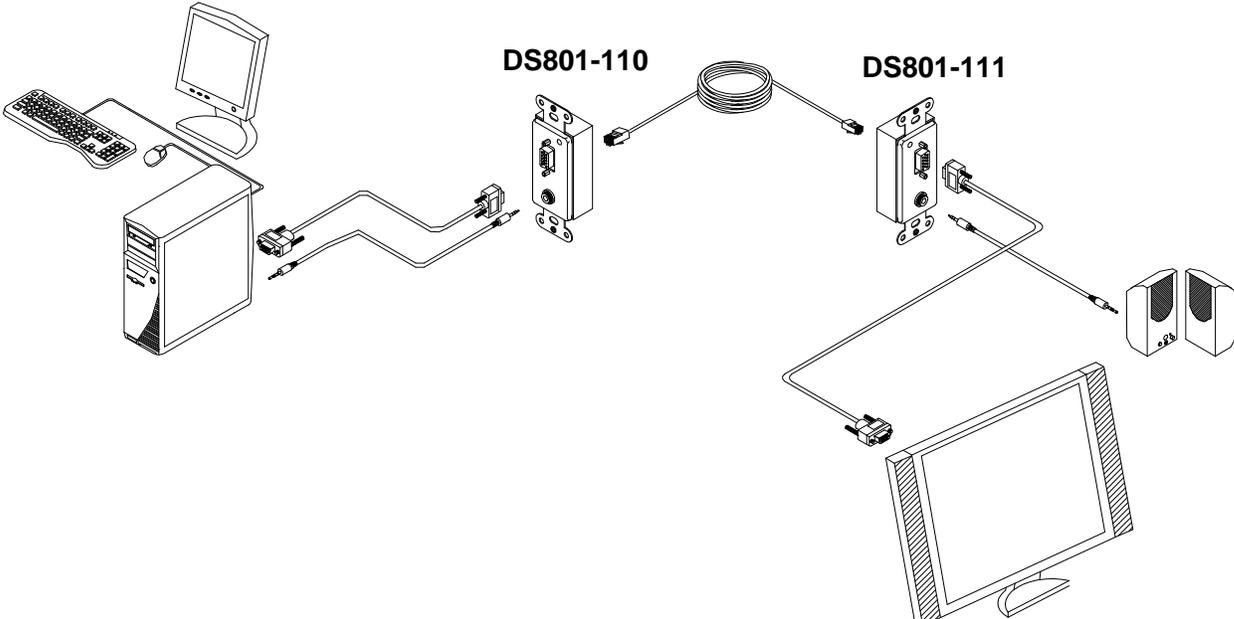
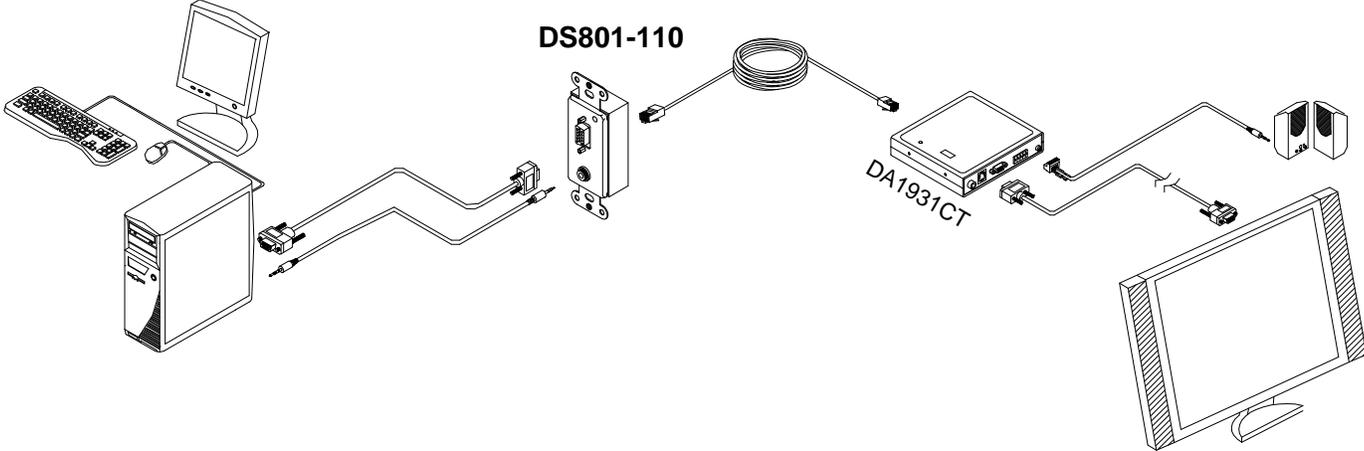
DIAGRAM 1: TYPICAL SETUPS

The **DS801-110** provides a means of transmitting computer video and audio signals over Twisted Pair-type (CAT-5/6) cable when used together with an ALTINEX UTP receiver, such as the DS801-111 or DA1931CT.

- Step 1.** Determine the best location for the **DS801-110** and TP Receiver. Where possible, locate the **DS801-110** as close to the video source as possible and the receiver as close to the receiving component as feasible.

- NOTE: Ensure good signal transmission by routing the cable to avoid any sharp angles, creases, or bends.
- Step 6.** Connect the TP Receiver per its installation instructions. In the case of the **DS801-111**, when the TP signal from the **DS801-110** is applied, the LED will turn from red to green.
