DIXON INDUSTRIES, INC. A BLOUNT COMPANY AIRPORT INDUSTRIAL PARK PO BOX 1569 COFFEYVILLE KS 673370945 316 251 2000 FAX 316 251 4117

TECHNICAL DATA BROCHURE Model 3301

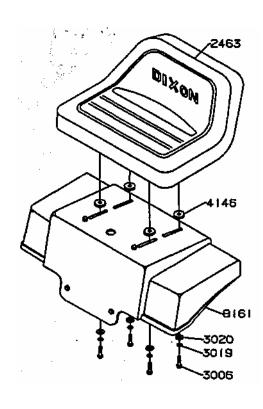
SEAT ADJUSTMENT

- 1. Pull or lift body retention latch P/N 3954 from transaxle backing plate, raise and push body and seat assembly forward.
- 2. Loosen four seat bolts P/N 3006 and slide seat forward or backward to desired position.
- 3. Re-tighten bolts. DO NOT operate mower without seat retention bolts properly tightened.
- 4. Close upper body and push retention latch P/N 3954 over transaxle backing plate.
