**(3)- (MAYTAG) FRONT LOAD WASHER MACHINE
CONTROL BOARD KIT #12001454, AND #12001725.**

Instruction Sheet

REPAIR PART NO. : 12001454, 12001725**DESCRIPTION : Machine Control Board Kit****This kit contains:**

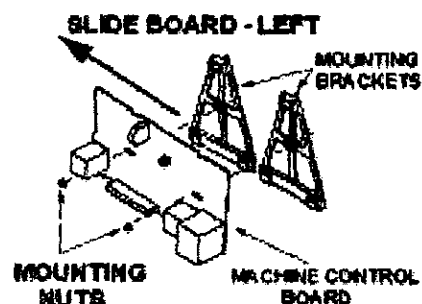
The following chart will depict which components apply to the washer you are servicing.

Model Number	Prior to Series 17	Series 17 & Later
MAH3000AWA	A	B
MAH3000AWQ	A	B
MAH3000AWW	A	B

A = Use all components and follow instruction steps 1 - 11 below.

B = Use only the 22002988 board and follow instruction steps 1, 2, 9, 10 & 11 below.
