SAFETY ALERT and MEDICAL DEVICE RECALL

Affected products: GlideScope Reusable GVL, AVL, and Ranger Blades

Affected products: GlideScope Reusable GVL and AVL Blades

SAFETY INFORMATION

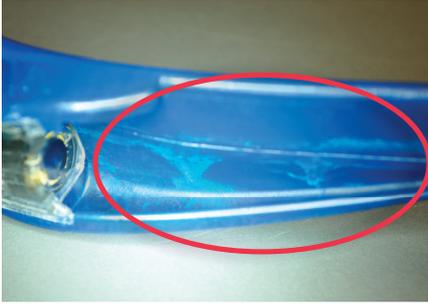
Surface Degradation

Damages and wear that may affect safety are shown inside the red circles and are the result of accelerated cycle-to-failure testing to simulate worst-case usage (end-of-life).

1. Regularly inspect the GlideScope video laryngoscope reusable blade before and after every use to identify any damage or wear that may lead to breakage (see representative examples on reverse side). It is critical to conduct regular inspections throughout the life of the product to prevent any risk to patient safety.
2. Immediately discontinue use if inspection reveals any of the following defects:
 - Rough surfaces
 - Protrusions
 - Sharp edges
 - Surface delamination
 - Cracks
 - Shell separation
3. Report any suspected blade defects to Verathon Customer Care at:
