Inspection Report

Final Random inspection

Packaging: each set packed in poly bag and bubble bag with paper board card then into a gift box
 Color:silver, yellow, grey.
 Dimension:product: product: LxWxH: 40x27x26.5cm, cable length: 476-480cm, hose: L150cm, telescopic tube: Ø35.5/Ø31.5x720/440mm,
 Weight:gift box: 660g, instruction manual: 23g, poly bag and bubble bag: 49g,paper board card:98g, nylon: 12g.product: 4300g . product assembly:5.42kg.
 Material: metal, plastic.
 Accessories: 1pc instruction manual include france for FRCA.
 1pc floor brush, 1pc bristle brush, 1pc crevice nozzle with brush, 1pc hose, 1pc holder,1pc telescopic tube.

Your Request No.: 802984
Inspection No. : 254968
Product Ref. : CVC930-11

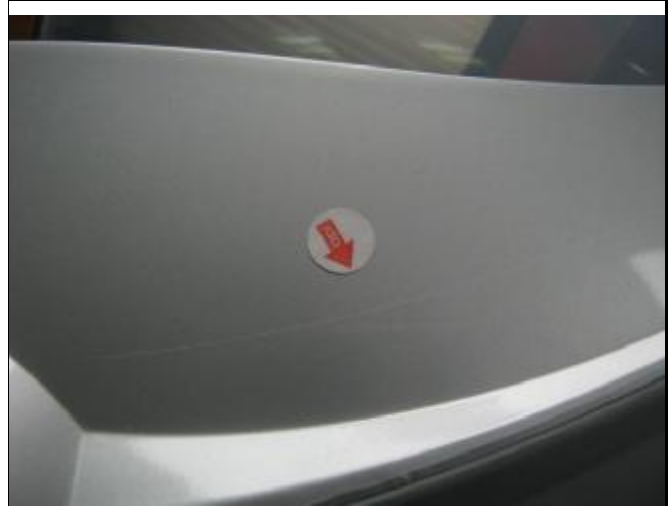
146 Defect1

No.	Defect Description	Critical	Major	Minor
1	Scratch mark on housing(image146-147)	0	0	3
2	Poor painting(image148)	0	0	1
3	damny of housing(149)	0	0	1
4	Poor surface of housing edge(image150-152)	0	0	5
Total :		0	0	10
