# **BIELA14 Series Gen II LOV**<sup>™</sup>**Electric Fryer**

# **Service Manual**

Part Number: FRY\_SM\_8196446 05/2015

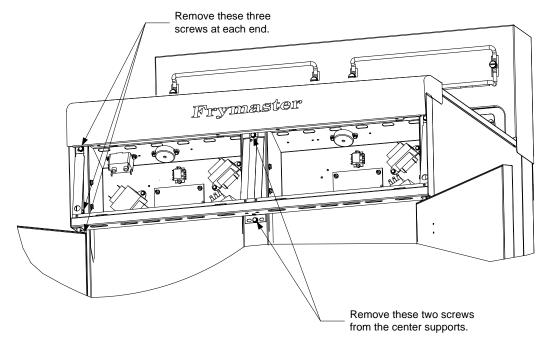
**NOTE:** If more room to work is required, the control panel frame assembly may be removed by removing the hex-head screws which secure it to the fryer cabinet (see illustration below). If this option is chosen, all computer assemblies must be removed per steps 1 thru 4 above. The cover plate, on the lower front of the component box, may also be removed to allow additional access if desired.

Removing the Control Panel Frame and Top Cap Assembly

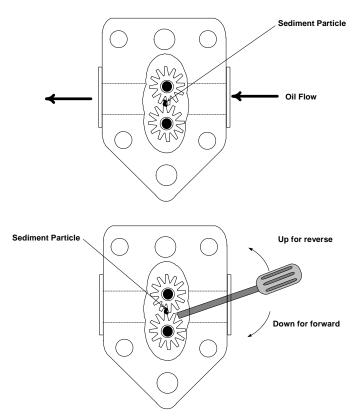
Disconnect power to the filter system, remove the input plumbing from the pump, and use a screwdriver to manually turn the gears.

- Turning the pump gears in reverse will release a hard particle.
- Turning the pump gears forward will push softer objects and solid shortening through the pump and allow free movement of the gears.

A pump seized by debris or hard shortening can usually be freed by manually moving the gears with a screwdriver or other instrument.

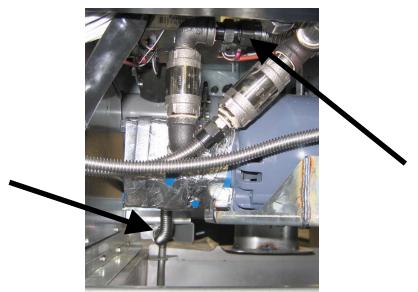
Disconnect flexlines indicated by the arrows.

- 2. Disconnect the fryer from the electrical power supply and reposition it to gain access to both the front and rear.
- 3. Disconnect the flexline running to the oil-return manifold at the rear of the fryer as well as the pump suction flexline at the end of the filter pan connection (see photo on the following page).

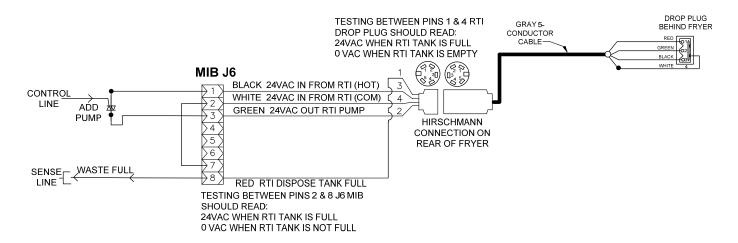
#### 1.12.2 RTI LOV™ Wiring

#### **BULK OIL LOV WIRING**

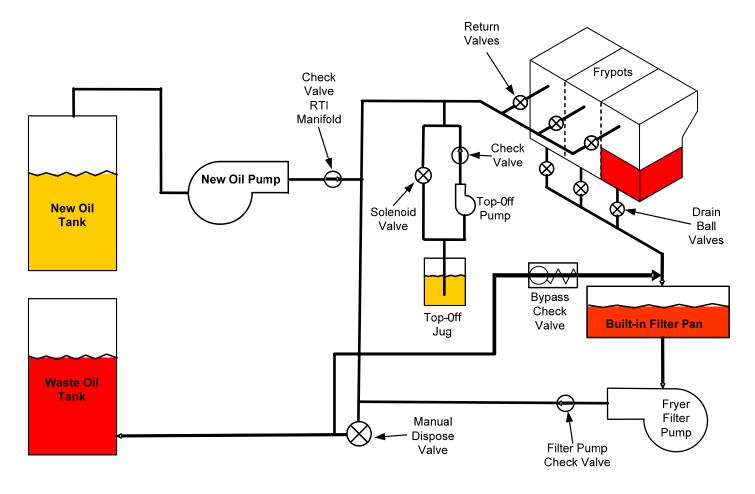
# 1.12.3 Frymaster LOV™ Fryer and RTI Bulk Oil System Plumbing Schematic

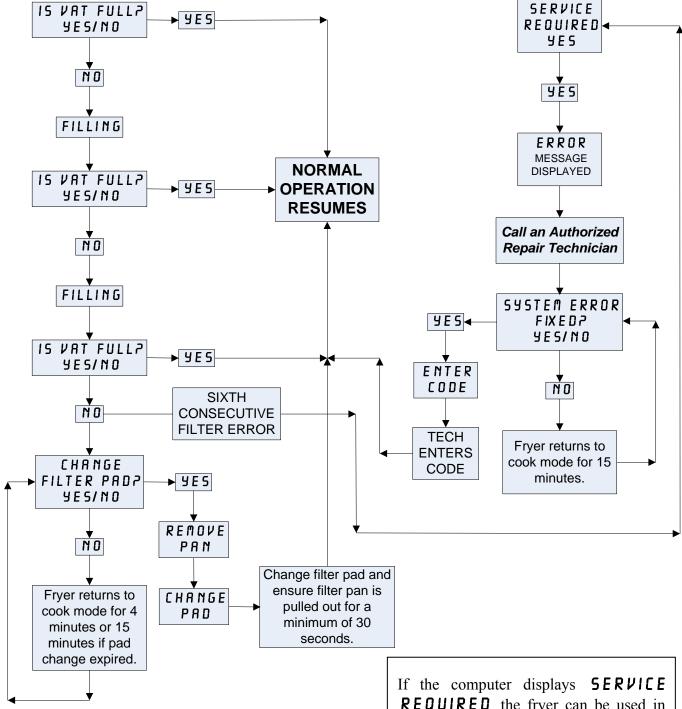
#### 1.14.6 M3000 Filter Error Flowchart

This chart follows the process of clearing a filtration issue. The prompt is displayed when any of the following occur:

- 1. a clogged filter pad,
- 2. a tripped or defective filter pump,
- 3. a leaky O-ring on the pick-up tube,
- 4. a failed drain valve/actuator, or
- 5. a failed return valve/actuator.

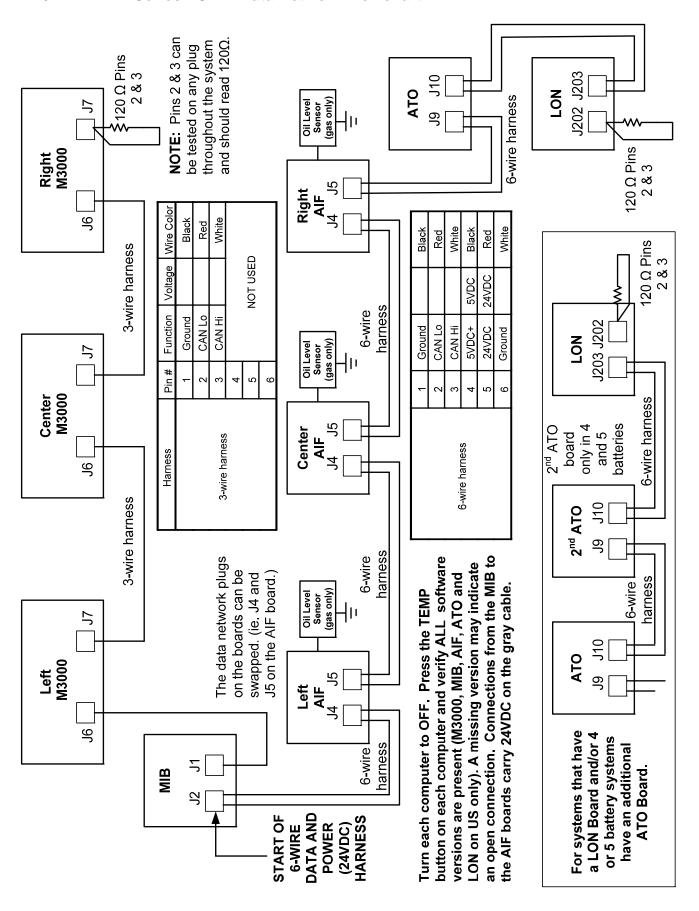
### 1.16 BIELA14 Series LOV™ Data Network Flowchart

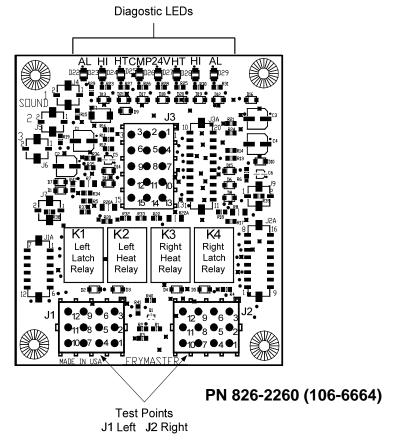
## 1.17 Interface Board Diagnostic Chart

The following diagram and charts provide ten quick system checks that can be performed using only a multimeter.

**Diagnostic LED Legend** indicates power from 12V transformer indicates power from 24V transformer НІ (RH) indicates output (closed) from right latch НІ (LH) indicates output (closed) from left latch relav HT (RH) indicates output from right heat relay (LH) indicates output from left heat relay HT (RH) indicates output (open) from right latch AL AL (LH) indicates output (open) from left latch
