SERVICE MANUAL Massage chair

ALPHA 2008.M (EUROPE)

ALPHA 2008.E (EUROPE)

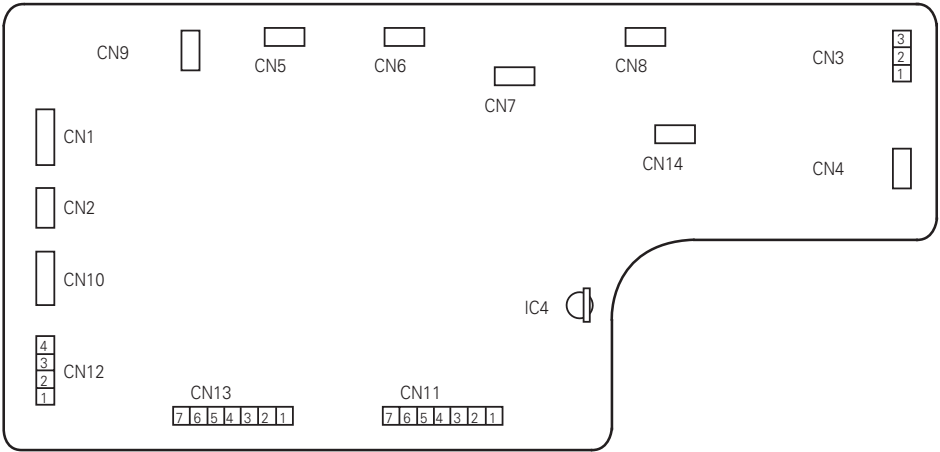
(ON-Printed-board Connectors Configuration Drawing)

Printed board (main)

Printed board (relay)

Printed board (pulse)

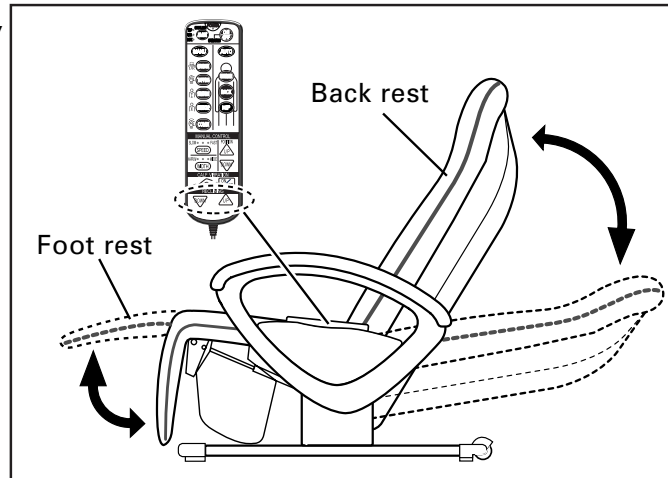
Motorized reclining operation

1. The back rest can recline steplessly up to 170 degree maximum by operating "RECLINING" switch on the remote control.
 2. According to the movement of back rest, foot rest, too, moves automatically.
(ALPHA 2008.E Only)
- The foot rest rises while the Back rest topples.
(ALPHA 2008.E Only)
 - This lowers a foot rest while raising a Back rest.
(ALPHA 2008.E Only)

1. The reclining motor rotates both clockwise and counterclockwise to make the cylinder stroke length adjustable.
2. The cylinder stroke length is made shorter simultaneously with startup of reclining motor, so that the backrest is pulled and reclines from frame supporting center by the cylinder.
3. Also, at the same time, this pushes a link ass'y and raises a foot rest.
(ALPHA 2008.E Only)

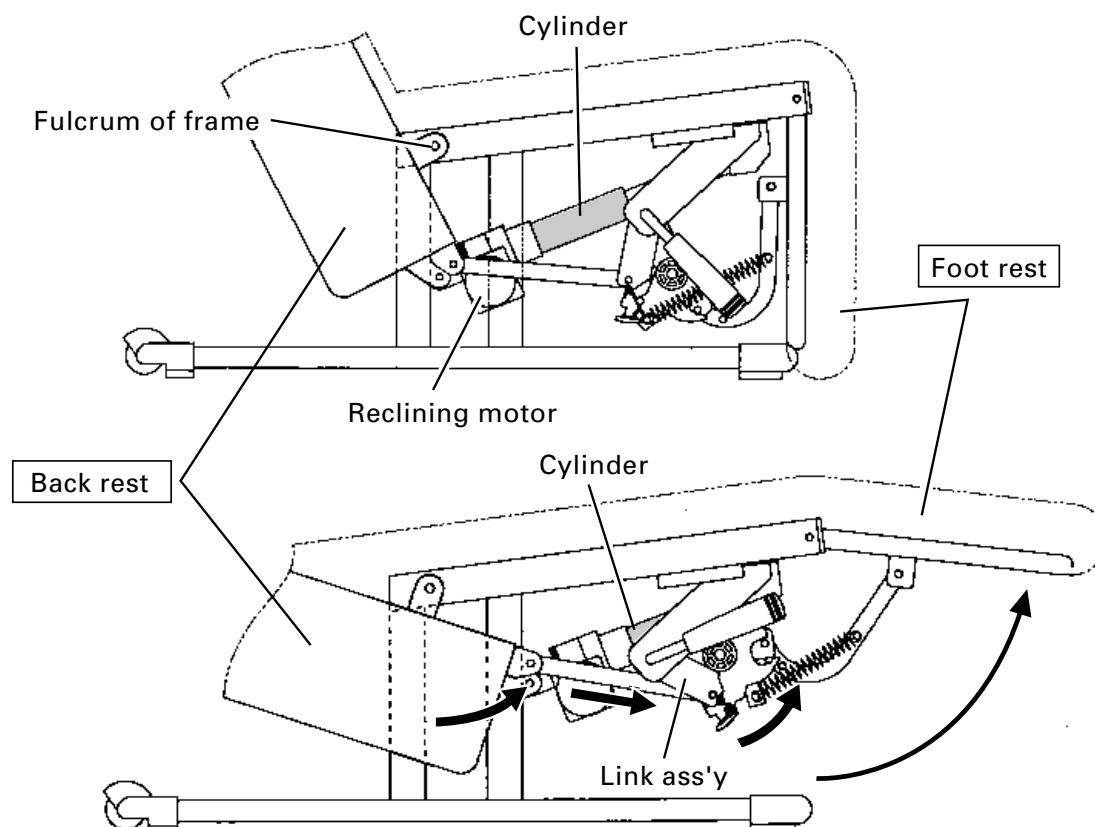
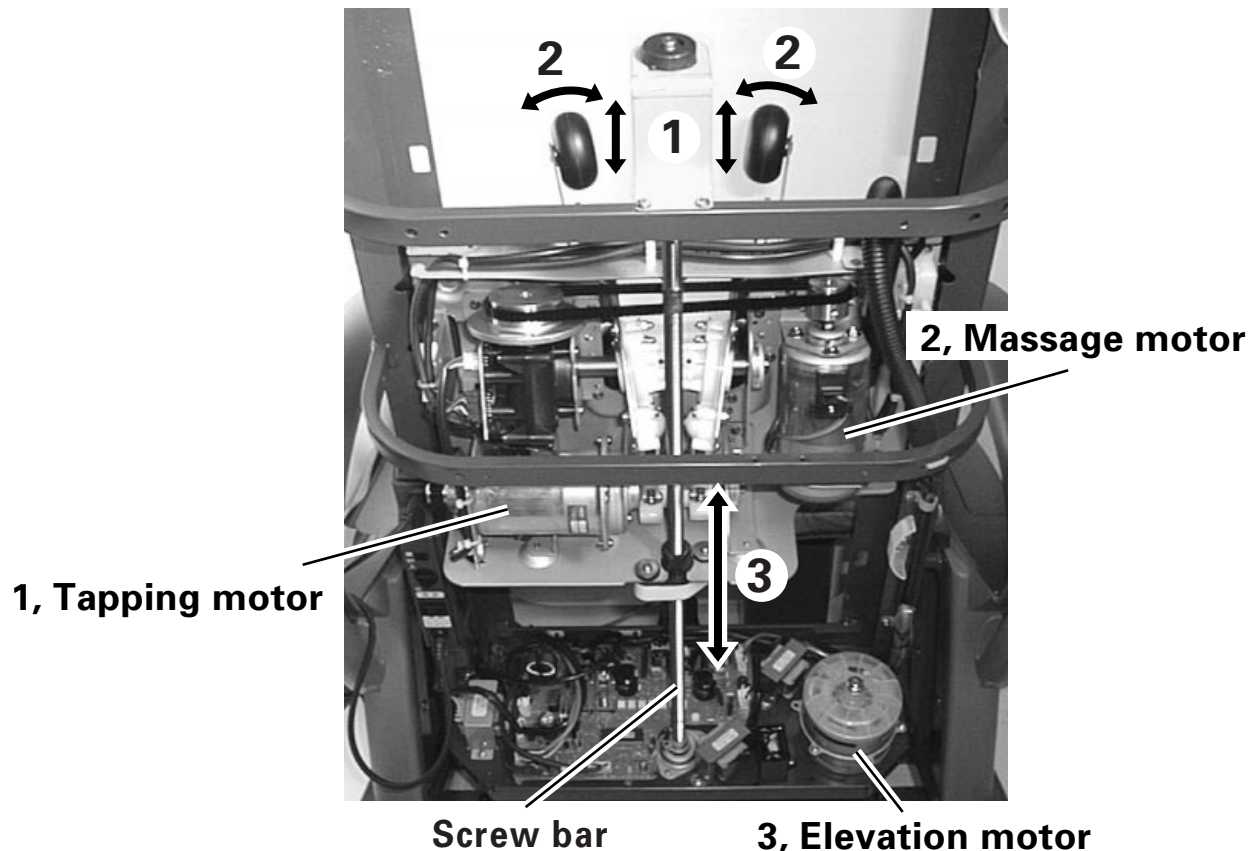
1, Tapping motor

This motor rotates to move the massage balls upward and downward alternately via the driving belt coupled to the motor.

2, Massage motor

This motor rotates to move the massage balls crosswise via the driving belt and gear box coupled to the motor.

3, Elevation motor

This motor rotates to transmit its rotating torque to the threaded rod via the driving belt, whereby the massage unit is moved upward and downward.

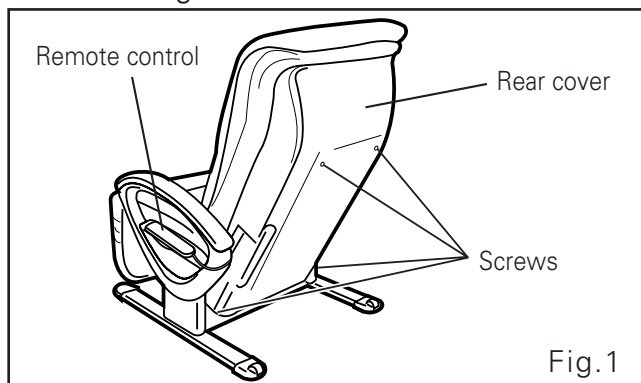
(1) How to remove the rear cover

1. Unscrew four fixing screws to remove the rear cover. Fig.1

2. Unscrew four remote control case fixing screws to open the case. Fig.1

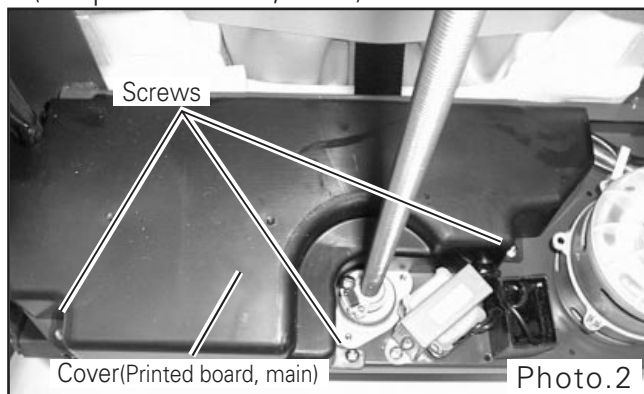
1. Unscrew three fixing screws to remove the cover (the printed board, main). Photo.2

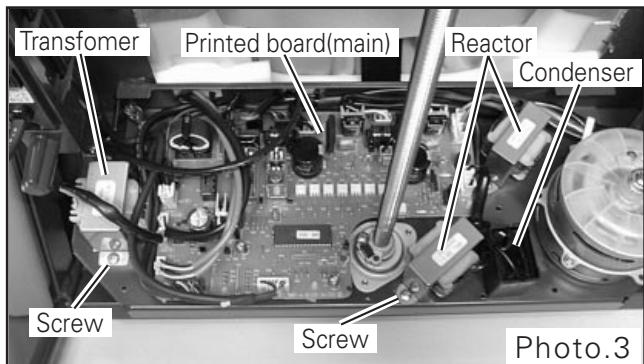
2. Pull out 14 connectors which are connected to the printed board (main) and thereafter demount the printed board.

3. Unscrew two transformer fixing screws to remove the transformer. Photo.3

4. Unscrew two reactor fixing screws and one capacitor fixing screw. Photo.3

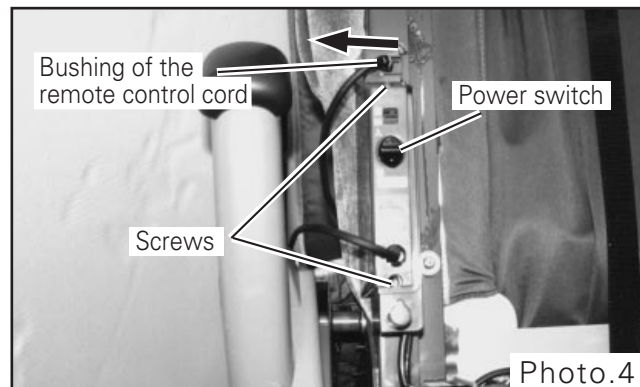
1. Unscrew two case fixing screws to remove the power switch. Photo.4

* In removing, shift the switch in arrow direction from the bushing of the remote control cord.

1. Remove the bushing from the remote cord. Photo.4

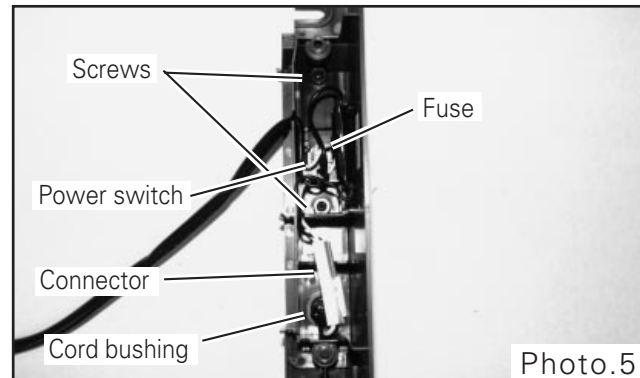
2. Open the power fuse case to take out the fuse. Photo.5

3. Unscrew two switch holder fixing screws to remove the power switch. Photo.5

4. Pull out the auxiliary connector outward, which is fitted in the case (power switch). Photo.5

1. Disconnect the power cord connector to remove the cord bushing from the power cord. Photo.5

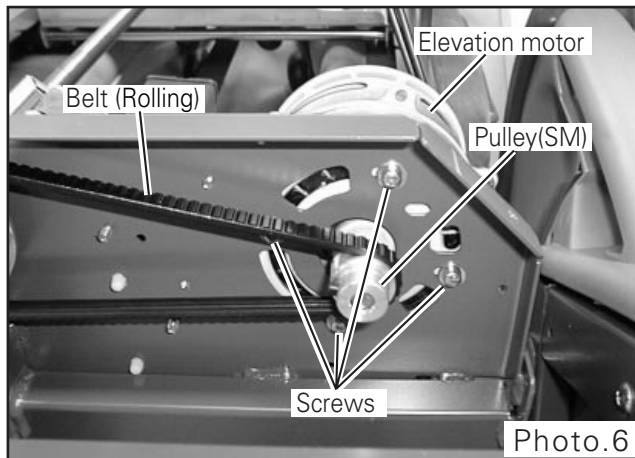
1. Disconnect the elevation motor lead wires.
2. Remove the belt (Rolling) and unscrew four motor mounting screws. Photo.6
3. Remove the pulley (SM) from the elevation motor output shaft and unscrew four elevation motor fixing screws. Photo.6

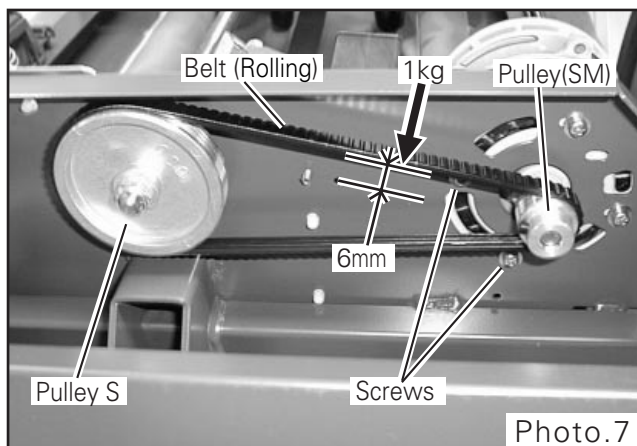
Apply the elevation belt to the pulley and adjust the belt tension as shown in Photo.7.

Thereafter, tighten four motor mounting screws with specific torque. Photo.7

Adjust and mount the pulley (SM) so its groove is kept in line with that of the pulley (S).

Be careful not to allow adhesion of grease to the belt drive unit, etc.

(Adhesion of grease thereto would result in malfunction due to slip.)

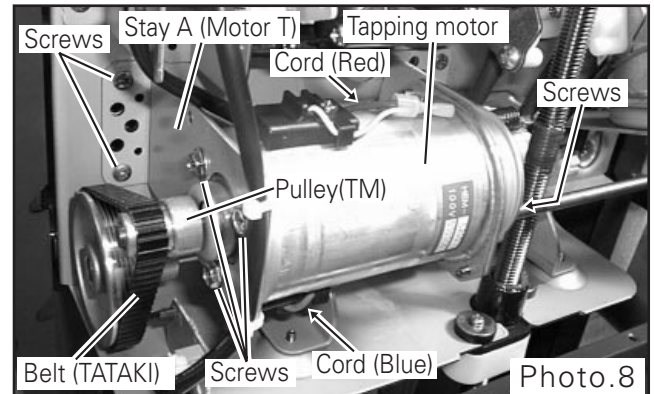
1. Disconnect the tapping motor cord connector.
2. Remove the belt (TATAKI). Photo.8
3. Unscrew one motor fixing screw. Photo.8
4. Unscrew two stay A (motor T) fixing screws and remove the tapping motor unit. Photo.8
5. Draw the pulley (TM) out of the tapping motor shaft and unscrew three tapping motor fixing screws. Photo.8

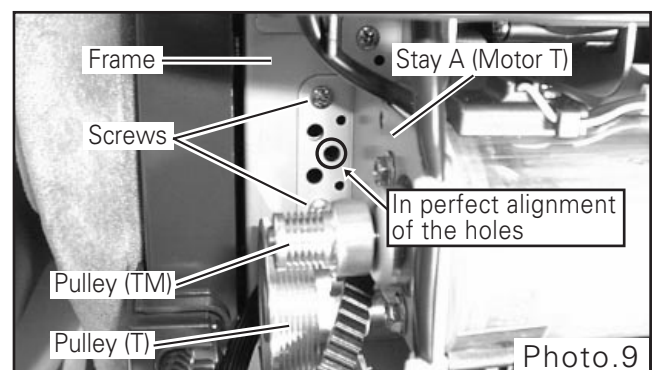
Photo.9

Fix the stay A firmly with two fixing screws so the round portion shown in Photo. 9 is aligned with the holes of the frame and of stay A (motor T). Photo.9.

Adjust and mount the pulley (TM) so its groove is kept in line with the groove of pulley (T).

Be careful not to allow adhesion of grease to the belt drive unit, etc.

(Adhesion of grease thereto would result in malfunction due to slip.)

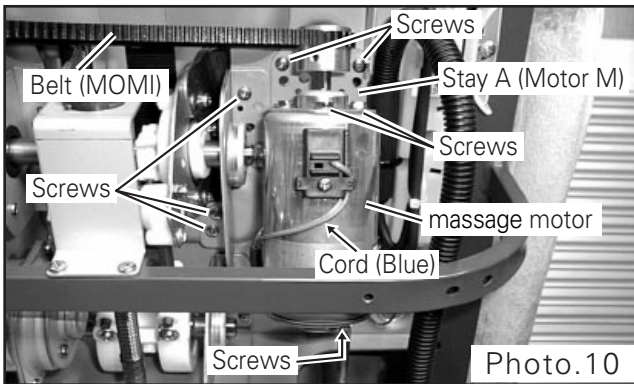
1. Disconnect the massage motor cord connector.
2. Take off the belt (MOMI). Photo.10
3. Unscrew one motor fixing screw. Photo.10
4. Unscrew two stay A (motor M) fixing screws to remove the massage motor unit. Photo.10
5. Draw the pulley (MM) out of the massage motor shaft and unscrew three massage motor fixing screws. Photo.10

5. Loosen a little four right-side shaft M fixing screws. Photo.10
6. Unscrew four gear box fixing screws to separate the gear box from the shaft. Photo.13
7. Remove the pulley (M) from the gear box. Photo.13
8. Unscrew two stay fixing screws at each side of the gear box to remove the stays (left and right). Photo.13

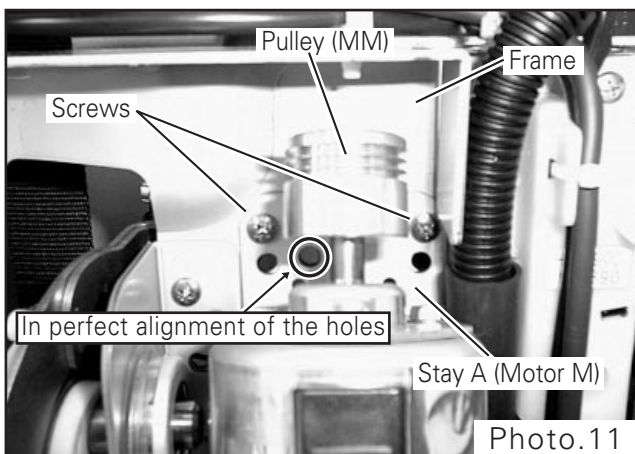
Fix the stay A firmly with two fixing screws so the round portion shown in Photo. 11 is aligned with the holes of the frame and stay A (motor M). Photo.11

Adjust and mount the pulley (MM) so its groove is kept in line with the groove of the pulley (M).

*Be careful not to allow adhesion of grease to the belt drive unit, etc.
(Adhesion of grease thereto would result in malfunction due to slip.)

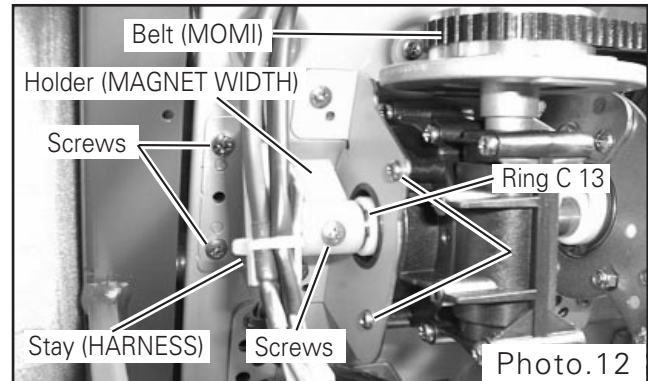
1. Take off the belt (MOMI). Photo.12
2. Unscrew two stay (HARNESS) fixing screws to remove the stay (HARNESS). Photo.12
3. Unscrew one holder (MAGNET WIDTH) fixing screw to remove the holder (MAGNET WIDTH) from the shaft. Photo.12
4. Take off C-ring from the shaft. Photo.12

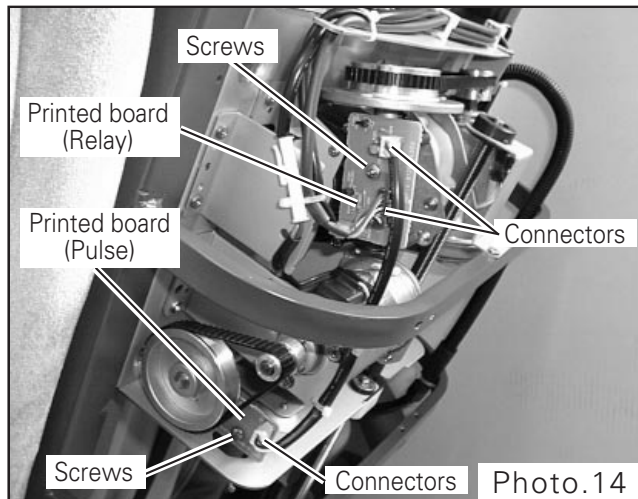
1. Disconnect three connectors connected to the Printed board (Relay). Photo.14
2. Unscrew one screw fixing the Printed board (Relay) to remove the Printed board (Relay). Photo.14
3. Disconnect one connector connected to the Printed board (pulse). Photo.14
4. Unscrew one screw fixing the Printed board (pulse) to remove the Printed board. Photo.14

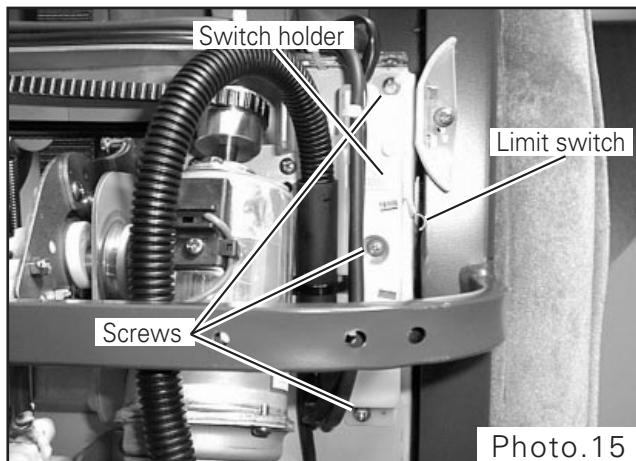
1. Unscrew three switch holder fixing screws. Photo.15
2. Unscrew switch fixing screws. After that, remove solder from each switch terminal to demount the switch. Photo.15

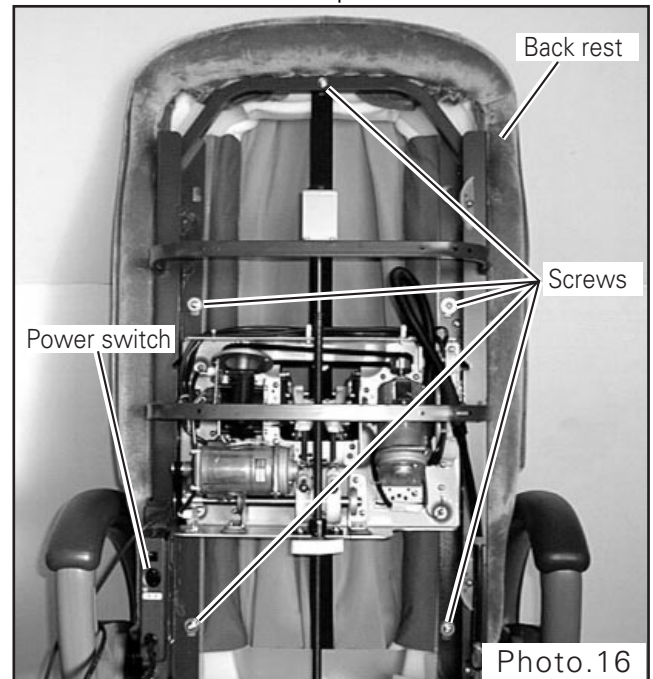
1. Turn OFF the power switch after moving the massage unit to the position shown in Photo. 16 using "UP/DOWN ADJUSTMENT" on the remote control.
2. Unscrew five back rest (pair) fixing screws to remove the back rest (pair). Photo.16

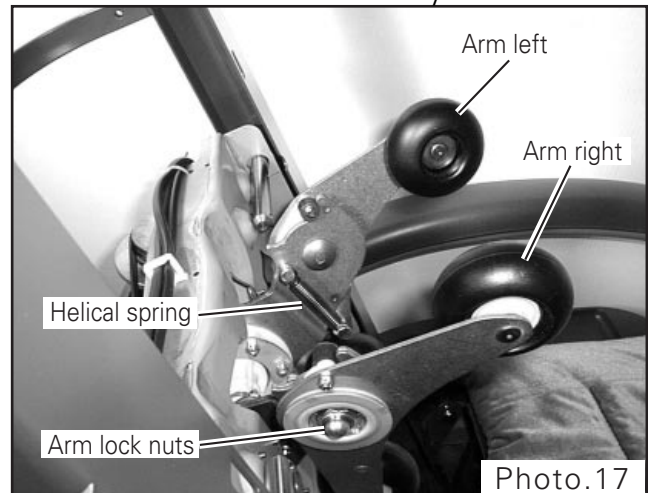
1. Remove the helical spring for the arm. Photo.14
 2. Unscrew the right arm fixing nut to remove the right arm. (Also, remove the left arm similarly.) Photo.14
- * Remove the left arm similarly.

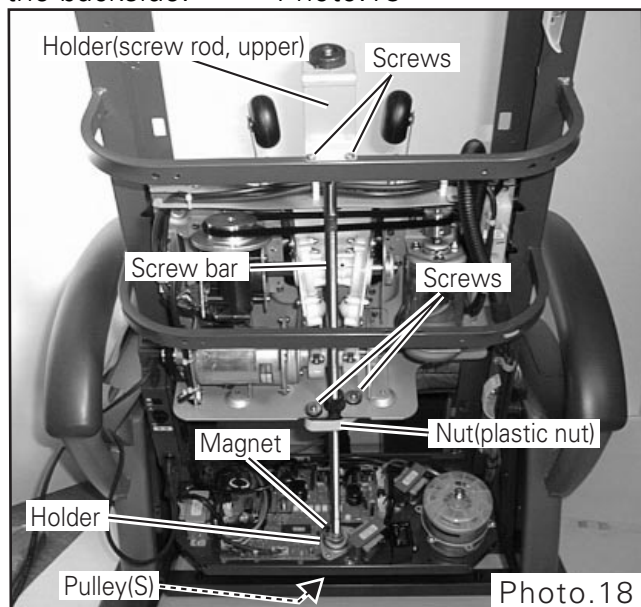
1. Unscrew two nut (plastic nut) lock screws. Photo.18
2. Unscrew two holder (Screw rod, upper) fixing screws and remove the holder, subsequently taking out the massage unit upward. Photo.18
3. After temporarily locking the magnet with a pliers or the like, unscrew the backside pulley (S) fixing nut and remove the pulley (S) from the screw rod. Photo.18
3. Unscrew two screw rod holder screws from the backside. Photo.18

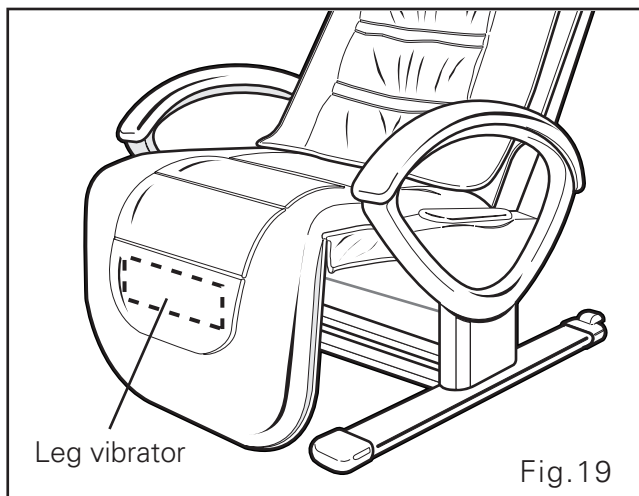
1. Disconnect the lead wires of the leg vibrator motor.
2. Remove the seat cover from underside, with the foot rest lifted.
3. Open the fastener and take out the leg vibrator. Fig.16

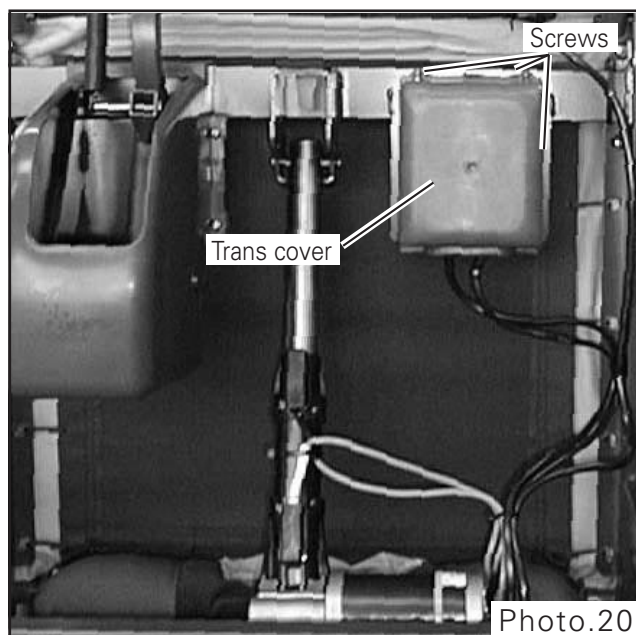
1. Unscrew three fixing screws to remove the transformer cover. Photo.20

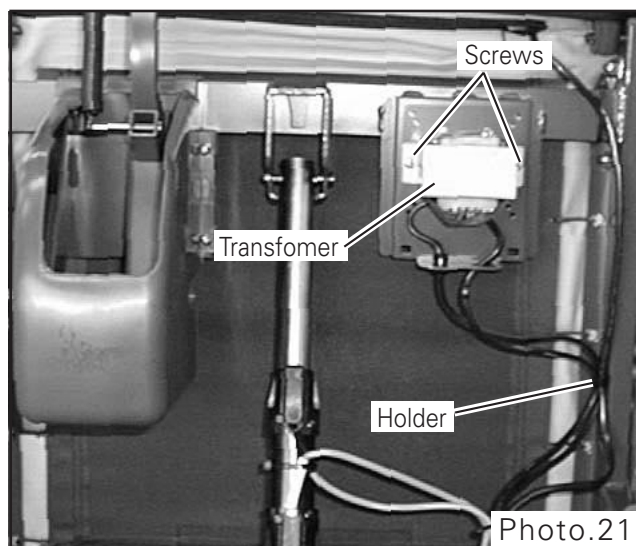
2. Unscrew fixing screws to remove the folder and pull out a connector.
3. Unscrew fixing screws to remove the transformer. Photo.21

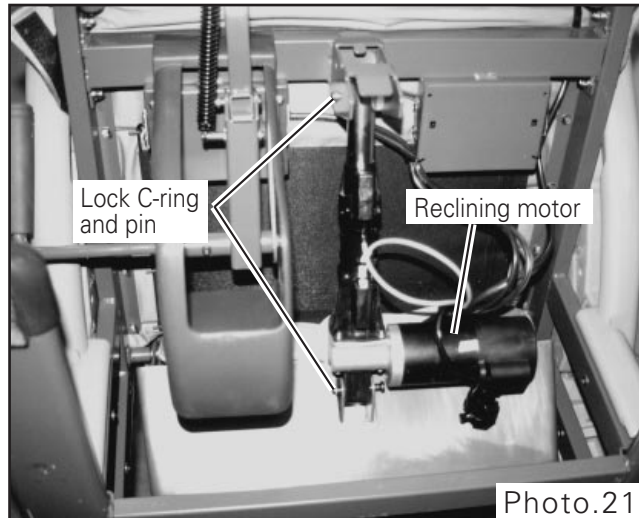
1. Disconnect the lead wires from the reclining motor.
2. The reclining motor is fixed at the both end sides. Take off the lock C-rings from the both ends and pull out the pin. Photo.21
