SQUEAK AND RATTLE TROUBLE DIAGNOSES

2006 350Z

INSTRUMENT PANEL ASSEMBLY Component Parts Drawing

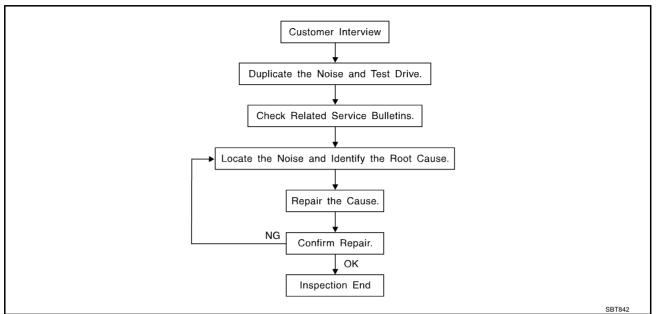
Work Flow

CUSTOMER INTERVIEW

Interview the customer if possible, to determine the conditions that exist when the noise occurs. Use the Diagnostic Worksheet during the interview to document the facts and conditions when the noise occurs and any customer's comments; refer to IP-8, "Diagnostic Worksheet". This information is necessary to duplicate the conditions that exist when the noise occurs.

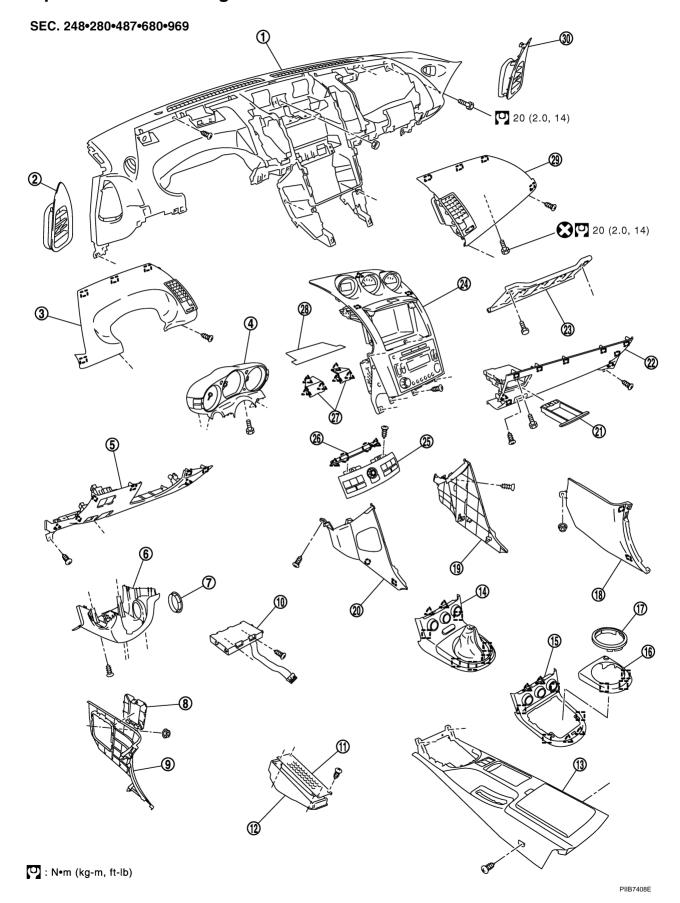
1.	Instrument panel	2.	Instrument side finisher (LH)	3.	Instrument driver panel upper
4.	Combination meter	5.	Instrument driver panel lower	6.	Steering column cover
7.	Steering lock escutcheon	8.	Fuse cover	9.	Dash side finisher (LH)
10.	Unified meter and A/C amp.	11.	Foot rest plate	12.	Foot rest
13.	Center console	14.	Console boot (M/T)	15.	Cluster lid C lower
16.	Console finisher (A/T)	17.	Console finisher (A/T ring)	18.	Dash side finisher (RH)
19.	Instrument side panel (RH)	20.	Instrument side panel (LH)	21.	Card holder
22.	Instrument passenger panel lower	23.	Knee protector	24.	Cluster lid C
25.	NAVI switch	26.	Instrument center panel	27.	Instrument finisher (LH/RH)
28.	Pocket mat	29.	Instrument passenger panel upper	30.	Instrument side finisher (RH)
<u> </u>	Pawl	(_)	Clip	[-]	Metal clip
		_

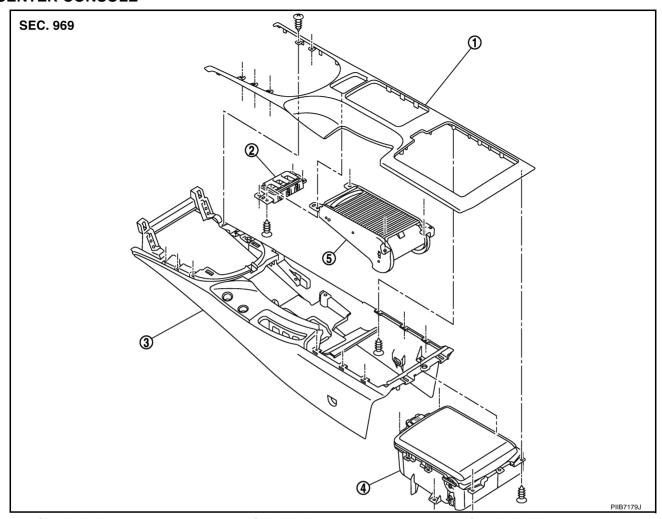
Disassembly and Assembly CENTER CONSOLE

- Console body upper
 Console rear pocket
- 2. Switch bracket
- 5. Cup holder

Console body lower

- 1. Remove screws, remove console body upper.
- 2. Remove screws, and then remove console rear pocket from console body lower.
- 3. Remove screws, and then remove switch bracket from console body upper.
- 4. Remove screws, and then remove cup holder from console body upper.

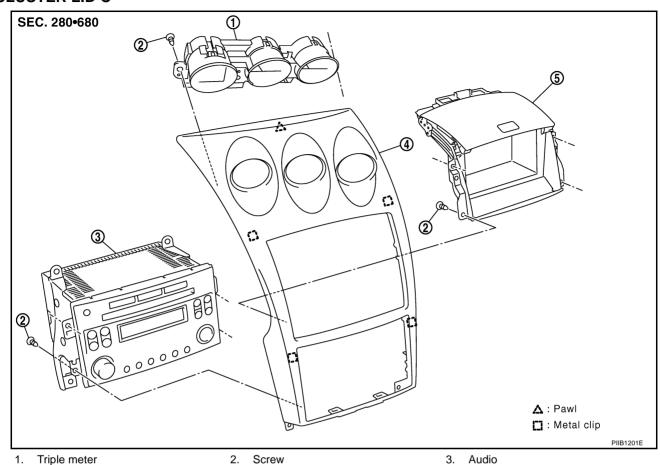
CLUSTER LID C

4. Cluster lid C

- 1. Remove screws, and then triple meter.
- 2. Remove screws, and then instrument upper box. (Without NAVI models)
