Plexus P2500

Aire Select System

Service Manual

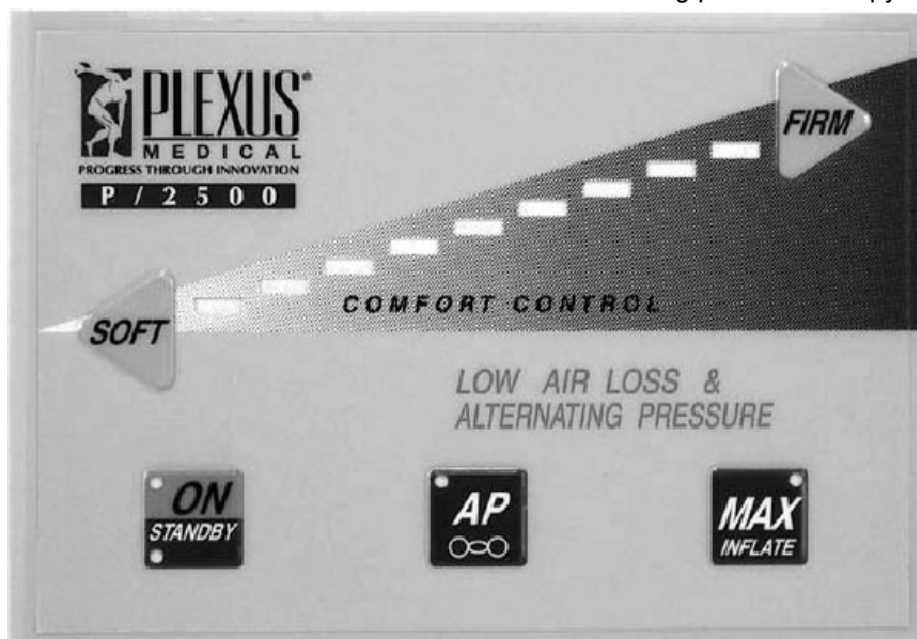
Figure 1 – C/2500 Front Control Panel

5.1 Front Panel Features (see figure 1)

- Used to turn the system on and off.
- The amber LED indicates the unit is in standby mode.
- The green LED indicates the unit is in normal running mode.

- The Plexus 2500 provides the added benefit of patient comfort control.
- The soft button is used to decrease the pressure in the mattress, and the firm button is used to increase the pressure in the mattress, with a range between approximately 10mmHg and 32mmHg max.
- Nine pressure settings are available to enable the user to select the lowest possible pressure that will still support the patient.
- An LED panel reminds the caregiver of the system settings that are correct for their patient.

- The air mattress can be maximally inflated (32mmHg) by pushing the "MAX INFLATE" button on the control unit, to assist in patient ingress/egress as well as normal nursing procedures.
- Upon initiating the maximum inflate condition, the mattress will rapidly inflate to its highest (firmest) level and maintain that setting.
- "MAX INFLATE" button will remain illuminated while system is in maximum inflation mode.
- If the "MAX INFLATE" button is pushed during max inflation mode, the button will cease illuminating and the system will return to previously chosen settings.
- After 30 minutes in the "MAX INFLATE" mode, the system is programmed to automatically return to the therapeutic settings. This fail-safe feature prevents a high-risk patient from inadvertently being left on a firmer than therapeutic surface.

- The Plexus Aire Select system gives the caregiver the option of whether or not to use alternating low-pressure therapy.
- A simple push of a button on the control unit transforms the Plexus Aire Select system from a low air loss therapy system to one that provides alternating pressure therapy.

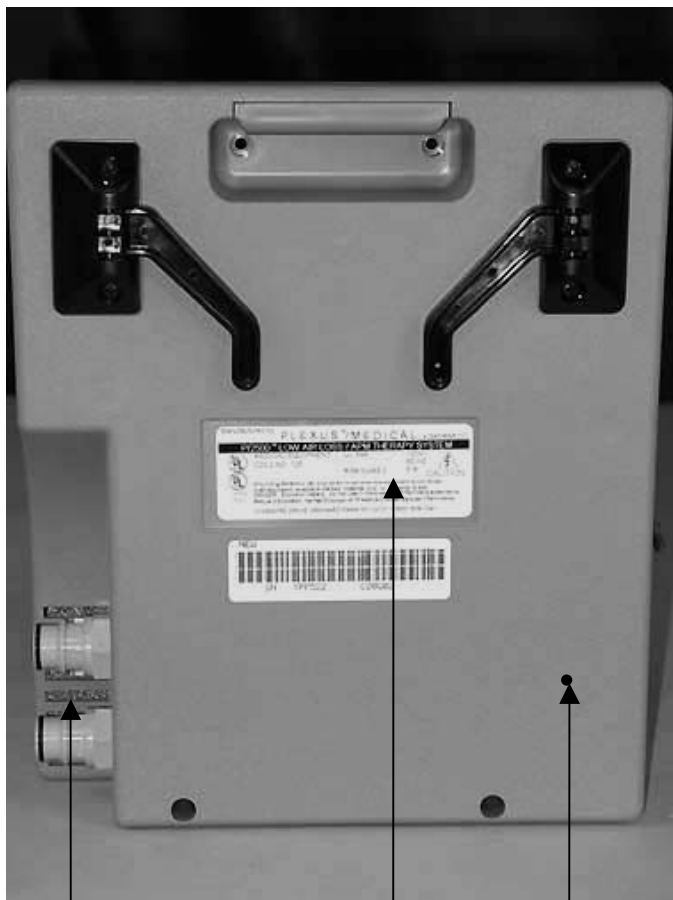
Figure 2 - C/2500 Rear Panel

5.2 Rear Panel Features (see figure 2)

1. WASHABLE FILTER ELEMENT

Requires periodic cleaning between patient uses or every 30 days.

2. MODEL/SERIAL NUMBER /IDENTIFICATION PLATE

This barcode label must not be removed from the unit. The model and serial number information is needed to arrange for returns to the factory.

3. CURRENT LEAK TEST ACCESS POINT

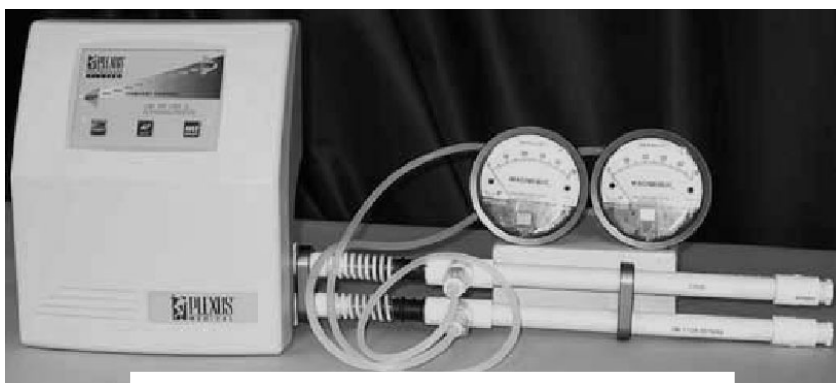
Figure 3 – C/2500 Function Test

7.0 Routine Maintenance and Function Testing (see figures 3 and 4)

Connect the unit to the mattress simulator or test mattress as shown in figures 3 and 4.

1. With the unit operating in the Low Air Loss mode (AP light off), press the appropriate soft/firm key until one LED bar is lit on the comfort control indicator. After a moment verify the test manometer reads 9 ± 4 mmHg.

2. Adjust the soft/firm keys until all the LED bars are lit on the comfort control indicator. After a moment verify the test manometer reads 27 ± 4 mmHg.

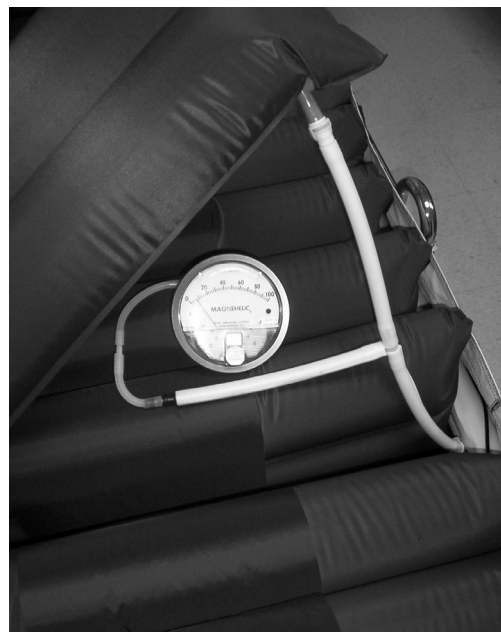
Figure 4 – C/2500 Function Test

M2500 mattress with P/N 11668-000 (see figure 4)
