Corvette Forum > C6 Corvette, 2005 - ????? > C6 Corvette General Discussion

■ Need help : cracked headlamp cover

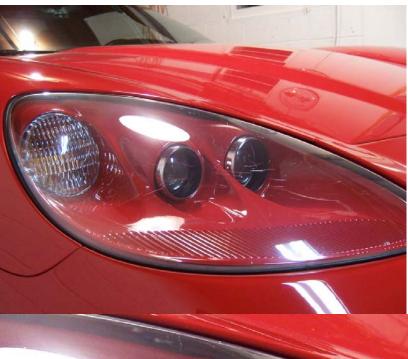
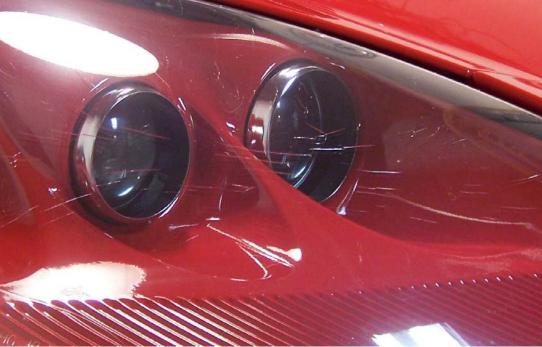
This just cracked with no known trauma at all.

No accident. No rock impact, as you can tell on the photos.

Just started cracking soon after I got the car, and continued with time to get worse.

There was absolutely no impact or other reason for this to occur.

Note that I did actually have Stongard film on both headlamps - it's really good stuff, I removed it before taking that picture. That stuff is so thick that it would have absolutely protected the headlamp if a rock had hit it. This just started on it's own for unclear reasons.

Yes, I've wondered if this ultra-thick stongard light protection might have somehow contributed to the cracking of the cover. Here is the Stongard light protection I used: it's VERY thick, about 2.5 mm thick (98 mil). More on this stuff at my web site - click on "protection".

I believe the aftermarket covers caused the cracking. If so, this is not warranty. I would suggest that you remove the cover from the other headlamp.

A variety of chemicals can cause crazing or cracking of the headlamp lens. Headlamp lenses are very sensitive. Care should be exercised to avoid contact with all exterior headlamp lenses when treating a vehicle with any type of chemical, such as those recommended for rail dust removal. Rubbing compound, grease tar and oil removers, tire cleaners, cleaner waxes and even car wash soaps in too high a concentration may also attribute to this condition. This could result in the need to replace the entire headlamp housing.

Also, crazing or deformations of the lens may occur if a shop mat or fender cover is draped over the fender and covers a portion or all of the headlamp assembly while the DRL or headlamps are on. This action restricts the amount of heat dissipated by the headlamps.

Once a heat buildup is generated by the headlamp, a degradation of the headlamp lens begins. This degradation of the lens can be unnoticeable at first and eventually manifest as spider cracks. In more extreme cases, it will begin to melt the lens of the headlamp.
