Service manual

Eschmann After Sales Service Department

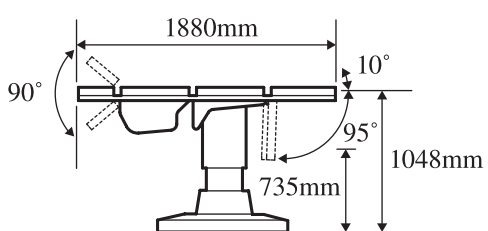
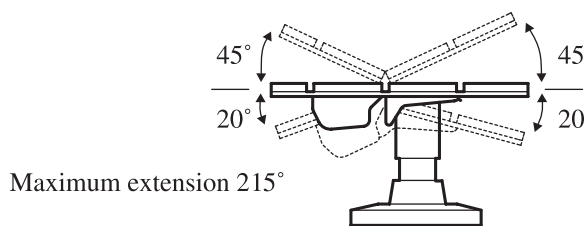
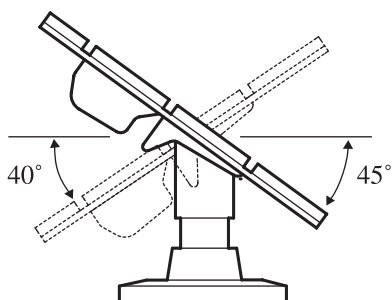
DIMENSIONS AND MOVEMENTS

Side bar dimensions

UK	31.75 x 6.35mm (1 1/8 x 1/4 in)
North America	28.5 x 9.5mm (1 1/8 x 3/8 in)
Europe	25 x 9mm

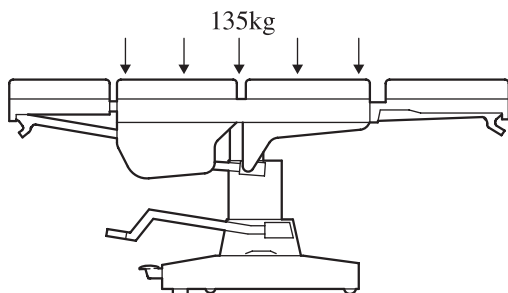
Retention of Adjusted Height: The table will retain its adjusted height with a load of 135kg uniformly applied to the trunk sections.

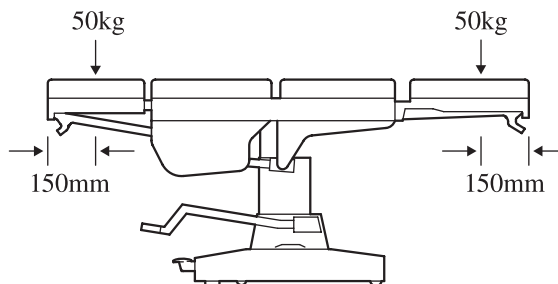
Longitudinal Deflection Load: The table will withstand a load of 50kg applied at a point 150mm in from either end of the head or leg section.

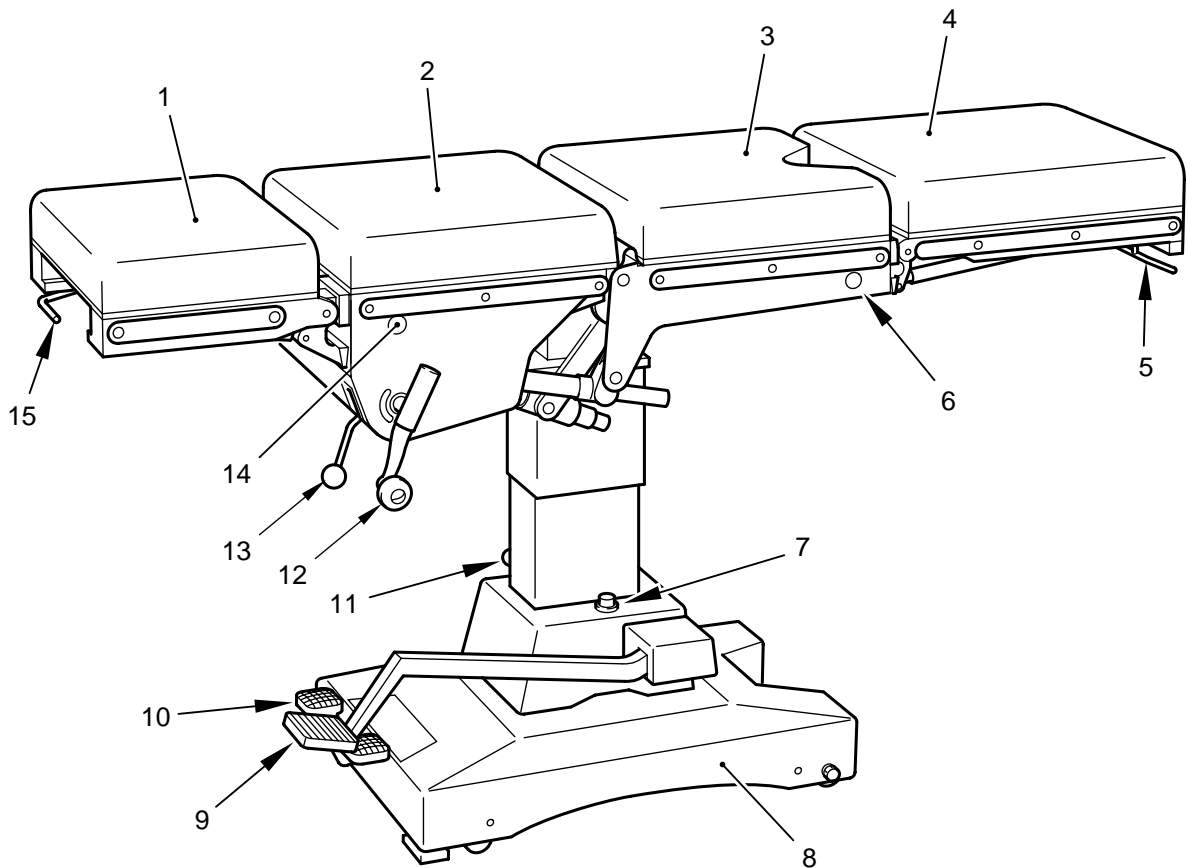
| 1 Head Section | 9 Height Control Pedal |

- i Lift table top and ram cylinder away from table base, as described in section 4.35 then, after draining off excess oil from cylinder back into table base, remove table top and cylinder assembly and lay it on its side. (Do not stand the assembly on the bottom of the cylinder as this will damage the relief valve mechanism).
- ii Invert table base to empty out all the oil and clean out the oil reservoir thoroughly.
- iii Reassemble the table into its base.
- iv Remove oil filler cap and pour 2.8 litres (5 Imp. pints) of the hydraulic oil supplied into the sump via the oil filler (7, Fig. 3). To do this effectively, the oil should be added little

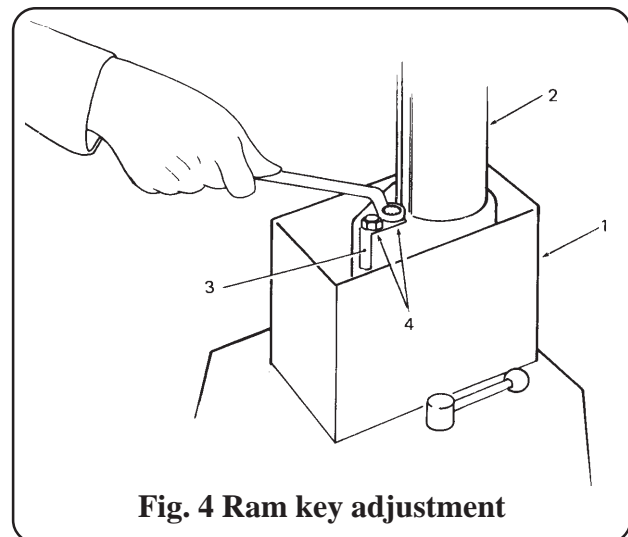
Fig. 4 Ram key adjustment

4.8 Raise the table top to its maximum height again and release the ram cover securing screws at the top. Refer to Fig. 4 and lower the 3-section telescopic cover (1) to expose the ram (2) and ram key (3).

4.11 Before refitting ram cover, check that table will raise and lower smoothly. If this is not the case, the ram key is probably secured too tightly. Release the key attachment bolts (4) slightly to remove excessive friction, then retighten.

4.25 Rotational movement of the table top is controlled by the tapered ram key (3, Fig. 4). Excessive movement is due to wear of the ram key increasing the clearance in the keyway. This can be corrected by slightly loosening the ram key clamping bolts (4, Fig. 4), gently tapping the key into the keyway until excess movement has been removed and retightening the clamping bolts. Check that the ram key has not been over-tightened by fully raising and lowering the table top. If the table top will not raise or lower correctly, the ram key has been over-tightened and must be slackened until normal raising and lowering of the table top can be achieved.

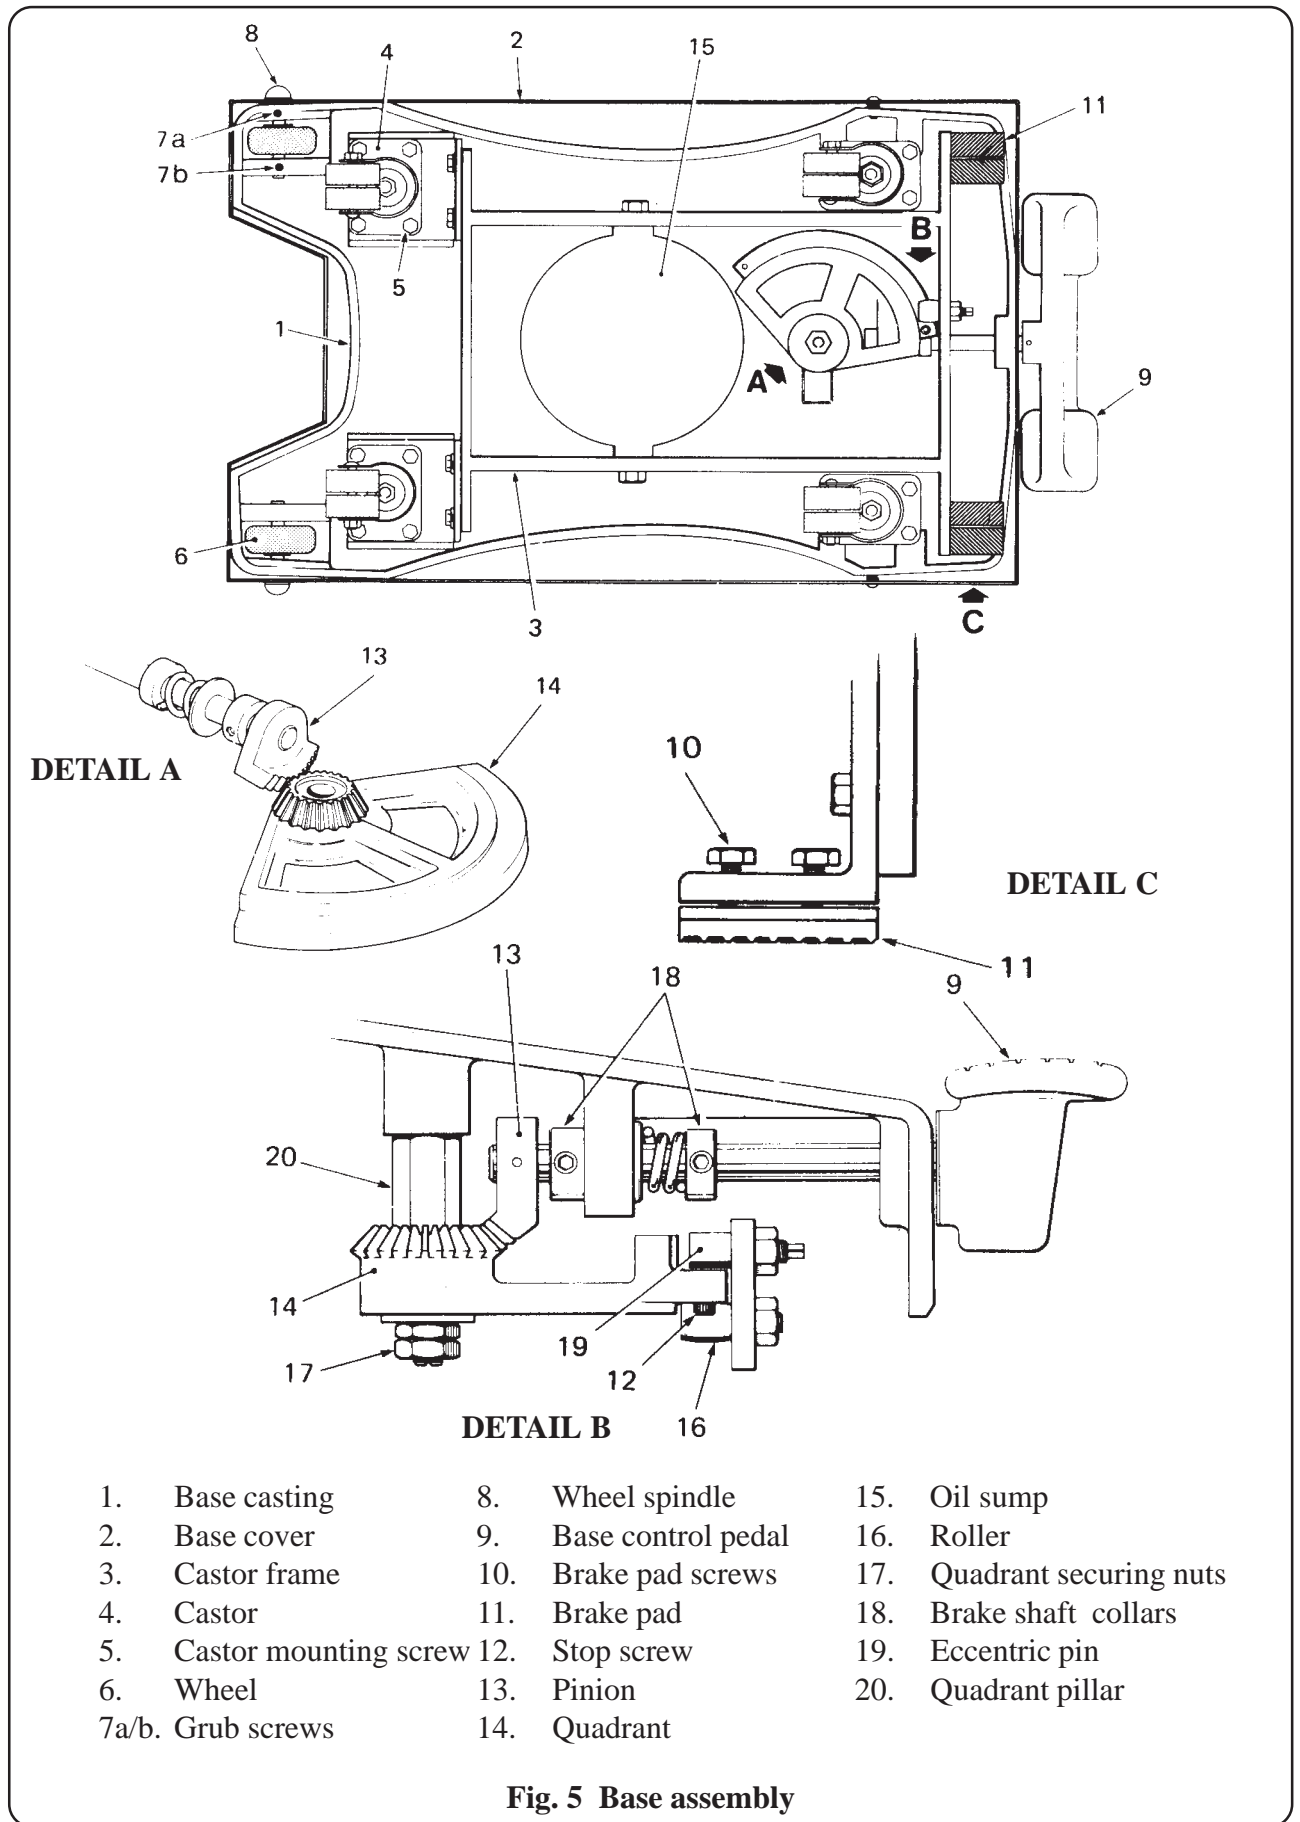
4.5. Check the action of the brake mechanism (see Fig. 5) and also check for wear on the brake pads, broken brake pinion or quadrant teeth, play in the quadrant taper pins and adjustment between quadrant, roller and eccentric pin. Check stop screws for wear. To replace quadrant see section 4.44; to replace quadrant pinion, see section 4.45.

- i Refer to Fig 5 and withdraw grub screw (7a) just sufficiently to be able to tap out the domed wheel spindle (8) from the inside, while still retaining the bush in position.
- ii Slacken grub screw (7b) then fit replacement antistatic wheel with original domed spindle. Adjust position of bush under grub screw (7b) to accommodate width of new wheel, then retighten grub screw (7a) into the dimple of the spindle.
- iii Finally, tap the inside bush under grub screw (7b) to make a close fit against the wheel and then tighten grub screw (7b).

- i Note the direction of tread pattern of the worn pad (11, Fig. 5), before removing pad.
- ii Remove the two hex screws (10, Fig. 5) securing brake pad to frame and install new pad, with the tread pattern facing in the same direction as that noted in (i) above.
- vii Locate base control pedal shaft in table base with collars and spring, and secure collars in correct position. Install pinion on end of shaft and fit taper pin.
- viii With base control pedal in 'castor' position (see diagram on base instruction plate) install quadrant between roller (16) and eccentric pin (19). Ensure that quadrant and pinion mesh correctly and that the base control pedal is parallel with the base instruction plate in the 'wheel' position, before fitting stop screw (12) to quadrant. Check that brake pads are just clear of the floor in the 'wheel' position.

- i Refer to Fig.5 and remove socket head stop screw (12) from beneath cut-out end of quadrant (14).
- ii Turn the quadrant clear of the roller (16) remove hex. nuts (17) and withdraw the quadrant. If quadrant teeth are broken, fit new quadrant. For renewal of quadrant pinion, carry out the procedure detailed in the following paragraph.

- i Remove quadrant (see section 4.44).
- ii Refer to Fig 5 and turn base control pedal (9) until small end of taper pin, securing pinion (13) can be seen.
- iii Using a hammer and punch, carefully knock out taper pin.
- iv Slacken the grub screws in the two collars (18) on the brake shaft.
- v Pull base control pedal and shaft out of table base, allowing quadrant pinion to fall clear.
- vi Position new pinion on shaft, lining up the taper pin drillings in the pinion with those on the shaft. Maintaining the tapers in line, ream the pinion drilling relevant to the shaft and loosely fit taper pin. Remove taper pin and pinion from shaft.

4.46 Proceed as described in section 4.44 to remove quadrant, then remove and replace broken quadrant pillar (20, Fig. 5). Reassemble components.

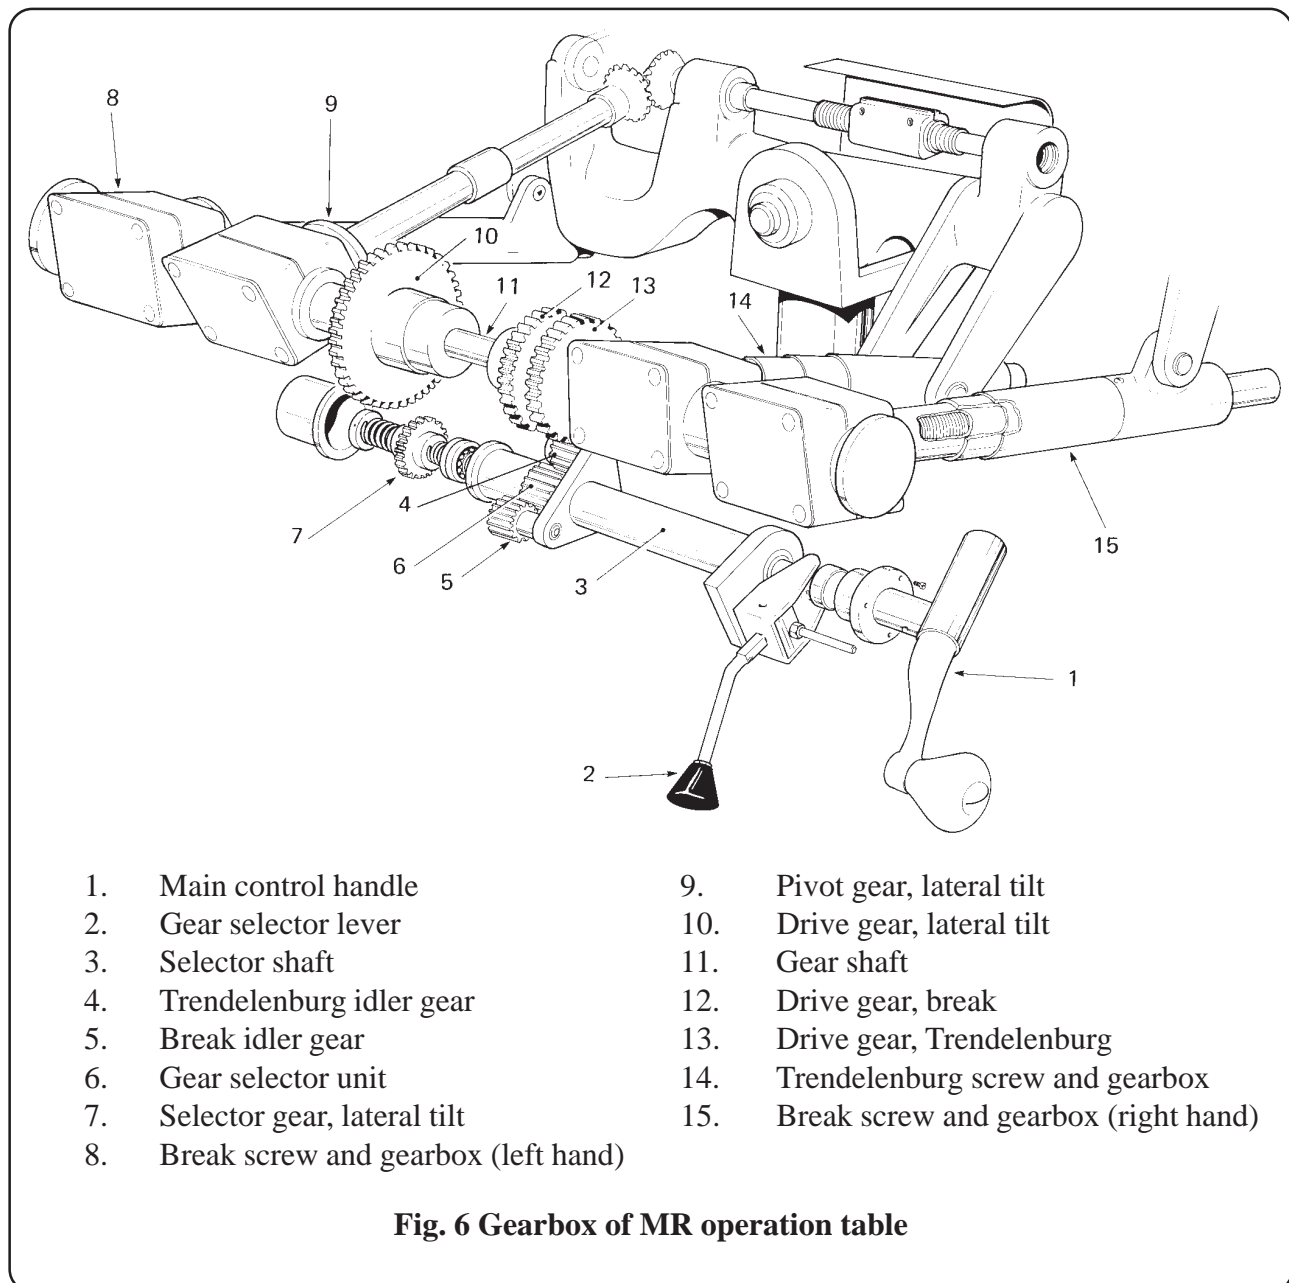
gears on the idler plate (Fig. 6) still have clearance and that securing screws are tight on driving and idler gears in main gear train. Check grub screw securing pivot bolt.

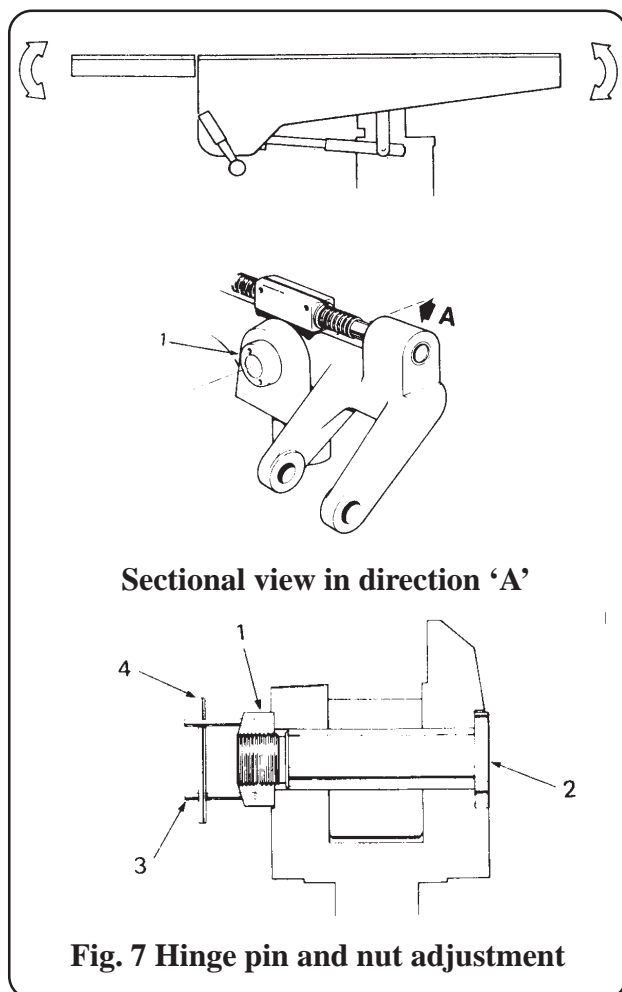
4.14 Pull table top as shown in Fig. 7 to check for excessive play in the direction of the arrows. If there is excessive play present refer to Fig. 7 and check to see if hinge nut (1) and bolt (2) are loose. If so, * tighten hinge nut (1) against hinge bolt (2) sufficiently to take up the slackness. To do this, Eschmann recommend using two short lengths of 3/16 in. diameter round bar (3) inserted in the nut sockets, as illustrated in Fig. 7 and applying an improvised tommy bar (4) to turn the nut.

***Note:** This could also indicate play in Trendelenburg gear. If this is the case the complete Trendelenburg screw assembly must be replaced. For adjustment, see sections 4.16-4.18.

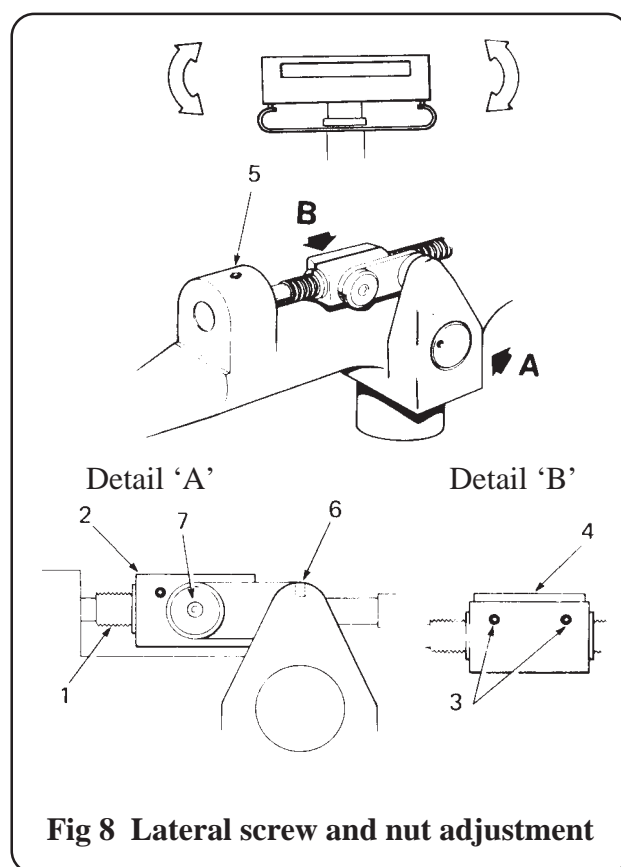
4.15 Place table top in reverse Trendelenburg position, then select Lateral Tilt and operate control handle to test movement is satisfactory. Pull as shown in Fig. 8. If undue play is suspected refer to Fig.8 and proceed as follows:

- i Check secureness of link pivot set screws (6) and (7).
- ii Check secureness of grub screw on yoke (5) which locks lateral screw bearing.

iii Finger testing at the point where the lateral screw (1) passes through the nut (2) will establish the need for the nut adjustment. First try tightening socket head screws (3) on nut. If excessive play is still present, shim removal will be necessary. Proceed as follows:

- (a) Unfasten socket head screws (3) on nut and extract shim pack (4).
- (b) Remove shims (0.002 in thickness per shim, approx.) one at a time until play is *just* taken up on re-tightening.

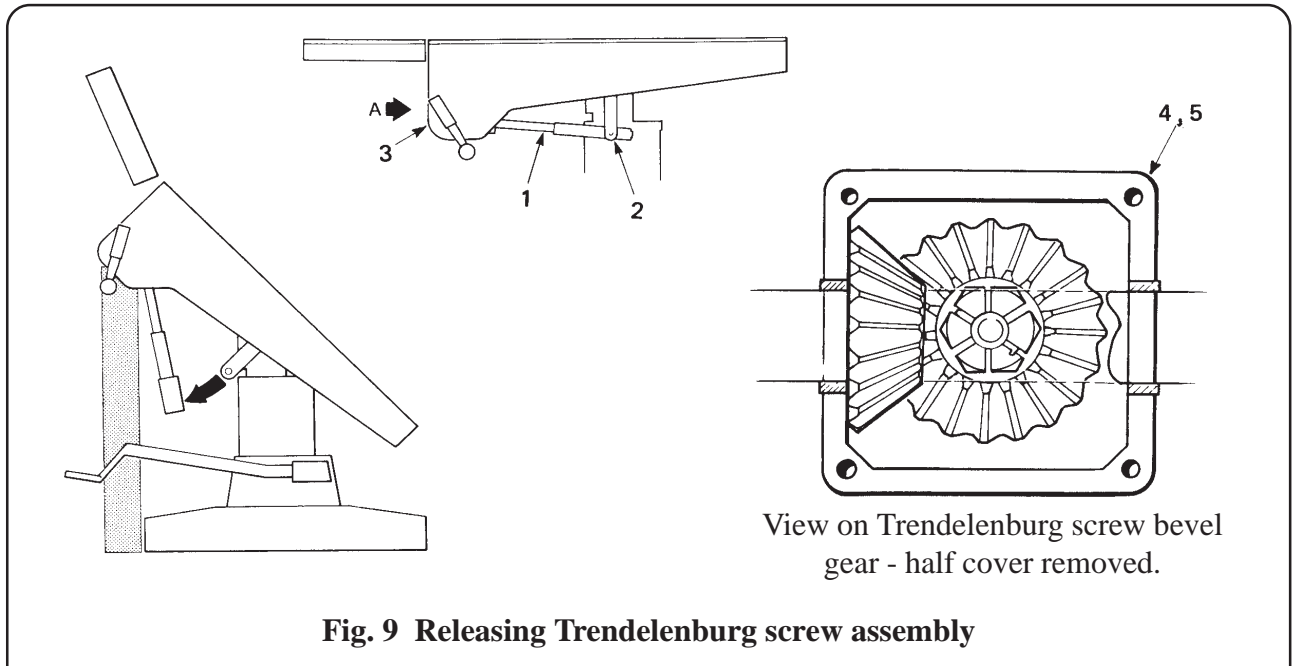
Fig. 9 Releasing Trendelenburg screw assembly

- i Remove the leg flap and place gear lever in Lateral Tilt position.
- ii Unscrew sleeve cap (1) and remove the end cap tubes (2) from the Trendelenburg screw assembly.
- iii Using torque screwdriver (Part No. 759581 set to 20-25 lbf.in. and fitted with adaptor T2095 Part No. 759653 and 20mm socket), check the setting by locating socket over the

Replacement of Trendelenburg screw (Fig. 9 and 10)

4.34 To replace the Trendelenburg screw, remove the old Trendelenburg screw assembly from the operation table as detailed in 4.16. Fit a new Trendelenburg screw assembly (latest style see note above 4.16) and adjust it to the correct torque setting as detailed in section 4.18. Reassemble the table.

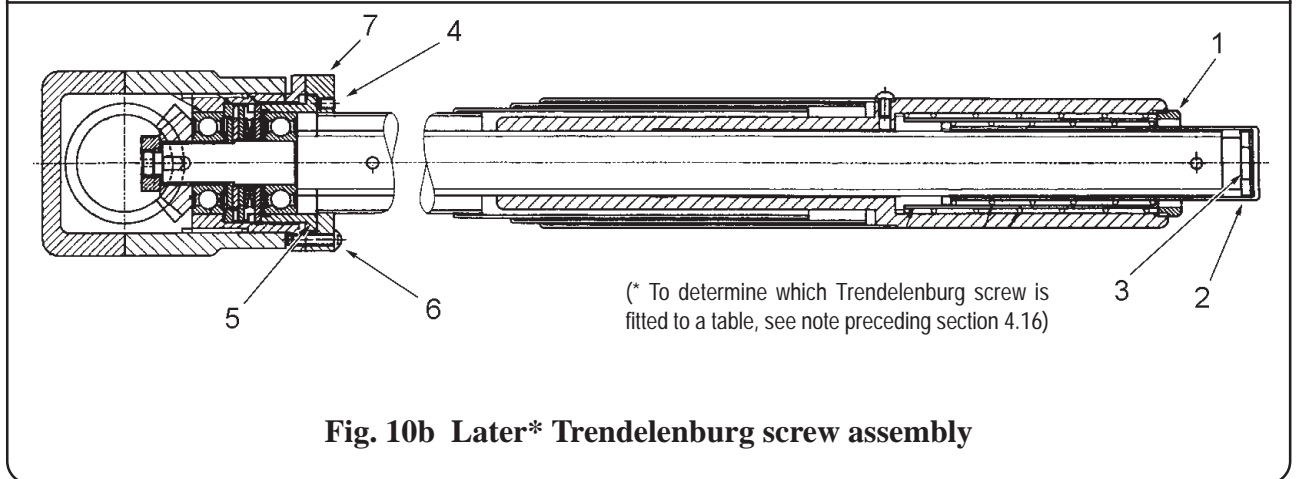
Fig. 10b Later* Trendelenburg screw assembly

- vi Replace the cap ring (7) and secure using the three screws (6), lock the torque adjuster nut (5) by tightening the single grub screw (4) and reassemble the table.

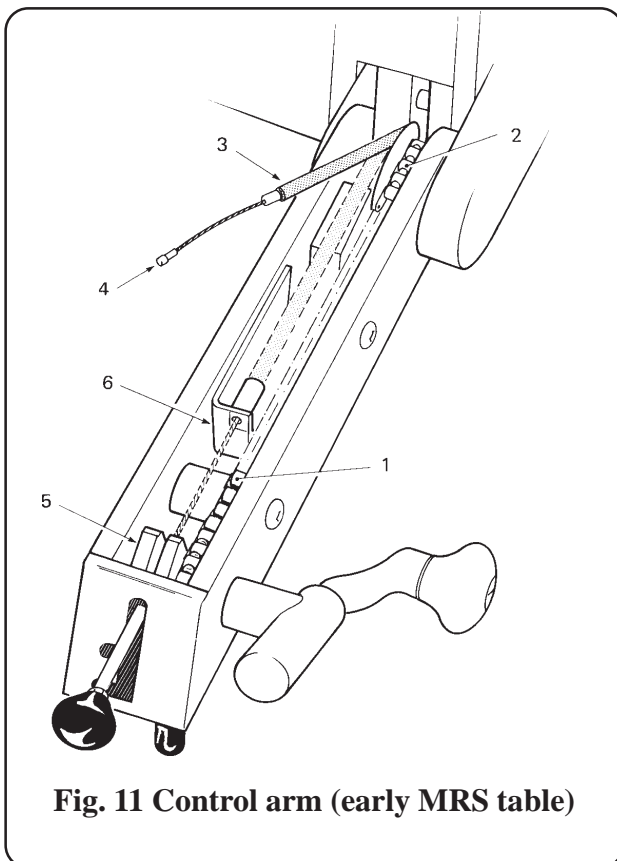
Fig. 11 Control arm (early MRS table)

4.31. The control arm gear lever operates the table top movement selection mechanism in the gearbox by means of a flexible cable assembly (3, Fig. 11). If movement selection fails to function correctly while the table is in use, immediate action must be taken to engage the standby controls. The fault symptoms can be any of the following:

- iii If the ferrule at one end of the inner cable has sheared-off, the inner cable will be loose and the opposite end may be disconnected from its control arm pivot (5, Fig. 11) or cable pivot (12, Fig. 15).

- iv Withdraw outer cable from cable holder (6, Fig. 11) and from the adjusting screw (1, Fig. 15). Remove cable assembly from control arm.
- v If a new cable is not to be fitted, soft-solder the loose ferrule to the end of the inner cable. Carefully restore the contour of the ferrule (4, Fig. 11)

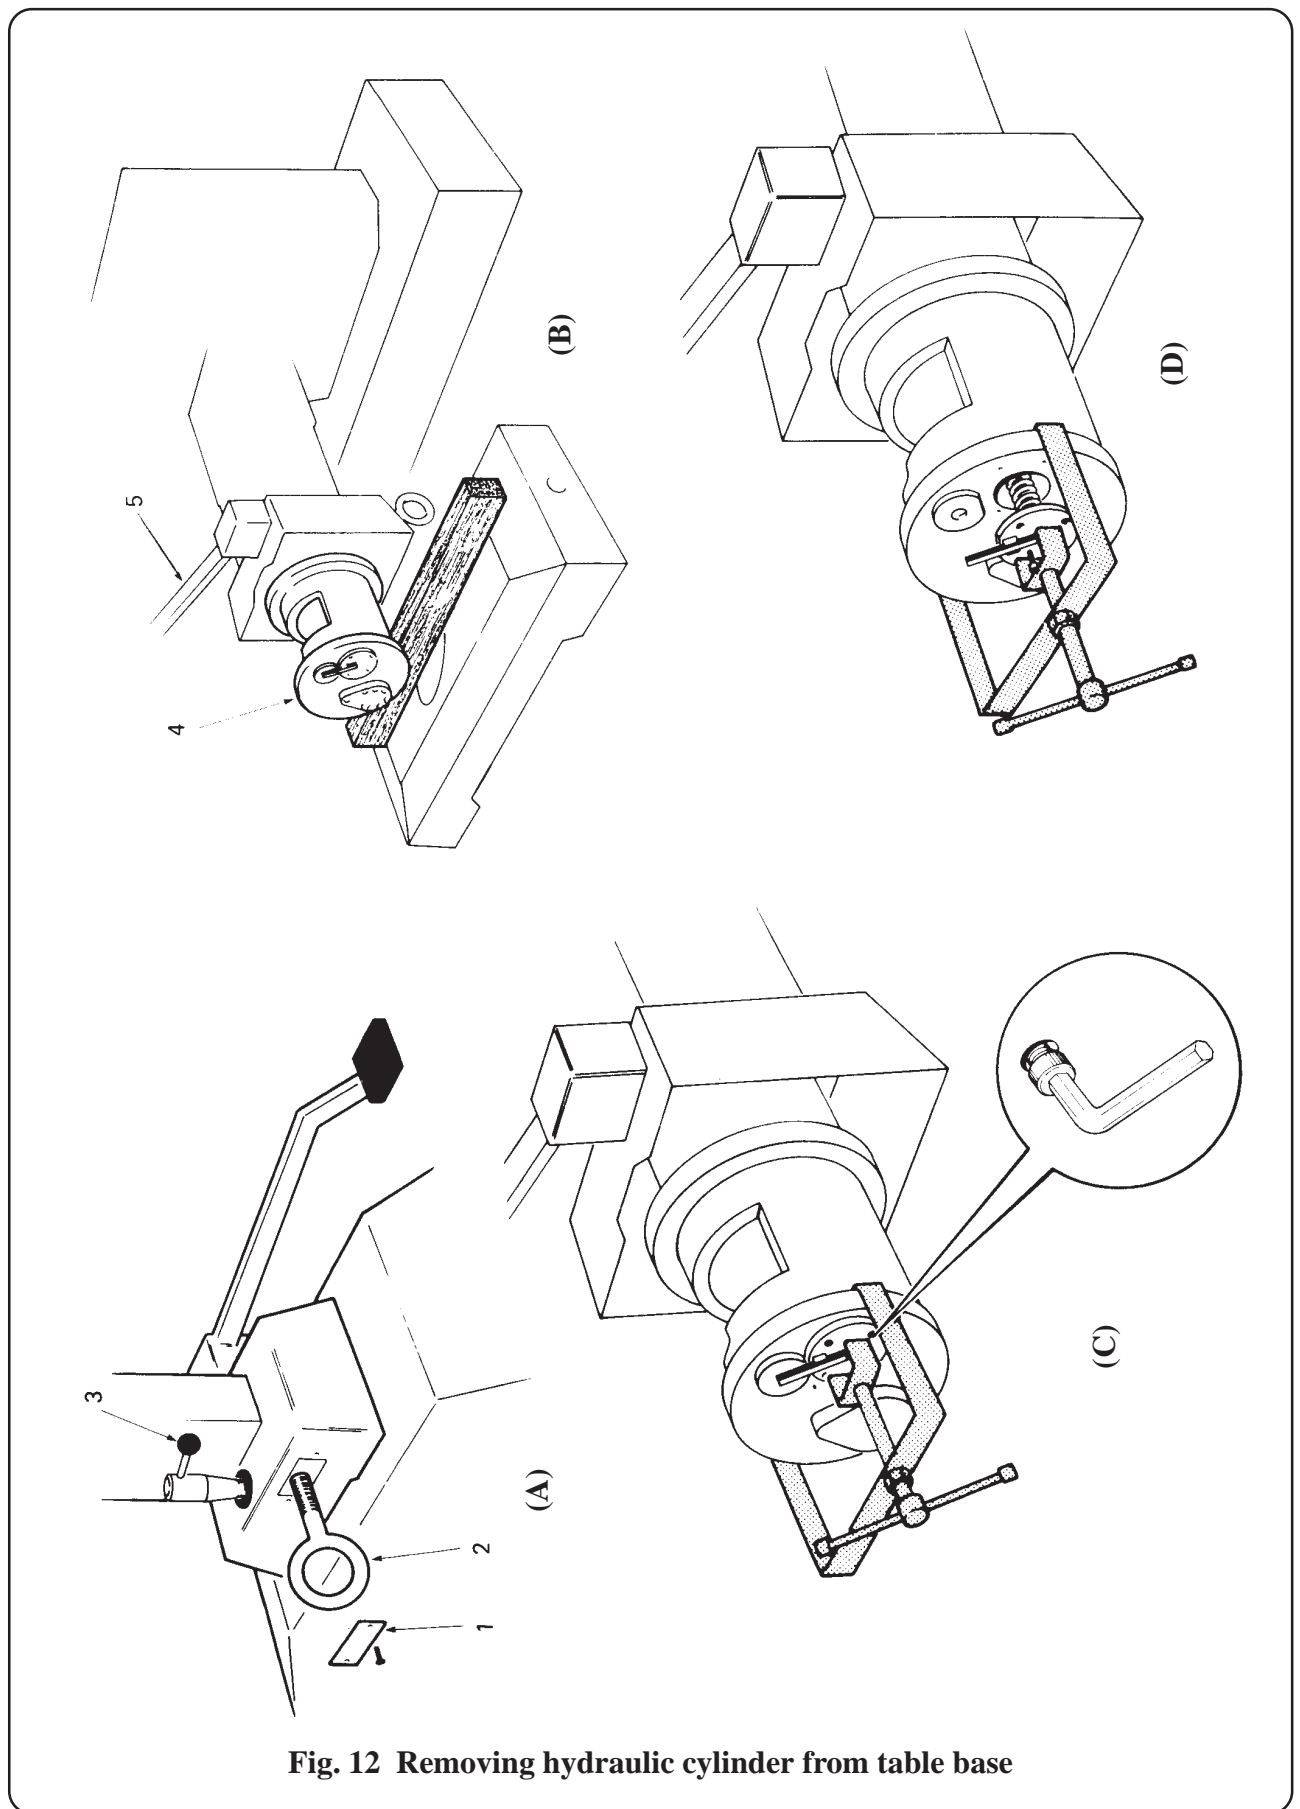
Fig. 12 Removing hydraulic cylinder from table base

- i Position the compression tool clamp (included in the tool kit available for the MR series tables, Part No. 751030) across the base of the cylinder (see Fig. 12c) and lightly tighten it onto the ram release. Use an Allen key to remove the four screws holding the ram release in position.
- ii Loosen the clamp until oil starts to run from the hole. Allow the oil to drain.
- iii Continue to unscrew the clamp until

completely loose then remove clamp and ram release (see Fig. 12(d)).

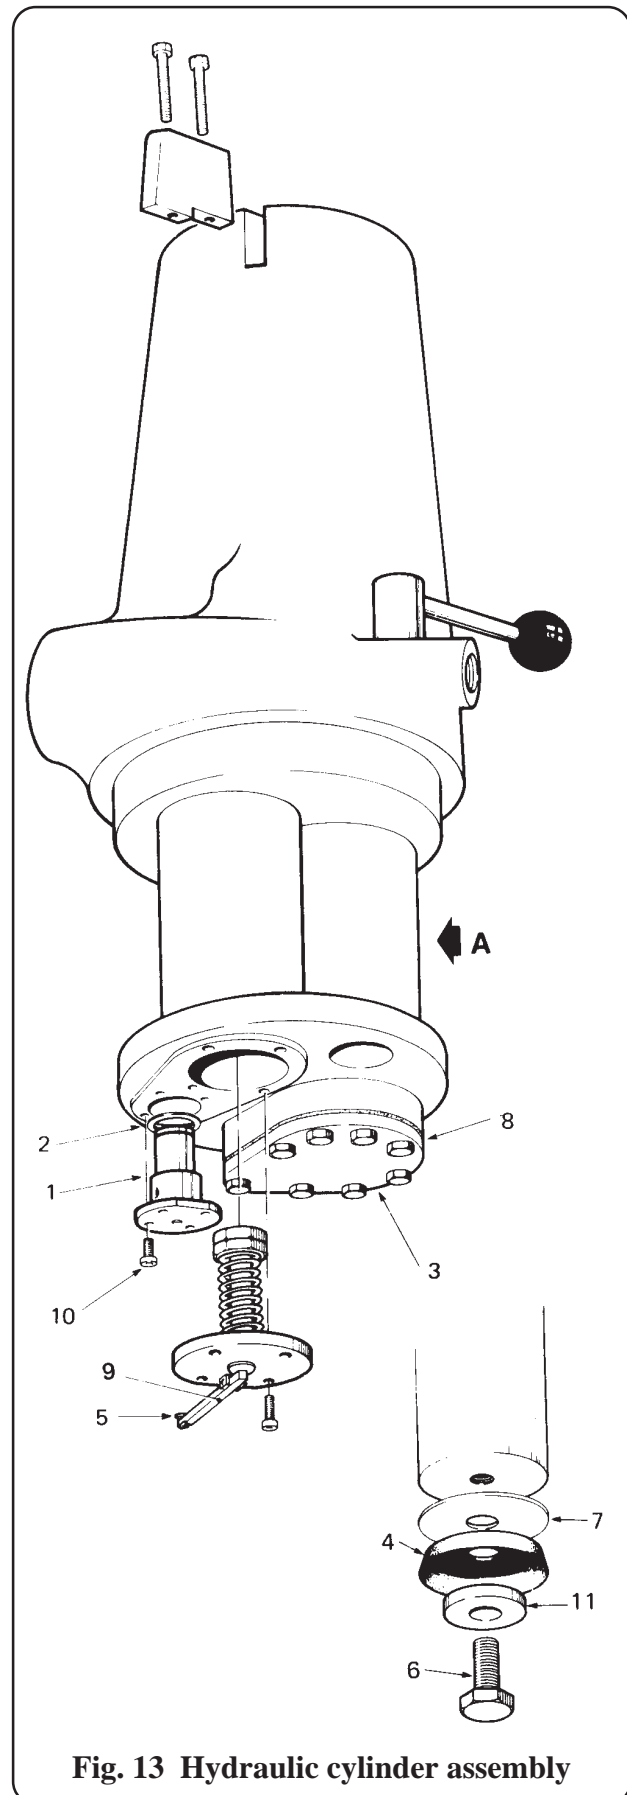
Fig. 13 Hydraulic cylinder assembly

travelling through its full stroke, the fault is probably due to the presence of dirt in the ball valve, (1, Fig. 13) of the hydraulic cylinder. It is often possible to clear this obstruction by vigorously operating the height control pedal. If this fails, remove hydraulic cylinder from base (see section 4.35); the ball valve should then be disassembled and cleaned (see section 4.37). If the pedal is suddenly inoperable either when raising or lowering the table, refer to section 4.28.

- i Condition of ball valve jointing washer (2, Fig. 13). If faulty, replace it (see section 4.37).
- ii Secureness of ram cover plate (3, Fig. 13). If it is loose, retighten it.
- iii Efficiency of ball valve (1, Fig. 13). If blocked or jammed, disassemble and clean it, (see section 4.37). If the seating of the larger (spring-loaded) ball has been damaged, replace the complete valve.
- iv Condition of ram cup washer (4, Fig. 13). If worn or chipped, replace it (see section 4.36).

- i Refer to Fig. 13 and remove cover plate (3) taking care not to damage the sealing gasket; the ram cup washer will then be exposed.
- ii Remove washer retaining screw (6), washer (11), ram cup washer (4) and backing disc (7).
- iii Refit the backing disc (7) together with a new cup washer (4) smearing the latter with a little of the oil used for the table hydraulics.
- iv Refit the retaining screw and its washer but use only *moderate* tension to tighten the retaining screw; too much and the ram cup washer will tend to buckle and allow peripheral oil seepage - too little and oil will leak past the backing disc.

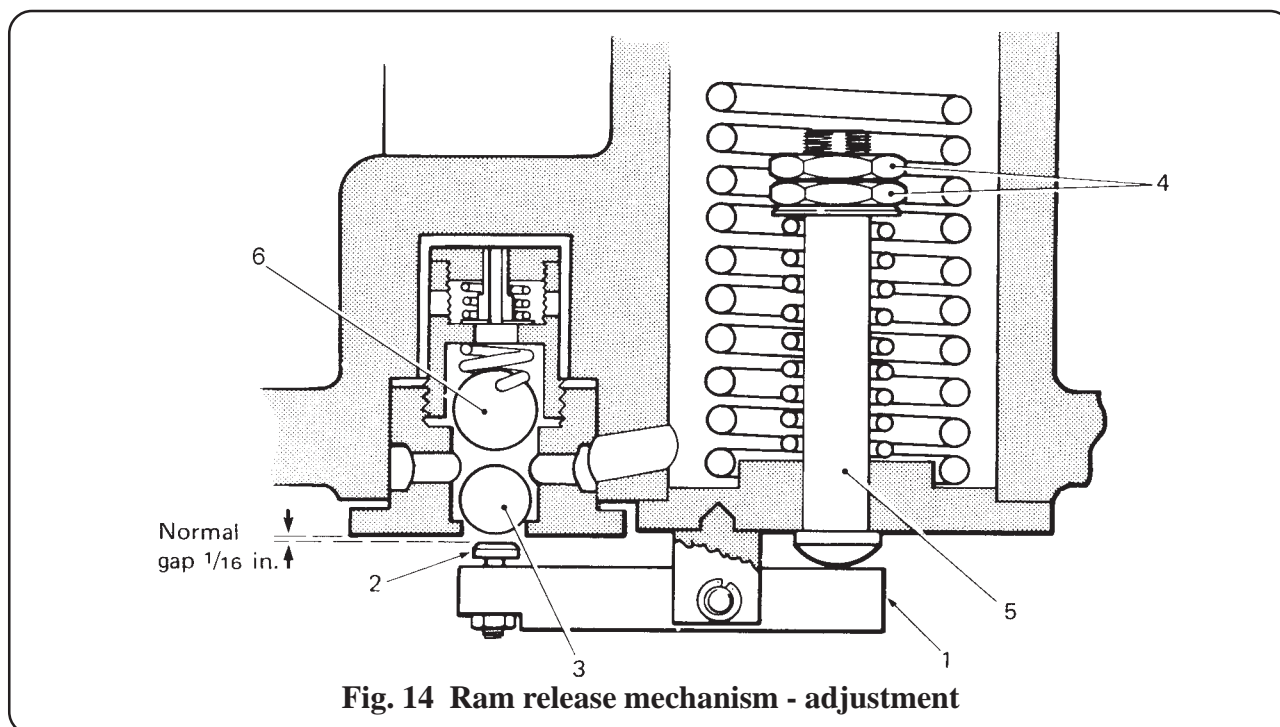
Fig. 14 Ram release mechanism - adjustment

- i Refer to section 4.35 and remove hydraulic cylinder from table base.
- ii Examination of the ram release movement must now be carried out. Refer to Fig. 14. When the pump lever is depressed fully, this operates the ram release lever (1). The ram release lever pivots and the release screw (2) enters the ball valve and should lift both balls (3 and 6) at the end of lever travel. Before testing this movement, the pressure in the ball valve should be overcome by forcing the release lever into the ball valve after covering the cylinder with a cloth to avoid leakage of oil under pressure.
- iii Now depress the pump lever fully and hold in this position. Test the ram release lever by trying the movement using thumb pressure. If the movement is other than very slight, adjustment is required.

- iv Refer again to Fig. 14. Adjustment consists of unscrewing, in a clockwise direction, the two large lock nuts (4) on the end of the release plunger (5) to allow more movement of the ram release lever. This is in order to cause the ball of the ball valve to be lifted further and so release the table ram. (For a more detailed explanation of the hydraulic system, refer to section 4.60 and 4.61).

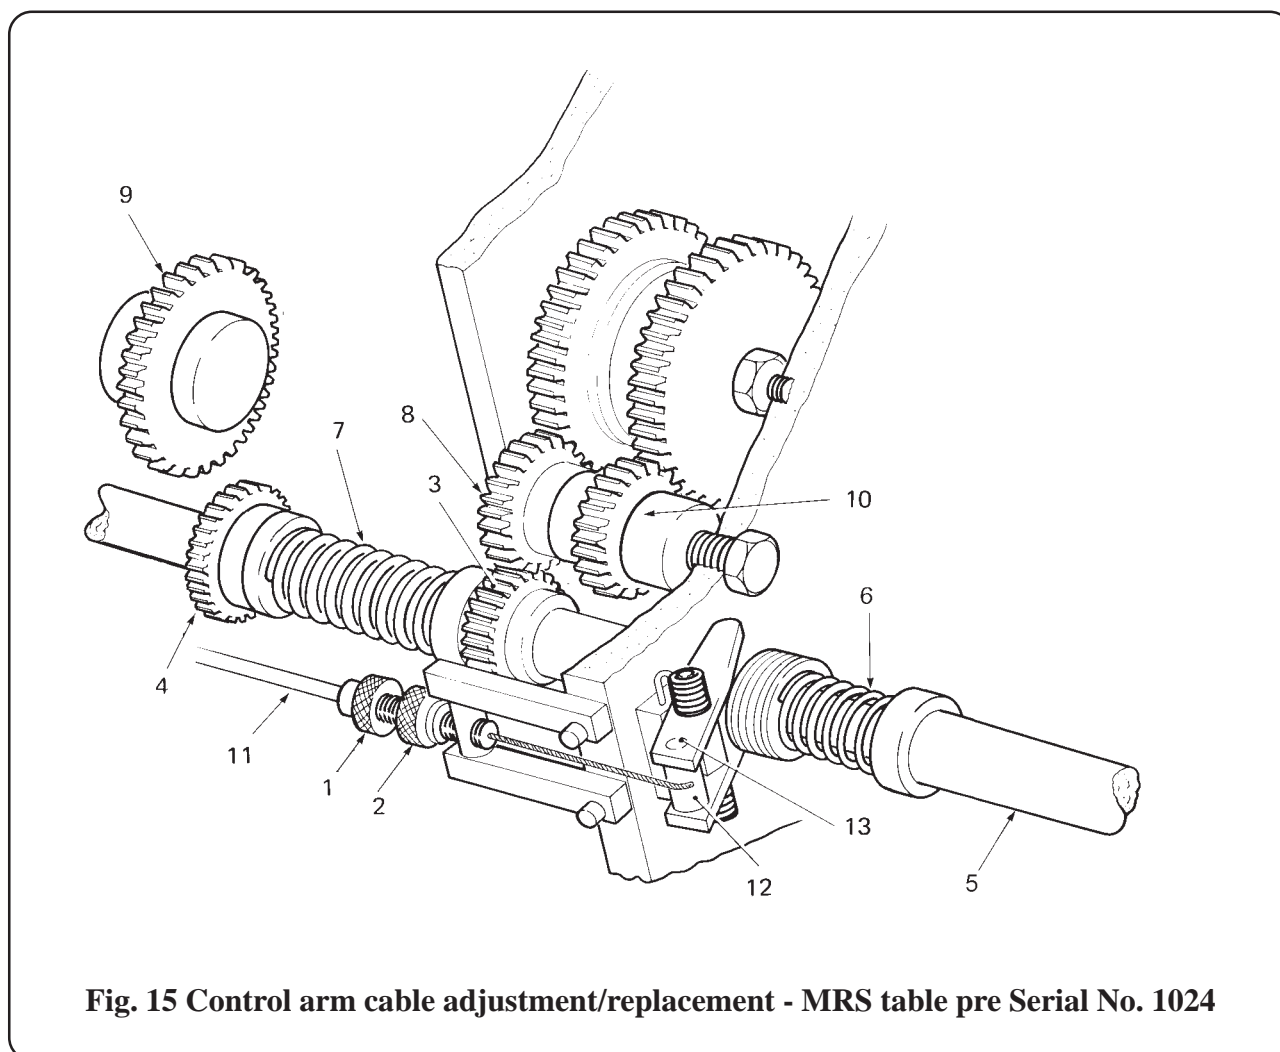
Fig. 15 Control arm cable adjustment/replacement - MRS table pre Serial No. 1024

- i Select Trendelenburg movement.
- ii Refer to Fig. 15 and locate adjusting screw (1) beneath upper trunk section.
- iii Slacken thumb nut (2).
- iv Check that selector gears (3) and (4) slide freely on the main shaft (5) and that the return springs (6) and (7) function correctly.
- v Check that the selector gear (3) is in full mesh with the idler gear (8); if necessary turn the adjusting screw (1) in the direction required to achieve this condition.
- vi Select lateral tilt movement.
- vii Check that the selector gear (4) is in mesh with the drive gear (9) and that the selector gear (3) is completely disengaged from both

idler gears (8) and (10). Small adjustments to the adjusting screw may be made to achieve these conditions.

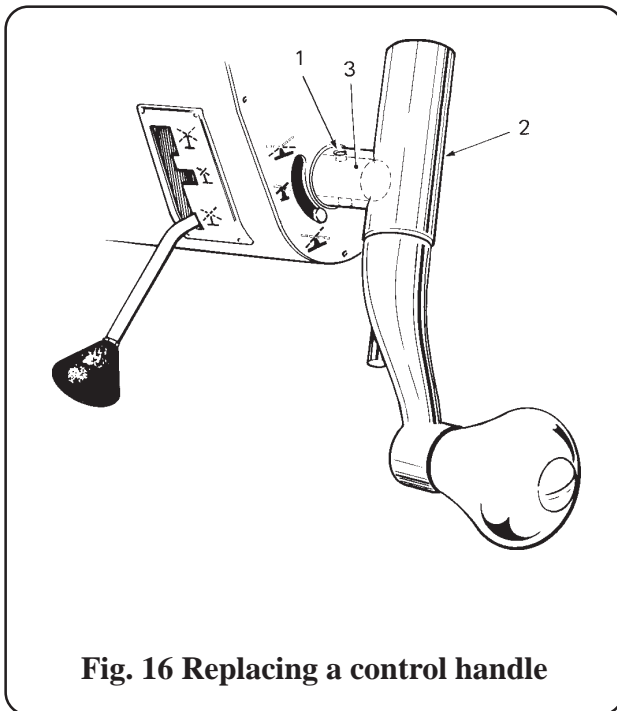
Fig. 16 Replacing a control handle

- iii Punch out taper pin (1) and remove damaged handle (2).
- iv Take measurement for drilling new handle, then drill (*one* side only) a suitable diameter hole to allow use of a tapered reamer.
- v Slide new handle onto shaft (3) and align hole through shaft with newly drilled hole in handle.

- vi Complete drilling through handle, using a wooden block for the drill to break into - hence protecting the plating on the handle.
- vii Use a tapered reamer to shape out the holes for the taper pin. Fit new taper pin (1) ensuring that it is inserted through the aligned holes the correct way round.
- viii Remove the distance piece from the selector shaft (see 'ii' above)

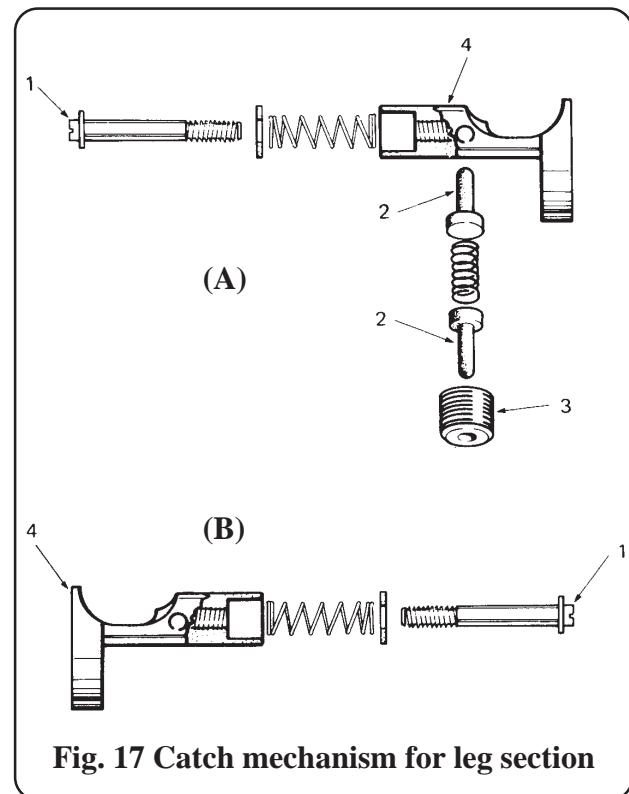
Fig. 17 Catch mechanism for leg section

4.51 Ensure that the spring loaded plunger (2, Fig. 17) referred to in section 4.49 moves freely in its socket. If the plunger has become damaged or distorted such as to impair free movement, it should be replaced. To remove plunger, unscrew threaded bush (3, Fig. 17).

- i Clean out any collected debris from the recesses of the locking and guide pin push button catches (4, Fig. 17) in the trunk sections of the table. Refer to section 4.49 to 4.52 and dismantle each push button check each component for damage or wear replacing as necessary, Check spring-loaded nylon plungers (2, Fig. 17) for smooth action. Clean and lubricate the catch mechanism then reassemble (again referring to section 4.49 to 4.52.) and test.
- ii Lubricate rack and fine adjustment movement of head/leg section.

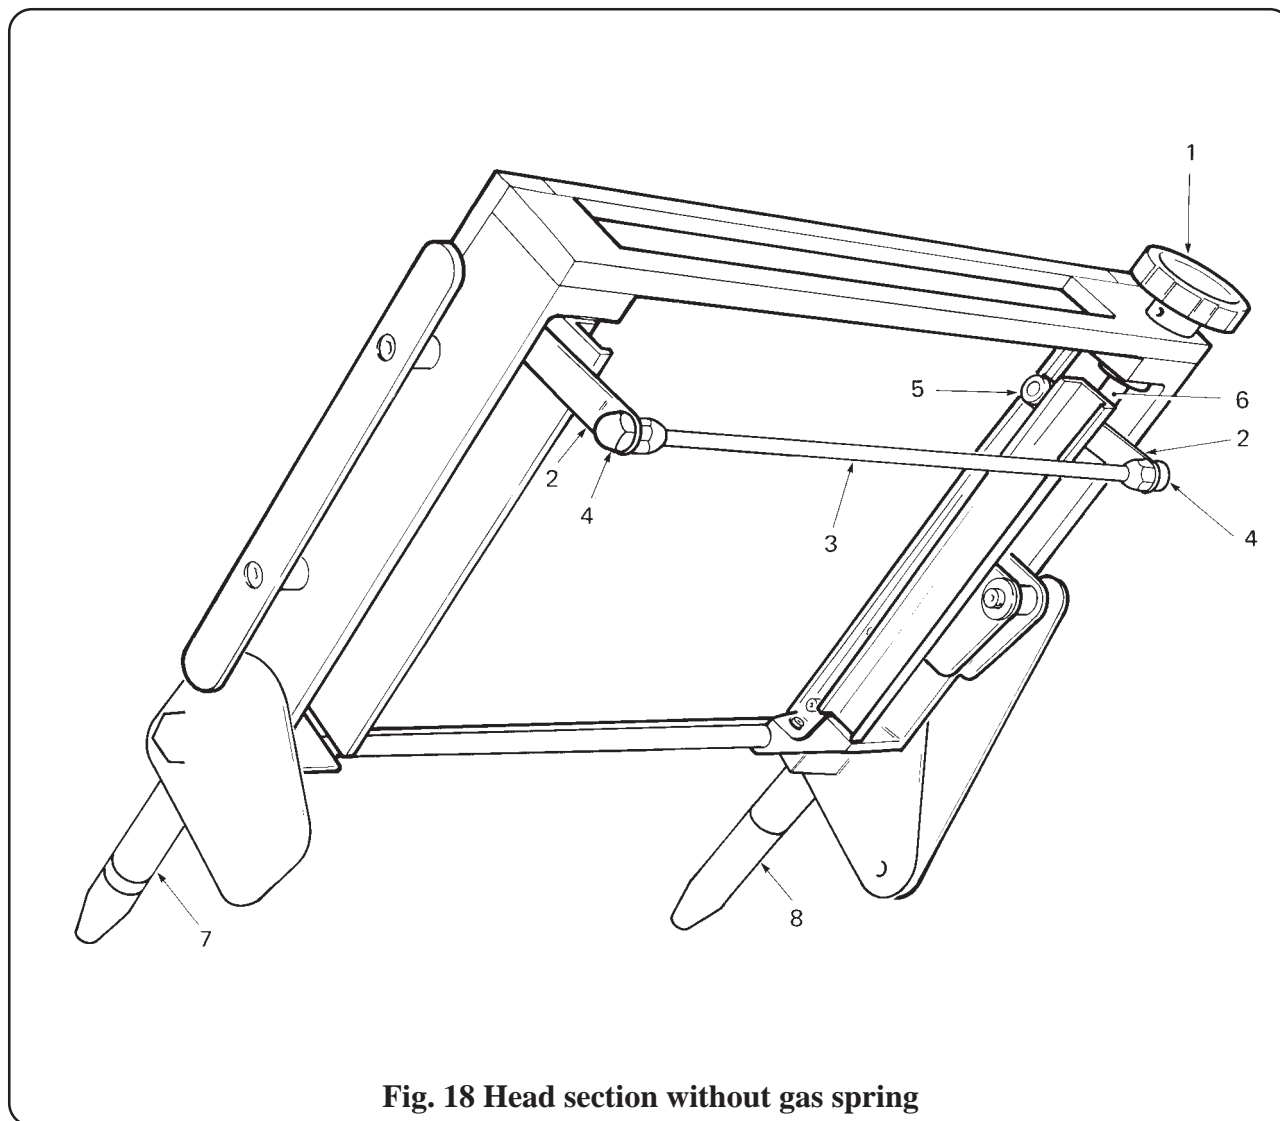
Fig. 18 Head section without gas spring

4.53. Remove grub screw from handwheel (1, Fig. 18), grip worm shaft (6, Fig. 18) then remove handwheel. When fitting a new handwheel, it is recommended that the grub screw should also be renewed.

4.54. Quick-release bar assembly consists of two rack lift levers (2, Fig. 18) and the release bar (3, Fig. 18). If it is only required to detach release bar, simply remove two domed nuts (4, Fig. 18) at each end of bar to free bar from rack lift levers.

4.55. If complete release bar assembly is to be removed including rack lift levers (2, Fig. 18), unscrew socket head screws (5, Fig 18) on either side and ease lever pivots out of their slots.
