Service manual

Eschmann After Sales Service Department

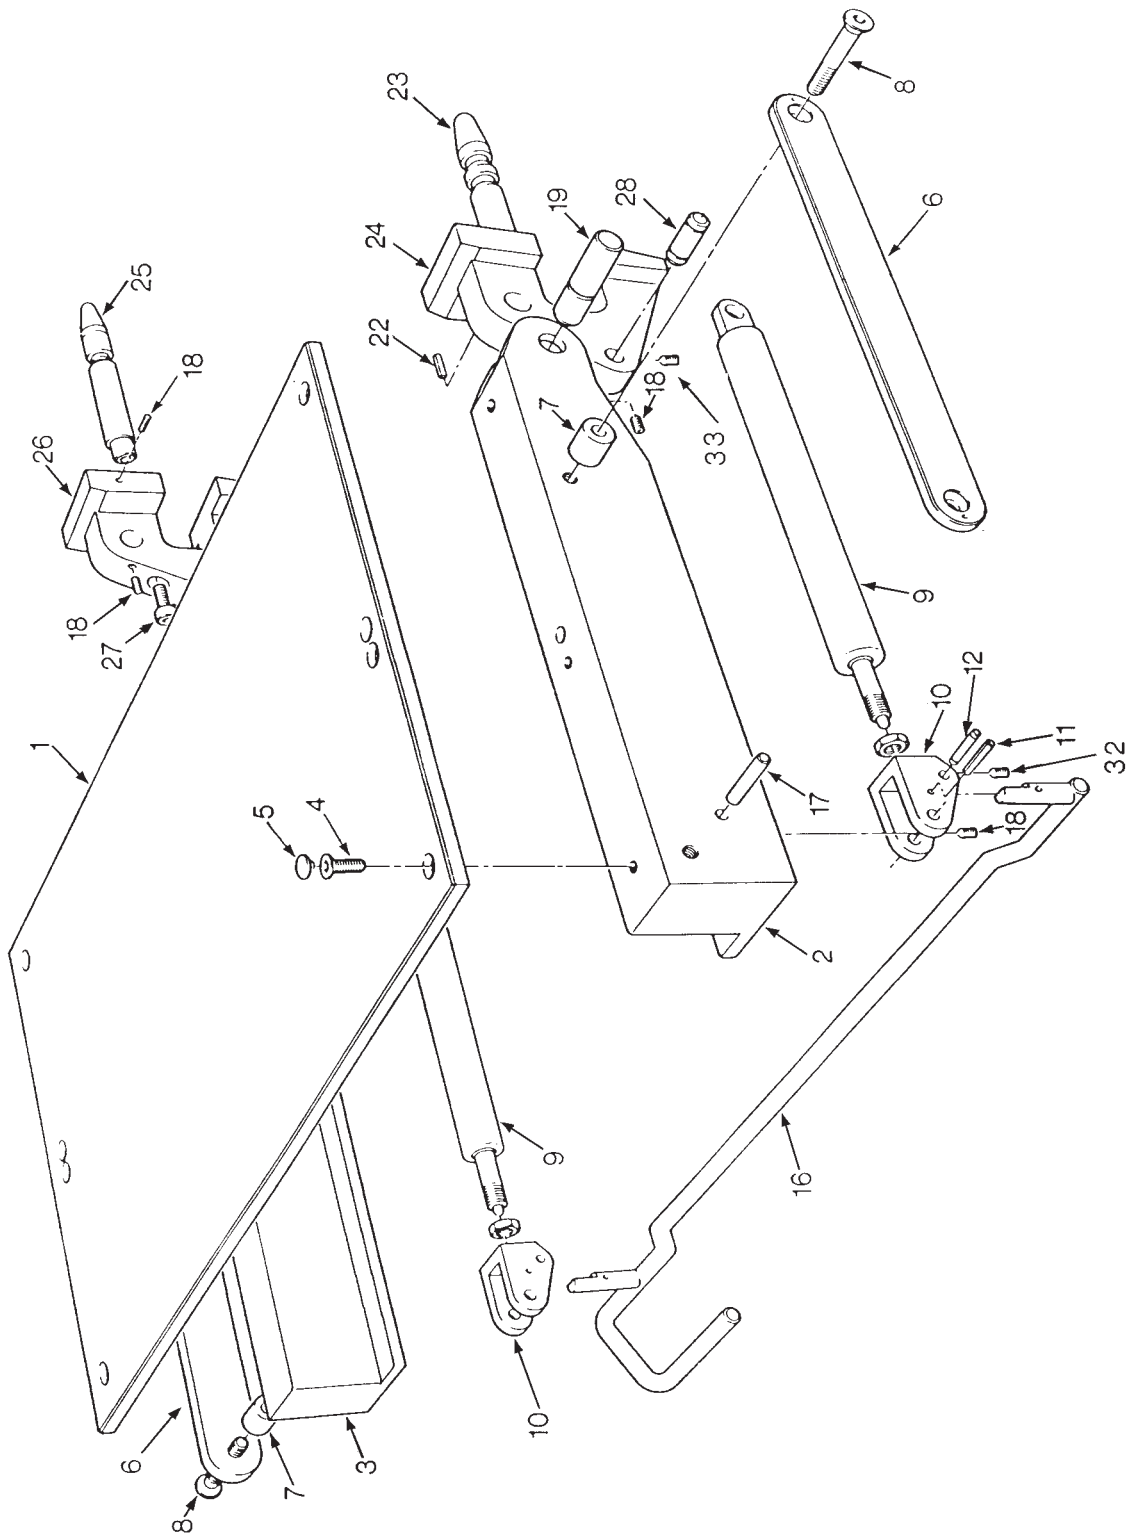
Fig. 19 Head section with gas spring

- v Reassemble by the reverse of above ensuring correct orientation of handle and that the spacers (7) are correctly repositioned, also check correct function and adjustment of gas springs (see section 4.24(iii) and section 4.57(iii)).

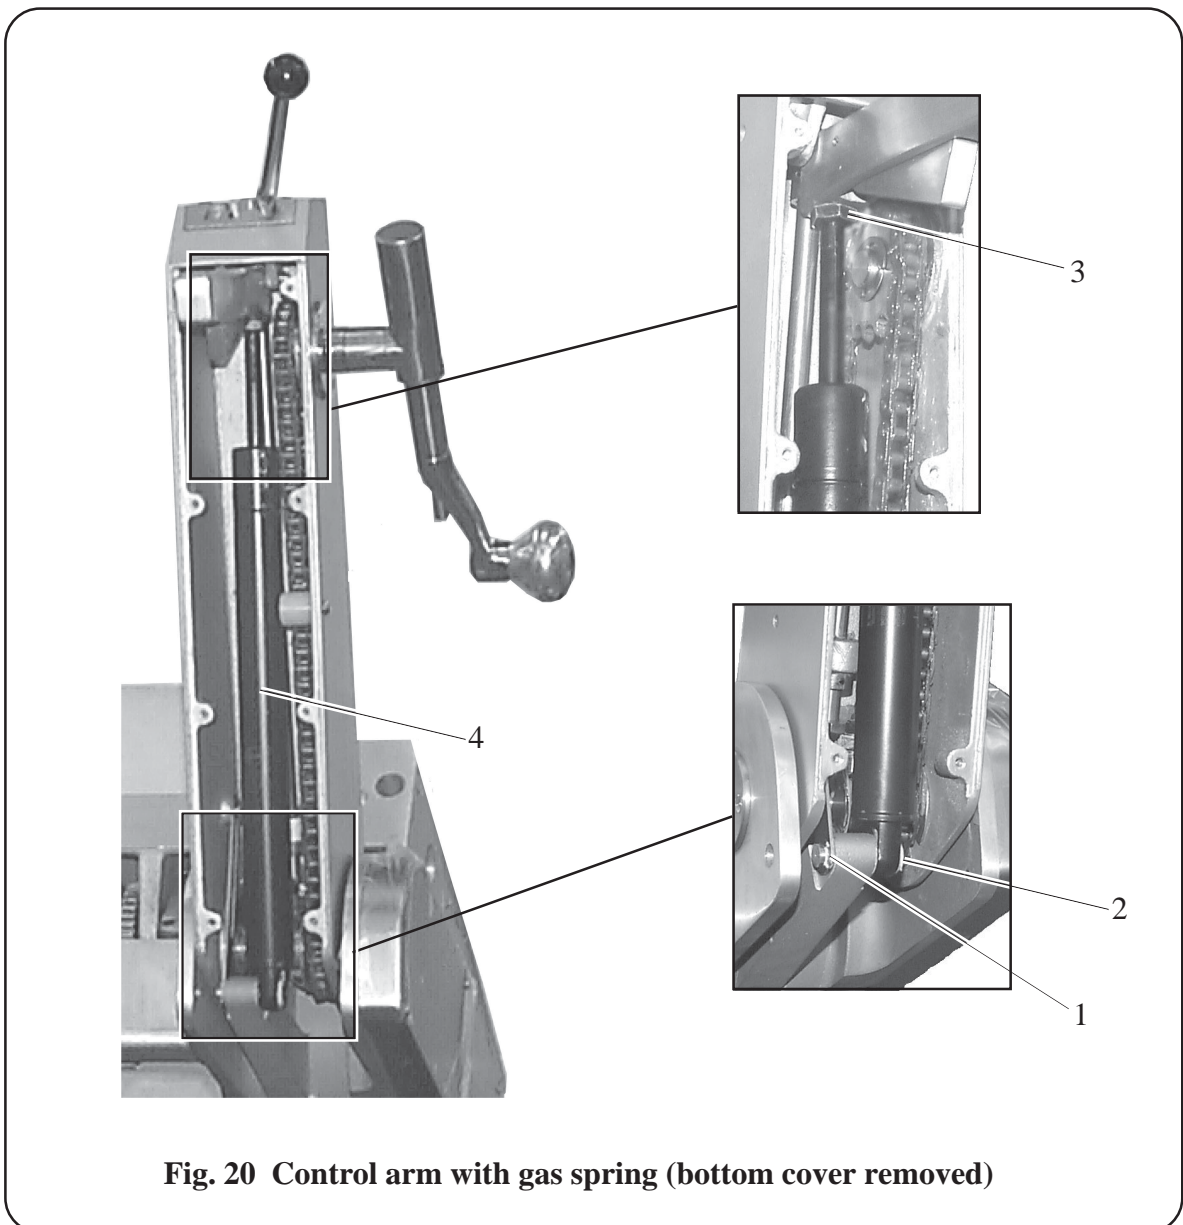
Fig. 20 Control arm with gas spring (bottom cover removed)

4.21 Gas spring operated control arms have been fitted to tables from Serial Number 1024 onwards. Remove the extended head end control arm cover (see Fig. 20) and carry out the following procedures to ensure the correct function of the control arm.

4.33 If the control arm will not maintain its position this is normally indicative of a faulty gas spring. Remove the lower control arm cover (as shown in Fig. 20) and check for signs of a damaged or a leaking gas spring, replace if required, see section 4.58. Do not lubricate gas springs and do not attempt to repair them (see WARNINGS and CAUTIONS above section 4.21).

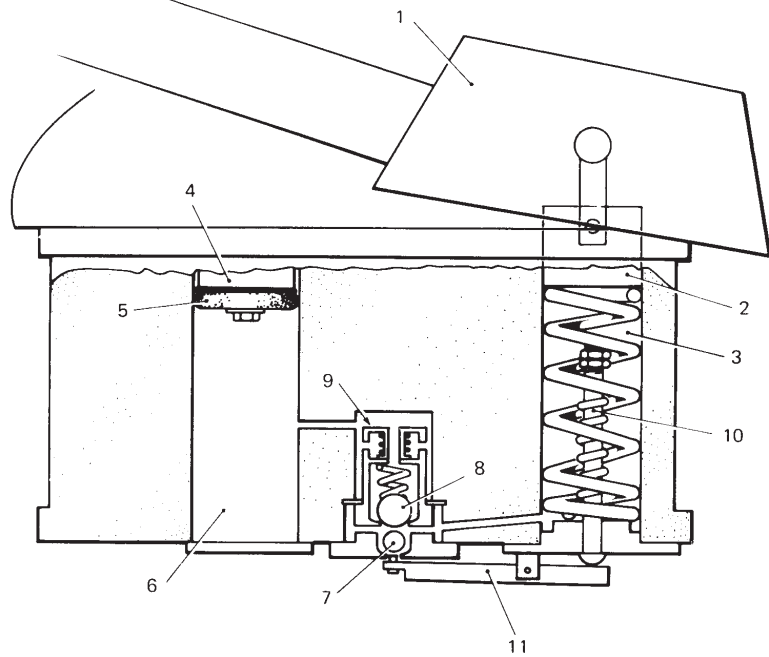
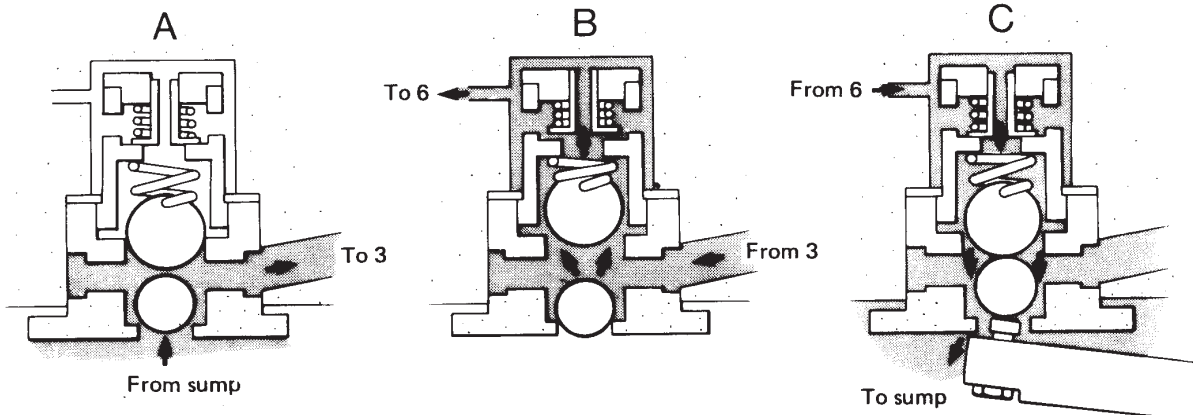
Fig. 21 Hydraulic system operation

- A. Pump pedal up-stroke. Oil is drawn from sump into piston chamber (3) via the small ball valve (7) which is lifted from its seat.
- B. Pump pedal down-stroke (using normal foot pressure). Oil under pressure from piston chamber (3) closes small ball-valve (7) but opens large ball-valve (8) and pilot valve (9), allowing pressurised oil to reach the ram chamber (6).
- C. Pump pedal pushed fully down. Piston (2) contacts release plunger (10) to operate ram release lever (11) which opens both small and large ball-valves (7) and (8). Oil from ram chamber (6) then flows at a controlled rate back to the sump via *inner bore* of pilot valve while the pilot valve is seated.

- 1. Pump pedal
- 2. Piston
- 3. Piston chamber- 4. Ram
- 5. Ram cup washer
- 6. Ram chamber
- 7. Ball valve (small)
- 8. Ball valve (large)
- 9. Pilot valve
- 10. Release plunger
- 11. Ram Release lever
