*Self-Study
Training Program*

*Servicing
Spring Brakes*

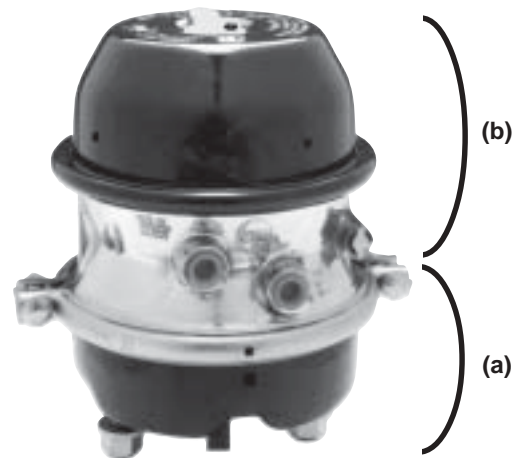
Figure 6

- A. The service brake chamber (Fig. 6a) performs the normal slowing and stopping function.
- B. The parking/emergency brake or "piggyback" chamber (Fig. 6b), mounted in tandem on top of the service brake chamber, contains a diaphragm (or piston) and a large powerful spring.

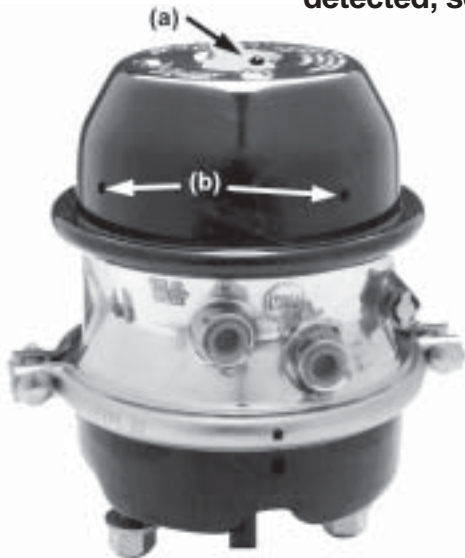
Figure 11

The first thing you want to inspect is the plastic END CAP or DUST PLUG (**Fig. 11a**). Make sure it is not damaged and that it is snapped tightly in-place, and, if it is designed to be attached to the head, it is securely attached. While these caps/plugs require no special positioning or maintenance, they must be snapped tightly into the release bolt access hole to prevent ingestion of

Be sure to inspect the VENT HOLES (**Fig. 11b**) in the head of the spring brake to ensure they are fully open and unrestricted. Brakes need to "breathe" when operating. When installed on vehicles operating in dump truck, ready-mix concrete and other similar operations, spring brakes can become encrusted with dirt or concrete which can prevent the circulation of air through the unit and entrap moisture and contaminants. If the holes are restricted, carefully ream the holes out by hand with a 3/8-inch drill bit (**Fig. 13**).

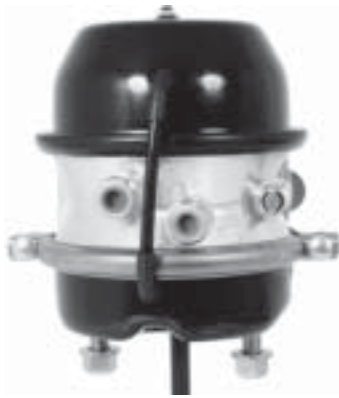
Figure 14

On units equipped with an EXTERNAL BREATHER-TUBE (**Fig. 14**), be sure to inspect the breather-tube and elbows for damage. Make sure the BREATHER-TUBE is inserted a minimum of 1/2-inch into each elbow and securely fastened with a high quality rubber adhesive or clamp.

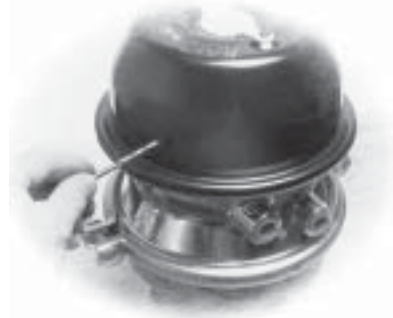
Figure 13

⚠ WARNING: DO NOT use a power drill as you may damage the diaphragm or other internal parts.

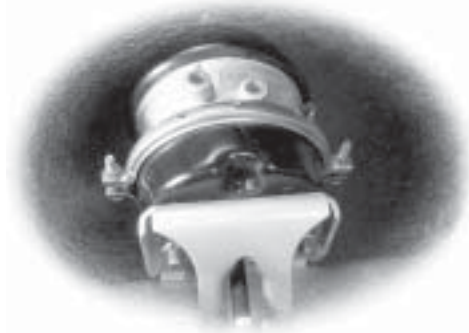
Figure 17

Next, check the actuator to be sure it is mounted solidly to the mounting bracket by placing one hand on the head of the brake and try to move the brake up and down or to the side (**Fig. 17**). The mounting stud nuts should also be properly tightened to the manufacturer's recommended specification.

MGM Brakes recommends 133-155 Lbs.-Ft. of torque (clockwise). Check to be sure that the split lock-washers, or hardened-steel flat washers (used by MGM Brakes), are positioned properly in-place between the nut and the bracket. Placing the washers between the brake chamber and the bracket will allow the chamber to "flex", resulting in premature failure of the NON-PRESSURE CHAMBER.

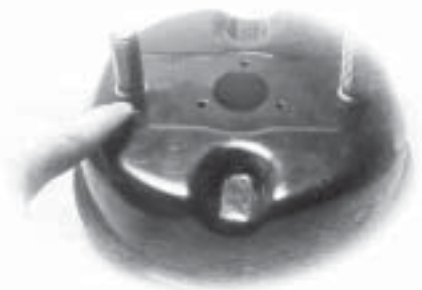
Figure 18

Inspect the NON-PRESSURE CHAMBER (**Fig. 18**) for damage and/or cracks around the MOUNTING STUDS. If damage or cracks are evident, remove the complete chamber by following the directions in *Section 7* of this booklet or refer to *Section 3* of the MGM Brakes TR Service Manual (Form #5011). Inspect the VENT HOLES in the NON-PRESSURE CHAMBER to ensure they are fully open and unrestricted. If the holes are restricted, use a 3/8-inch drill bit and carefully ream the holes out by hand (**Fig. 13**).

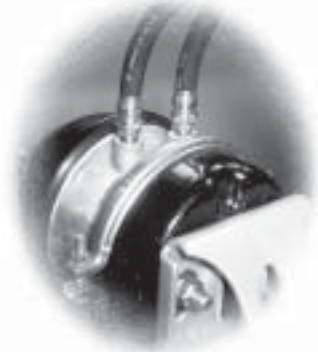
Figure 19

Carefully inspect all air lines, hoses and fittings attached to the chamber (**Fig. 19**). Remove and replace any damaged or leaking parts. Remember, never disconnect any air hose or air line that contains air pressure as it may "whip" as the air escapes. Never remove a component or pipe plug unless you're absolutely sure that all system pressure has been depleted. Be careful to never exceed recommended air pressures. Always wear safety glasses while working with pressurized air and never look directly into air jets or direct them at anyone.

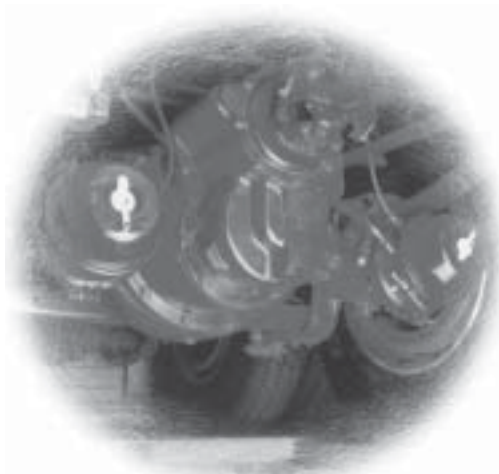
Figure 23

And finally, before you come out from under the vehicle, visually inspect the foundation brake (**Fig. 23**) to make sure there are no loose, missing or broken mechanical components. Many commercial vehicles are placed “out-of-service” by *Commercial Vehicle Safety Alliance (CVSA)* inspectors for the following, highly visible problems:

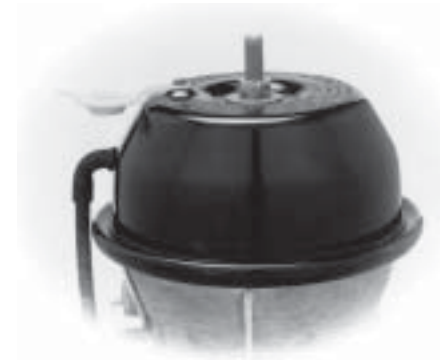
Figure 27

When you are sure the RELEASE BOLT is locked into the piston, hold it in position and install the flat washer and nut. Turn the nut down against the flat washer until finger tight (**Fig. 27**).

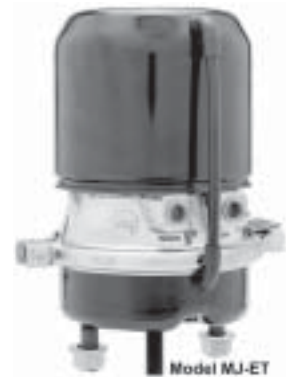
Figure 31

NOTE: With MGM Brakes "Magnum" piston-type brakes, models MG-T and MJ-ET (Fig. 31), the spring brake is manually released by turning the release bolt counter-clockwise using a 3/4-inch deep socket wrench. The release bolt can be completely removed on MG-T models. However, MJ-ET units have a non-removable release bolt. Use the following recommendations when manually releasing MJ-ET models:

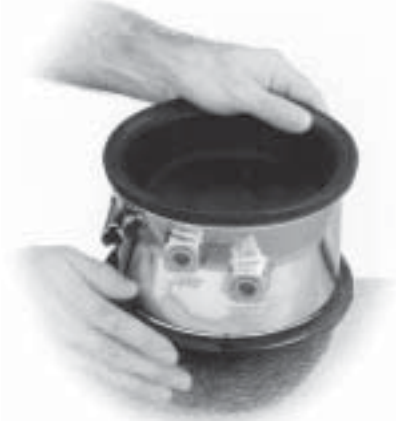
Figure 37

Before installing the new single/piggyback spring brake, make sure it is fully released to zero stroke. Now, position the new diaphragm into the bottom recess of the single/piggyback chamber (**Fig. 37**).

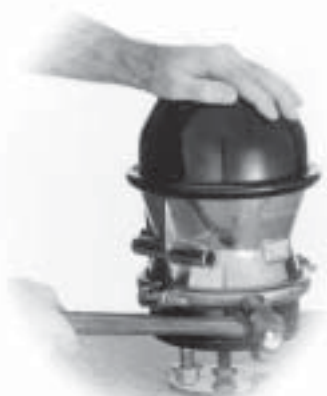
Figure 38

Install the new clamp band bolts and nuts and alternately tighten each nut in 5 to 10 Lbs.-Ft. torque increments while constantly rechecking the alignment of the mating parts. If re-alignment of the mating parts is required, loosen the clamp nuts and repeat the installation process. To help seat the clamp band, firmly tap around the circumference of the clamp band with a plastic or rubber hammer (**Fig. 38**) while alternately tightening the nuts to 30-35 Lbs.-Ft. of torque.

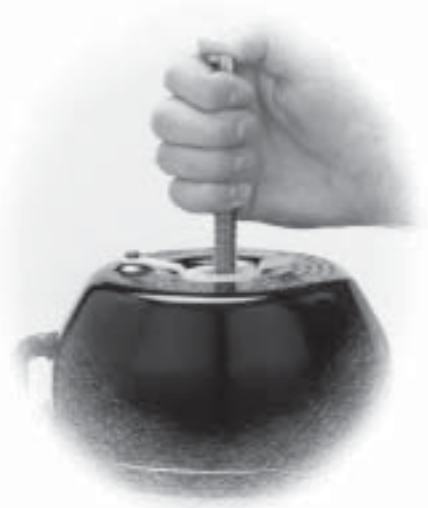
Figure 41

securely into place (**Fig. 41**). Install the RELEASE BOLT, NUT and WASHER into their storage pocket (**Fig. 42**) on the side of the chamber (or put them into the vehicle tool box or glove box). Tighten the RELEASE NUT against the flat WASHER to 10 Lbs.-Ft. torque. If the spring brake chamber is equipped with an integral release bolt (**Fig. 29**), use a 15/16-inch wrench (**DO NOT USE AN IMPACT WRENCH**) and simply turn the release bolt clockwise until the bolt is fully engaged into the unit and the slotted nut bottoms out. Tighten the nut to 45-50 Lbs.-Ft. of torque.

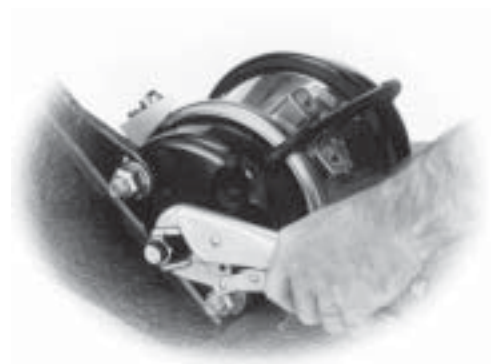
Figure 44

To begin with, make sure the wheels of the vehicle have been securely chocked (or blocked) to prevent the vehicle from moving. Now, manually (or with system air pressure) extend the service push-rod slightly and clamp it in place with vise-grip pliers to prevent sudden separation of the single/piggyback from the service chamber when the clamp band is removed (Fig. 44).

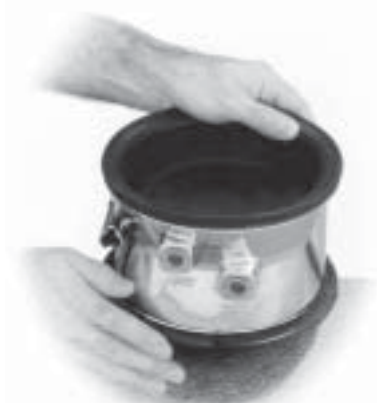
Figure 48

Place a new diaphragm into the cavity of the single/piggyback chamber flange case (**Fig. 48**) and align the single/piggyback with the non-pressure chamber.

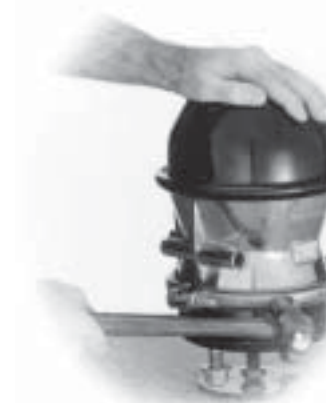
Figure 49

while alternately tightening the clamp band nuts in 5-10 Lbs.-Ft. torque increments (**Fig. 49**). Constantly checking the alignment of the mating parts during this operation will ensure proper seating. MGM Brakes recommends tightening the clamp band nuts to 30-35 Lbs.-Ft. of torque. Be sure to reinstall or replace any I.D. tags that may have been attached to the clamp band bolt, such as the 3-inch trapezoid identification tag or the "Heavy Duty" identification tag.

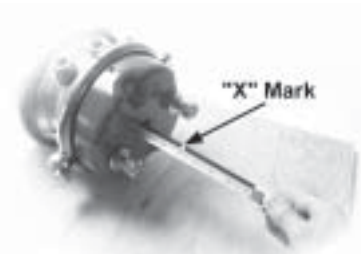
Figure 53

Before marking the push-rod to be cut on the new unit, be sure the spring chamber and push-rod are fully retracted to the zero (0) stroke position. This may be done with the release (or caging) bolt or by applying 90-100 psi air pressure to the spring chamber air inlet port. Then, take the measured "X" dimension from the removed unit and mark the push-rod of the new unit from the bottom of the actuator (**Fig. 53**).

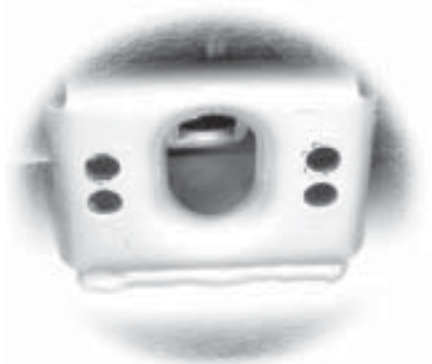
Figure 57

Remove the hex nuts and the flat washers from the mounting bolts of the new chamber. Prior to installing the new combination/tandem brake, take a few minutes to inspect the mounting bracket to insure the bracket surface is free of all cracks, burrs and debris that may prevent the brake from mounting flush to the bracket's surface (**Fig. 57**).

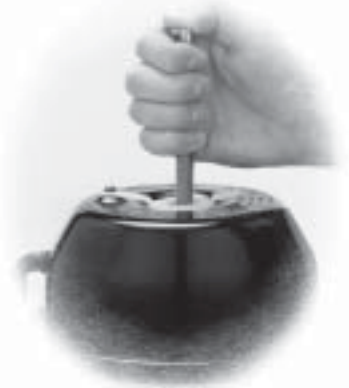
Figure 66

Replace the END CAP or DUST PLUG. Use the RELEASE BOLT to seat the END CAP or DUST PLUG securely (Fig. 66). Operating units equipped with the EXTERNAL BREATHING TUBE not having the END CAP (with O-RING) securely in place will void the MGM Brakes warranty without remedy.
