Instructions for Continuing Airworthiness Service Manual Supplement (FAA STC)

Replacement Comanche Stabilator Horn P/No ADS 1002080828

REPORT NO
ADS 100517-1-15-FAA

PROJECT: COMANCHE STABILATOR HORN APPROVAL

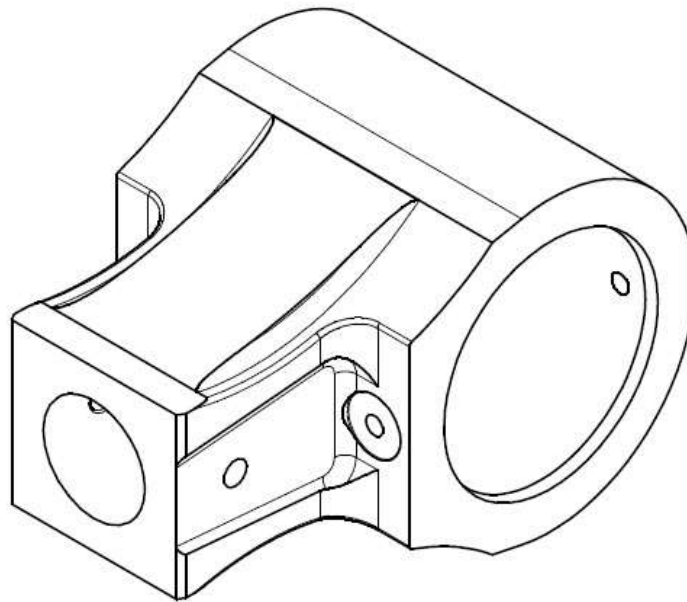
□Figure 1

Figure #1 shows the Stabilator Horn as a separate component.

The Aeronautical Designs Stabilator Horn has been designed as a replacement component for the Piper Stabilator horn P/No 20397-00 in the aircraft listed in Table #1. Added strength and manufacturing features have generated a distinctively different shape for this component. Even with this change in shape the AeroDesigns Component is a direct replacement for the Piper Component.

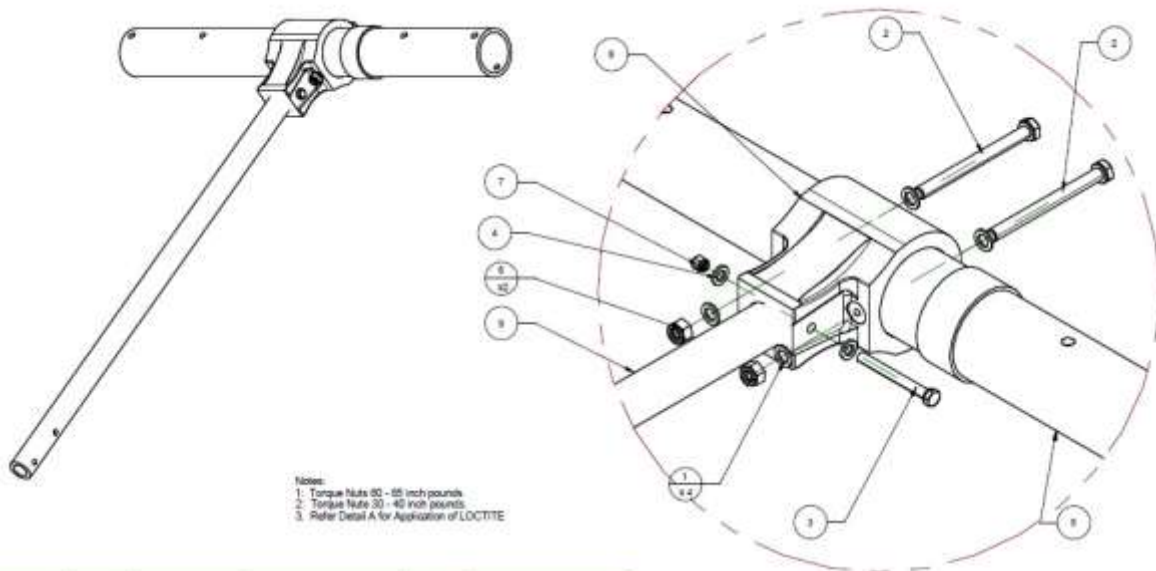
□Figure 2

Figure #2 shows the Stabilator torque tube assembly and includes the Parts List. .

- Notes:
 1. Torque Nuts 90 - 85 inch pounds
 2. Torque Nuts 30 - 40 inch pounds
 3. Refer Detail A for Application of LOCTITE

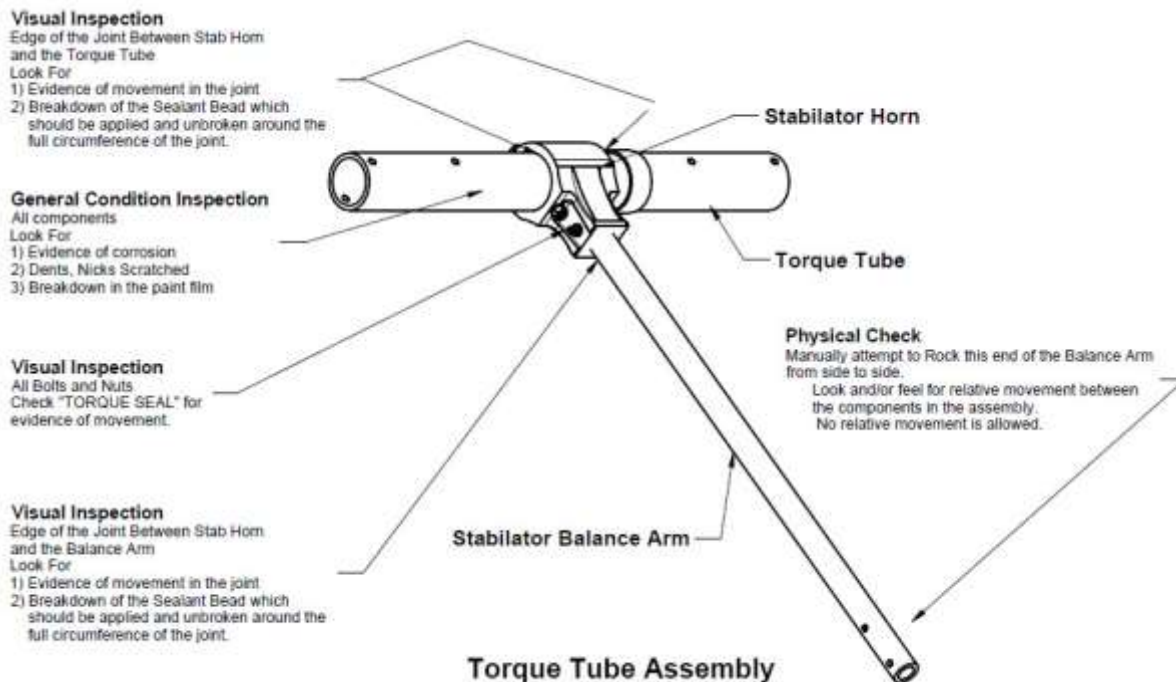
Figure 3

Servicing procedures specified in the Piper Comanche Service Manual continue to apply when this Aeronautical Designs Stabilator horn is fitted however additional inspections are required to check features which are unique to this component. The additional instructions specified in Figure #3 are to be completed at each 100 hourly inspection of the aircraft.

This servicing is done with the stabilator installed on the aircraft. There is no need to remove the stabilator unless the inspection identifies defects which require further investigation.

When conducting these inspections it is important to understand the following acceptance criteria

- 1) Any evidence of movement in the joints is unacceptable, and an engineering dispensation is required before further flight after the movement is detected

- b. Classification and assessment of defects on the Replacement Stabilator Horn should be in accordance with the following
 - i. Scratches
 1. Surface Scratches and Sharp Edged Nicks are unacceptable

- a. All scratches and Sharp Edged nicks are to be removed by blending.
 - i. Acceptable blends have a depth to surface length ratio of 1:3 or greater
 - ii. Blend depths up to 0.5mm are allowable

- iii. Blend depths exceeding 0.5mm must receive evaluation and Engineering Dispensation
 - ii. Dents
 1. Smooth dents with no visible cracking are acceptable up to 0.5mm

- a. Dents should be checked with Fluorescent Dye Penetrant NDI methods (Per SAE –AMS 2647 or ASTM E1417, or equivalent) to check for cracking
- b. Dents deeper than 0.5 mm will require Engineering Dispensation

- iii. Corrosion
 - 1. All corrosion damage must be addressed by
 - a. Abrading to remove all traces of corrosion
 - b. Blending to achieve a smooth 1:3 (or larger) blend profile

- c. Etch prime and paint the reworked surface.
- iv. Cracks
 - 1. It is unacceptable to have any evidence of cracking in the Replacement Stabilator Horn

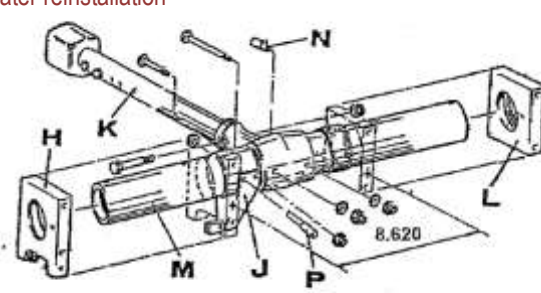
1.	<p>Remove all paint and rust from the outer surface of the torque tube. Coat the torque tube with a light oil to aid the removal of the various components.</p> <p style="color: red;">Note: During the removal of components from the torque tube assembly, note the relative position of the components to help reassembling them correctly.</p>
2.	<p>Remove the Both Bearing Blocks (Item H and L on diagram)</p> <p style="color: red;">Note the position of any shims, Record the thickness and location for later reinstallation</p>

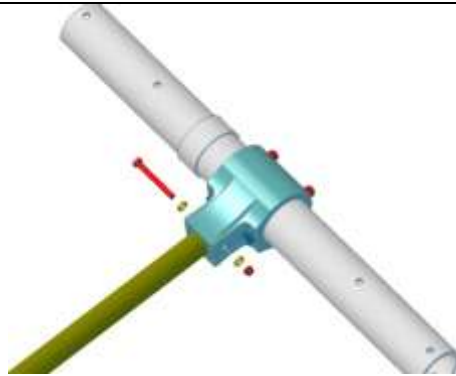
3.	<p>Look Up inside the Torque Tube to visually inspect the exposed sections of the stabilator horn and collar attaching bolts for corrosion. Dress the bolts using emery paper, to remove the corrosion if present on the bolts.</p>
4.	<p>Remove the AN4 Bolt attaching the Balance Arm to the Stabilator Horn.</p>

Note: LOCTITE is used as a retaining compound for this bolt, and the AN5 bolts. If the bolt cannot be driven out easily it may be necessary to apply heat (60 – 80 degrees Celsius) to the stabilator horn to soften the LOCTITE.

Apply heat to the stabilator horn using a hot air gun (not a propane or similar gas burner). Continue to apply the heat unto the horn is at 60 to 80 deg Celsius (Use an Infrared Thermometer to measure this temperature) Avoid heating the torque tube shaft as much as possible.

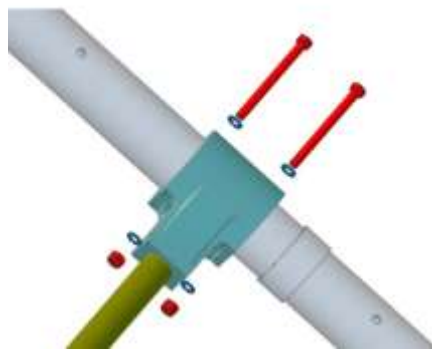
5. Remove the two bolts attaching the Stabilator Horn to the Torque tube.

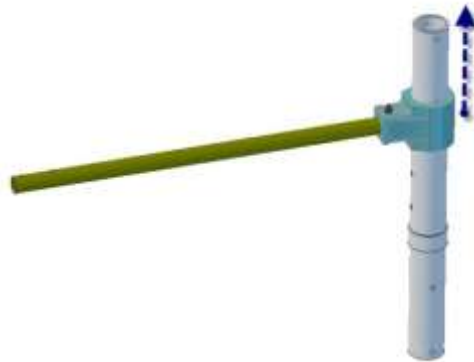
6. Place the Torque Tube Assembly in a soft jaw vice with the torque tube axis vertical. Tighten the vice sufficiently to hold prevent the torque tube from rotating.

Note: Experience has shown that it is easy to permanently deform the torque tube, particularly the torque tube from single engine aircraft, when clamping in a vice. Use of the clamping Collar (ADS 1011031045) or similar fixture is recommended to reduce the risk of permanently deforming the torque tube.

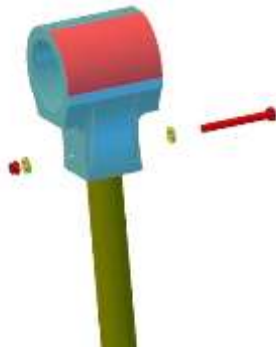
8. Remove the 1/4inch bolt attaching the balance arm to the horn.

<p>9.</p>	<p>Withdraw the balance arm from the stabilator horn.</p> <p>Note: The joint between the balance arm and the stabilator horn is an interference fit and it is secured with LOCTITE Retaining Compound. Use of heat (60-80 degrees Celsius) and a puller will be necessary to withdraw the arm from the horn. Take care not to damage the horn or the balance arm in this process as both items will be reused on assembly</p> <p>Apply heat to the stabilator horn using a hot air gun (not a propane or similar gas burner). Continue to apply the heat unto the horn is at 60 to 80 deg Celsius (Use an Infrared Thermometer to measure this temperature) Avoid heating the torque tube shaft as much as possible.</p>
<p>10.</p>	<p>Visually inspect the balance arm internal and external surfaces</p> <ul style="list-style-type: none"> • looking for corrosion, • evidence of cracking, or • other damage <p>Warning: Replace the balance arm, or seeking further engineering appraisal of there is evidence of cracking.</p> <p>Caution: Remove light surface corrosion, using 3M Abrasive Impregnated Nylon Wheel (ROLOC) Fine Grade. Material removal up to 0.5mm (0.020”) is acceptable. Seek further engineering evaluation depth of material removed exceeds this amount at any location on the shaft.</p>

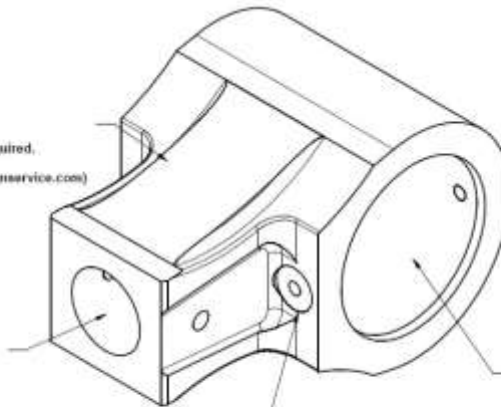
□Figure 4

Clean and inspect the Stabilator Horn. Acceptable defect, and rework criteria are provided in Figure #4

External Surface for Dents, Nicks, Cracks or Corrosion.

Smooth Dents up to 0.5mm deep are acceptable
Blending of corrosion to a depth of 0.5mm is acceptable
Blend nicks to a smooth profile, up to 0.5mm deep
Seek engineering Dispensation if greater blend depth is required.

Internal Bore for evidence of cracks or corrosion.
Inspect using Dye Penetrant Methods for cracks
The edges of all bolt holes

Smooth Score marks in the bore cause by installation or removal operations. Permitted depth is 0.5mm

All Bolt Holes for elongation.
Obtain Engineering Dispensation if Oversize holes are required.

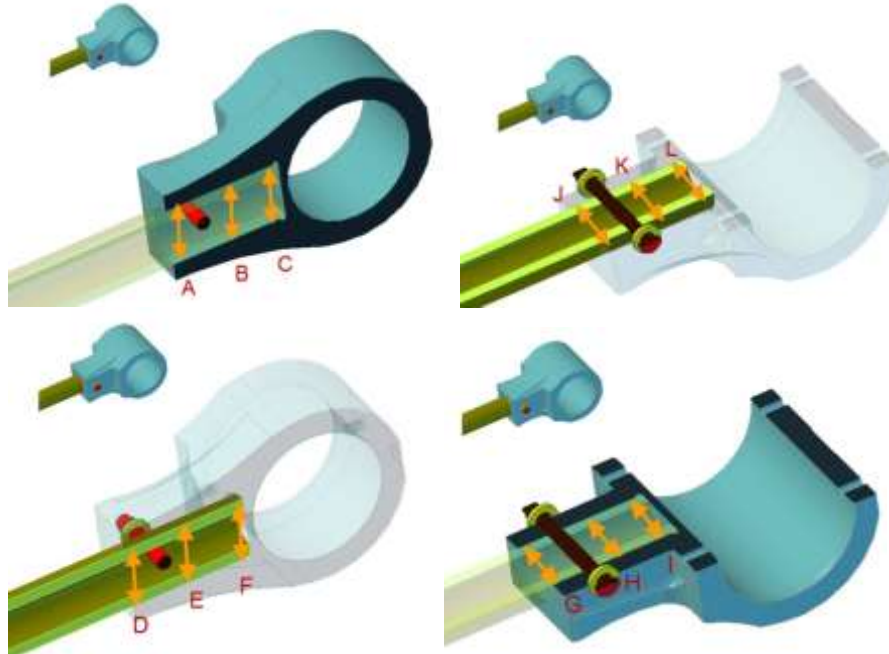
15. Use a 25 to 50mm (1 to 2 inch) micrometer to measure the outside diameter of the balance arm at the six locations “D”, “E”, “F”, “J”, “K”, and “L” shown in the diagram opposite. .
Record the readings in the Measurement Table at the end of these instructions.
(Measurement Accuracy 0.0005”)

Note: Dimensions “A”, “B”, “C” and “G”, “H”, and “I” are measurements of the “BORE” sizes, while “D”, “E” and “F” and “J”, “K”, and “L” are measurements of the shaft diameter.

16. Calculate the level of interference at each of the six locations using the following relationship

$$\text{Interference} = \text{Shaft Diameter} - \text{Bore Diameter}$$

17. The allowable level of interference is within the range 0.000” to 0.002” (0.00mm to 0.05mm).

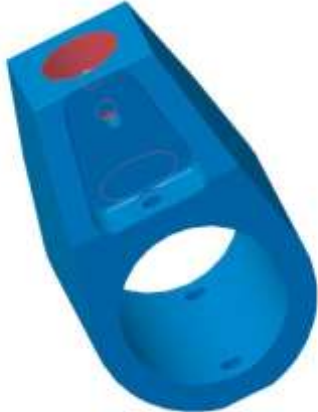
<p>20.</p>	<p>Clean the 28mm bore by wiping with a clean lint free cloth moistened with LOCTITE Cleaner Degreaser</p>

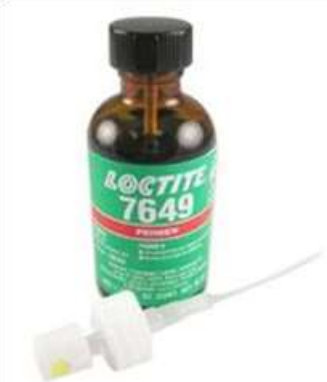
<p>21.</p>	<p>Apply LOCTITE Primer (Product 7649 to the surface of the bore, and allow to dry)</p>

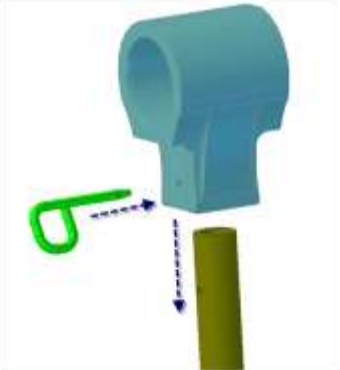
<p>28.</p>	<p>Hold the horn above the end of the balance arm and rotate the horn to obtain a correct alignment of the ¼ inch hole in the horn with the ¼ inch hole in the balance arm.</p>

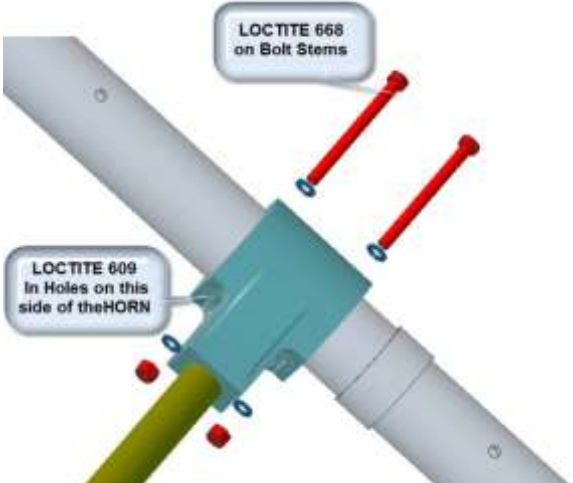
48.	<p>Install AN5-34A bolts from the front of the horn until fully seated on the horn.</p>

49.	<p>Fit MS21083N-5 nuts and AN960L-516 washer. Torque nuts to 60 to 85 inch pounds. (ADS Dwg 1010250946 Refers).</p>

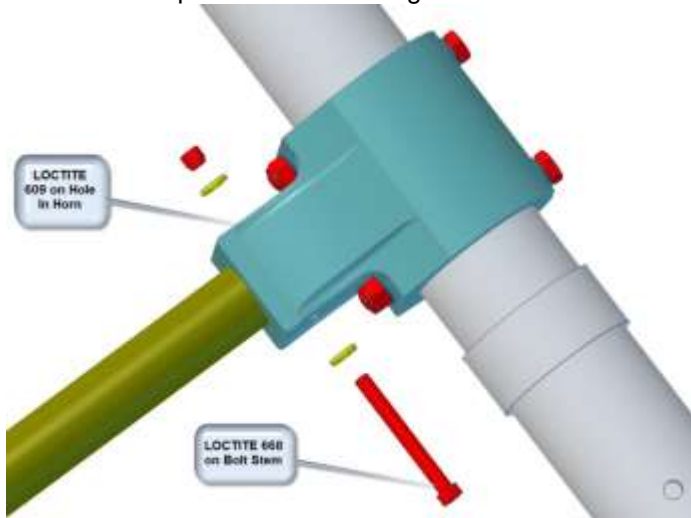
50.	<p>Coat the shank of the bolt 15mm from the head with LOCTITE 668 prior to installation. Install the AN4-22A Bolt , MS21044-4 nut and AN906-416 Torque Nut to 30 to 40 inch-pounds. Per Drawing ADS 1010250946.</p>
