HP LaserJet Family Quick Reference Service Guide

Volume I

Publication number 5021-8943

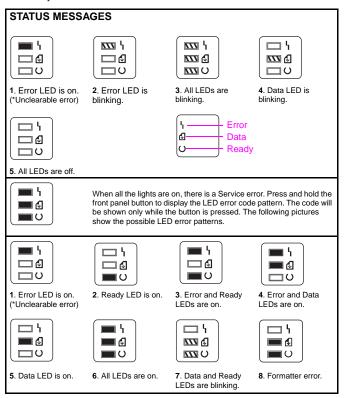
LJ 6L, 5L Printer Light-Emitting Diode (LED) Displays

See the legend that follows for a description of the error and the action to remedy it.

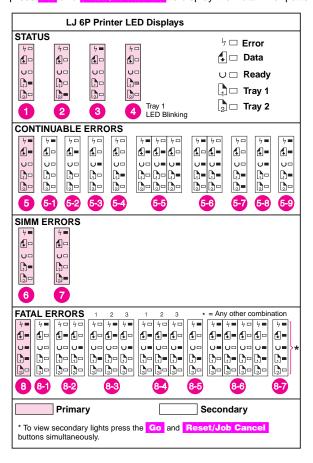
LJ 6P Printer LED Displays

See the legend that follows for a description of the error and the action to remedy it. If both the error and data lights are lit, simultaneously press Go and Reset/Job Cancel to display the Data Error pattern.

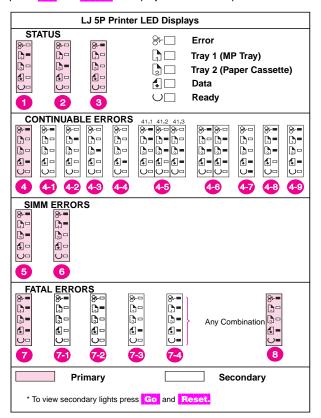
LJ 5P Printer LED Displays

See the legend that follows for a description of the error and the action to remedy it. If both the error and data lights are lit, simultaneously press Go and Reset to display the Data Error pattern.

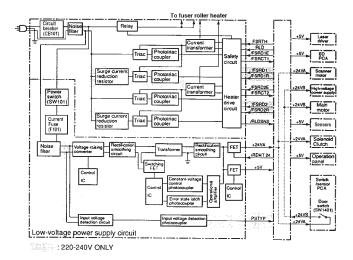
Figure 3-2 Low Voltage Power Supply and Distribution System

The AC and DC power supply circuits are contained in the Low Voltage Power Supply (LVPS). The high voltages required for image formation are generated by the High Voltage Power Supply (HVPS). The Low Voltage Power Supply and Distribution System are illustrated below.

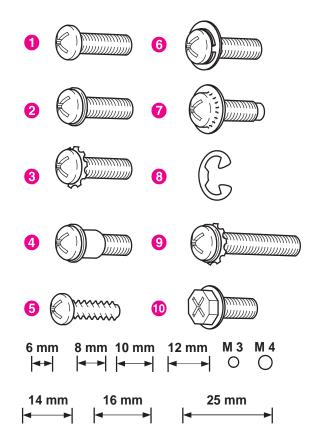
Figure 8-1 Common Hardware

This chapter provides a list of the hardware found in HP LaserJet printers. In the following tables, the shaded areas refer to the location of the part in the printer, as shown in the corresponding illustration. The tables also provide the part or product number and a description.

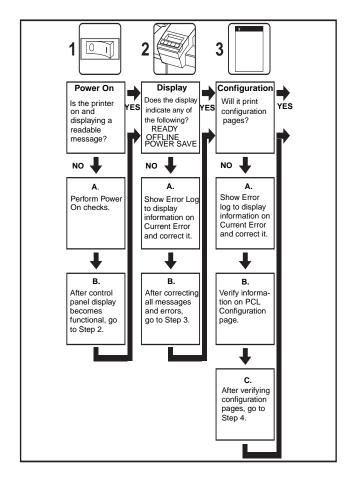
Figure 9-1 Troubleshooting process for HP LaserJet printers

The troubleshooting process, illustrated in figures 9-1 and 9-2, is a systematic approach to resolving printer problems. In searching for the causes for printer malfunctions and errors, the troubleshooting process addresses major problems first and then identifies secondary problems.

In figures 9-1 and 9-2, each heading depicts a major troubleshooting step. A **YES** answer to the questions allows you to proceed to the next major step. A **NO** answer indicates that additional testing is needed. Proceed to the referenced location and follow the instructions for that area. After completing the additional testing, proceed to the next major step.
